2018 Town of Richmond, VT Facilities Assessment

BreadLoaf

Executive Summary

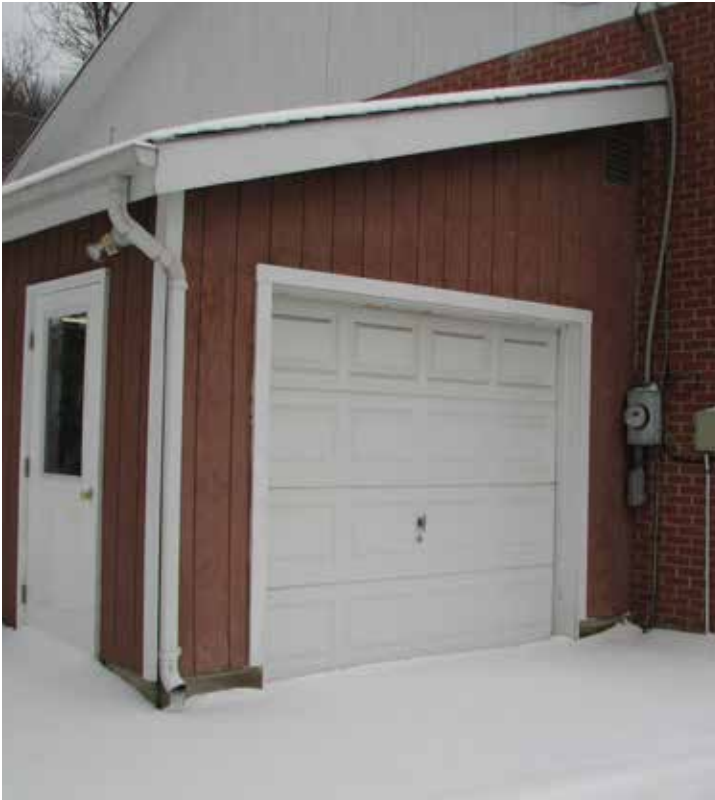
Wood framed antique truck bay

7. Replace all windows. *(HW)* 2019 BUDGET: \$2,500
8. Demolish wood-framed antique truck bay and construct a new bay to house recently purchased truck. *Functionality Recommendation (FR)*
2019 BUDGET: \$193,000

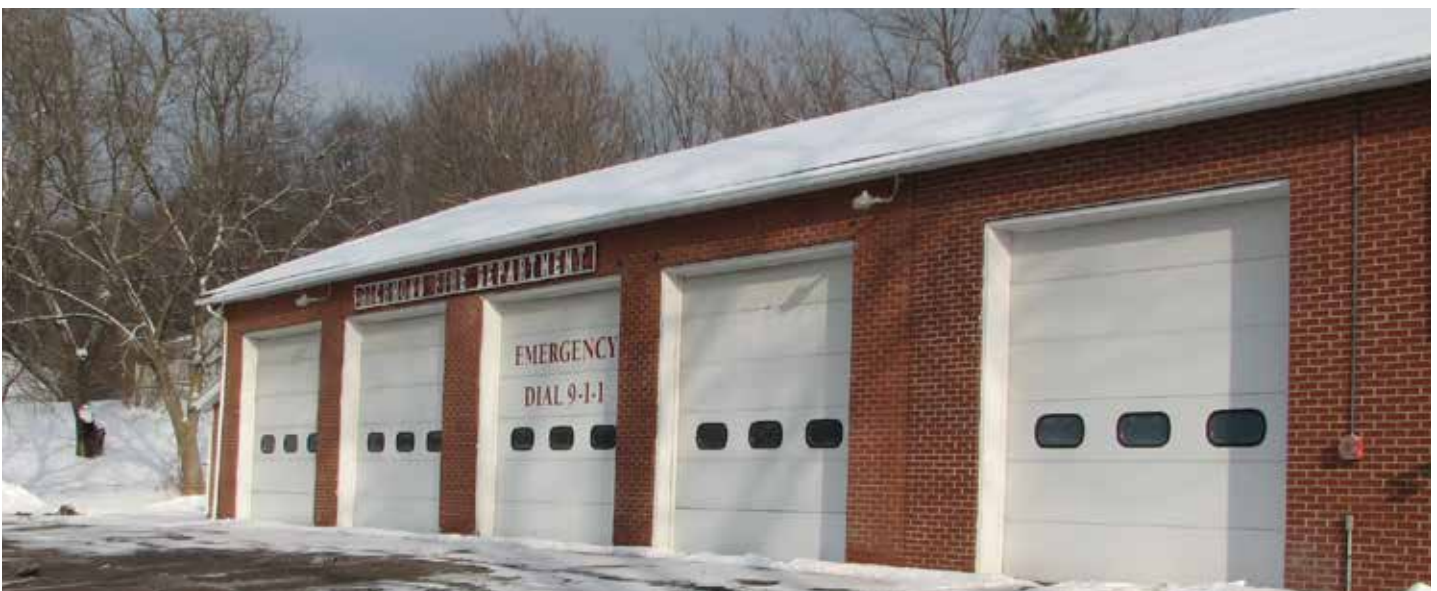
The overhead doors are in poor condition. There is rotting wood visible at all of the jambs where they meet the concrete slab. The panels on the doors are warping. Vinyl weather-stripping has hardened and chipped in multiple locations. The overhead door remote operators will not close the doors once a truck has exited a bay, causing the firefighters to exit the truck, re-enter the building and close the doors from inside.

Apparatus Bay overhead doors with inadequate lighting

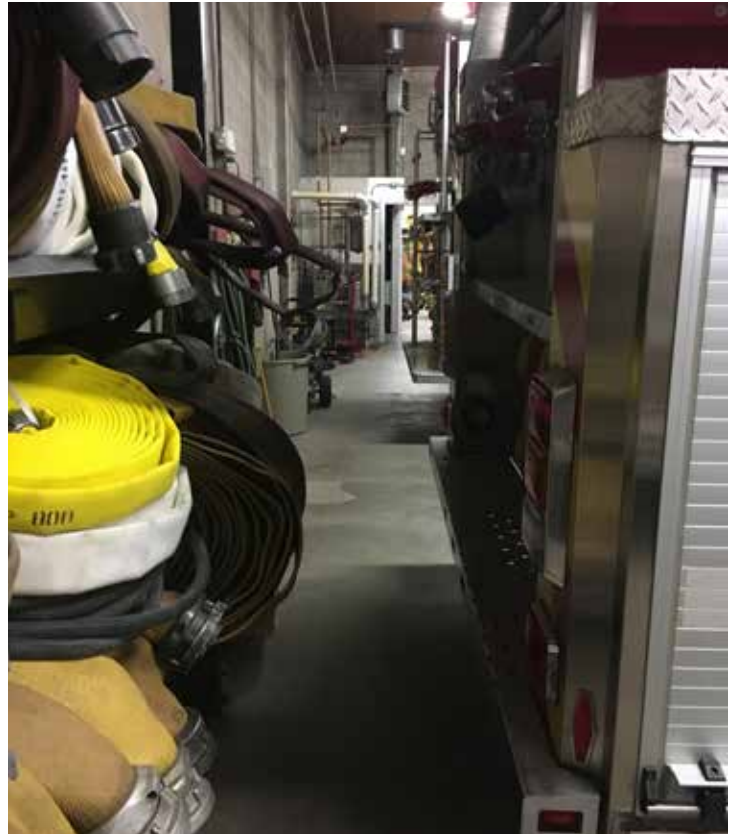
The apparatus bay is just deep enough to fit the trucks that RVFD currently has in service. Circulation space in front of and behind the trucks is very tight and this is a limiting factor when it comes time to upgrade to newer fire apparatus, which average 38 feet long. Space between the trucks is also tight, resulting in insufficient space to lay out and dry the hoses. The concrete slab is in fair condition but there is some damage around the floor drains. The existing truck fill system is comprised of a plastic 1,000 gallon tank which feeds into an overhead PVC pipe with a small diameter soft hose above each truck. This results in a very long fill time per truck.

Tight space at hose storage and back of trucks

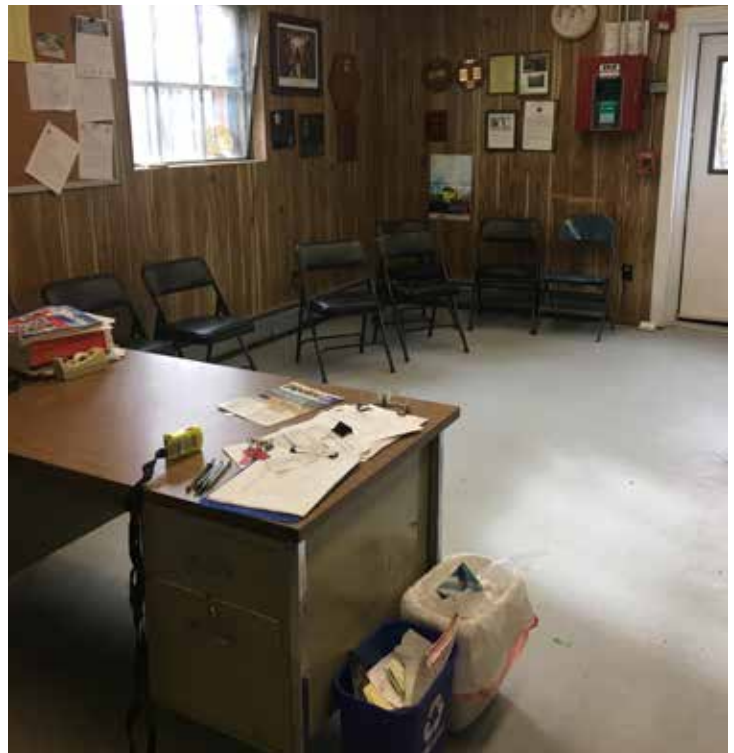
The training room is approximately 260sf and is used for department meetings and training. The space is too small to adequately hold 18 firefighters in a meeting or training setting. The wood paneling on the walls is in poor condition. The floor is painted concrete and is in fair condition.

Undersized training room

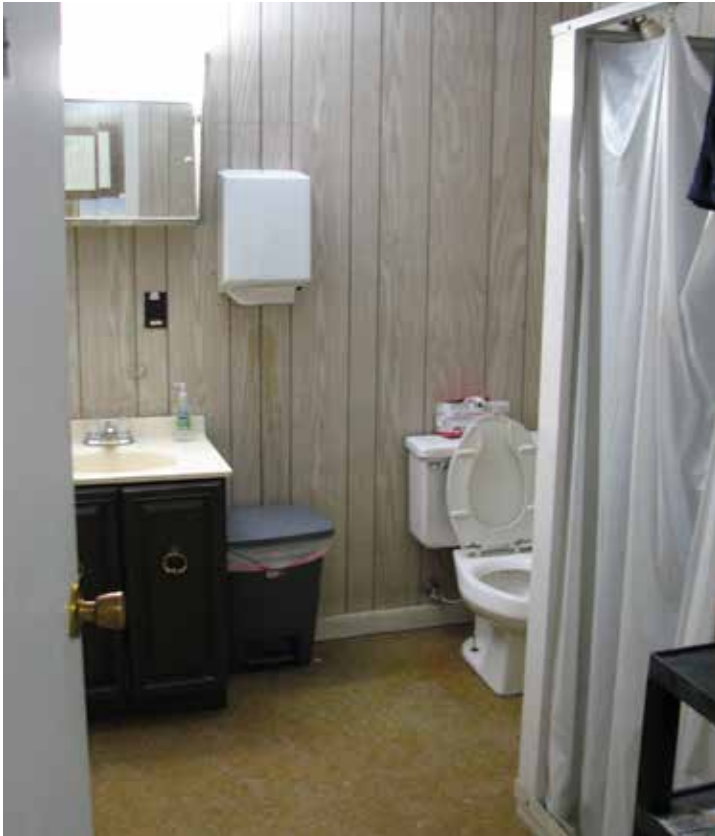
There is one small bathroom in the building. It does not meet ADA requirements for accessibility and would be required to be updated and enlarged during a renovation. There is a small free standing, fiberglass shower that is not used by department personnel due to its small size and poor condition.

Non compliant bathroom layout

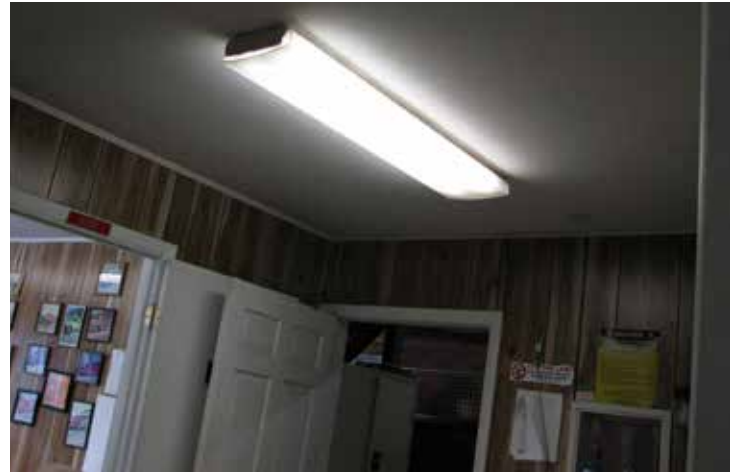
Two-bulb T8 fluorescent light fixtures

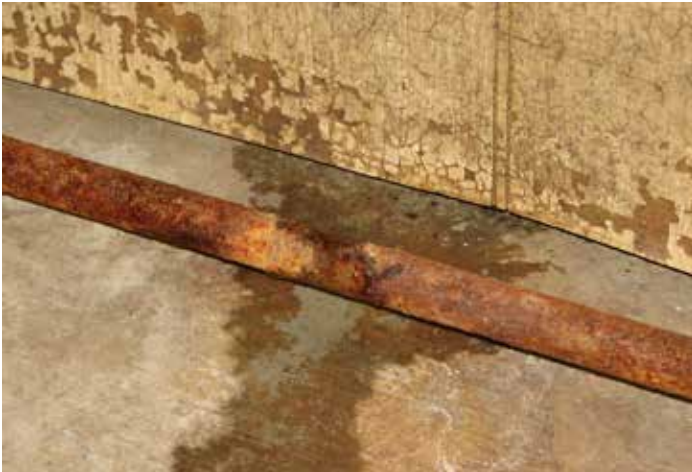
Corrosion of water service pipe

The building is fed via a ¾" town water service to a 1,000 gallon plastic storage tank. The fill system is 1.5" PVC and is failing. The PVC line should be replaced in the near future. Upon discussion with the Town of Richmond water authority, it was determined that the water service is protected by a backflow preventer in the exterior meter pit. Domestic hot water is provided by a SuperStor SSU-30 indirect water heater fed from the building boiler zone #4. The indirect heater is less than one year old and has an anticipated service life of 20 plus years. The system has a code compliant mixing valve. The domestic hot water piping however is uninsulated and should be insulated to meet current energy codes. The piping system is in fair condition but will require repairs over the next 10 years due to corrosion of pipe and fitting.

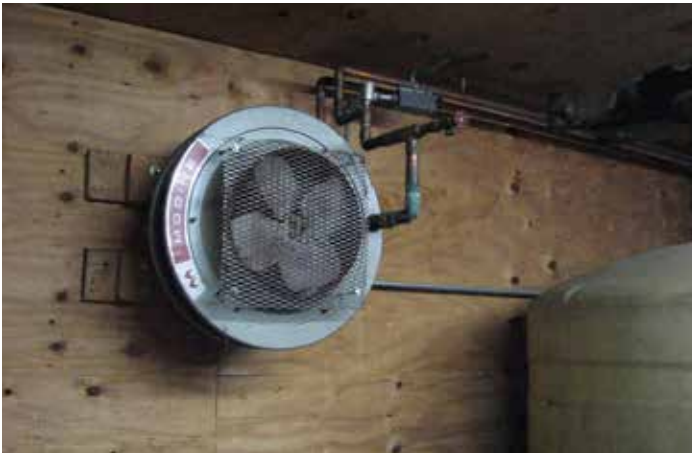
1. Six (6) Hot water Modine type unit heaters for apparatus bays.
2. Hot water fin tube radiation in Meeting and Office area.
3. The equipment has a service life of 25 plus years and appears to have been replaced within the last 10 years.
4. Controls of unit heaters and fin tube is via manual thermostats.

Modine heater in antique truck bay

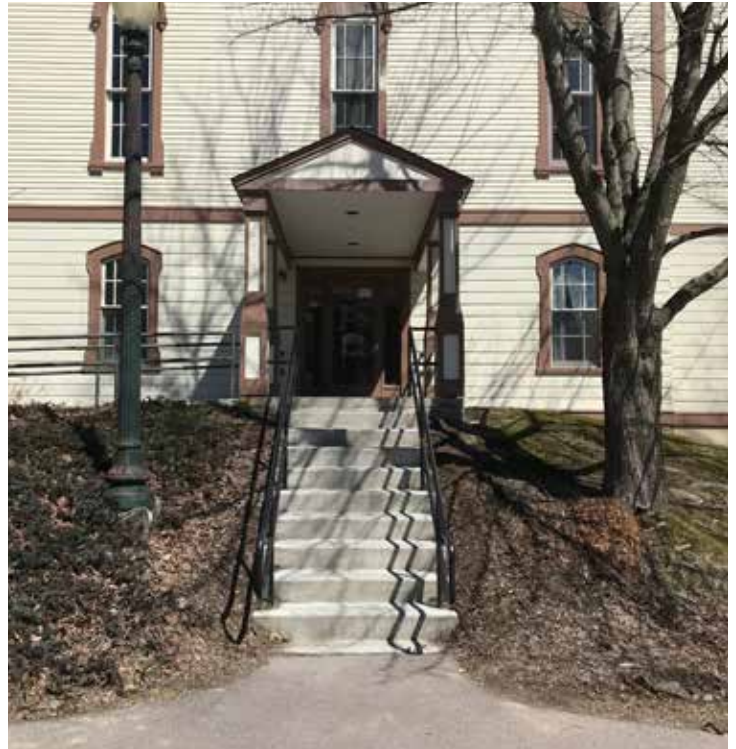
Stairs at main entrance

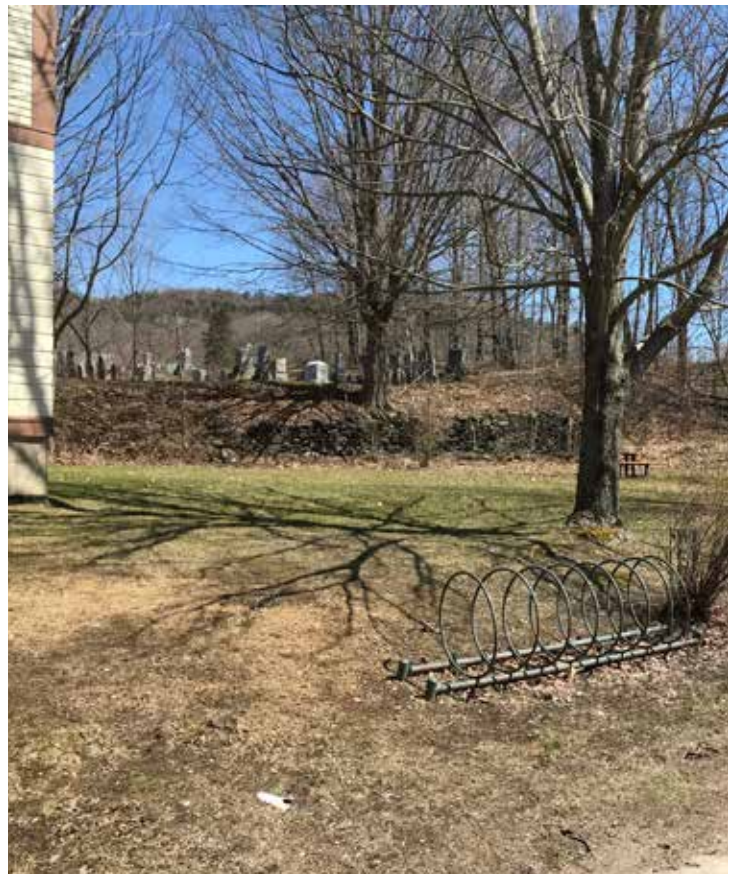
There is a lawn area on the south side of the building that is greatly under-utilized. There is one picnic table in the area but there is nothing leading pedestrians to the space either from parking or the building. This could be an area to develop into a nice space for some outdoor program for the Library.

South lawn space

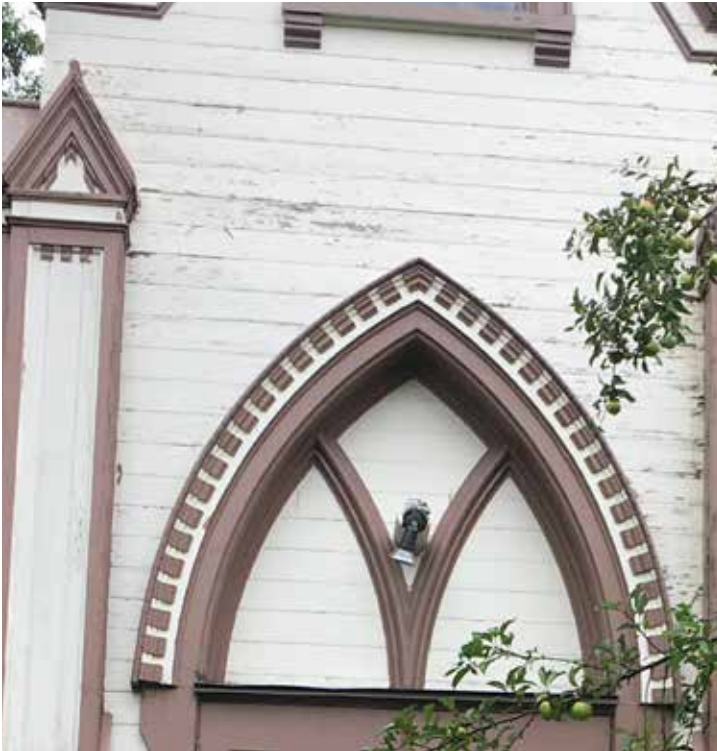
The majority of the exterior wood siding is in fair condition. The paint has started to crack and peel in certain locations and needs to be scraped. There are some areas where the siding is cracked and will need to be replaced. There is some significant rot and paint peel visible on the northwest steeple. This location appears to be in the worst condition compared to the rest of the building. The northeast steeple has some significant paint peel above the doors. The east side of the building is heavily shaded by adjacent trees which are causing some moisture related damage on the siding and window trim. There is a lot of paint damage along this elevation.

Paint peel and rot at northeast steeple above door

- 6d. Full window replacement.(HW) 2019 BUDGET: \$136,000
- 7. Scrape and repaint exterior clapboards and trim and replace rotted wood trim as required. (HW) 2019 BUDGET: \$83,000
- 8. Renovate main desk (see adjacent page) (FR) 2019 BUDGET: \$8,600
- 9. Install vapor barrier over basement dirt floor. (HW) 2019 BUDGET: \$8,500
- 10a. Repair historic slate roof, full replacement (see recommendations of 2015 Jan Lewandoski survey in Appendix) (HW) 2019 BUDGET: \$142,000
- 10b. Repair/restore roof on North East steeple. (HW) 2019 BUDGET: \$157,000
- 11. Install new lighting and controls. (HW) 2019 BUDGET: \$15,000
- 12. Add drinking fountains as required by code. (LSC) 2019 BUDGET: \$2,700 EACH

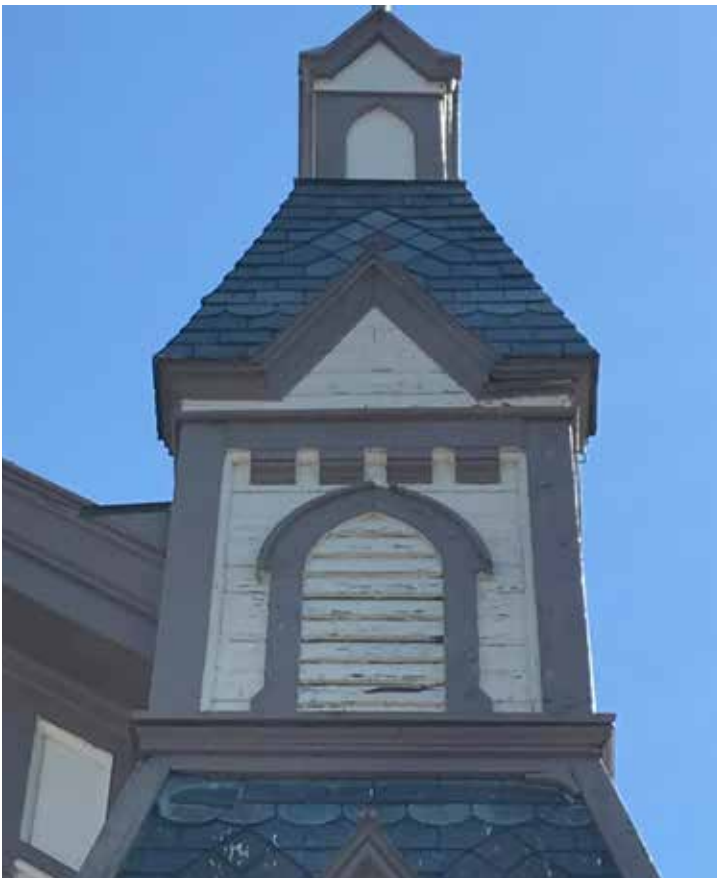
North gable end rot

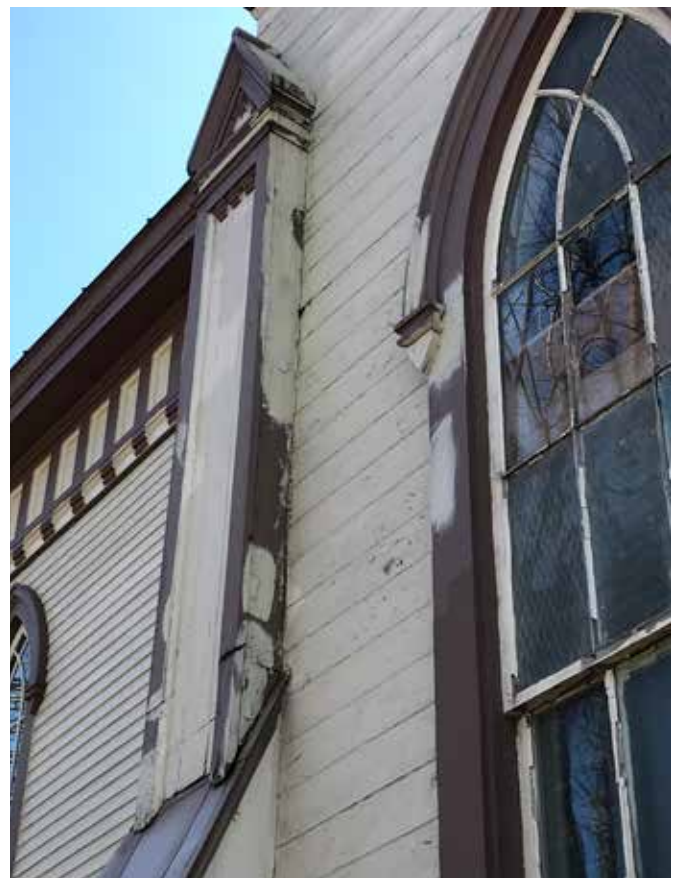
East elevation paint damage

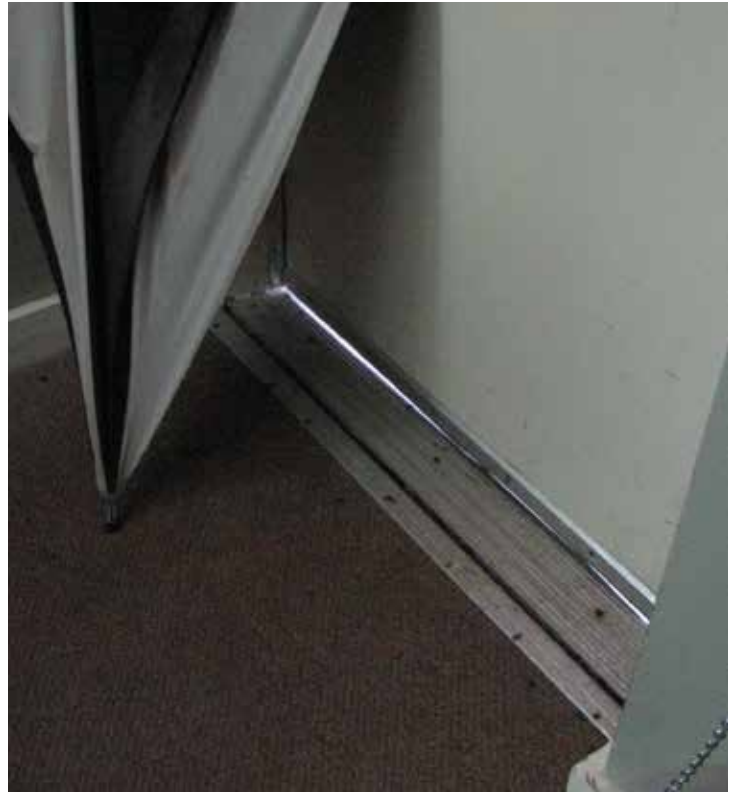
The first floor windows are from the 1991 renovation. The second floor windows are from the 2003 renovation. Excluding the custom built windows in the community room, the windows of the are all Marvin units. Even though the newest windows are from 2003, all units are experiencing some degree of air infiltration. Specifically, there are two windows on the Bridge Street side of the Library where daylight is visible between the window frame and jamb framing. The exterior door on the northeast steeple leaks air along the threshold. On the south side of the building, the exit door on the stair tower has visible daylight along the entire bottom of the door.

Daylight at stair tower door

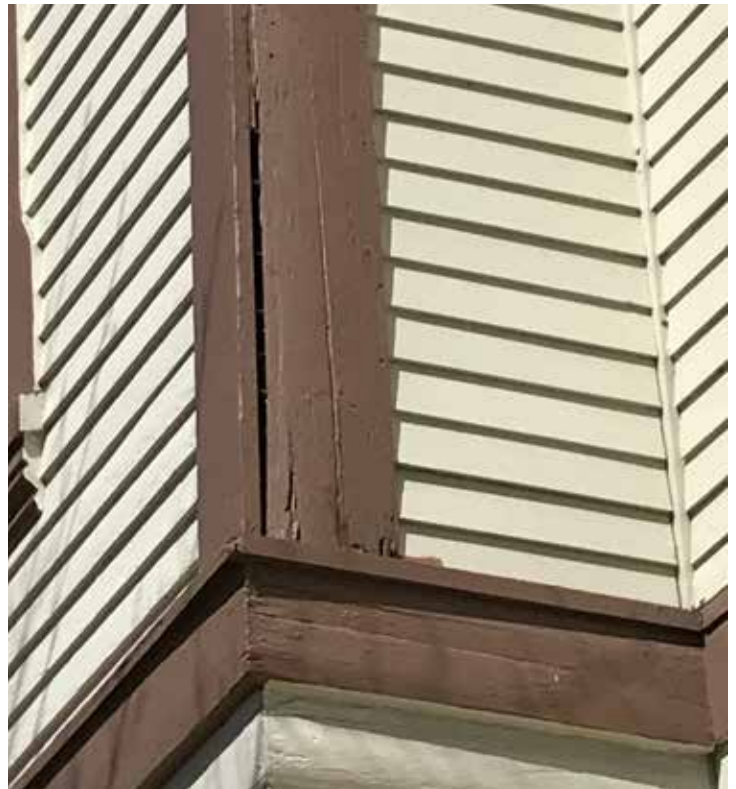
Damaged wood trim

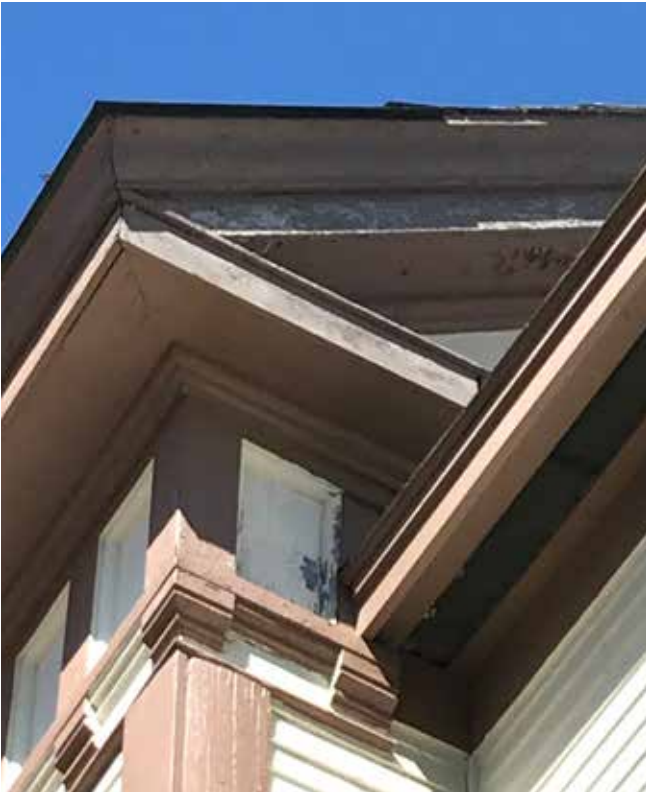
Wood trim rot and peeling paint

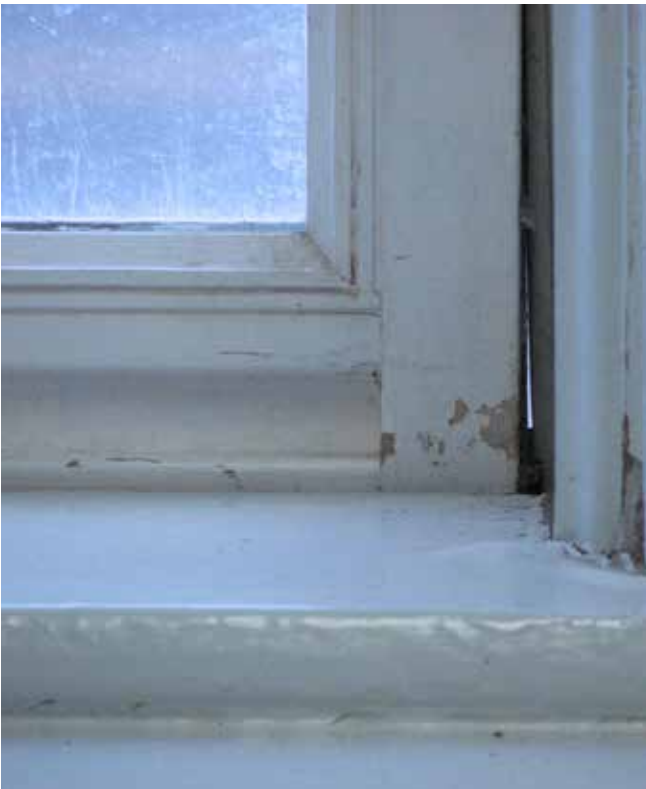
Daylight at window frame

- 6a. Add weatherstripping to windows to close major gaps. (HW) 2019 BUDGET: \$8,100
- 6b. Add interior storm panels to windows. (HW) 2019 BUDGET: \$27,000

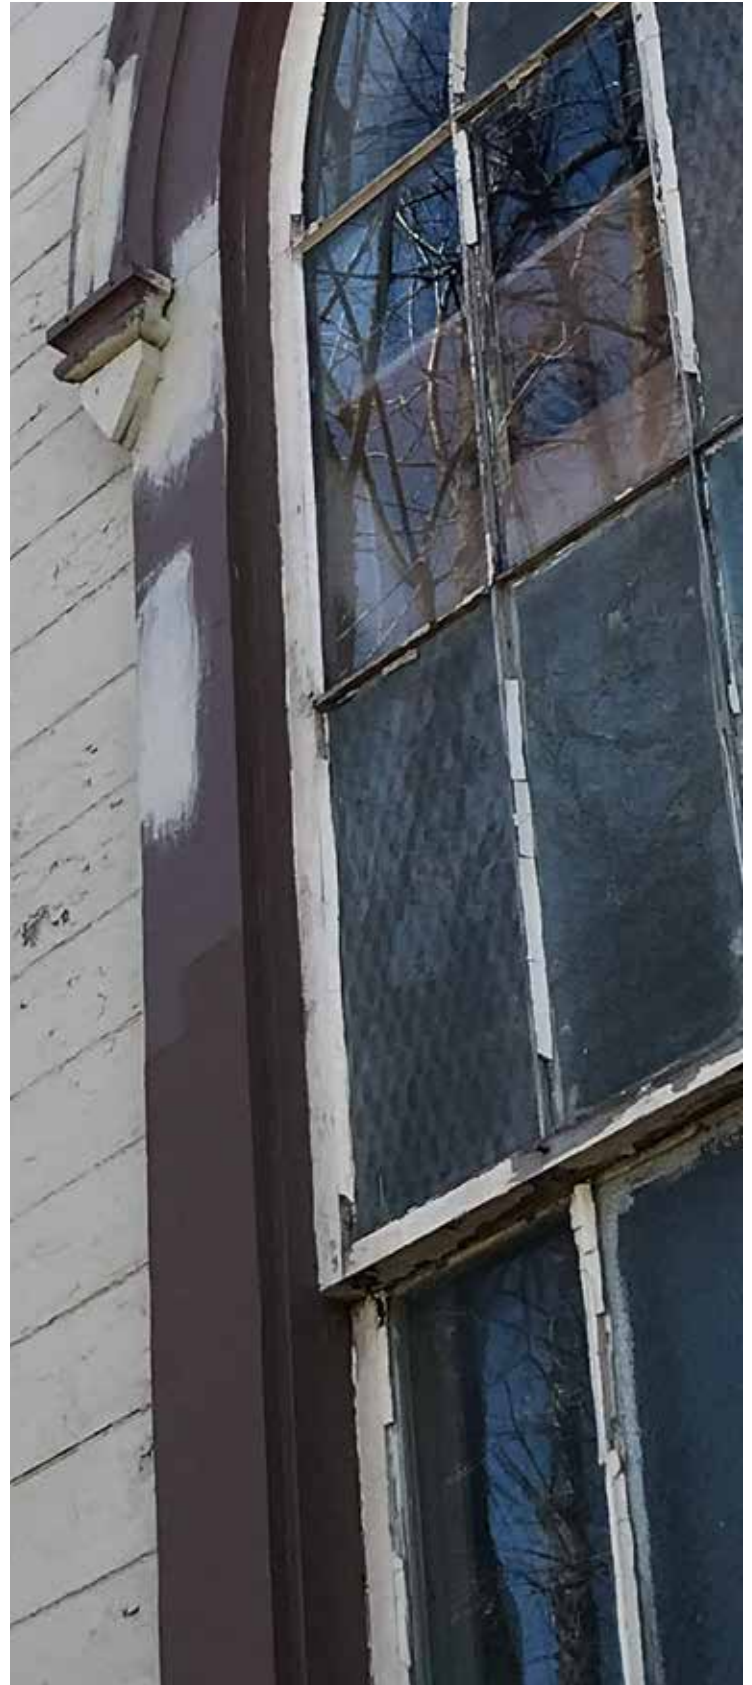
Community Room window exterior

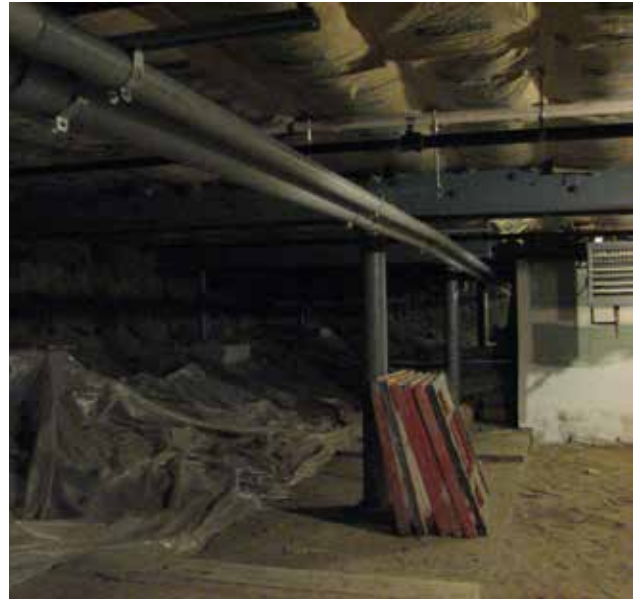
The basement level includes a small storage closet, elevator machine room and access into the elevator shaft, all on a concrete slab. The remainder of the space is on a dirt floor with heights to underside of structure ranging from three feet to six feet. There is a small enclosed room within this area that includes the boiler as well as manifolds for the first floor radiant heat system. There are multiple unsealed penetrations in the foundation wall resulting in air & moisture infiltration. There are fiberglass insulation batts installed between the floor joists, some of which have fallen over time. A blown-in type of insulation was installed along the perimeter foundation wall and has collapsed or is in the process of collapsing in multiple locations. Mouse traps were observed during the survey and staff reported that there is a rodent problem in the basement. At the time of survey, there was a musty smell present in the elevator cab and hoistway. An air and mold testing assessment is recommended for this area of the building.

Dirt floor at basement level

- 5a. Replace radiant floor heat system at first floor. (HW) 2019 BUDGET: \$32,000
- 5b. Hire ATC to perform air/mold test around the elevator shaft. (HW) 2019 BUDGET: \$2,800

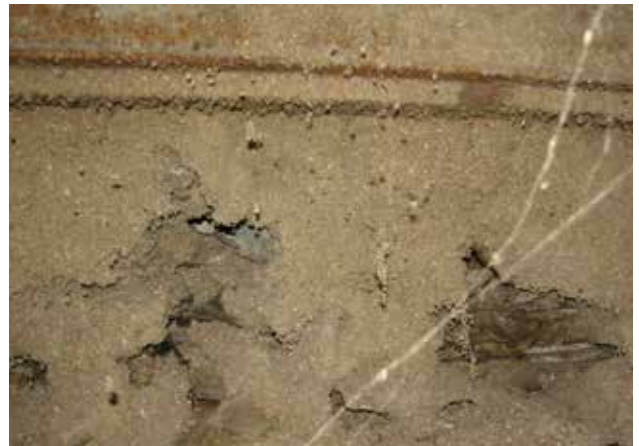
Insulation collapsing at interior of foundation wall

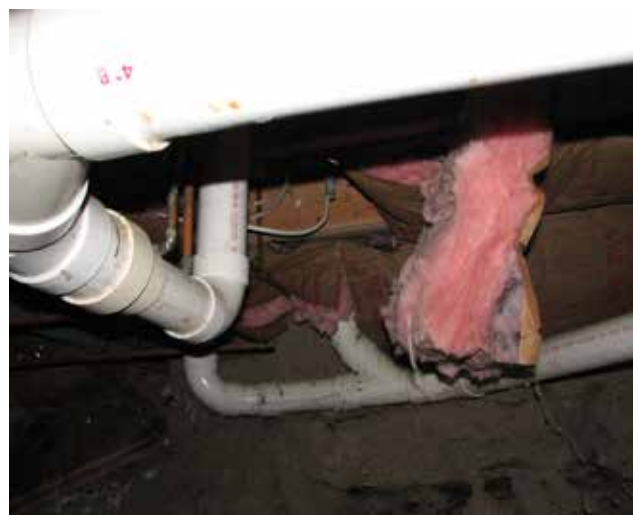
Insulation falling from floor joist cavity

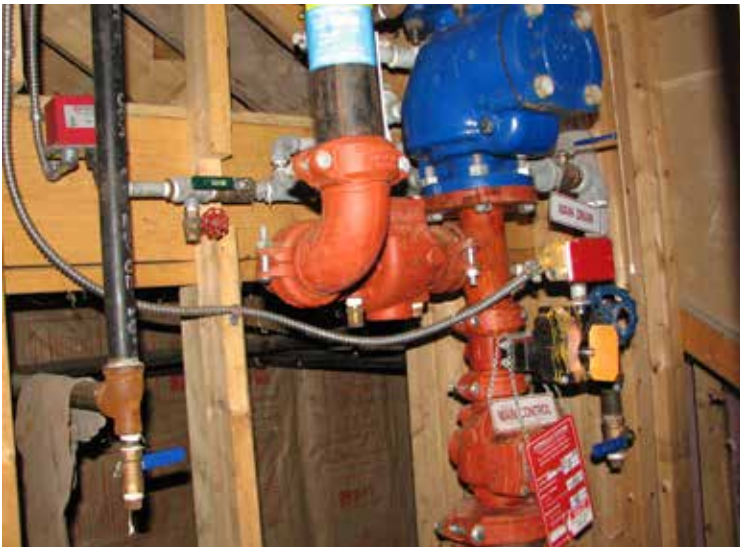
Sprinkler service entrance

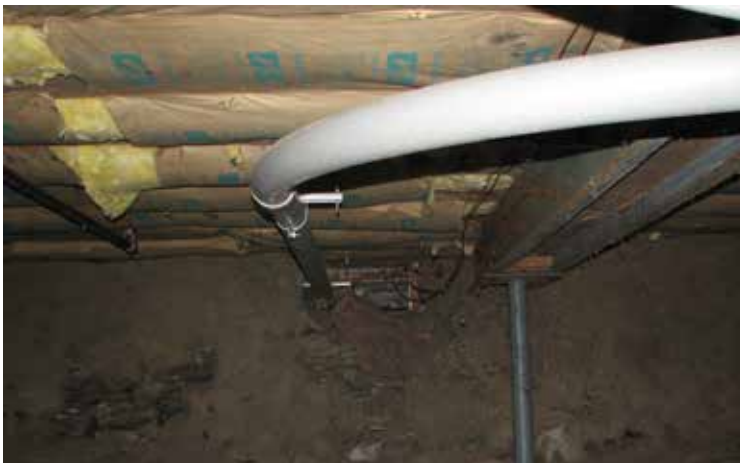
Unsealed pipe penetration through foundation

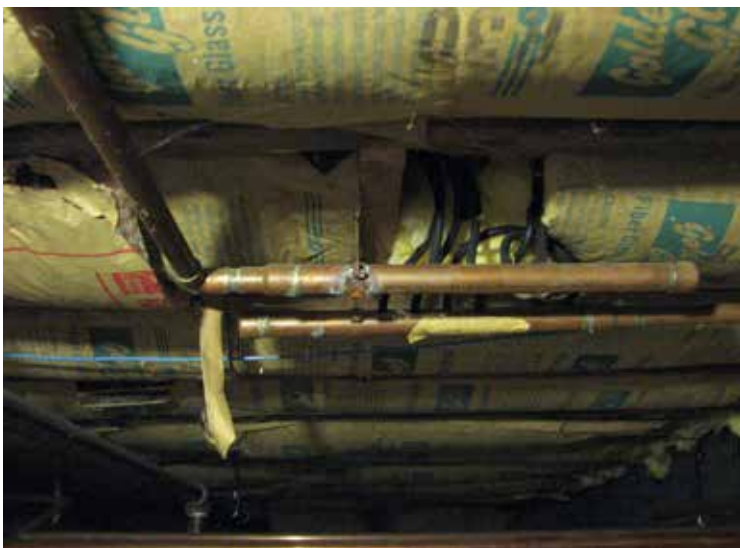
Corrosion of copper piping in radiant floor system

A Weil McLain natural gas CGS sealed combustion 167,000 BTUH boiler serves the serves radiant floor, perimeter baseboard and unit heaters heat in the basement and lower level of the building. The boiler appears in good condition and has a useful service life of 15 plus years. The hot water heat distribution piping throughout building is uninsulated. The radiant floor system appears to be a Bio Energy Radiant Roll 2-tube EPDM system. The system manufacturer is no longer in business and the system is at or near the end of its life expectancy. Other installed systems have reports of numerous failures and class action suits. The primary issue is that the black EPDM radiant tubing does not have an oxygen barrier. Consequently, ferrous components within the heating system corrode leading to premature failure of the ferrous boiler and boiler system components. This corrosion often results in plugging or flow restriction in the less than .25" ID tubing and there are numerous reports of the tubes having a no flow condition. In addition, the oxygen entering the system through the tubing results in a low PH (acidic) condition of the water causing the EPDM tubing to dry rot and fail. Per the adjacent picture, it is apparent that tubing failures have occurred, (see corrosion of header pipes). While there are still installed systems such as this that have not had reported major issues, it appears that a system replacement should be planned for in the near future.

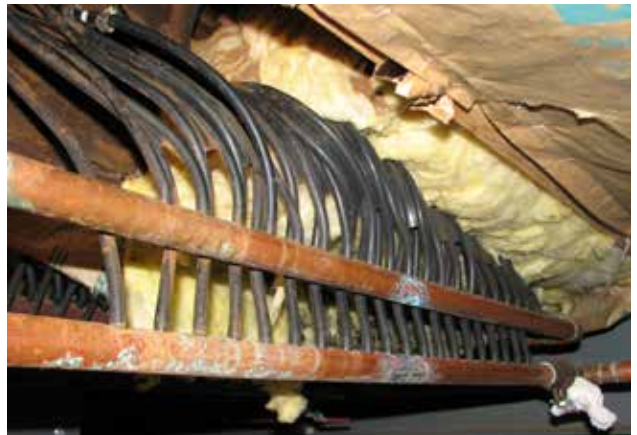
First floor radiant heat piping

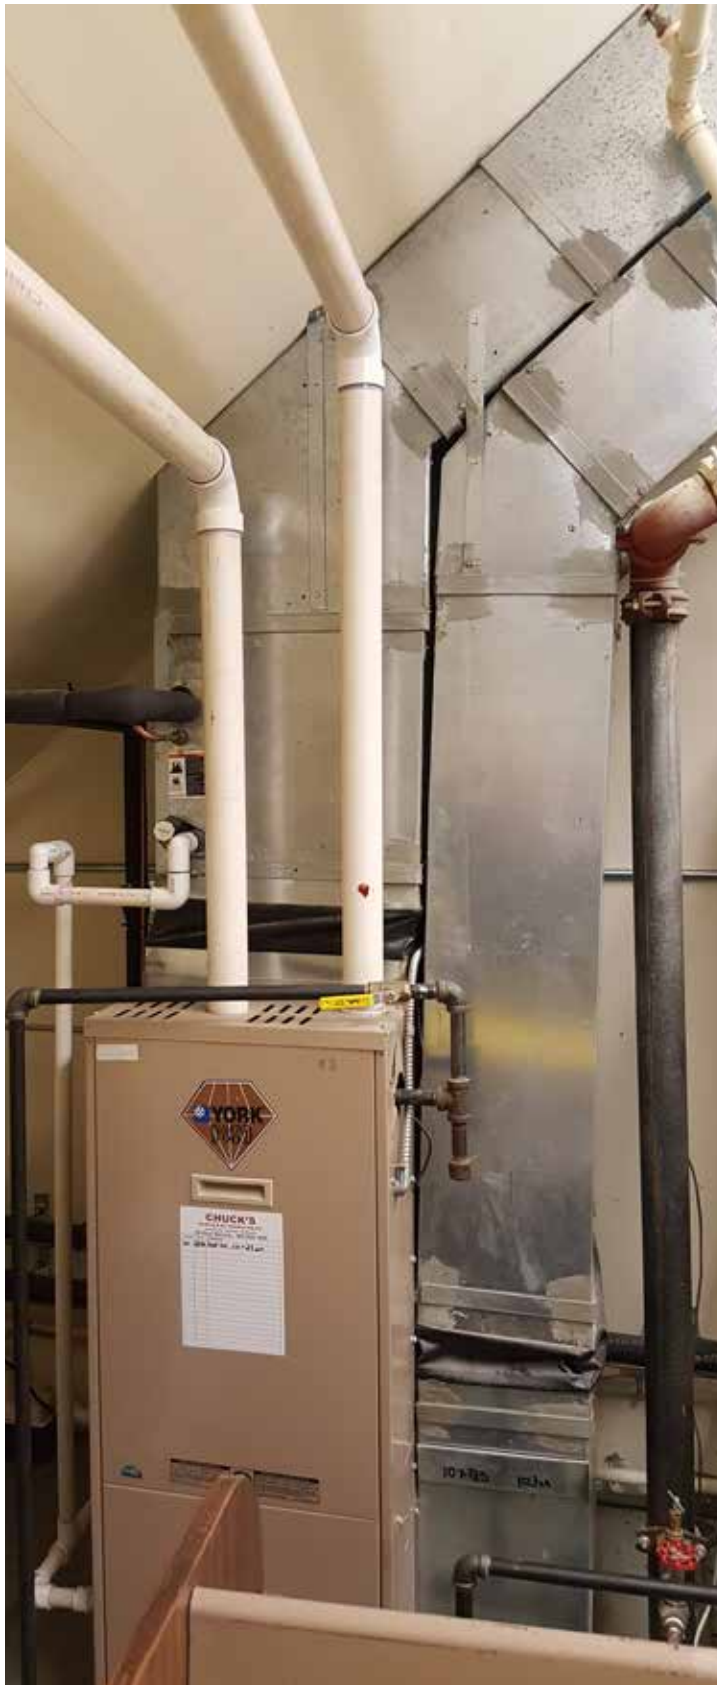
Intake & Exhaust ducts from Outdoor Air Furnaces

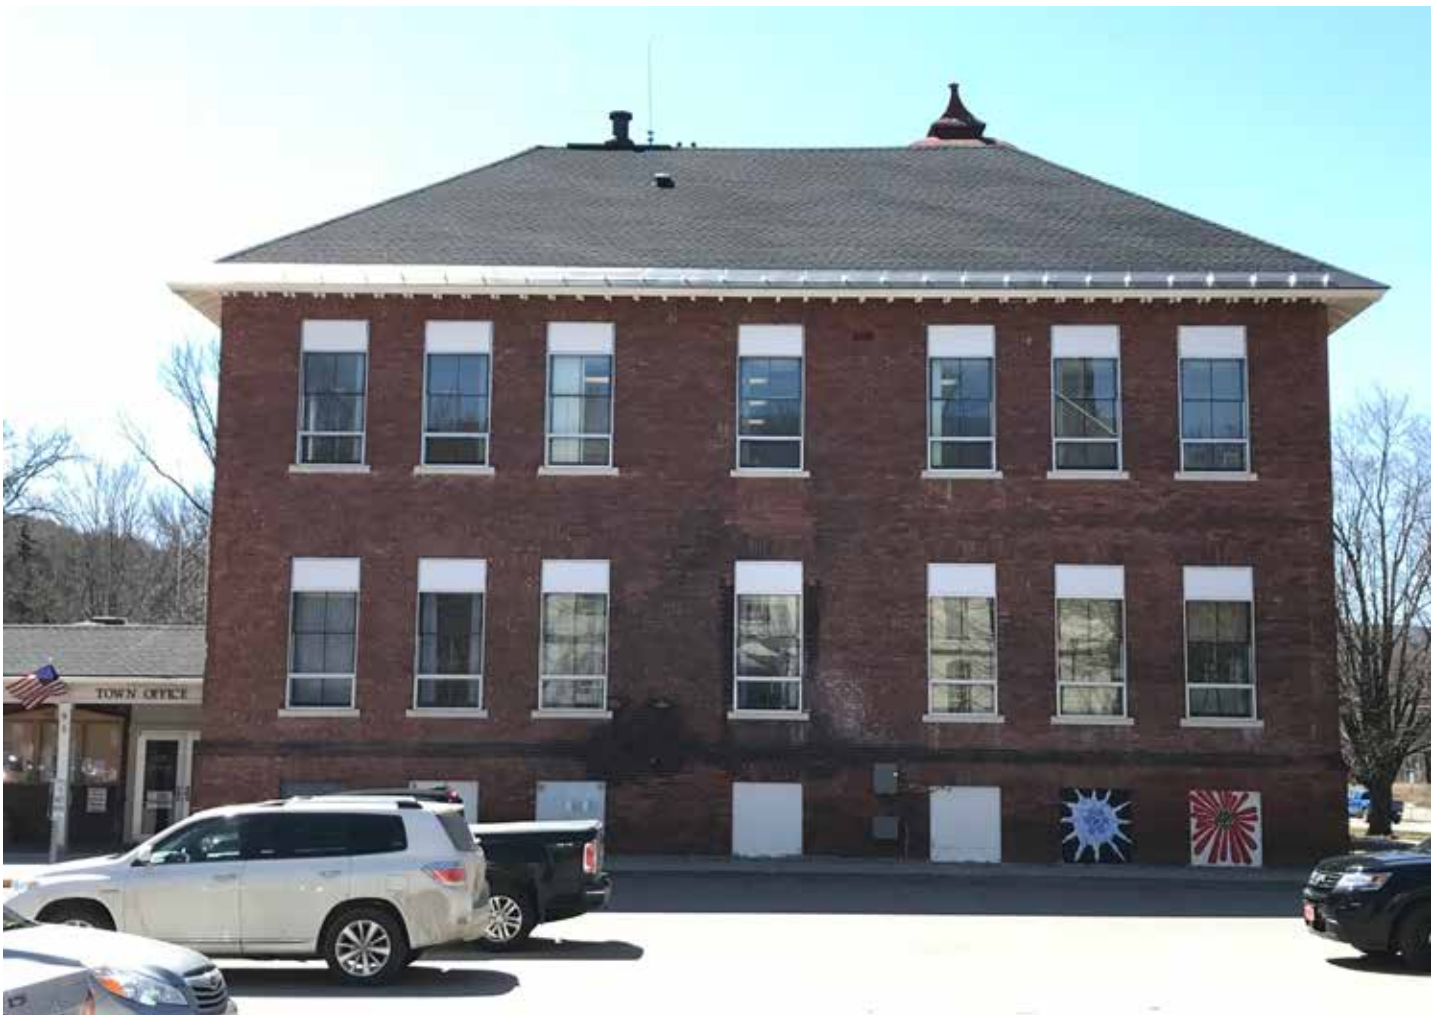
The exterior brick veneer is in fair condition. Efflorescence is visible under window sills and in multiple other locations on all sides of the building. Several areas in the brick veneer will need repointing. A washing of all the brick is recommended. There is also new evidence of brick spalling occurring at the southeast corner of the building near the main entrance for the town offices. This may be related to the recent roof replacement and extended drip line which is leading to water falling onto the sidewalk and splashing up against the brick. This condition should be monitored going forward.

West Elevation Brick Veneer

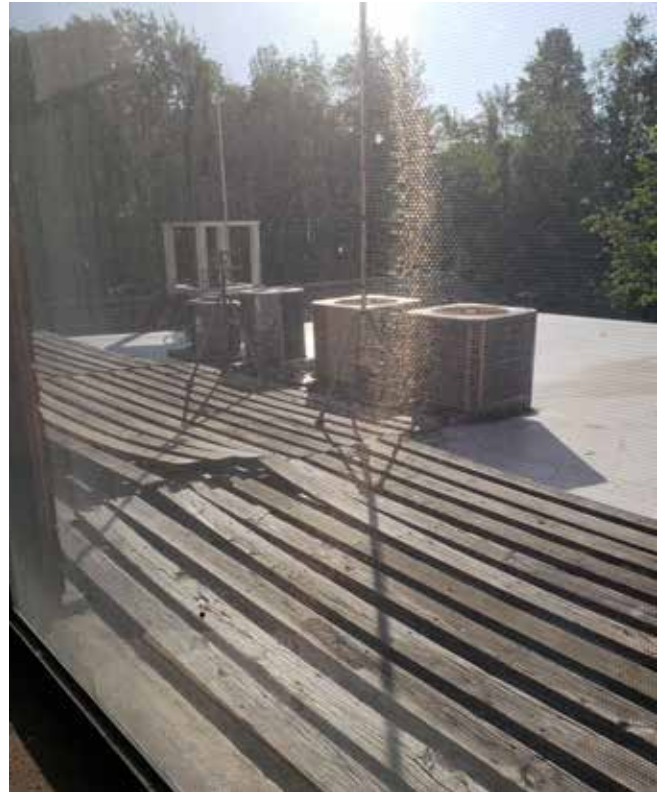
Photo of Post Office roof

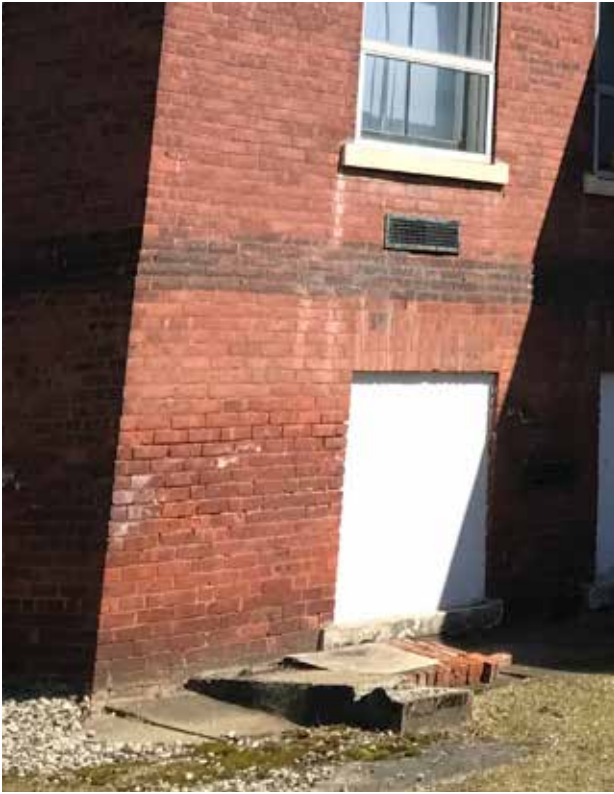
Deteriorating brick mortar at NW corner

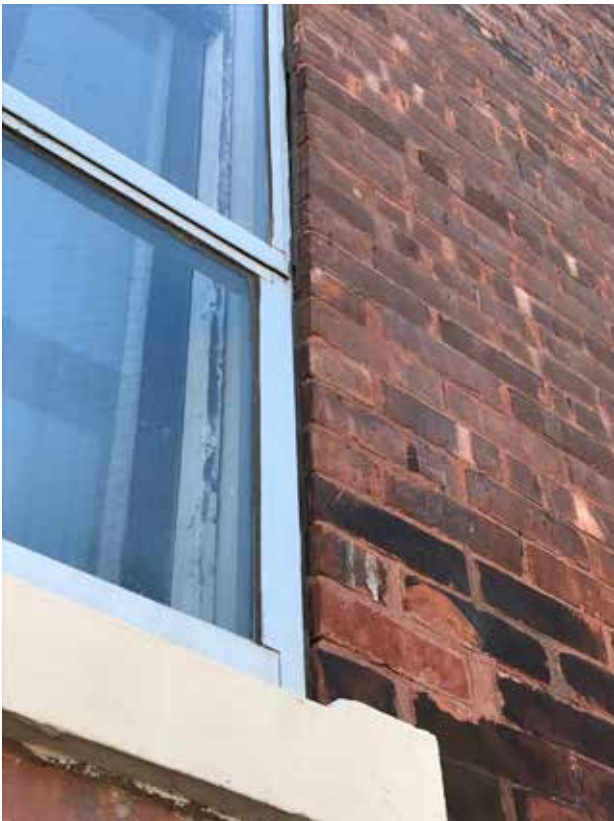
Cracked perimeter caulking at jambs

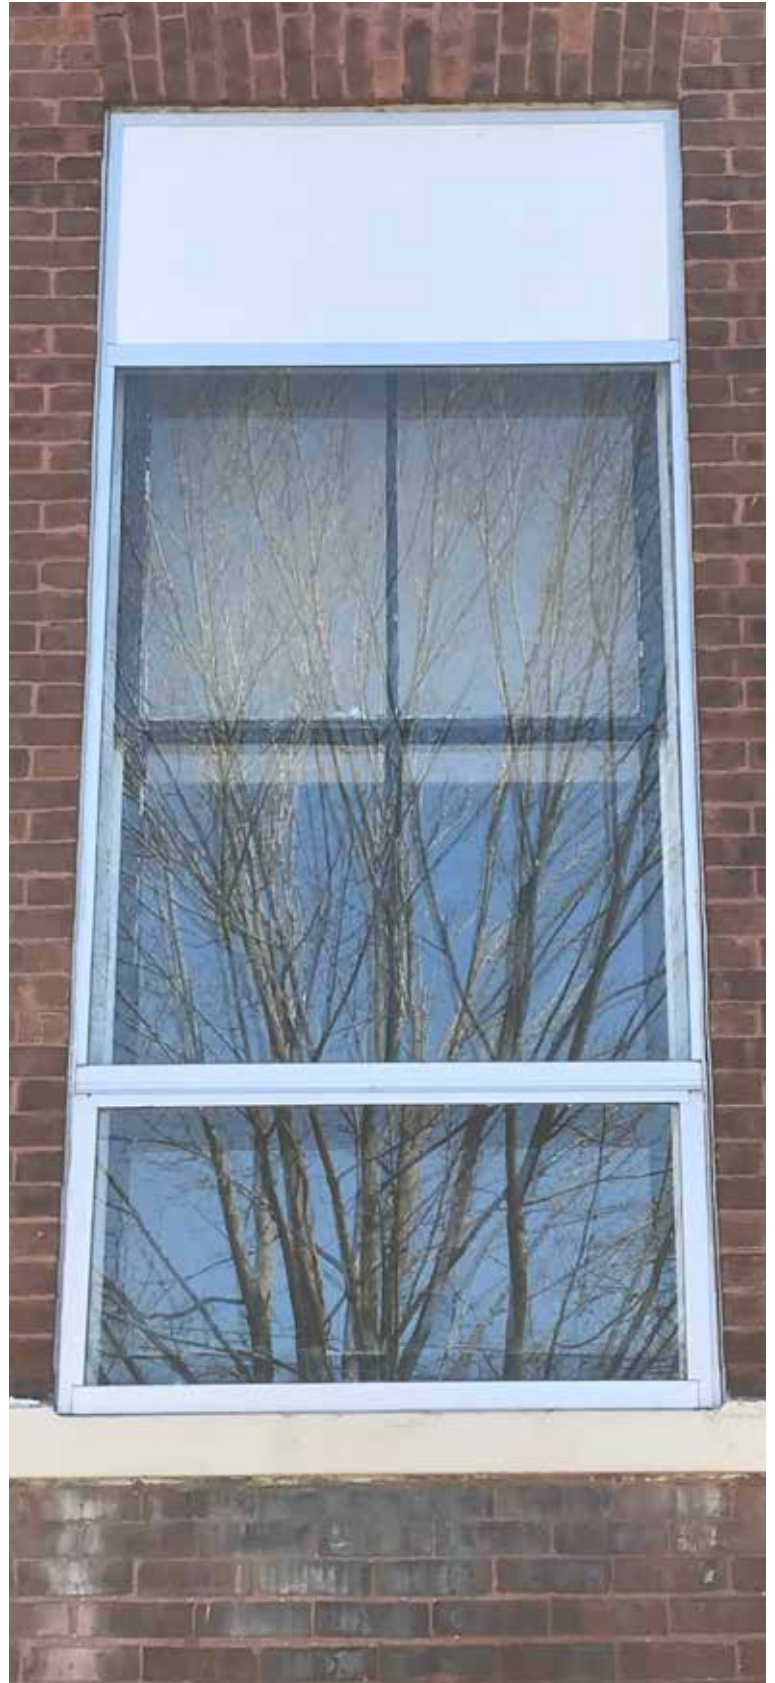
All of the windows in the Town Center Building are original and have had storm windows installed. There was a noticeable amount of air infiltration at each window in the building. During the walk through, all windows had plastic sheeting installed on the interior to reduce the draft caused by air infiltration. The windows are coated with lead paint and there is also a possibility that the perimeter caulking contains asbestos. Testing should be done prior to any work on the windows throughout the building. The north and east entry doors are in good condition and no daylight was visible along the thresholds.

Window exterior elevation photo

10. Replace all windows with new energy code and historic compliant windows. (HW) 2019 BUDGET: \$305,000
11. Remove and replace all exposed Romex wiring. (LSC) 2019 BUDGET: \$40,000

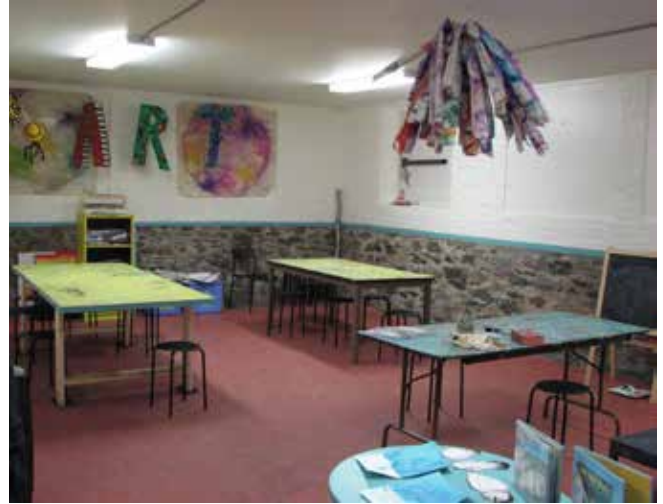
Art classroom with no access to daylight

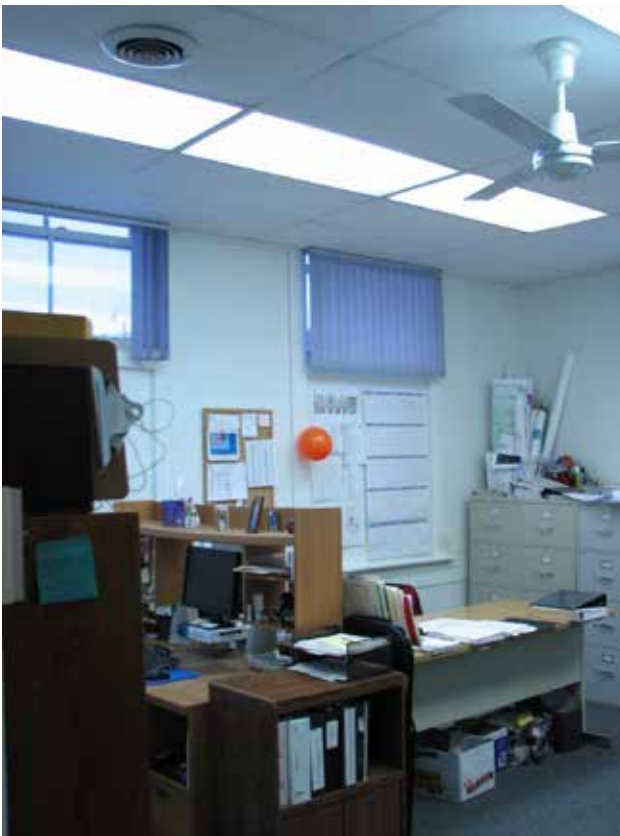
Zoning Office - Infill panels over windows

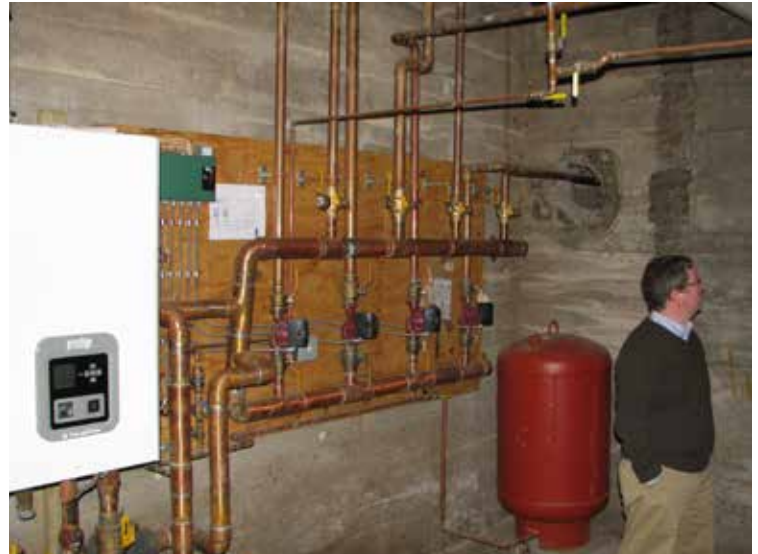
Hot water manifold
