2018 Town of Richmond, VT Facilities Assessment

BreadLoaf

Executive Summary

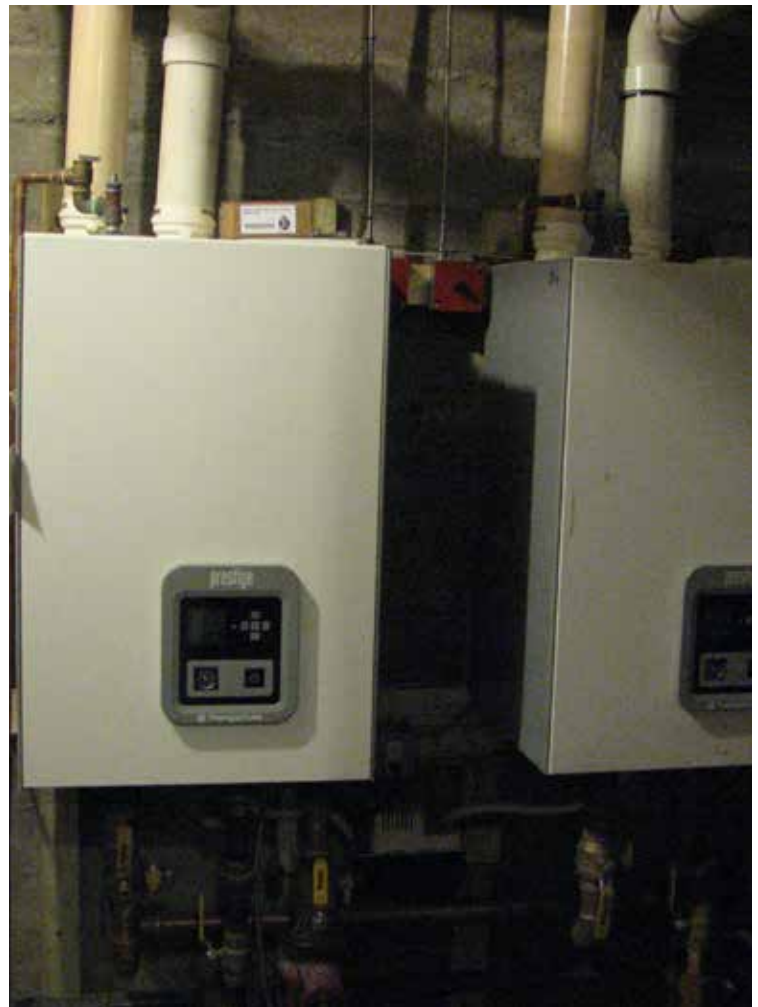
Two (2) high efficiency natural gas boilers serve the building. The Triangletube Prestige Solo boilers each have a nominal output of 379,000 Btuh. The boilers are in good condition and have an expected life of 25 plus years. The boilers fuel source is a 1-1/2" natural gas line and associated Vt. Gas meter. The boilers serve four (4) zones via Grundfos zone pumps and a copper distribution system serving baseboard, unit heaters and fan coil unit hot water coils. The basement is heated with a series hot water unit heaters controlled by non-programmable T-87 thermostats.

New natural gas, high efficiency boilers in basement

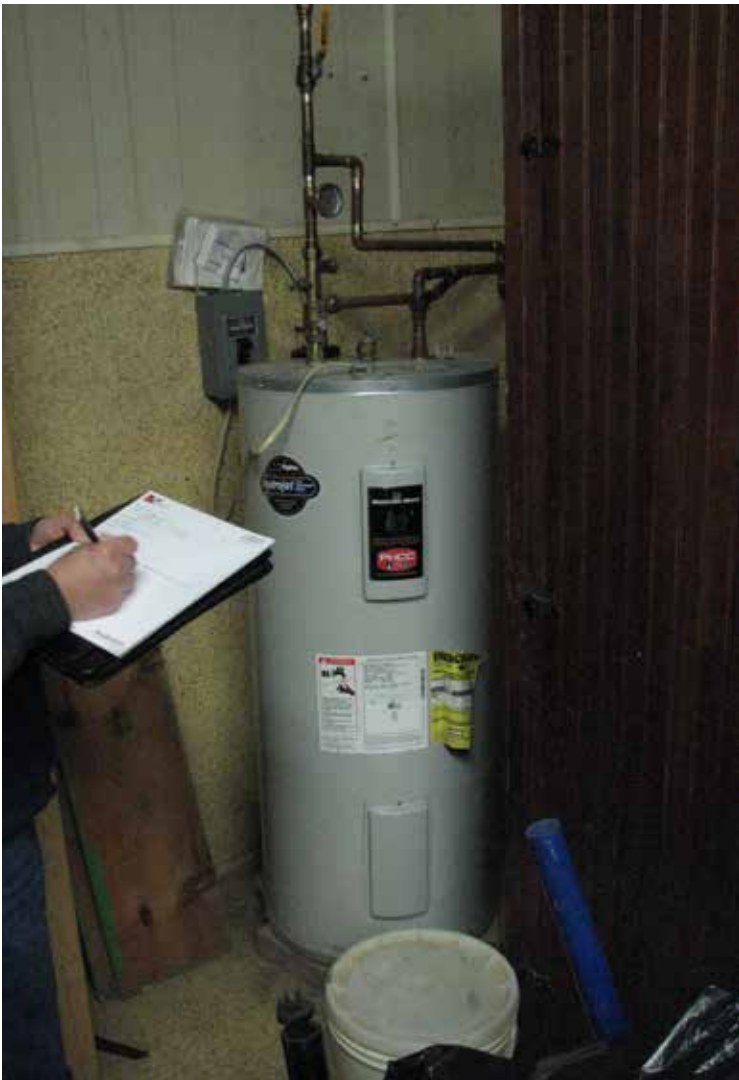
Water heater for Town Office and Post Office domestic

The building is served via a 1" city water line complete with a water meter, backflow device, and pressure-reducing valve. It appears the water entrance and the sanitary sewer lines are in the same trench coming into the building and are not separated by the current code recommended distances (10'). Domestic hot water is served by a series of electric tank type water heaters. Some of the water heaters observed are missing code mandated mixing valves and most likely have a set point below the recommended temperature of 140° to prevent Legionella. A 6" cast iron sanitary line serves the building. ADA compliant water coolers should be provided in any future major renovations. Mixing valves are needed on all water heaters.

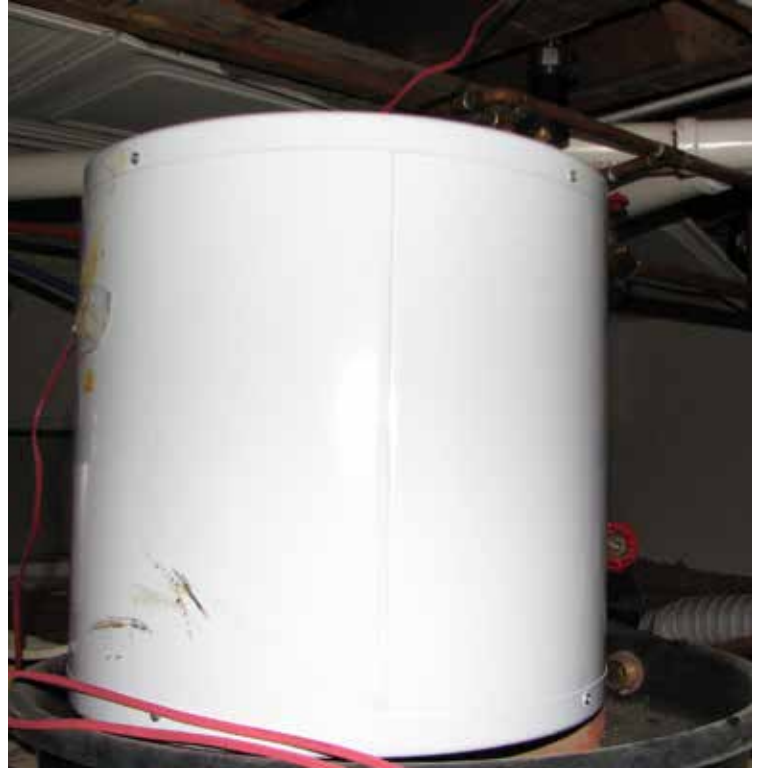
On demand hot water heater above bathroom ceilings

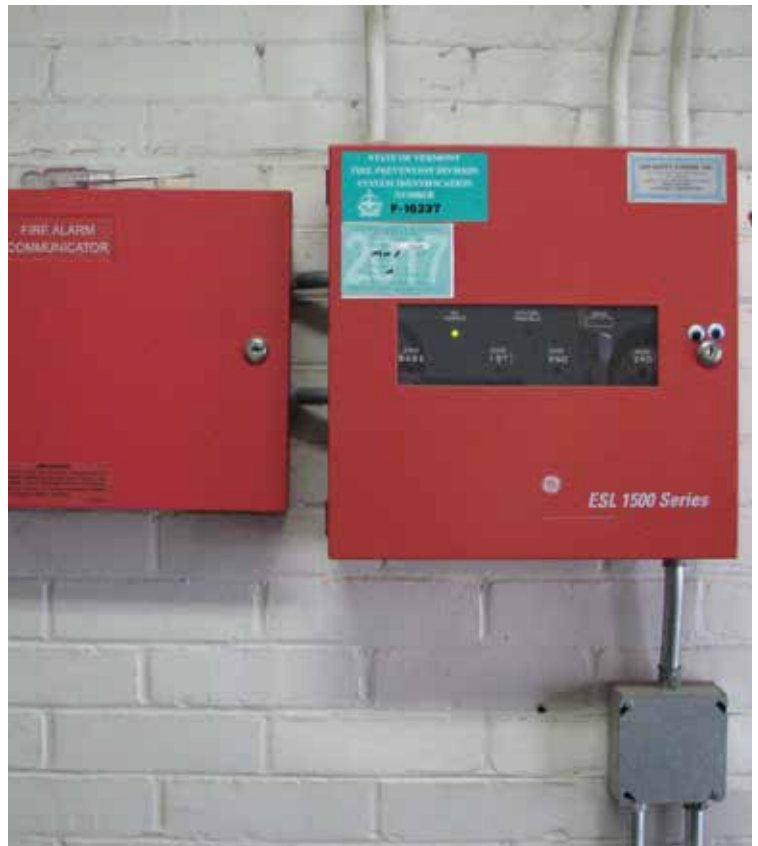
The building is served by a four-zone GE Series ESL 1500 non-addressable Fire alarm panel. The panel serves pull stations and horn strobes for the building. CO2 & Smoke detection are not provided. The basement is missing code compliant horn strobes in the back of house and storage areas and in some egress paths such as the stair to the half size egress door. The basement is missing a pull station at the stair to the half size egress door in the art room. There is not a code required sprinkler system in the building.

Fire alarm control panel or partial alarm system in entry

1. Install code required automatic sprinkler system. (LSC)
2019 BUDGET: \$119,000
2. Install code required fire alarm system. (LSC)
2019 BUDGET: \$50,000
3. Install code required exit signage. (LSC)
2019 BUDGET: \$2,700
4. Abandon storage closet under stair at lower floor level. (LSC) *2019 BUDGET: \$1,800*
5. Replace Mechanical Room door and frame with a 1-hr fire rated door and frame. (LSC)
2019 BUDGET: \$3,400
6. Provide an ADA compliant ramp at door to lower level classroom and bathrooms. (LSC)
2019 BUDGET: \$6,200
