**Corrective Action Feasibility Investigation
for Site Remediation**

**Former Richmond Creamery
Richmond, Vermont
VTDEC Site #2008-3835**

The Johnson Company, Inc.
100 State Street, Suite 600
Montpelier, Vermont 05602
Contact: Kurt Muller, P.E.
(802) 229-4600

March 16, 2012

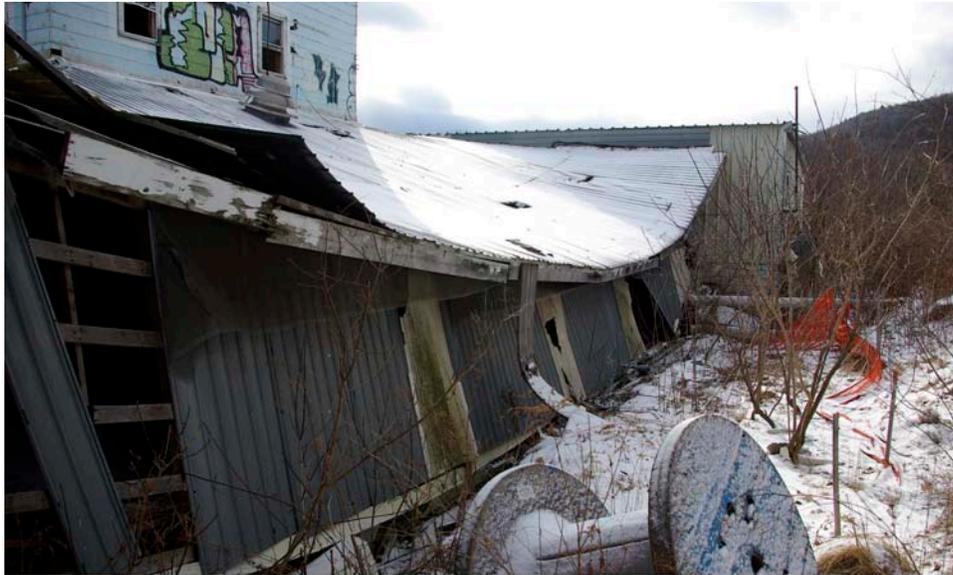
BLDG E collapsed foundation and roof

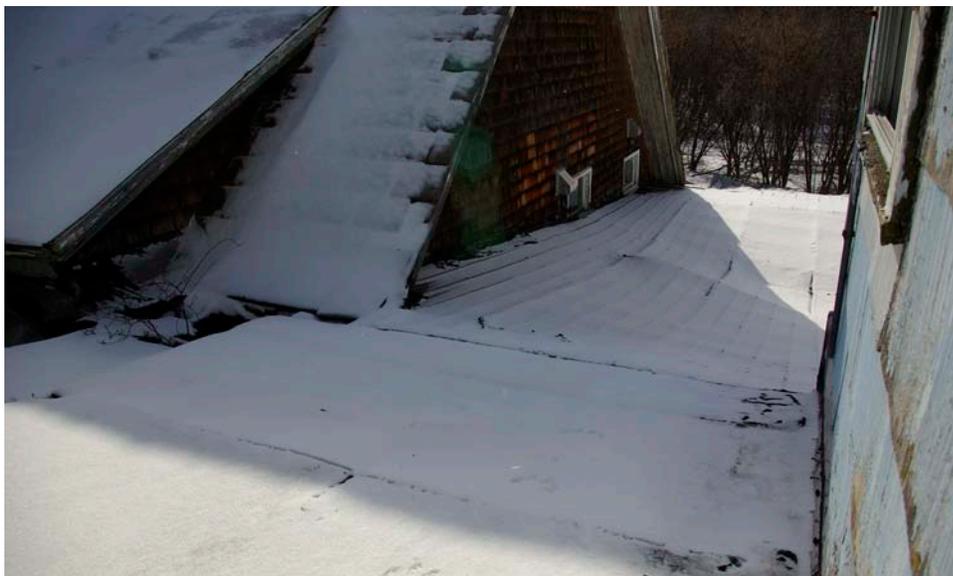
BLDG F - BLDG C-1 Collapsing roof beyond

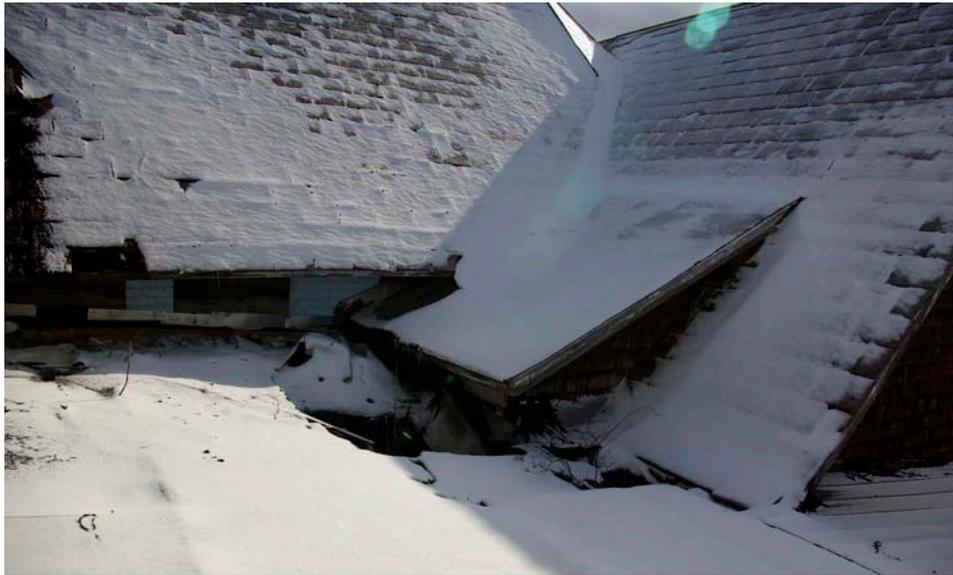
BLDG F Water damaged roof - collapsing

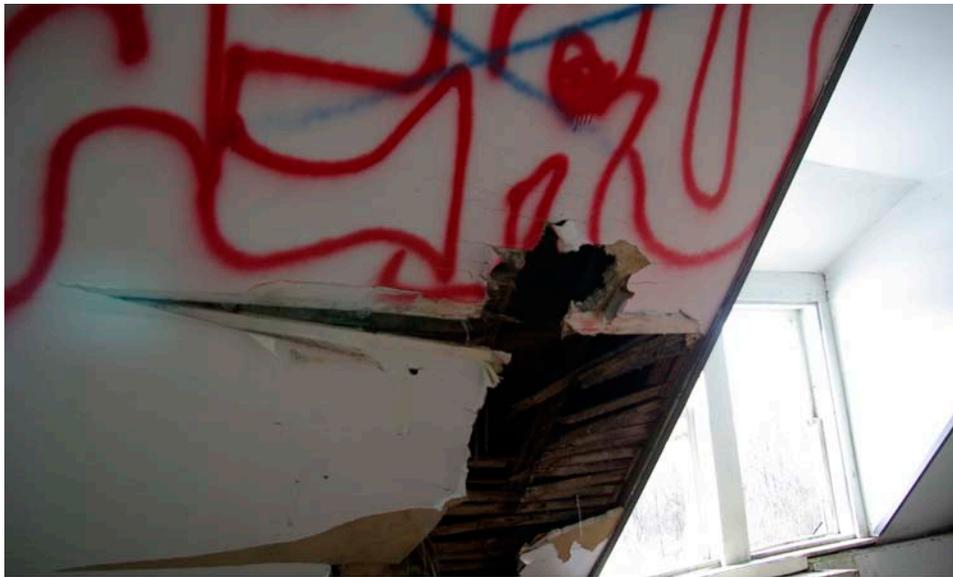
BLDG B South side roof water damage - rotted framing

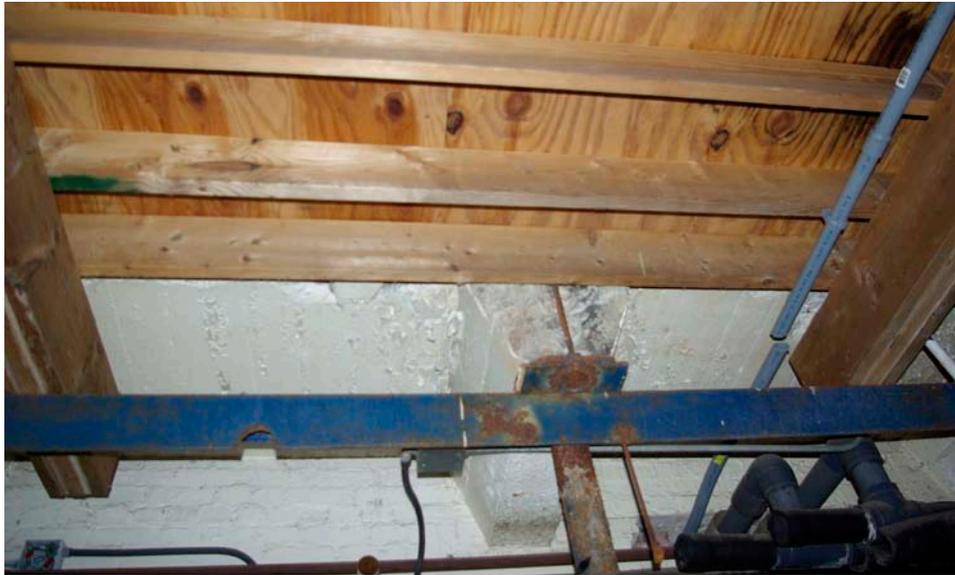
BLDG B - South East upper floor - Wood infill at Removed Concrete

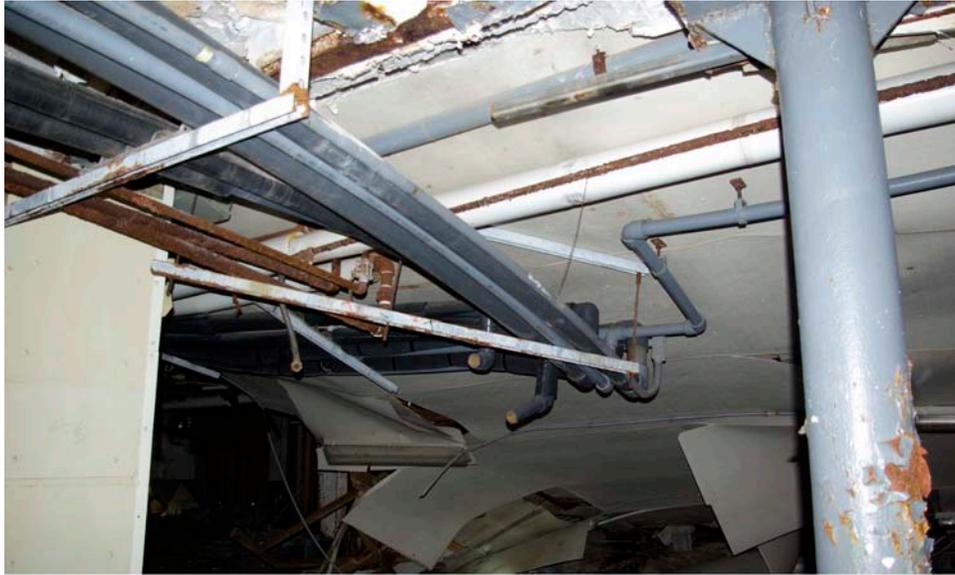
BLDG E Collapse

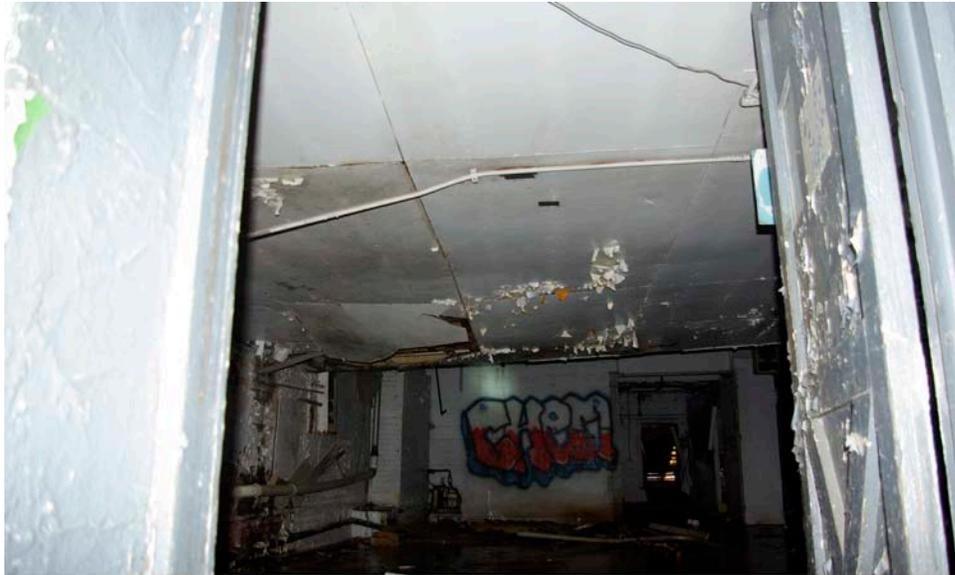
BLDG F - Connector between A and B Collapsing Roof
