Richmond Town Center
203 Bridge Street
Richmond, VT 05477

KAS #312210376

PRE-RENOVATION ASBESTOS INSPECTION REPORT

January 21, 2022

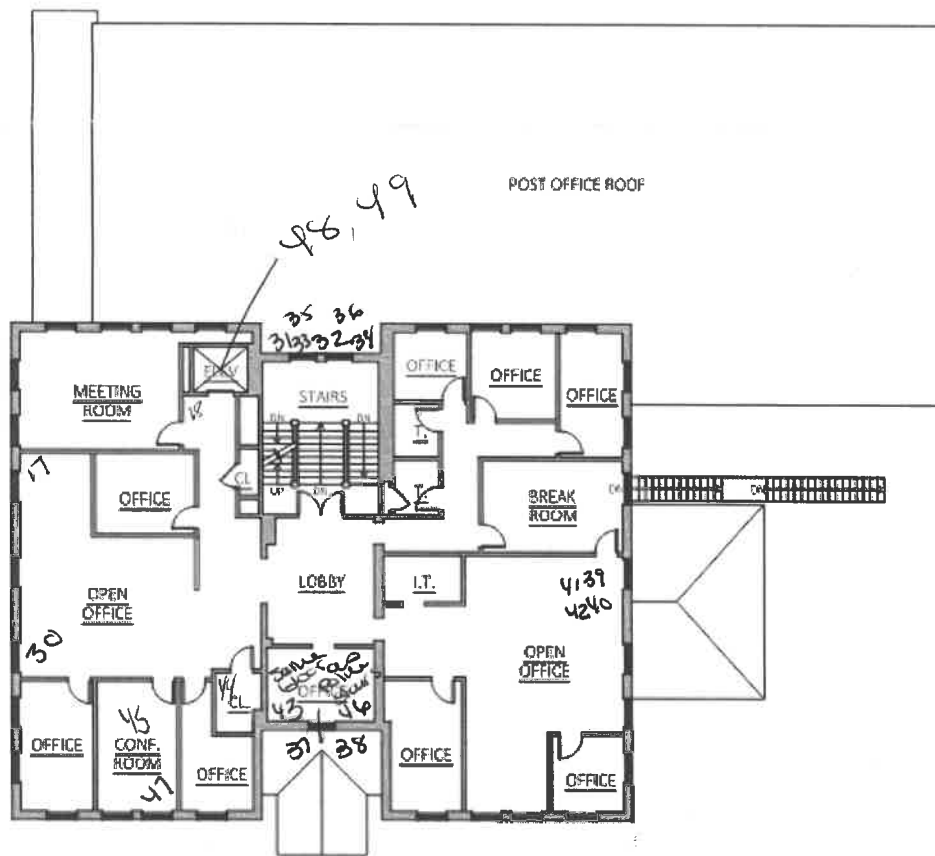
Second Floor Plan

(Bathrooms have the same flooring as police stairs)
 (Kitchen has white tile)
