Childs Engineering LLC

Project No. 1448

Re: **Concrete Water Storage Reservoir**
Jericho Road
Richmond, VT

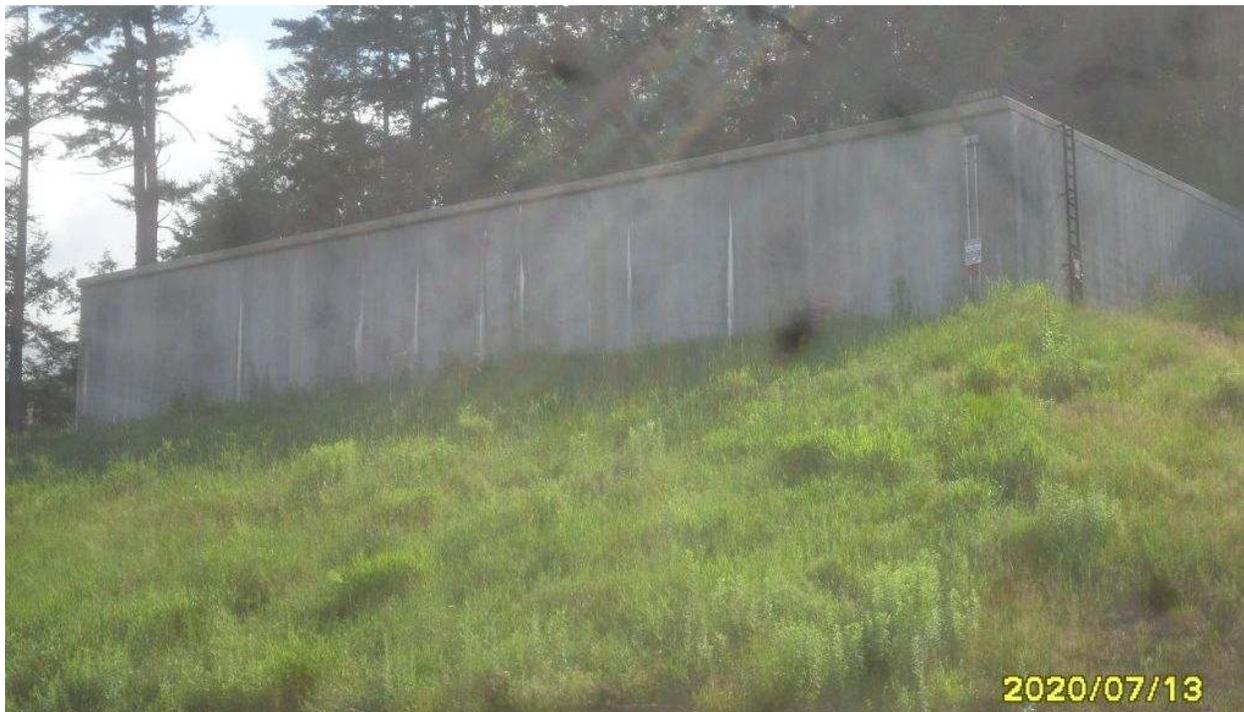
I looked at the efflorescence on Richmond's Jericho Road Water Storage Reservoir on July 13, 2020 and present my findings in this report. Efflorescence is an indication of water seepage and the town was concerned and asked me to look at it.

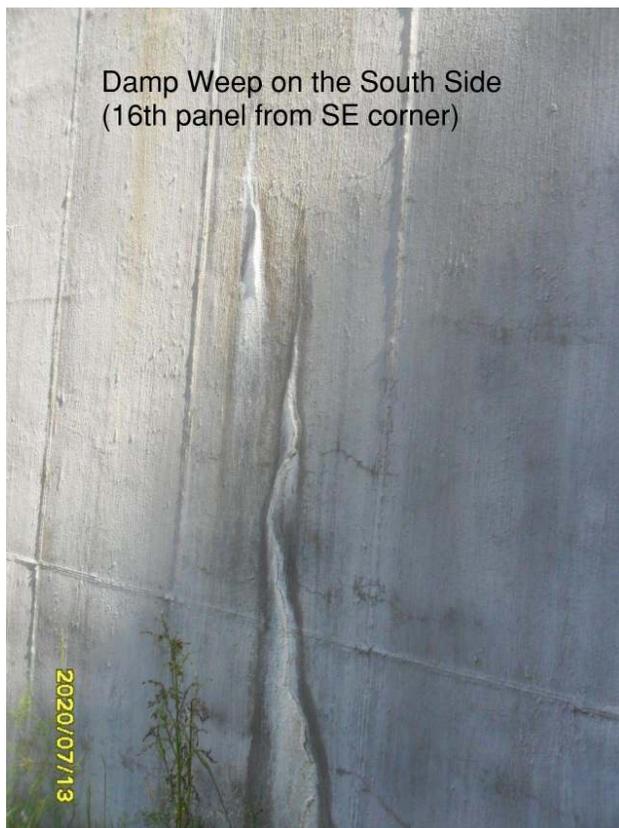
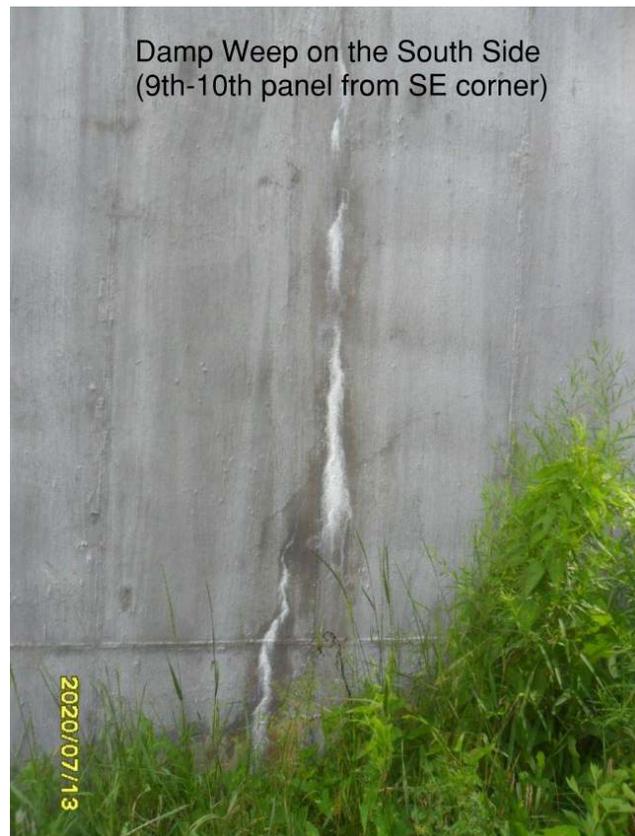
We noted 4 efflorescence streaks on the south side, 11 on the west side (side most visible from the road), and 7 on the north side. About half of these are minor (only obvious from up close), with the other half being more substantial. We also noted that 2 of the steaks appeared to be damp on the south side, 6 were damp on the west side and 2 on the north side. The dampness probably indicates water seeping through from the inside though, in some cases, it may be moisture trapped behind the coating which is working its way out.

Efflorescence is caused as water seeps through tiny masonry cracks, picking up minerals along the way and depositing them on the surface as the water evaporates. For this reservoir, the source of the water, in most cases, is the water inside the reservoir. But, in a few places, the efflorescence is at the very top of the wall indicating that the source of that water is probably rain.

The efflorescence is unsightly though structurally, it is not a problem. However, freeze-thaw at the most active weeps has caused the exterior coating to pop in a few places and this may be an ongoing issue. The coating itself is not structurally necessary and was put on for aesthetic reasons.

Stopping the efflorescence requires stopping the water source and this means sealing all the active weeps. Unfortunately, this is a lot easier said than done. You could try epoxy injection though it may take several attempts (or more), to finally seal the weep. The issue is, as the weep is sealed, the water finds another path and reappears, usually higher up along the same hairline crack. And with the coating, it is not readily apparent where the hairline cracks are.

Where rain is the water source, cracks and spalls in the roof slab coating will need to be patched to keep that water from getting under the coating.
