Road Safety Audit Review
Fays Corner
Town of Richmond

July 8, 2004

Fays Corner, Richmond

Road Safety Audit Review Review Report

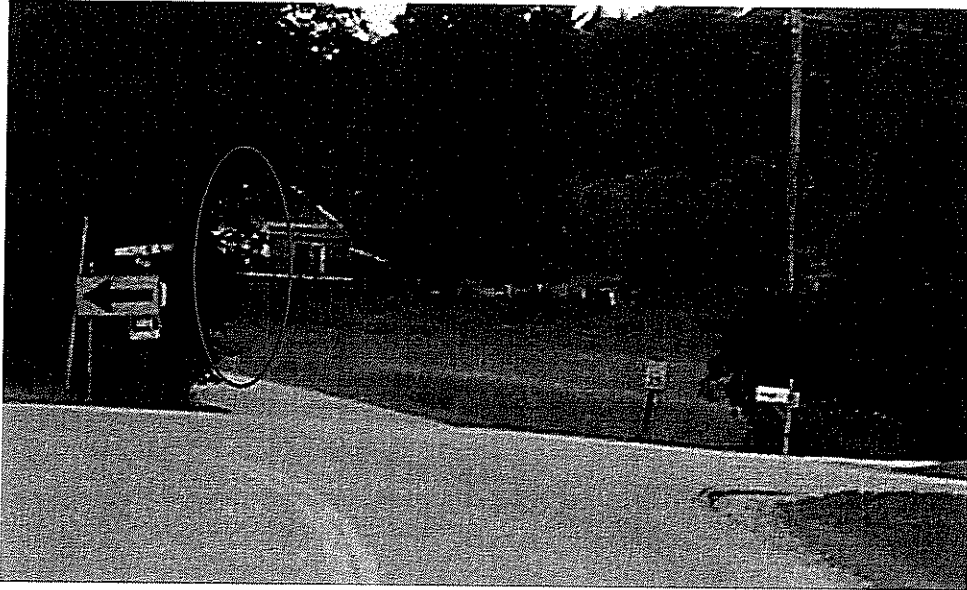
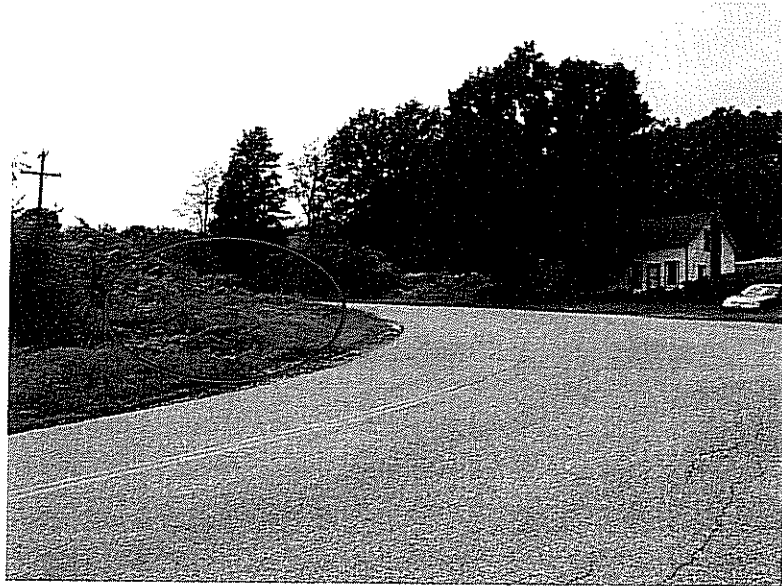
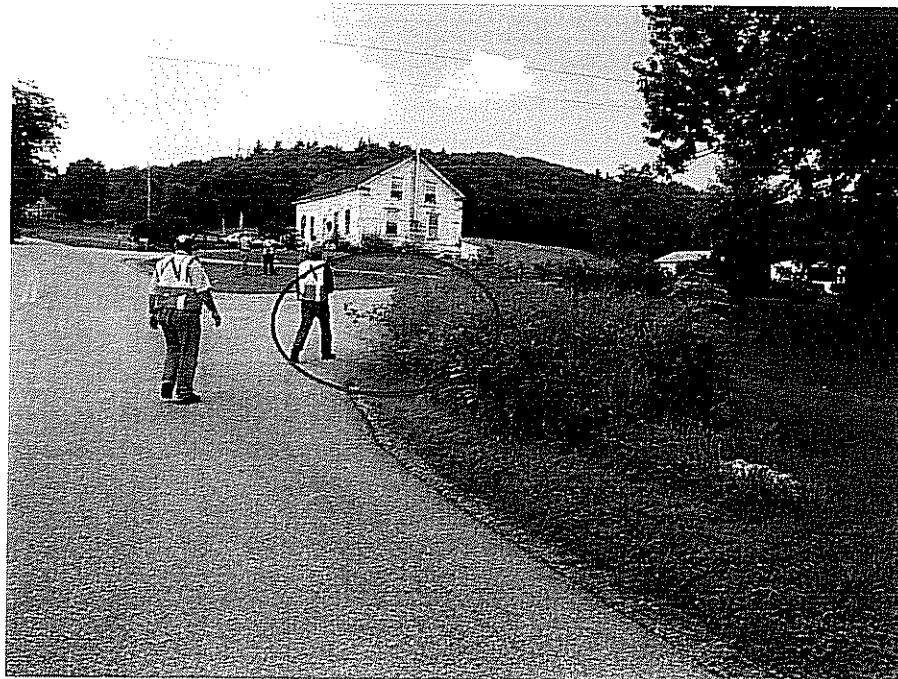
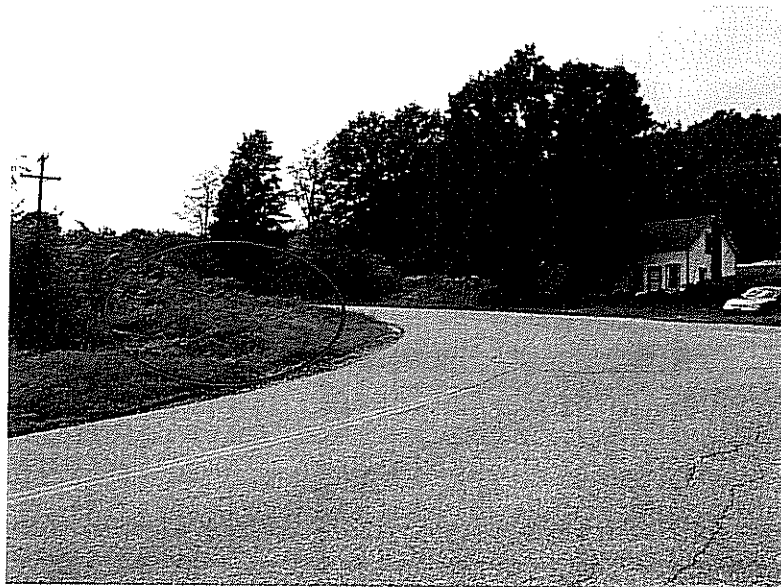
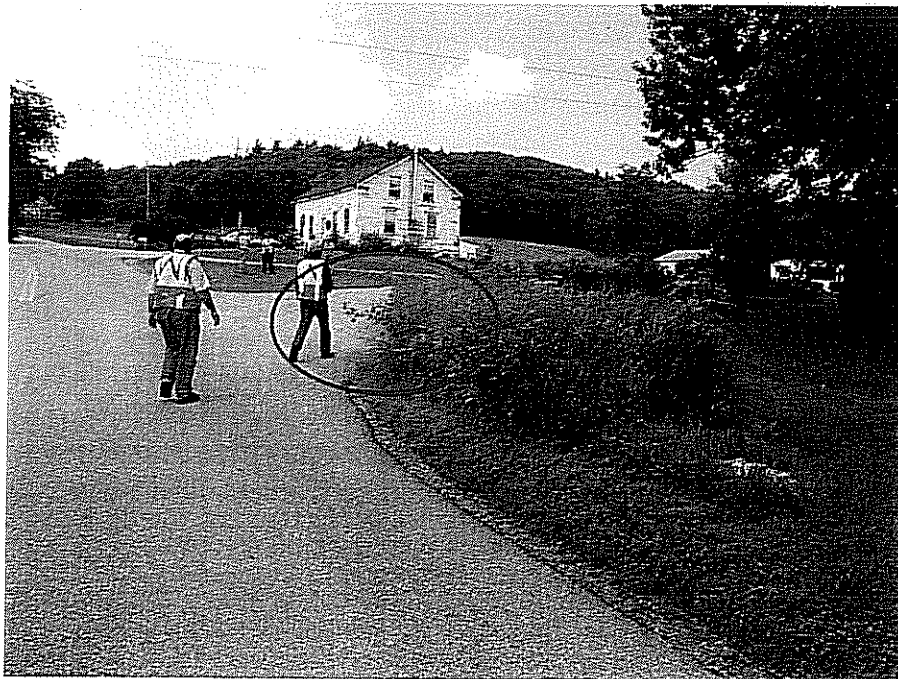
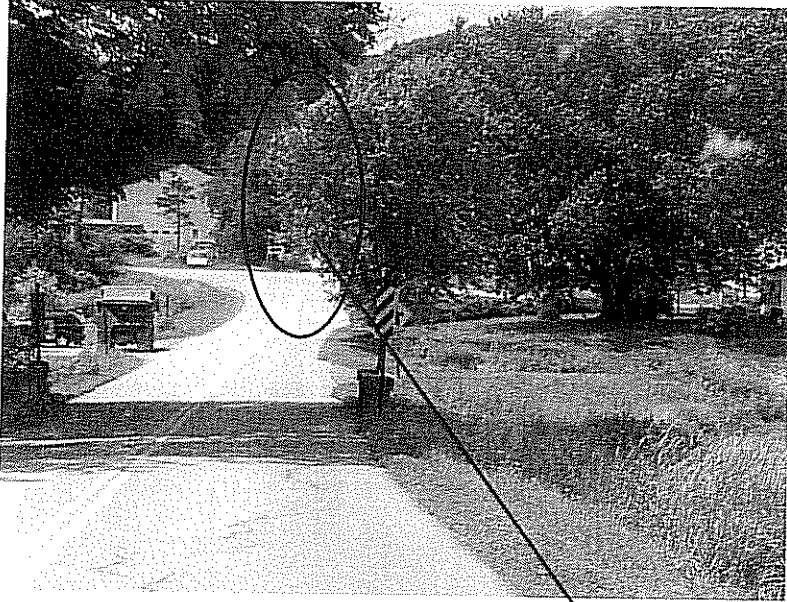
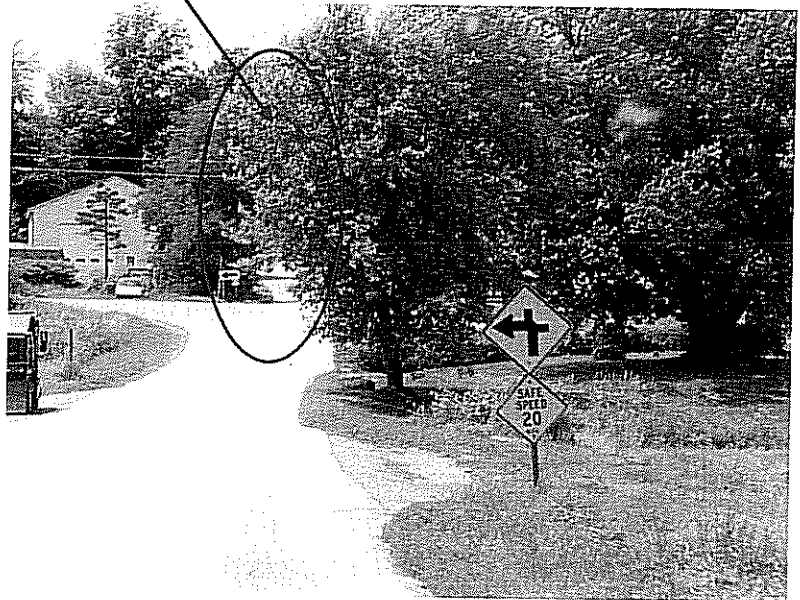
Figure 6. POOR CORNER SIGHT DISTANCE IS AN ISSUE ON ALL LEGS (view is of East Hill Rd Approach)

Figure 6 Continued. POOR CORNER SIGHT DISTANCE IS AN ISSUE ON ALL LEGS (top view is of the Hinesburg Rd Approach, from the Town of Hinesburg, bottom view is of Kenyon Rd)

Figure 6 Continued. POOR CORNER SIGHT DISTANCE IS AN ISSUE ON ALL LEGS (top view is of the Hinesburg Rd Approach, from the Town of Richmond, before the bridge, bottom view is just after the bridge.)

Observations & Possible Countermeasures	Responsible Entities								Strategy
	MPO	Town	AOT Traffic Ops						
<p>Poor corner sight distance is an issue on all legs.</p> <p>Brush should be removed.</p>		√							The Town should consider clearing brush as shown in Figure 6.
<p>The East Hill Stop sign is not visible.</p> <p>At a minimum brush should be removed.</p>		√	√						The Town should consider clearing limbs of tree, and also relocating this sign to a better location (could ask AOT Traf Ops to help with proper location). The Town should also consider upsizing this sign.
<p>The Stop Ahead sign on East Hill is properly located but could be enhanced with word markings.</p>		√							Consider installing "stop ahead" word markings.
<p>The East Hill approach lacks definition.</p> <p>Additional markings should be considered.</p>		√	√						<p>The Town should consider installing a stop bar and "stop" word markings. The Town could ask AOT Traf Ops to help spot the stop bar.</p> <p>The double yellow line needs to be refreshed.</p>

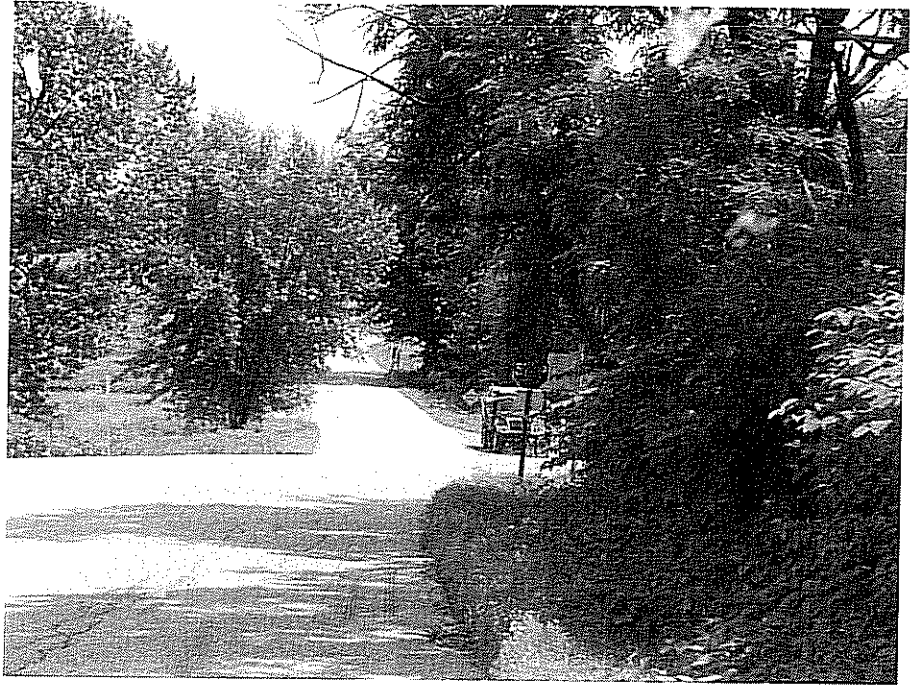
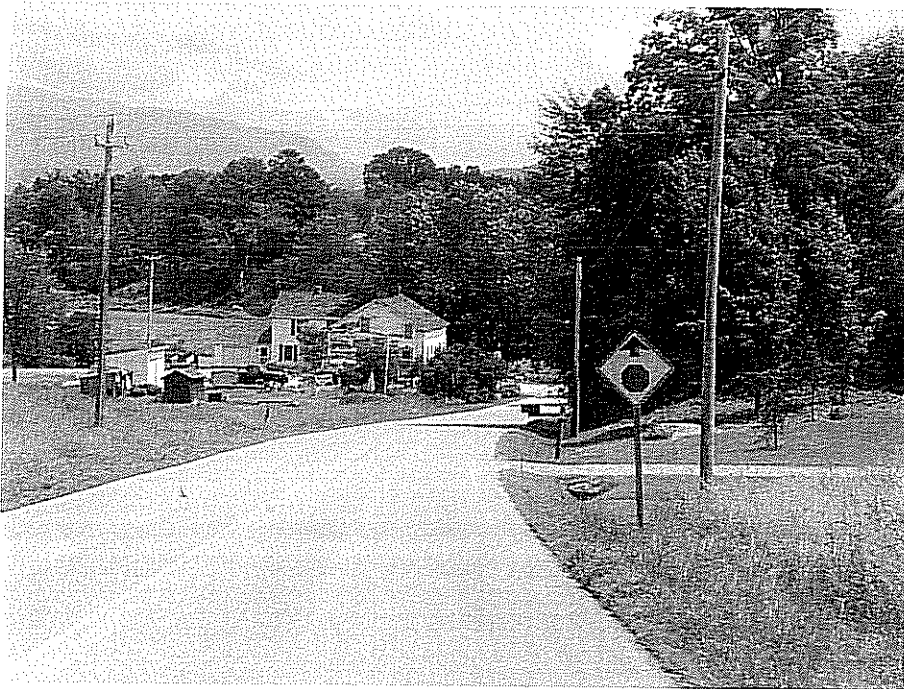
**Figure 7. THE EAST HILL
STOP SIGN IS NOT
VISIBLE**

Observations and Possible Countermeasures	Beg. MM	End MM	Decision Agree/Reject	Planned Completion Date	Reason for Dismissal/Comments
1) The East Hill Stop sign is not visible. The Town will consider relocating the sign. Show Town proper location if requested.					
2) The East Hill approach lacks definition. The Town will consider installing a stop bar. Show Town proper location if requested.					
3) The Kenyon approach lacks definition. The Town will consider installing a stop bar. Show Town proper location if requested.

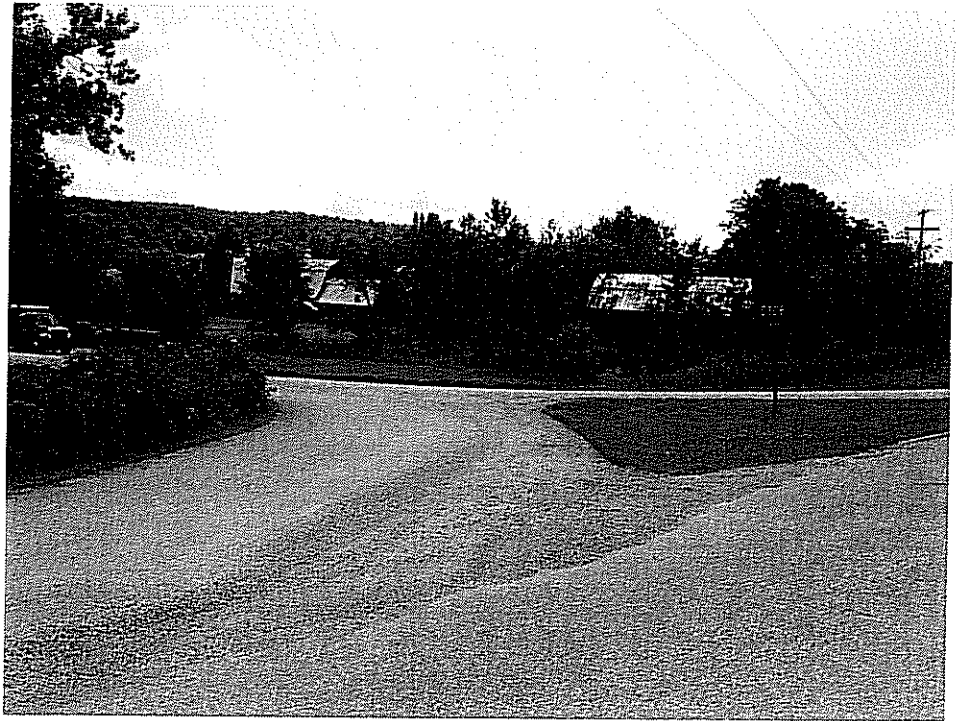
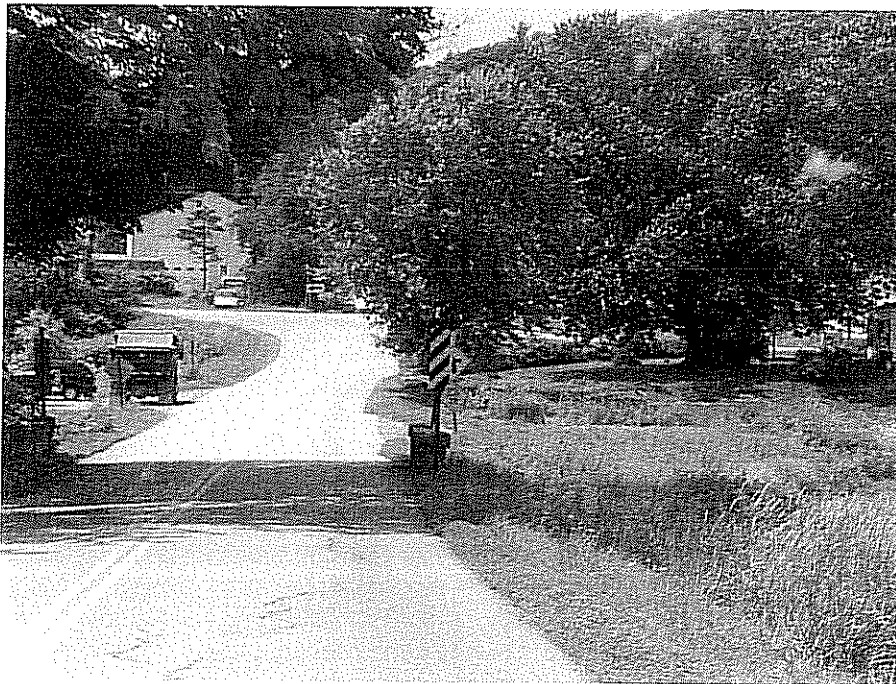
**Figure 8. THE STOP
AHEAD SIGN ON
EAST HILL IS
PROPERLY LOCATED
BUT COULD BE
ENHANCED WITH
WORD MARKINGS**

**Figure 9. THE
KENYON
APPROACH IS
CONFUSING,
THE ISLAND IS
UNNECESSARY**

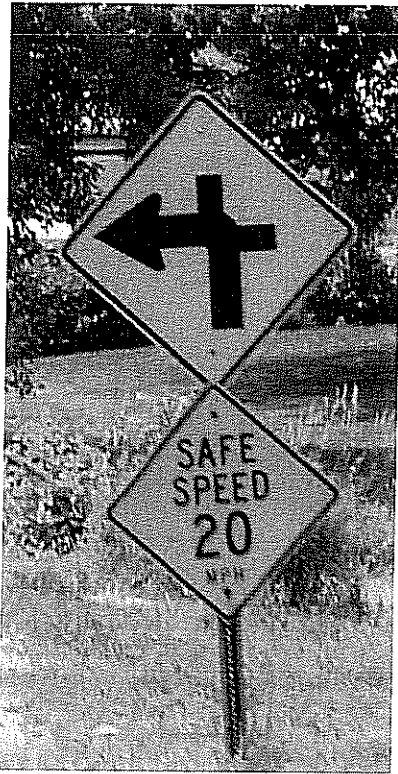
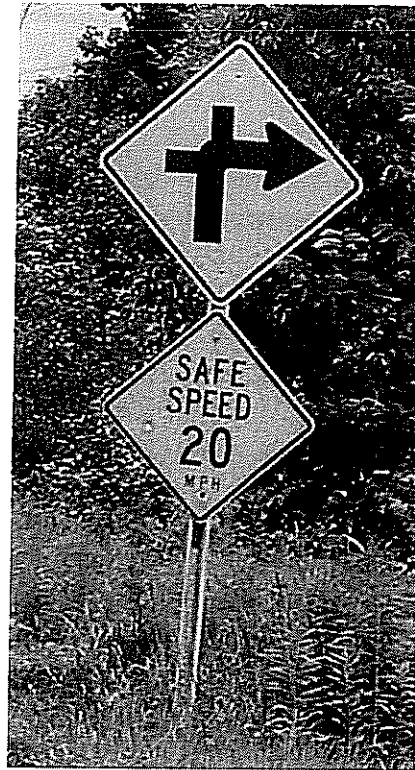
**Figure 10. THE CURVE
SIGN IS CONCEALED
BY THE BRIDGE
OBJECT MARKER
SIGN ON HINESBURG
RD GOING
TOWARDS
HINESBURG**

Observations & Possible Countermeasures	Responsible Entities								Strategy
	MPO	Town	AOT Traffic Ops						
									<p>The advisory speed could be reduced to 15 mph. The lettering on the current advisory speed signs is small. The Town should consider replacing these signs with 18" x 18" MUTCD compliant signs (See Appendix B). Alternatively, the Town could consider 24" x 30" rectangular signs with the actual safe speed wording.</p> <p>The chevrons could be increased in size. A new chevron could be added in front of the Mobbs' house.</p> <p>All warning signs through the intersection could be replaced with Yellow Fluorescent sheeting.</p> <p>There should be some edge lines to define the radii on all legs.</p> <p>Add yellow "cat tracks" between the centerlines of the south and the east approaches to define the curve.</p>
<p>On the east approach of Hinesburg Road, the curve sign is concealed by the bridge object marker.</p> <p>The curve sign should be relocated.</p>		√							<p>The Town should consider moving the curve sign with possibly a new 15 mph advisory speed plaque before the bridge. The narrow bridge sign could be relocated on its own post 100 ft before the curve sign.</p>

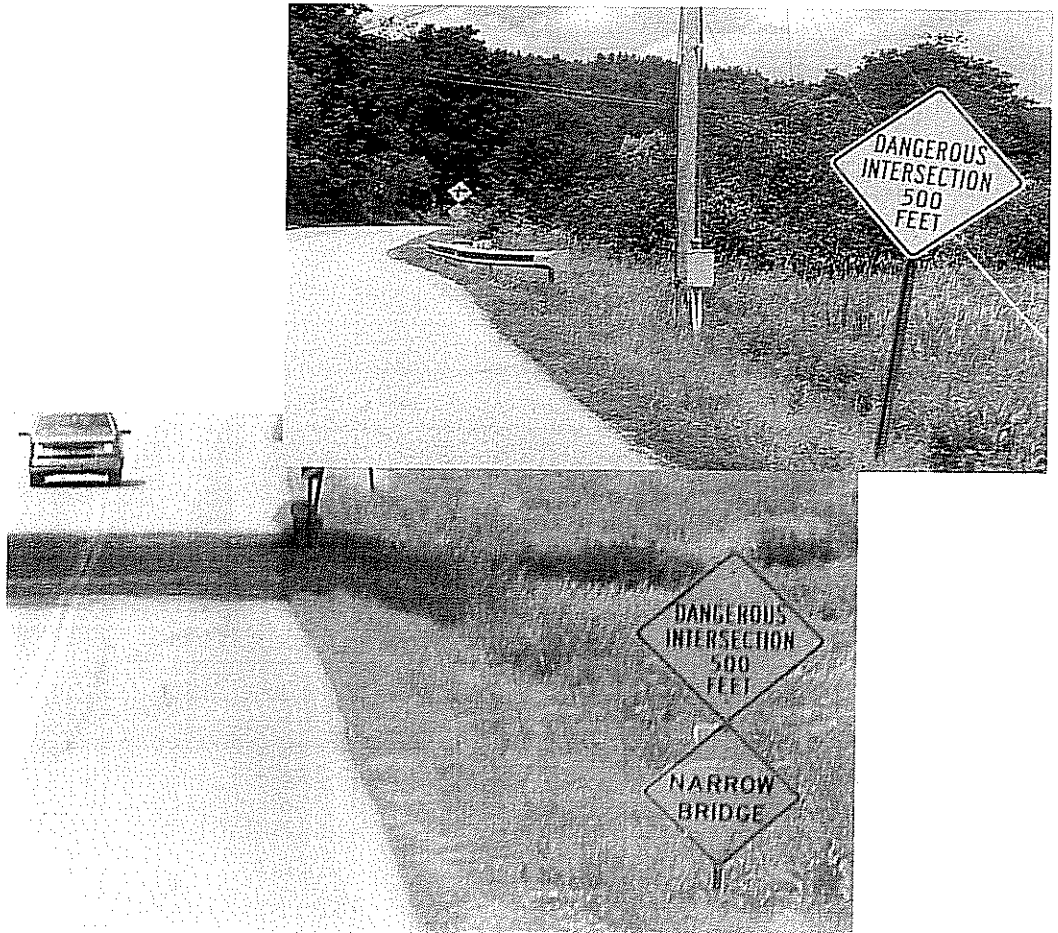
Figure 11.
LETTERING ON
ADVISORY
SPEED SIGNS IS
SMALL

Figure 12. USE OF
DANGEROUS
INTERSECTION
SIGNS IS
IMPROPER.
BOTTOM
PICTURE,
NARROW
BRIDGE SIGN IS
TOO LOW.

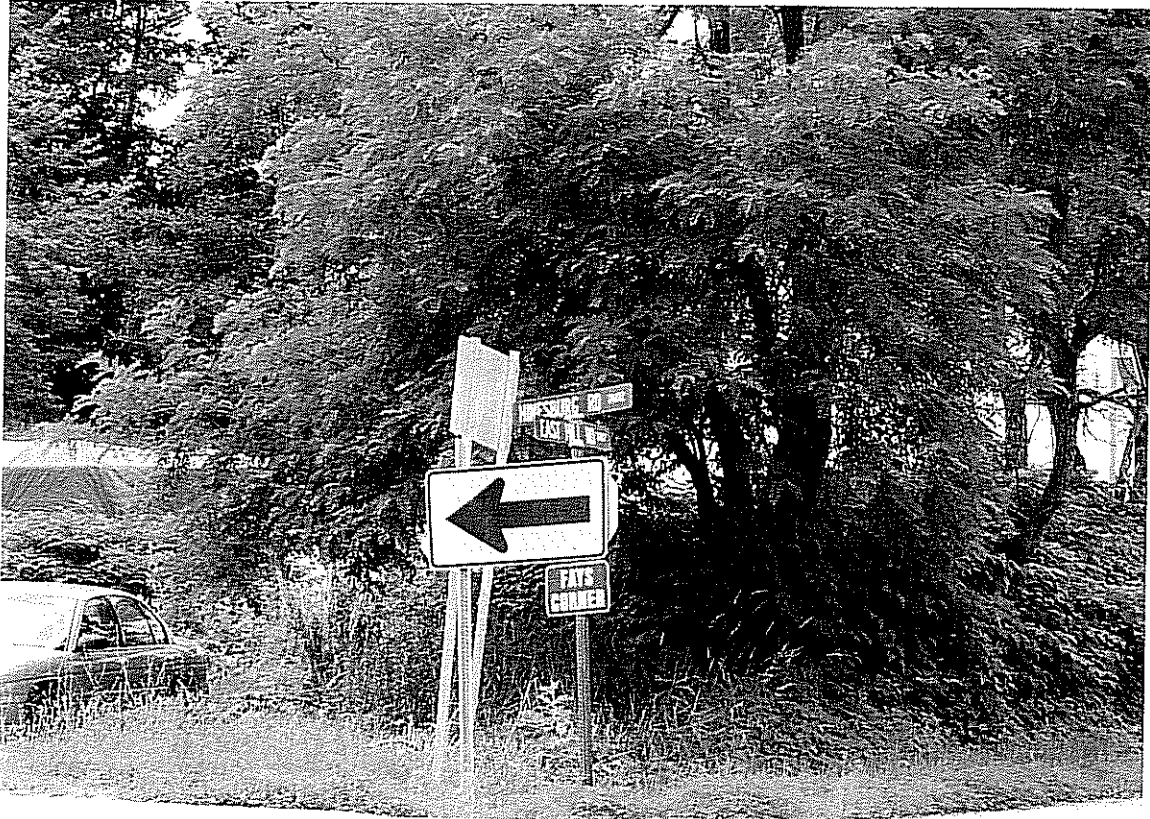
Figure 14. SIGN ASSEMBLY NEXT TO EAST HILL RD PROVIDES TOO MUCH INFORMATION

<p>Speeds are perceived to be high.</p> <p>Sight restrictions, conflict points, the bridge, grades, curves, and the drives are conditions that could lead to a reduction in speed limit.</p>	√	√							<p>The Town should consider conducting a study to reduce the travel speed. The MPO could possibly help with this.</p>
<p>Motorists lack guidance when traveling towards Richmond.</p> <p>A guide sign could be installed before the intersection.</p>		√							<p>The Town could consider adding a guide sign.</p>
<p>Sign assembly next to East Hill Rd provides too much information.</p> <p>The arrow board should be on its own posts.</p>		√							<p>The Town should consider separating the signs, keeping the street name signs with the stop sign and leaving the arrow sign by itself.</p>

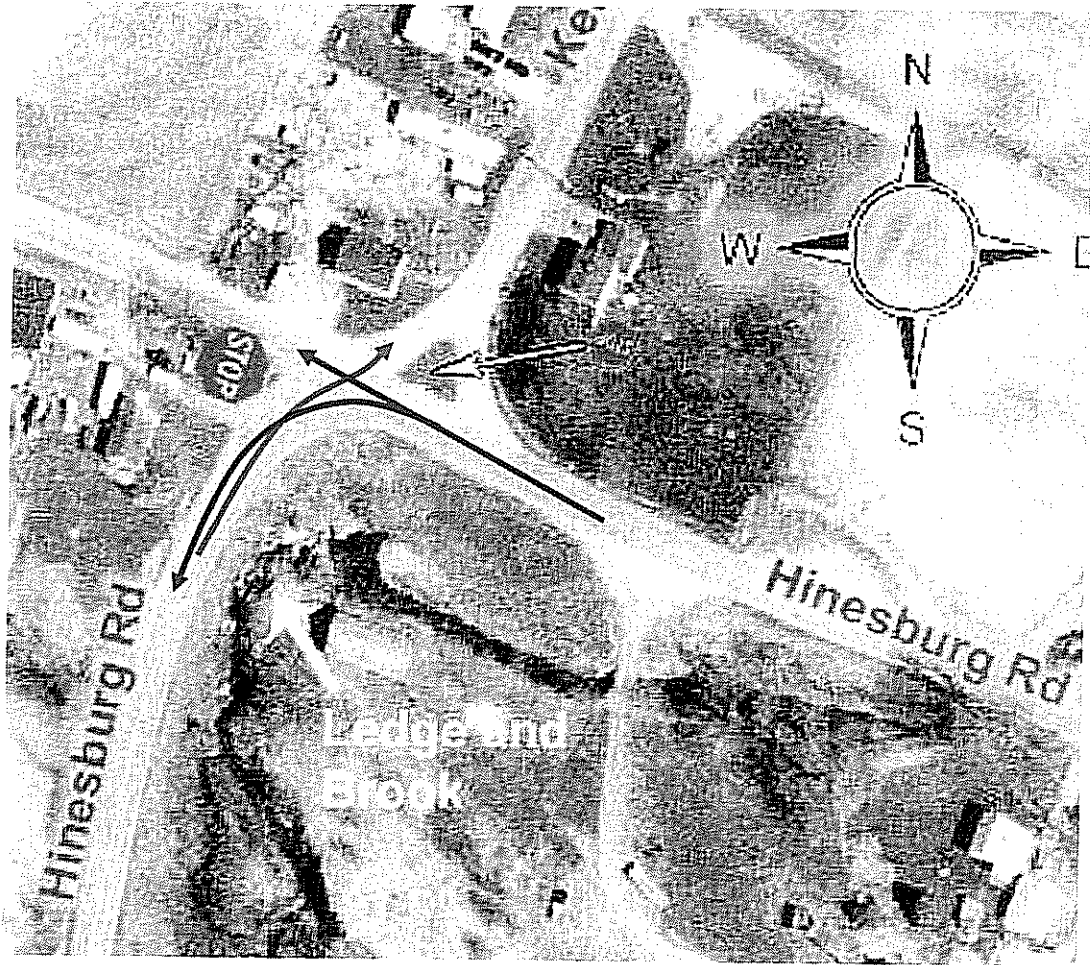
- 6) During the one-hour observation period, four conflicts were observed between somebody wanting to continue on Kenyon Rd and a motorist from the Richmond direction on Hinesburg Rd either going straight on East Hill Rd or turning on Hinesburg (towards Hinesburg). One other conflict was observed with a vehicle turning left on East Hill and a vehicle from Richmond on Hinesburg turning left.

Figure 13. TRAFFIC CONFLICTS WERE OBSERVED IN THE FIELD

Observations & Possible Countermeasures	Responsible Entities								Strategy
	MPO	Town	AOT Traffic Ops						
There exists a major conflict: traffic going straight on Kenyon from Hinesburg (from the Hinesburg direction) do not have to stop and traffic going straight on East Hill or continuing on Hinesburg from Hinesburg (from Richmond direction) do not have to stop either.		√							The option in Figure 4 could possibly result in more rear-end crashes. A stop sign on the south leg should be a last resort. Not everybody needs to stop, only those going straight to Kenyon or turning left on East Hill. Yielding to the right is the action sought in this case. Consider one of the options shown in Appendix A.
