# **Phase I Environmental Site Assessment**

**Former Saputo Cheese/Richmond Creamery  
125 Bridge Street and 74 Jolina Court  
Richmond, VT**

**October 2008**

Re: Phase I Environmental Site Assessment  
Former Saputo Cheese/Richmond Creamery  
Richmond, Vermont  
JCO Project #1-0346-3

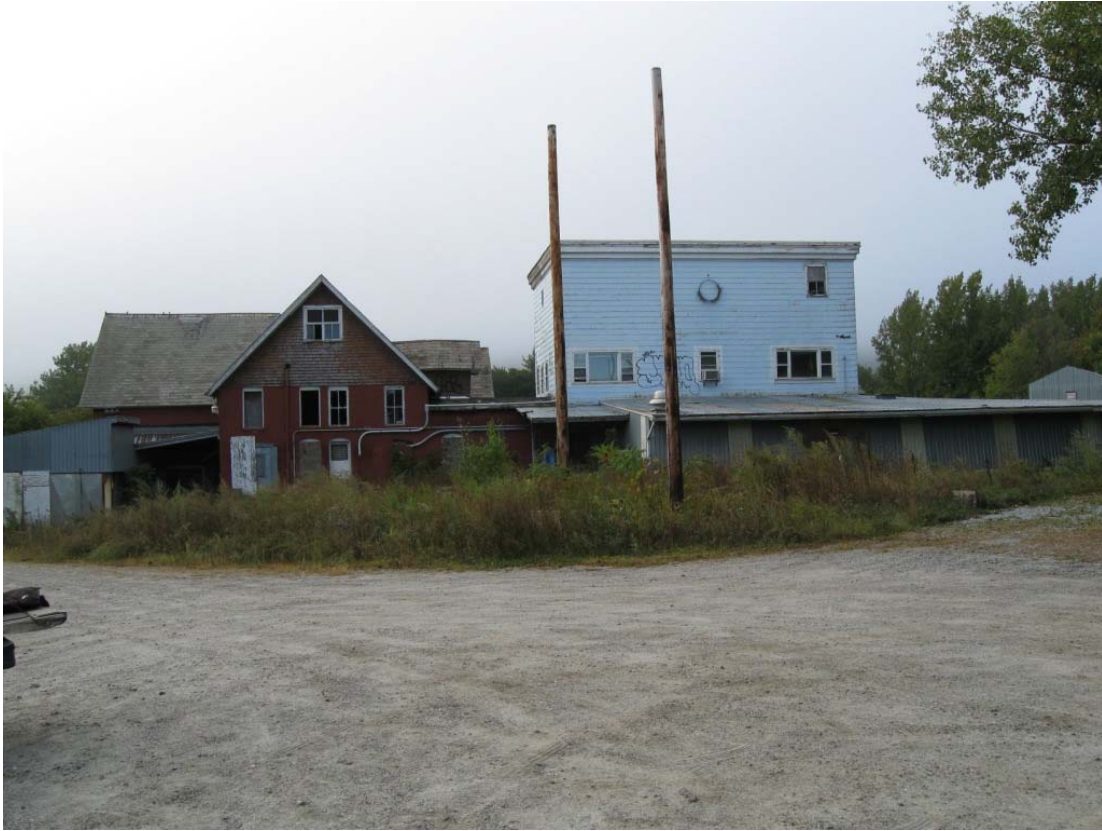
Plate 1: View of former Saputo Cheese/Richmond Creamery factory from Jolina Ct.

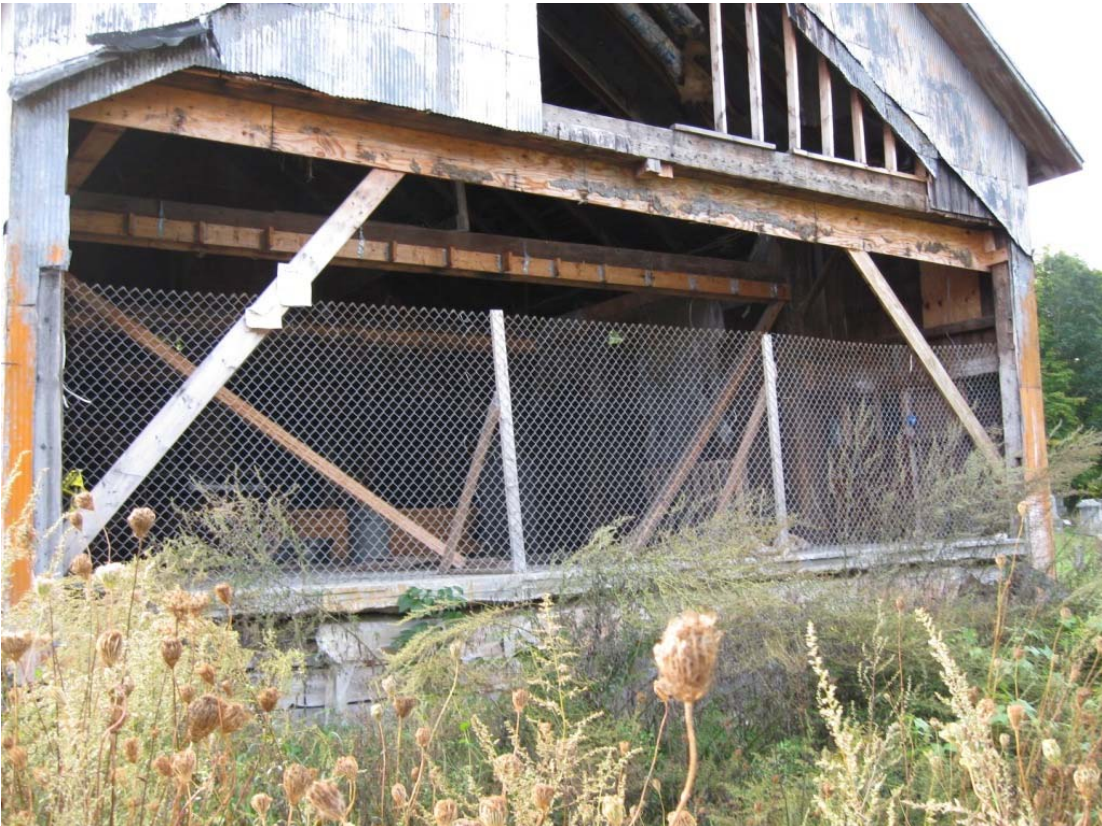
Plate 2: Former cooler storage building

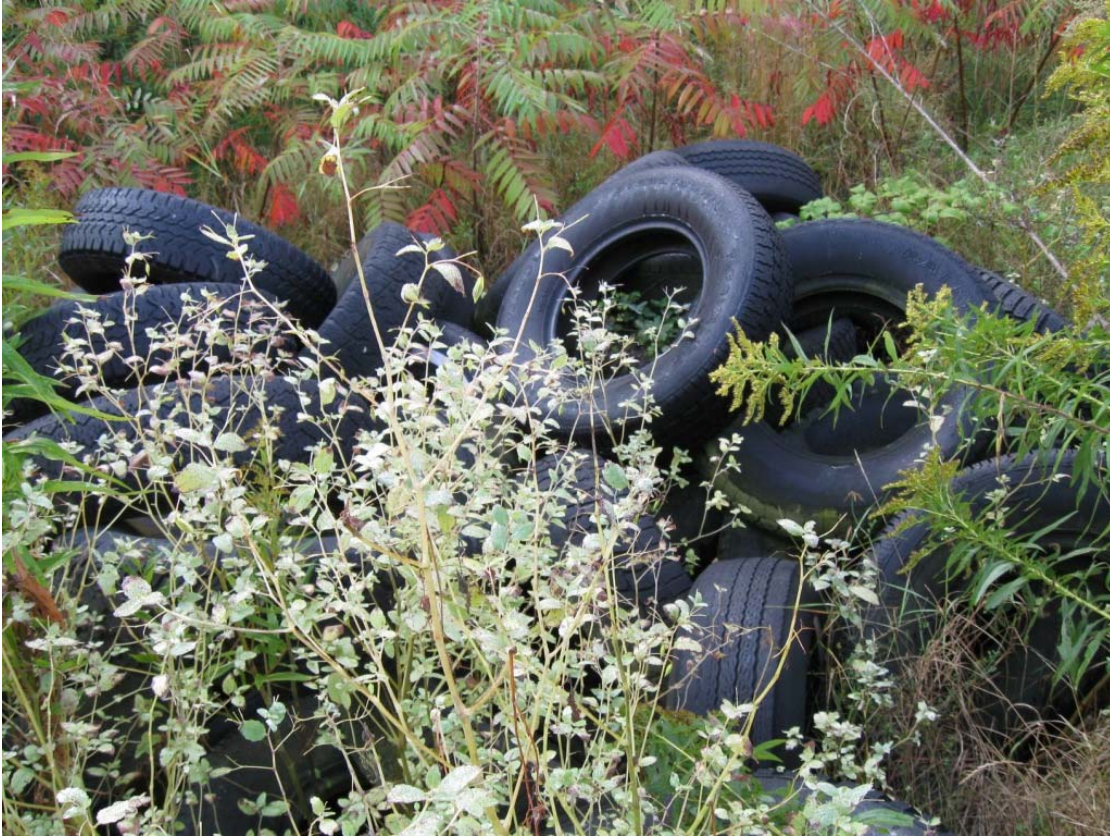
*The Johnson Company Follow Up: Although a pile of tires and small amounts of trash were observed, a “large amount of trash of unknown origin” was not observed by The Johnson Company. Mr. Ingalls indicated that, since the completion of the 2002 H&N ESA, he had removed and disposed of approximately 15 cubic yards of non-hazardous trash.*

Plate 3: Pile of tires

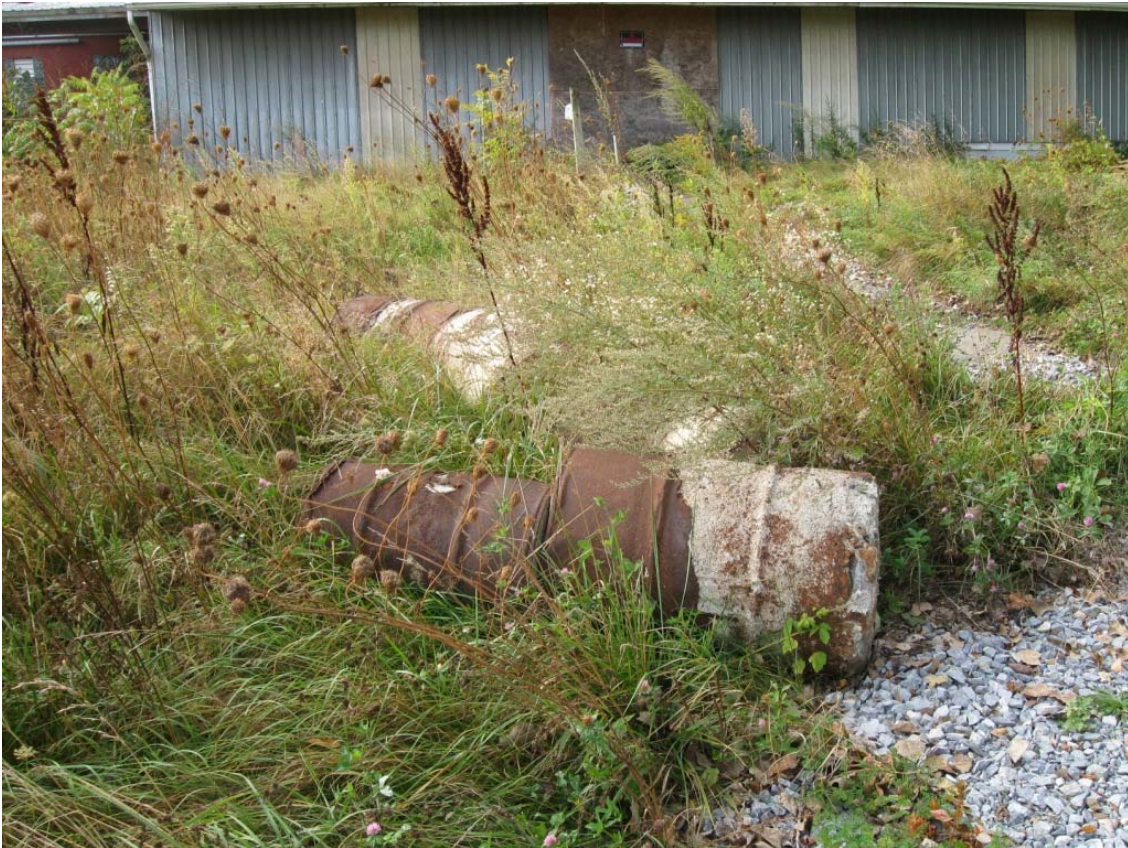
Plate 4: Drums filled with concrete

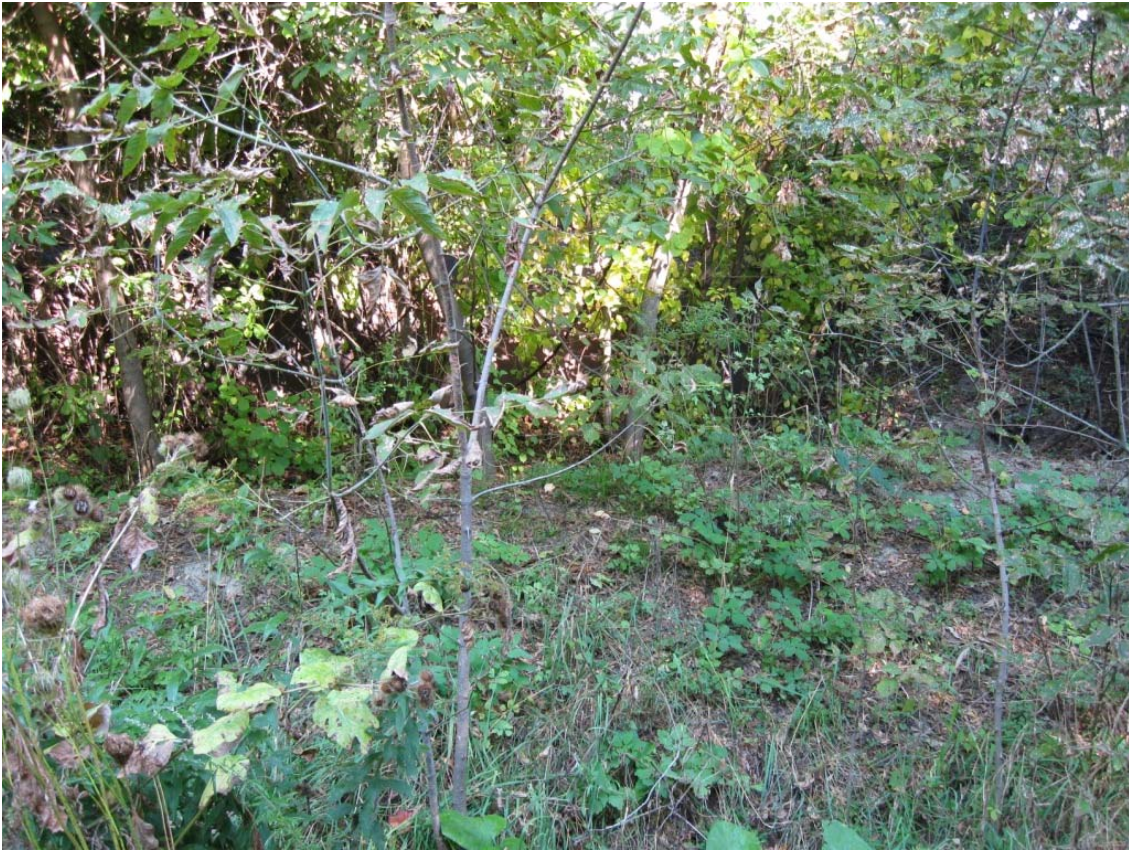
Plate 5: Berm covering wastewater conveyance pipe

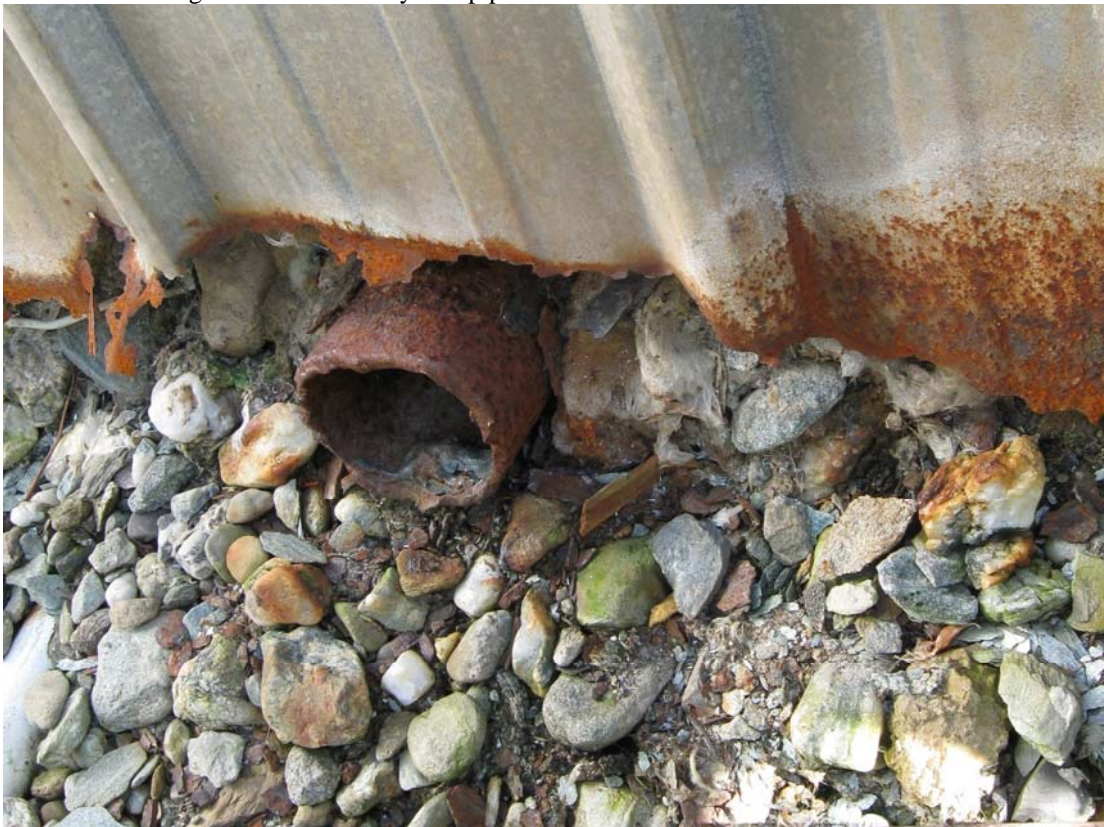
Plate 6: Severed pipe in rear of boiler building

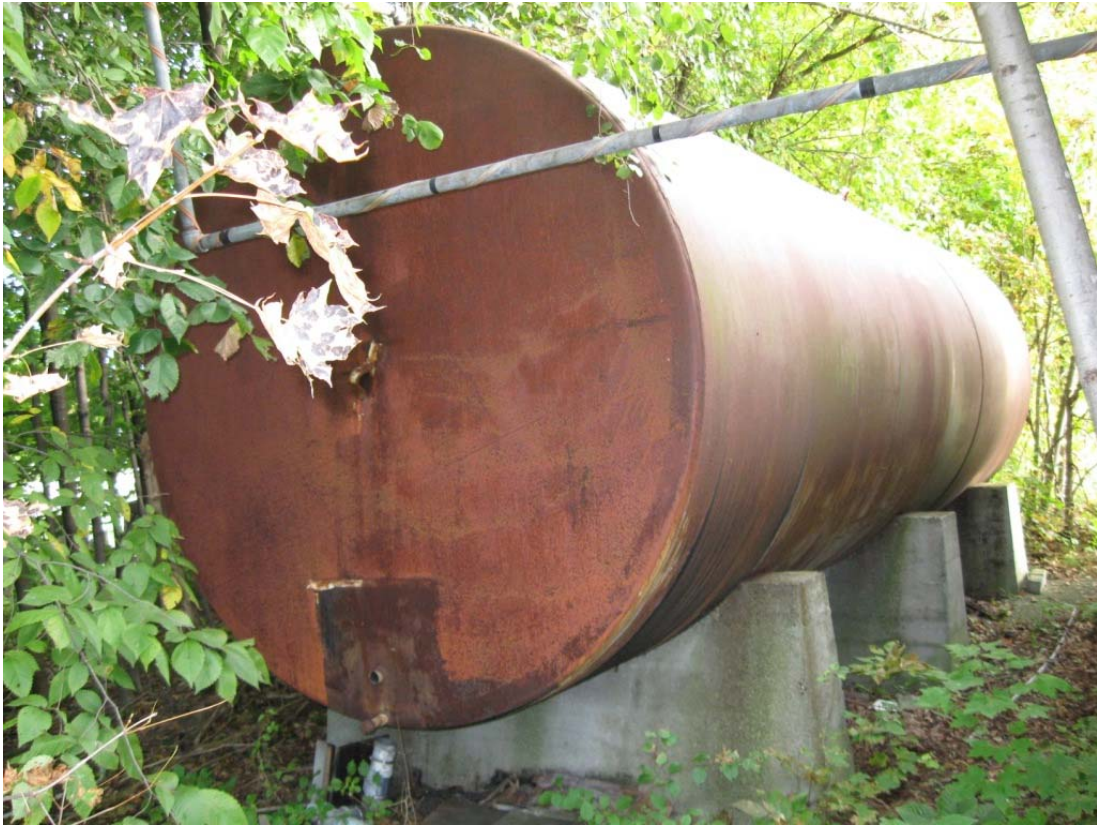
- A 10,000-gallon above ground storage tank containing some residual fuel oil sludge is present on the Site. The piping for this AST was routed overhead, and no staining or olfactory evidence of releases to the ground surface were observed.

Plate 7: Above ground heating oil storage tank

*Recommendation: The sludge from the AST should be removed and the tank should be cleaned. This would remove the potential for releases to the environment if the AST fails. If the AST is to be reused, it must be inspected before being filled with oil.*

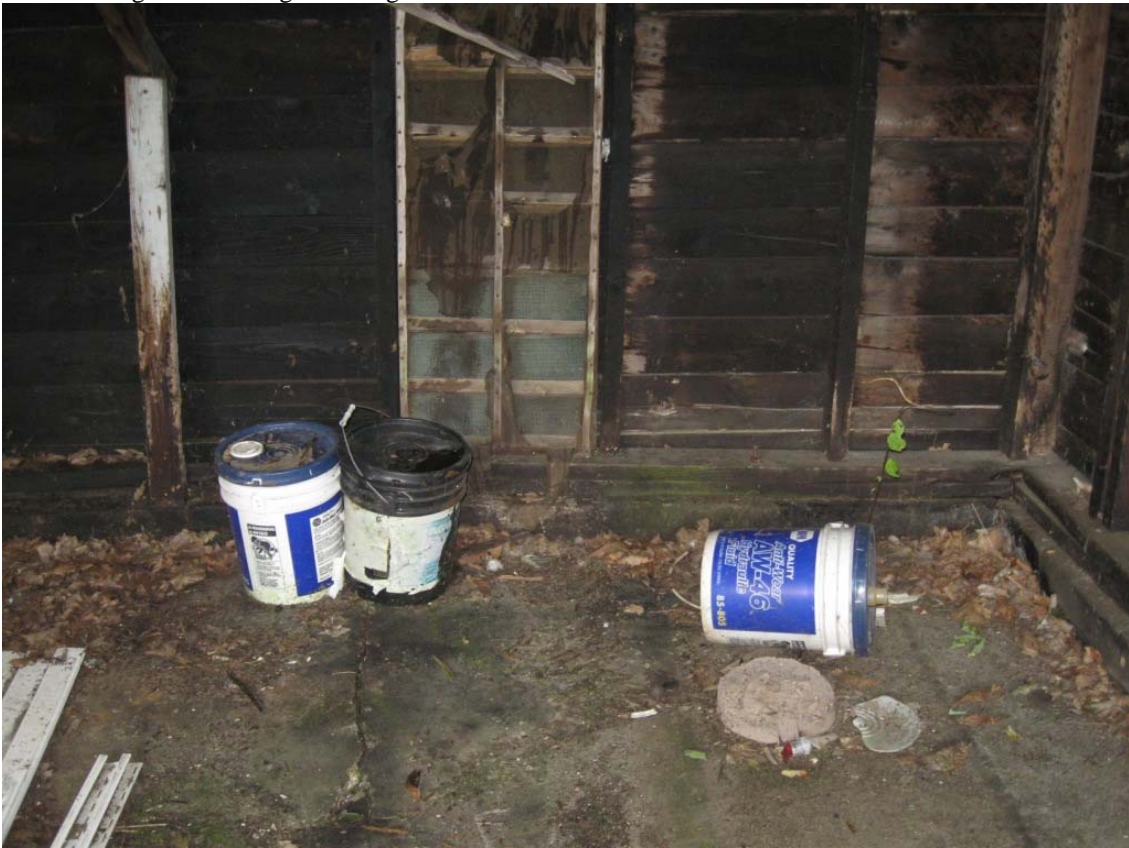
- Containerized potentially hazardous materials in the former factory and storage buildings. Some of these containers were observed to be uncovered, which presents risk for spills or releases.

Plate 8: Five gallon buckets in storage building

*Recommendation: A licensed environmental contractor should characterize and remove all containerized potentially hazardous materials.*

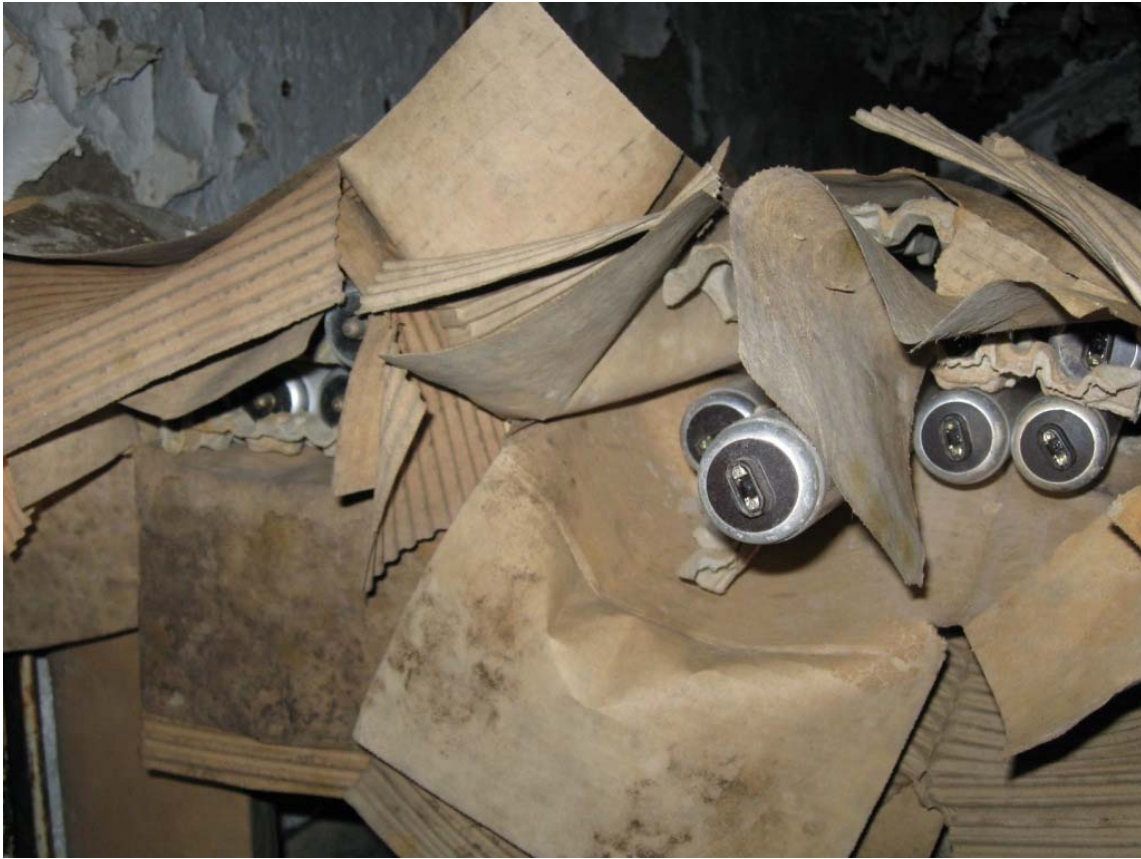
Plate 9: Fluorescent light bulbs

- Fluorescent light bulbs possibly containing mercury and lead in the factory building.  
*Recommendation Prior to any site reuse, a licensed environmental contractor should characterize and remove all out of service or unused fluorescent light bulbs and PCB-containing fluorescent light ballasts.*

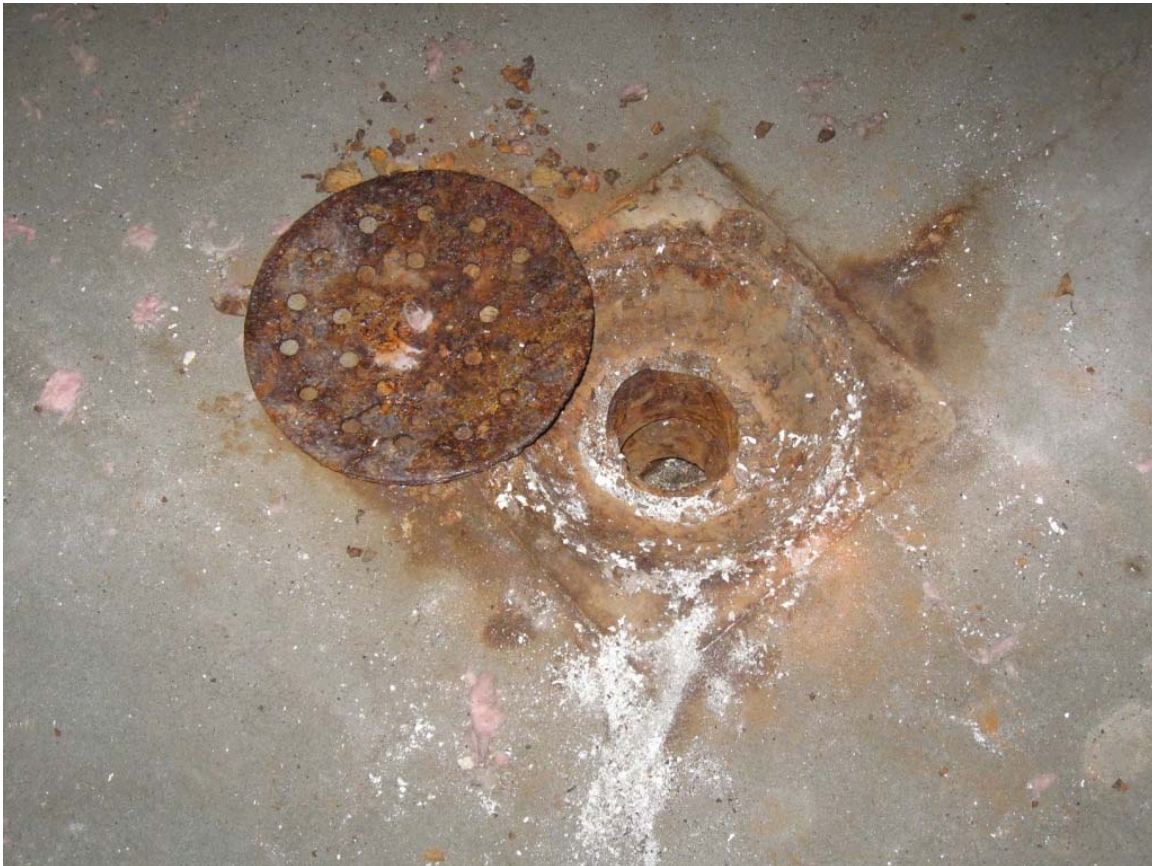
Plate 10: Floor Drain

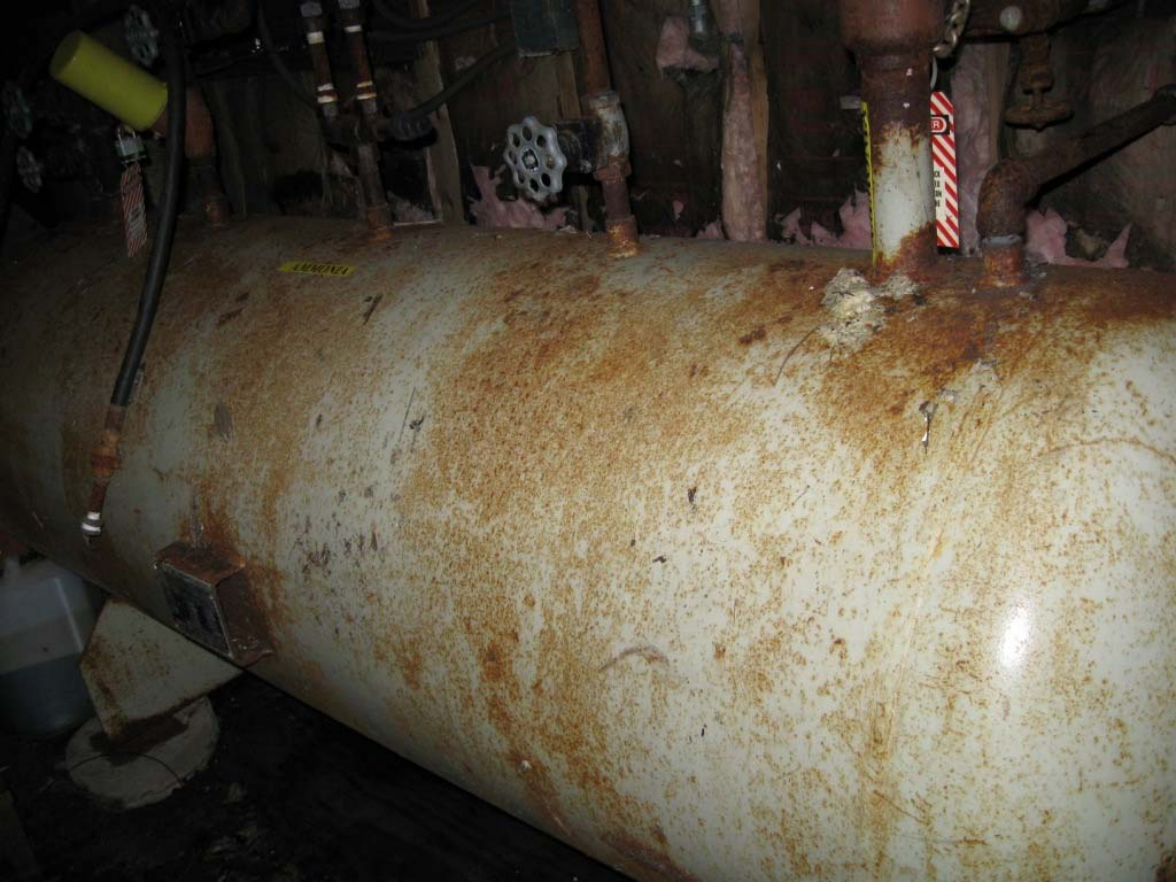
An ammonia refrigeration system was utilized in the factory operations, and the conveyance piping and ammonia tanks are still present. There was no visible evidence of leaks,

Plate 11: Ammonia tank

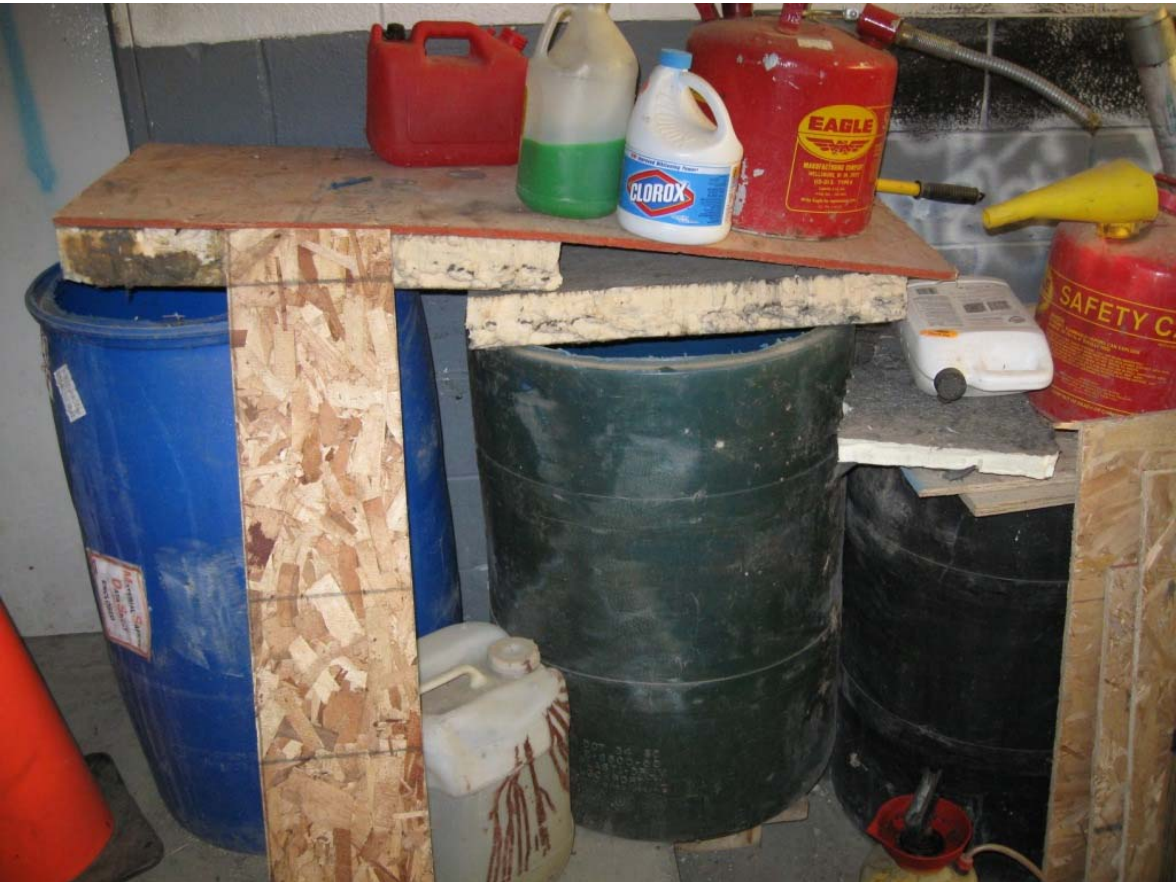
Plate 12: Various chemicals in maintenance area

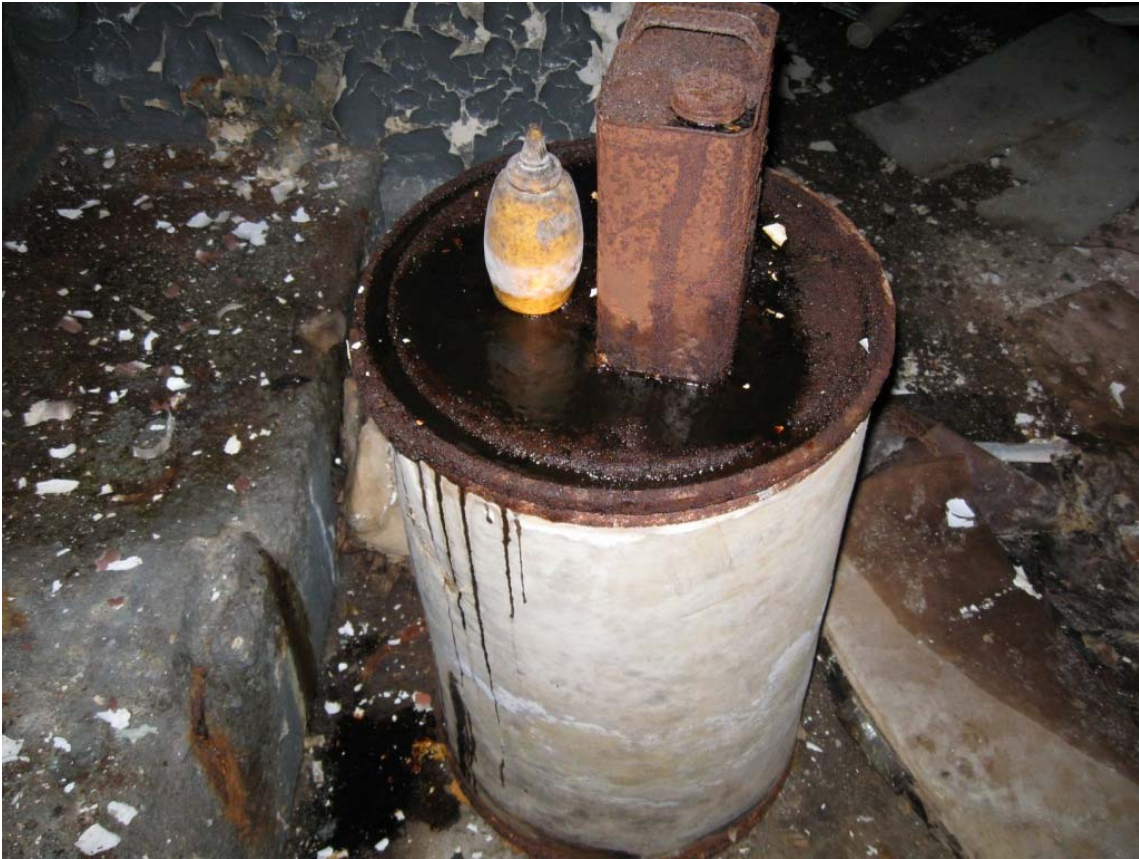
Plate 13: Containers with unknown substances

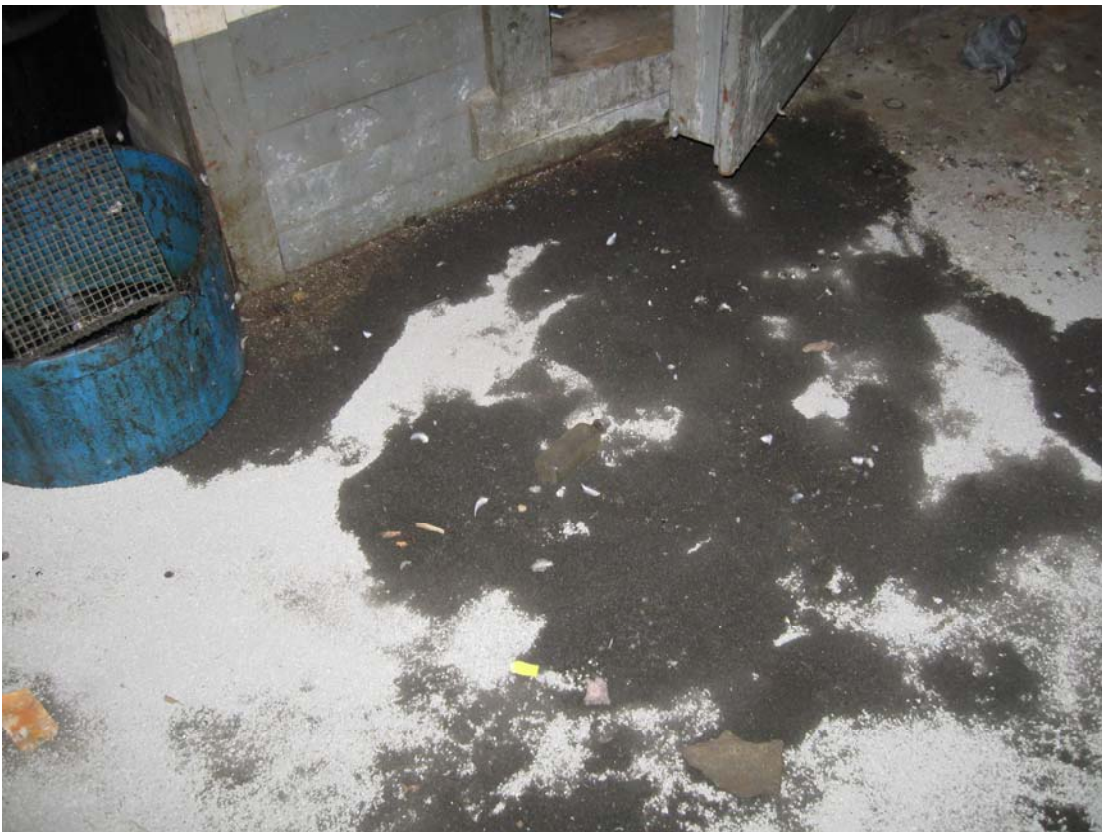
Plate 14. Oil spilled on Level 1 by vandals.

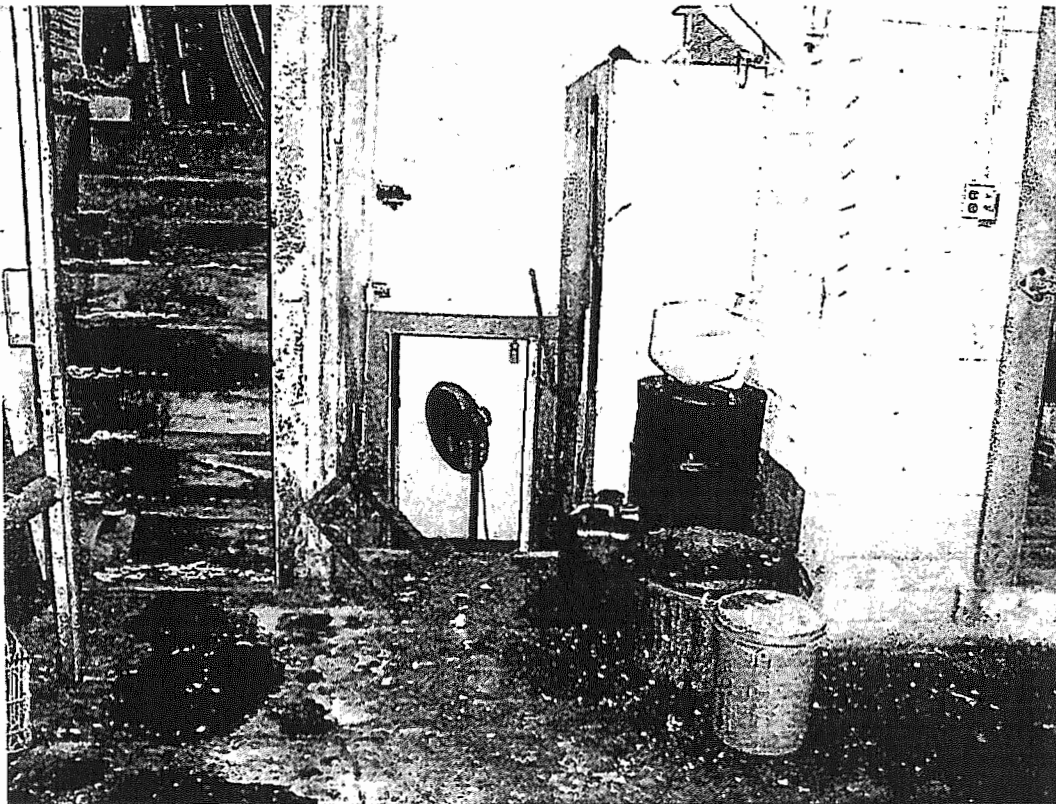
**Photo #4:** Drum and vat containing waste oil.

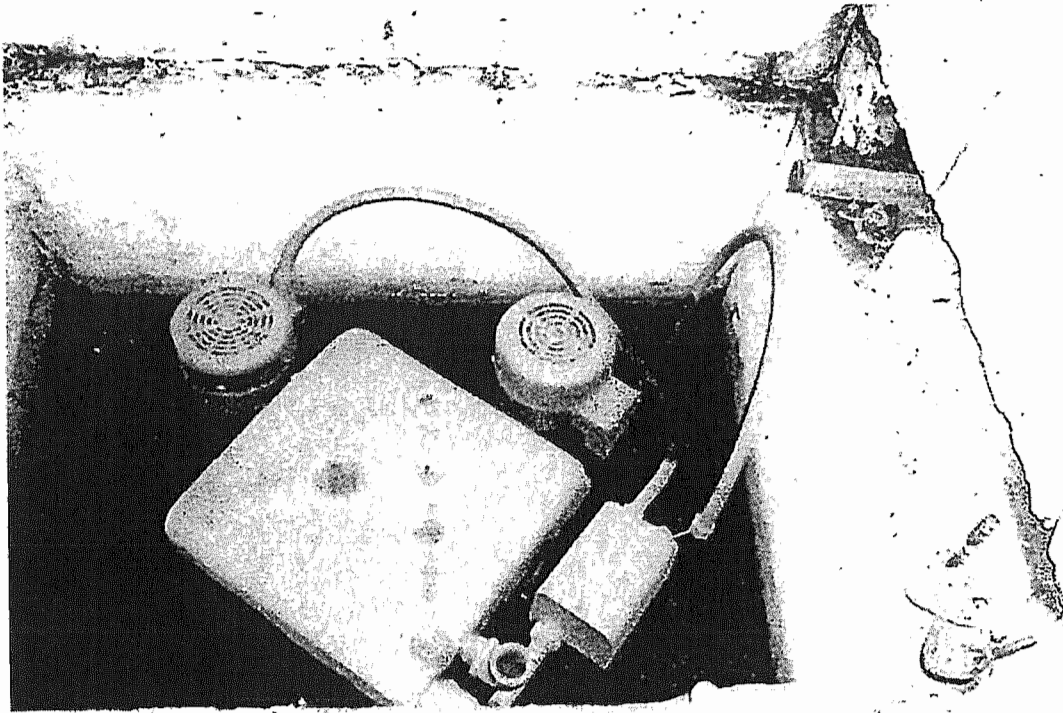
**Photo #5: Sump pump.**

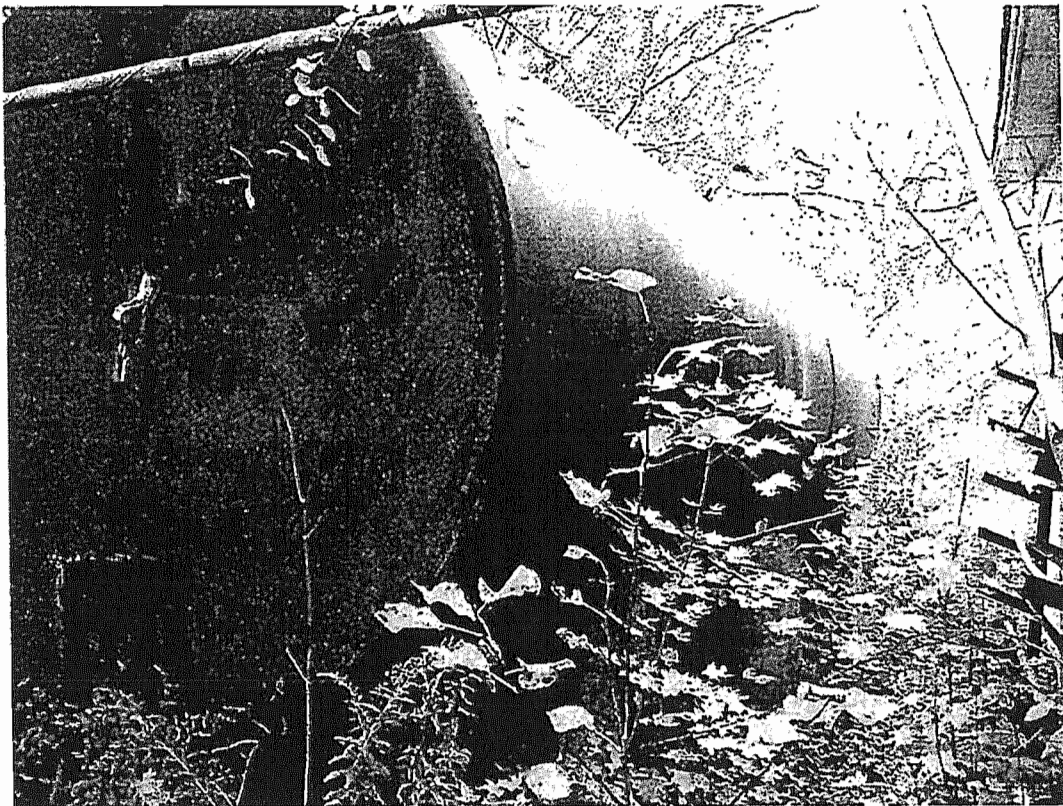
**Photo #6: Above ground storage tank.**

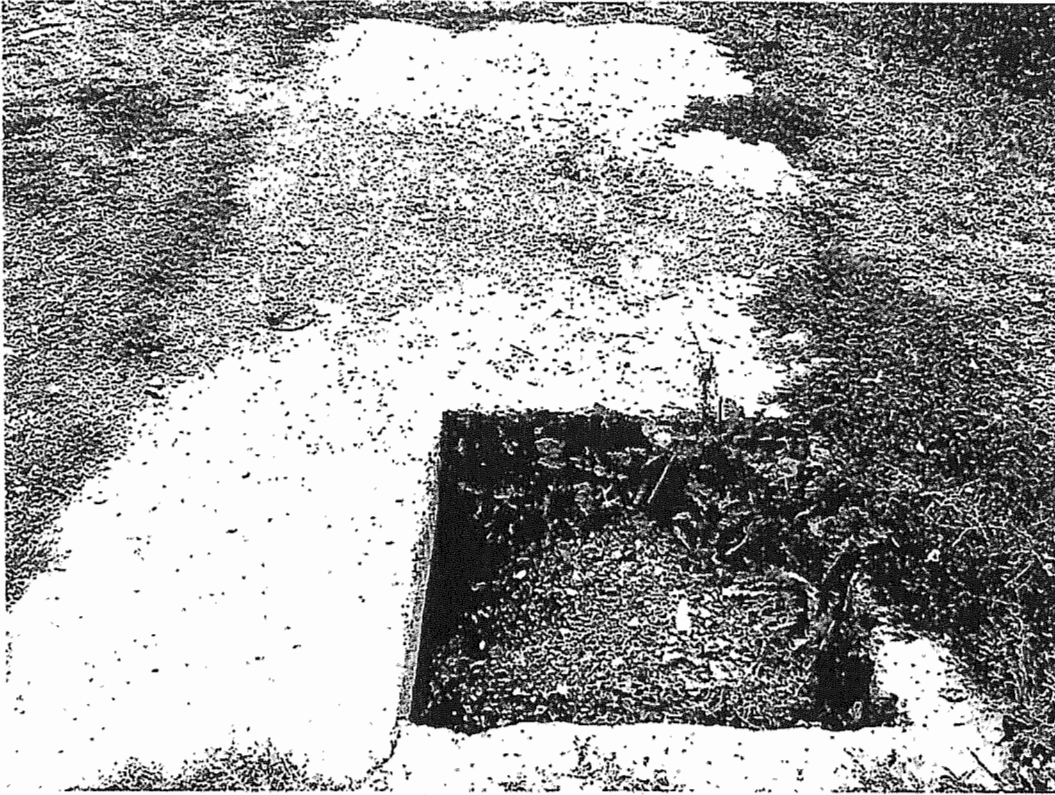
- A hollow pit of unconfirmed contents, covered by a concrete slab, is present on the Site. *Recommendation: The contents of the pit should be determined. If there is evidence that the pit once contained oil, soil and/or groundwater sampling should be conducted immediately outside the pit.*

**Photo #7: Pit of unknown origin.**

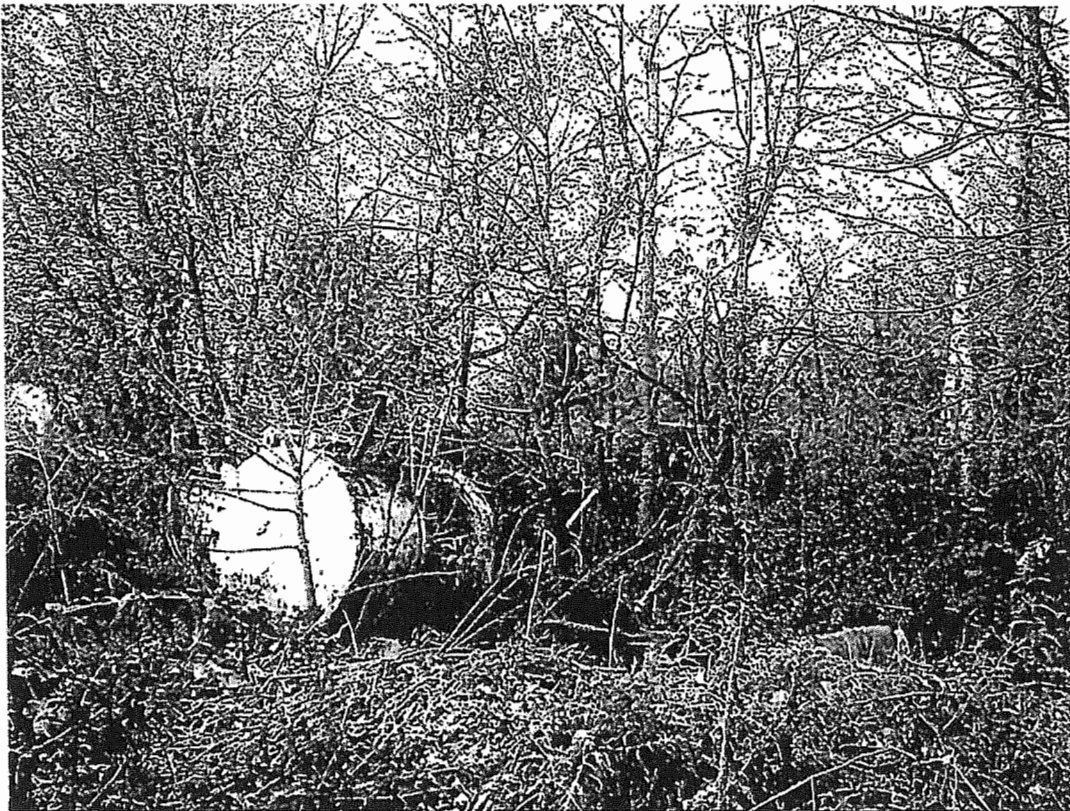
- 2002 H&N Observation: There is a large amount of trash of an unknown composition observed in one section of the property.

**Photo #8: Miscellaneous trash near railroad.**
