Richmond Street and Sidewalk Audit

Prepared by the Richmond Transportation Committee

4/28/2023

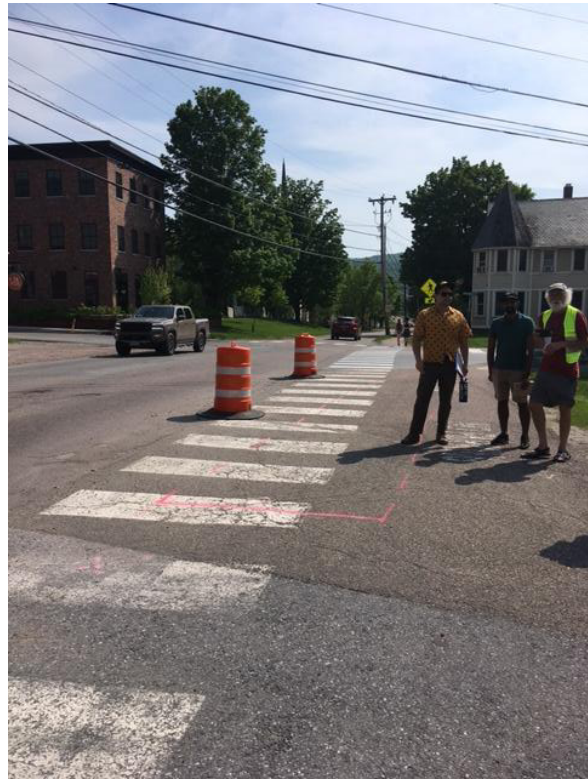
Missing Sidewalk next to Richmond Market

The gap in the sidewalk along Bridge Street in front of the Cumberland Farms gas station, as shown in the above figures creates a dangerous situation for pedestrians. This section is a large curb cut in which cars enter and exit the gas station, and park between the convenience store and Bridge Street. This segment has no pedestrian facilities and no clear guidance for pedestrians on how to cross the curb cut. Bollards and trash cans keep parked vehicles about two feet from the exterior building wall of the Cumberland Farms building, leaving a distance of about 20 feet to the edge of the roadway. Parked Vehicles force pedestrians out into the roadway.

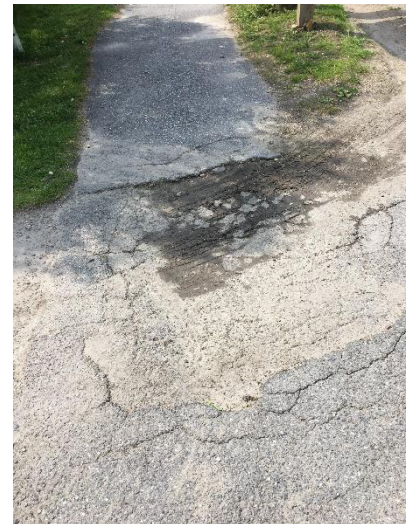
Rough sidewalk and driveway surface

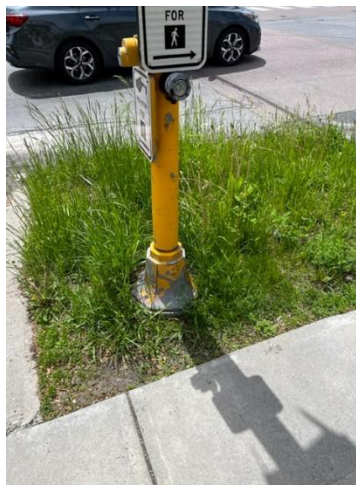
Walk signal for pedestrians

Volunteers observed that the walk signal gives pedestrians a five-second advance before the green light signal for traffic going straight. However, the intersection lacks a “no right turn” signal for vehicles when the walk sign is activated. Volunteers also noted the lack of a clear sight line from Bridge Street northbound to East Main Street eastbound.

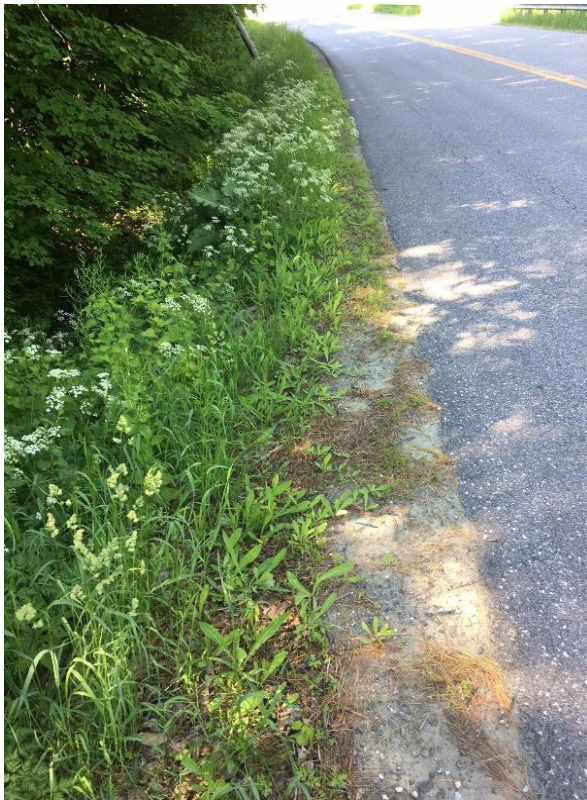
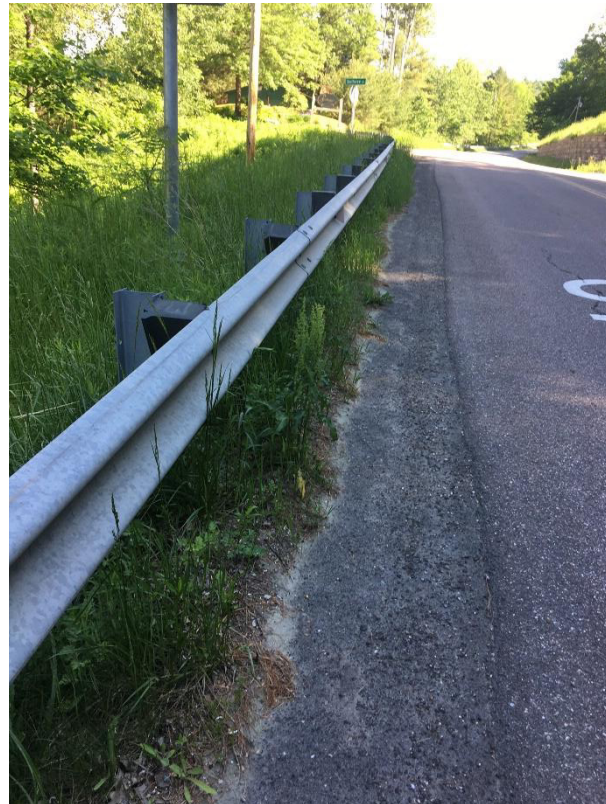
This Jericho Road segment begins at School Street and ends at Valley View Road approximately 0.4 miles north. This area is adjacent to and outside of the intended study area, and a couple volunteers studied this area. This entire segment is sloped. The speed limit is 25 miles per hour from School Street to Southview Drive, and 35 miles per hour from Southview Drive to Valley View Road. The vehicle travel lanes are 11-12 feet. This segment does not have a sidewalk or a paved shoulder. The shoulders in general in this location are narrow, as shown in Figure 6. The roadway has no fog lines, bike lanes or sharrows.

Measurements showed that most vehicles were traveling above the posted speed limit. The average speed of the observed traffic traveling northbound and southbound was 39 miles per hour. The maximum speed measured of the observed traffic traveling northbound was 54 miles per hour and the maximum speed measured of the observed traffic traveling southbound was 55 miles per hour.

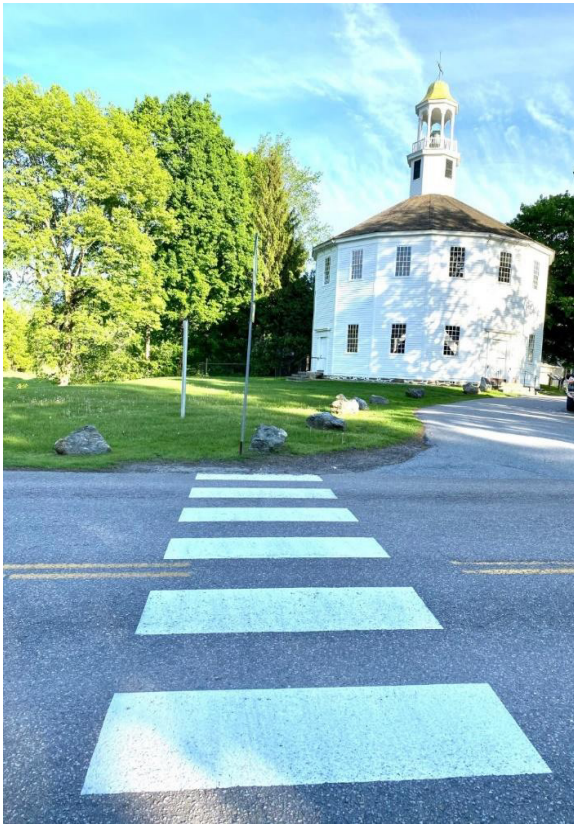
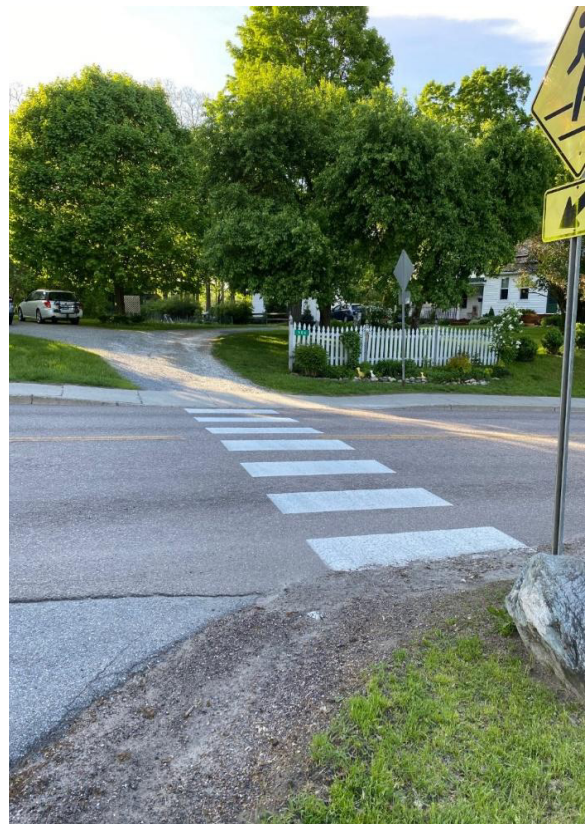
Drivers were observed using left-turn signals when driving straight from Bridge Street to Thompson Road, and some drivers get stalled at the stop signs at Thompson Road and Cochran Road unsure when they can drive. Some drivers appear to be confused about how to drive through the intersection. Drivers were observed not stopping for pedestrians at the crosswalk at this complicated intersection.

Vehicles move quickly through the intersection from Bridge Street to Huntington Road, and vice versa. In addition, drivers were observed driving through the stop sign from Cochran Road onto Bridge Street without stopping. Drivers were also observed not stopping for pedestrians at the crosswalk on Huntington Road.
