Richmond Library Assessment
Conducted by Alex Tolstoi, Hunger Valley Construction
October, 2023

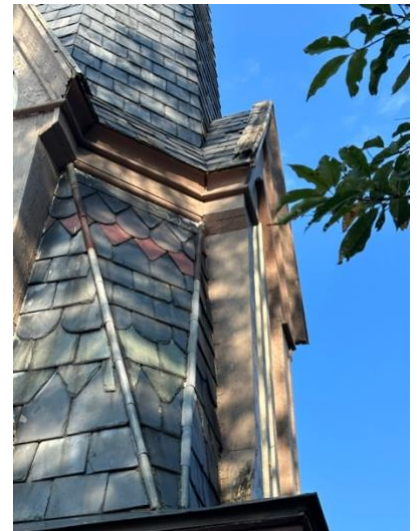
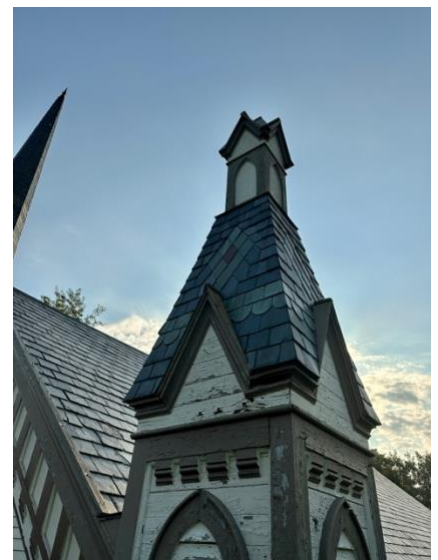
Other noticeable repair needs occur around the many applied decorative features on the towers and front facade. I believe this has occurred due to deferred maintenance and water being able to get behind the trim and rot the nails and wood. Again, painting and caulking will prevent further damage after repairs are done. One visible deteriorated feature is the cross on the front gable. The damaged section appears to be on a

previously replaced section, further evidence that quality materials should be used and maintained on all future restorations.

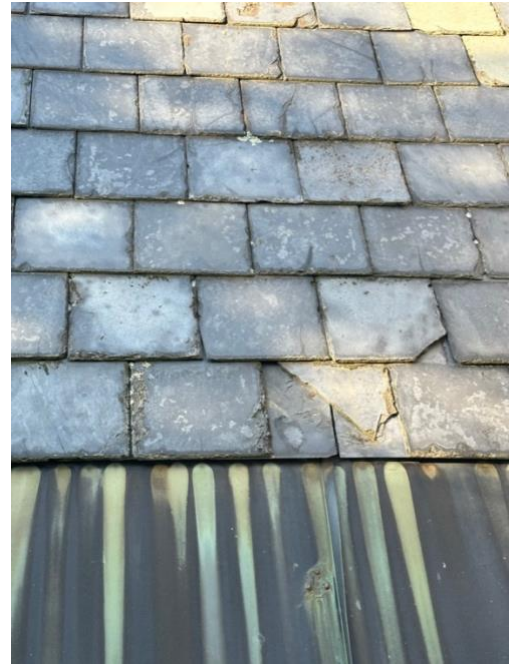
Roofing: All recommendations on the slate roof were offered by Jeff Spencer of Stewardship Slate. These recommendations are broken into two separate categories: restore and replace, for two separate areas: upper towers and main block. Because Jeff was unable to clearly identify the origin of the existing slate, it was difficult to make a definitive determination on the total lifespan of the material. To make a more accurate recommendation, Jeff would need to take a sample of the existing slate and send it off for identification by experts.
