## MEMORANDUM

To: Josh Arneson; Town of Richmond  
From: Jason Charest, PE, PTP; CCRPC  
Date: September 24, 2025  
Re: Fay's Corner Safety Audit

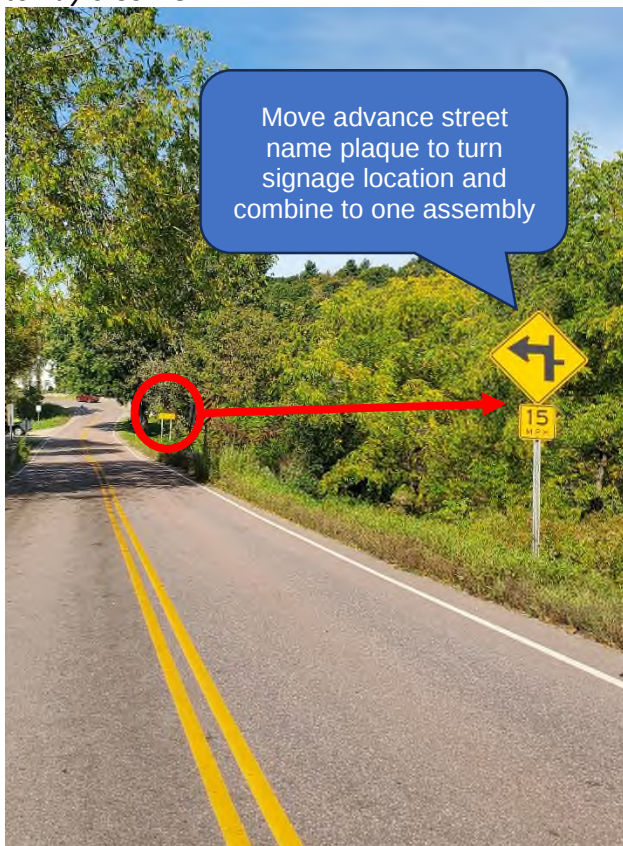
***Figure 4: Hinesburg Road westbound approach to Fay's Corner***

- The Hinesburg Road turn signage should be combined with the advance street name plaques on the westbound and northbound approaches to the intersection. For the westbound approach, the advance street name plaque should be relocated to the turn signage location to avoid being obstructed by the bridge object marker signage. For the northbound approach, the turn signage should be relocated to the street name plaque location as the turn signage is placed too far from the actual turn. (See Figures 4, 5, and 6)

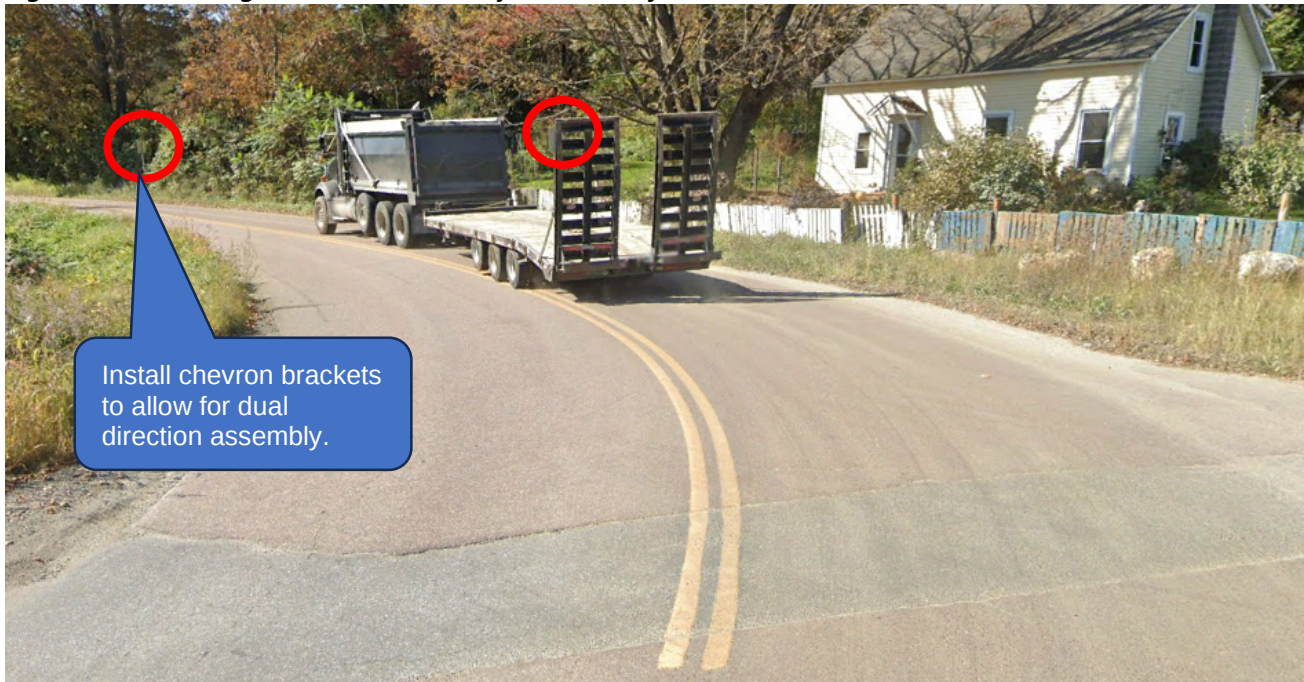
Figure 8: Hinesburg Road southbound just south of East Hill Road

- There are no chevrons in the westbound/southbound direction on Hinesburg Road. Brackets should be installed on the two existing southernmost chevron posts to allow for dual-direction assembly. (See Figure 7 above and 8 below) The post nearest the large arrow (northernmost) at the end of East Hill Road can remain as is given its proximity to the large arrow. Signing for the opposite direction in this location would be redundant.

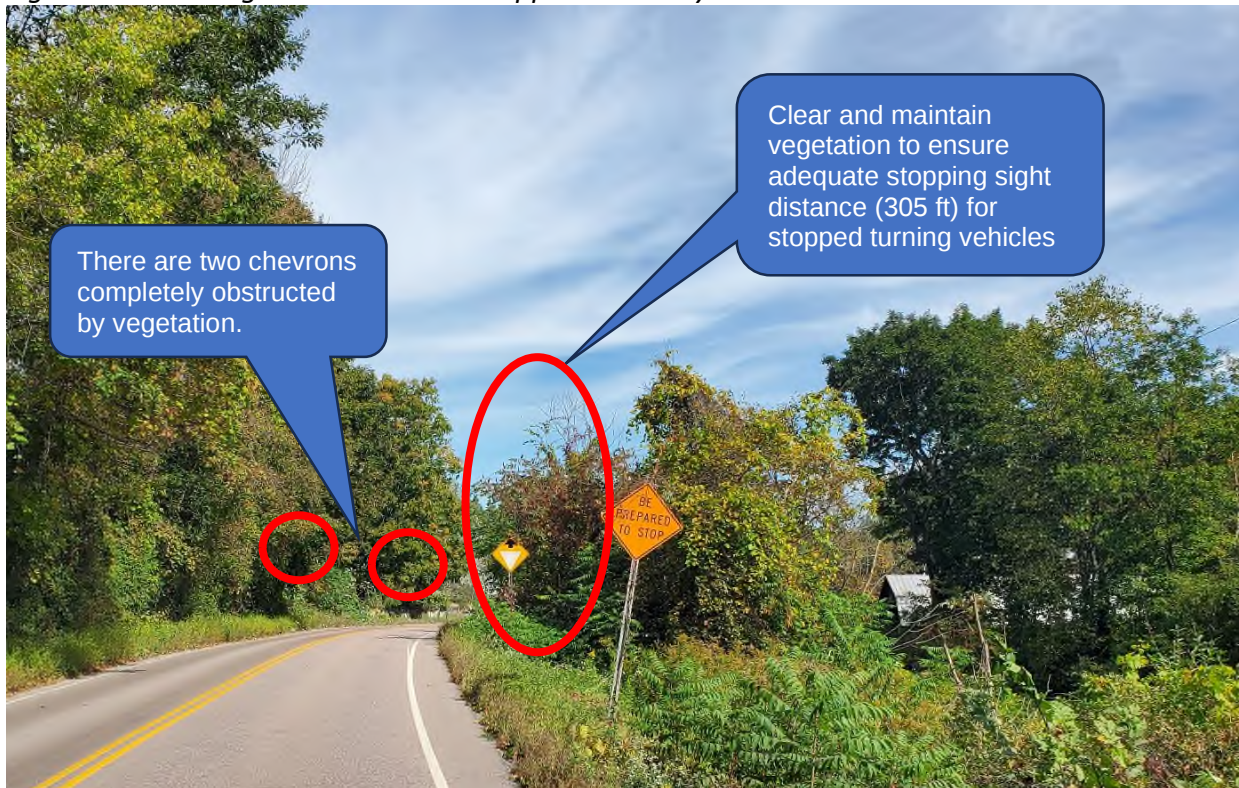
*Figure 9: Hinesburg Road northbound approach to Fay’s Corner*

- The Hinesburg Road northbound chevrons are blocked by vegetation. Vegetation should be cut back and consideration to upsizing the chevrons could be given. They appear to be 18 x 24 inches and could go up a size to 24 x 30. (See Figure 9 below)

- There is overgrown vegetation that obstructs the inside of the Hinesburg Road curve on the northbound approach. This should be cut back and maintained to ensure a safe stopping sight distance (305 ft for 40 mph) around the curve should a vehicle be stopped to turn left onto East Hill Rd or Kenyon Rd. (See Figures 9 and 10)

- o Once the vegetation has been cut back, the northbound “Be Prepared to Stop” and “Crossing Traffic Yield to Right” signs can be removed and replaced with a new “YIELD” sign placed in line with the break in the centerline. The Yield Ahead sign may also be able to be removed depending on the “YIELD” sign’s visibility. The “YIELD” sign should be visible 305 feet in advance. If not, a new Yield Ahead sign should be placed around 300 feet in advance of the “YIELD” sign.

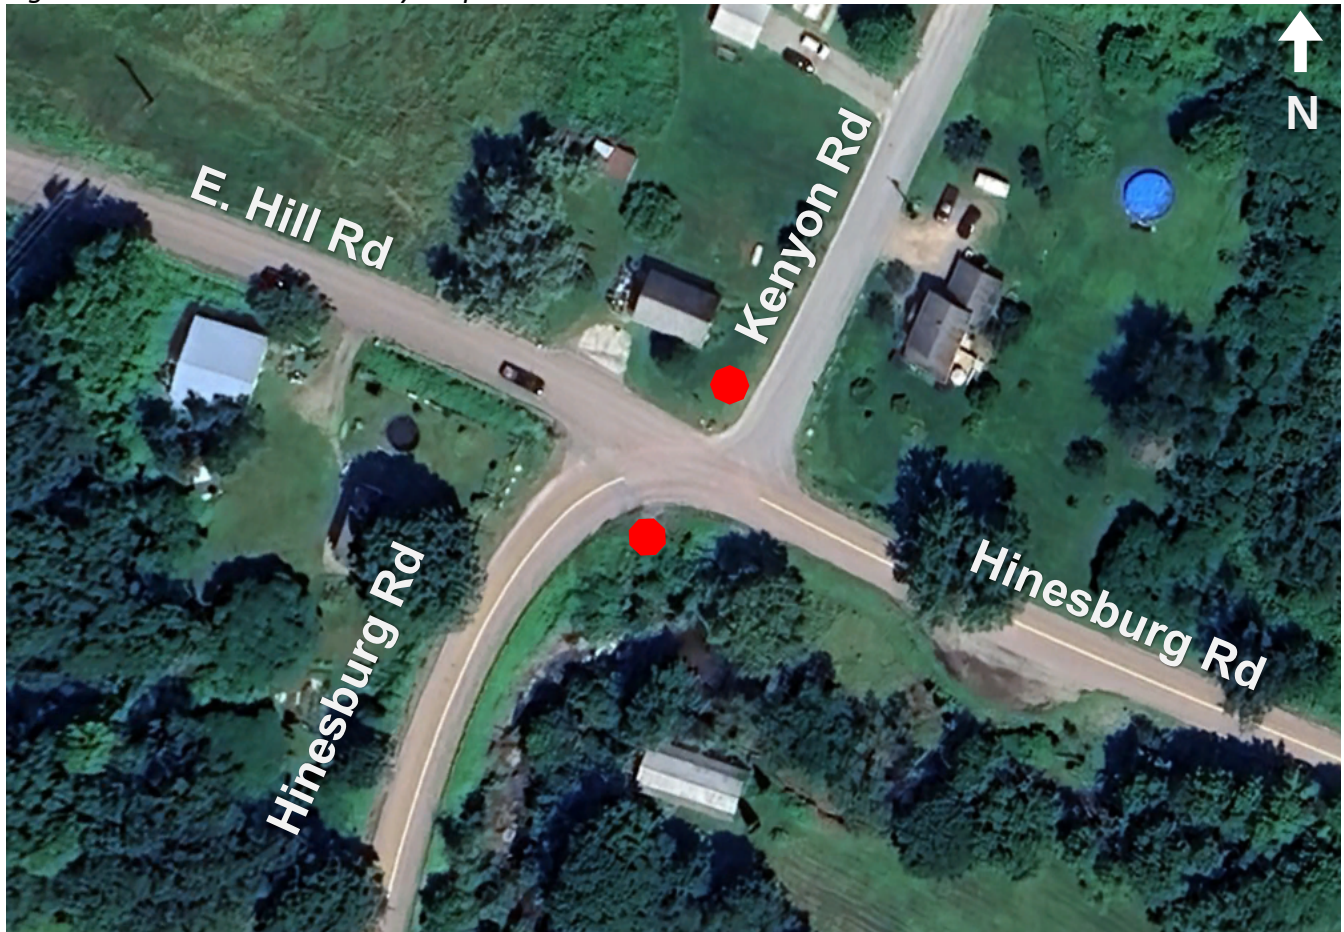
*Figure 11: Traditional Two-Way Stop Controlled Intersection*

A traditional two-way stop control would move the STOP sign on East Hill Road to the northbound Hinesburg Road approach shown below in Figure 11. This would make East Hill Road and the westbound Hinesburg Road approach the uncontrolled through movement. The northbound Hinesburg Road approach would need to be realigned to square up with East Hill Road. Even then, it's unclear if vehicles newly stopped northbound on Hinesburg Road would be able to see an adequate distance up East Hill Road to make a safe maneuver. This could also create an additional hazard of East Hill Road traffic speeding through the intersection eastbound to Hinesburg Road given its steep downhill approach to the intersection. Interestingly, existing speeding through the intersection was observed in the opposite (westbound) direction during a follow-up site visit.

Of these two reconfiguration options, a traditional two-way stop controlled intersection is not recommended due to the safety concerns noted above. An all-way stop controlled intersection is, however, a viable option. It would not meet any traditional volume or crash experience warrants as outlined in the Manual on Uniform Traffic Control Devices (MUTCD), but the MUTCD allows for other factors to be considered in the installation of all-way stop control. Conflicting turning movements between northbound Hinesburg Road and Kenyon Road, and the intersection's unconventional stop control nature, could both be considered justifiable reasons for an all-way stop installation.

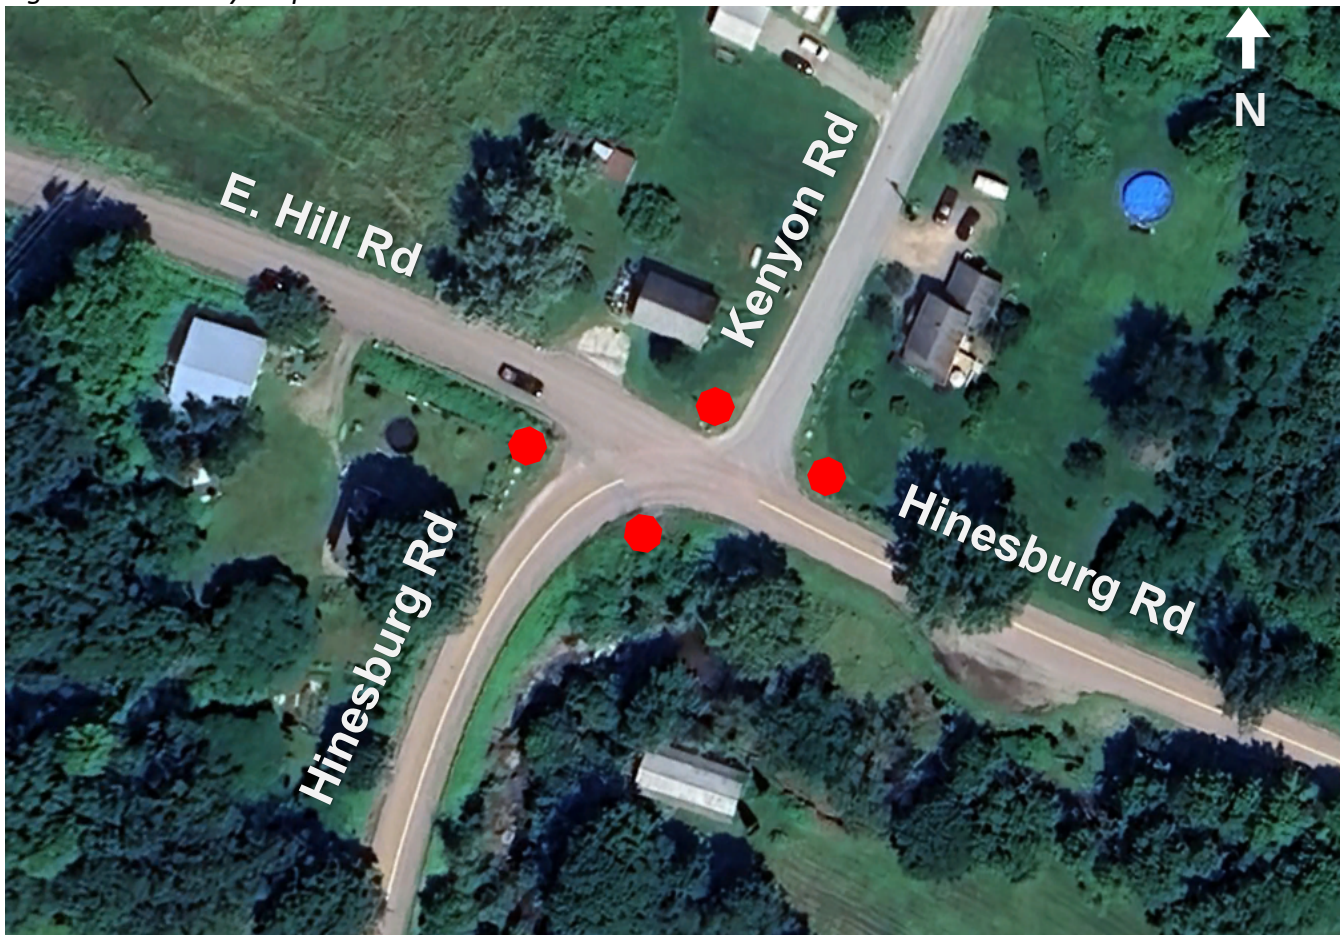
*Figure 12: All-Way Stop Controlled Intersection*

In an all-way stop control configuration, STOP signs would be added to the existing uncontrolled Hinesburg Road approaches shown in Figure 12 below along with accompanying supplemental signage and striping. Realigning the northbound Hinesburg and Kenyon Road approaches to a more traditional four-way intersection would be preferred in the longer term but not required in the immediate. Stop ahead signs would be recommended for the Hinesburg Road approaches along with an additional left-side STOP sign on the northbound Hinesburg Road approach to ensure visibility (unless the corner brush is sufficiently cleared out and maintained). Painting of stop lines would also be recommended. The other existing various signage could largely be removed.
