Project Kick-off Meeting

Project/File:	Richmond US-2 Pinch Points
Date/Time:	May 19, 2023 / 9:30 am – 12:30 pm
Location:	Site Visit
Next Meeting:	TBD
Attendees:	Jason Charest, Josh Arneson, Michael Fowler, Justin LaPerle, Cathleen Gent, Allen Knowles, Jim Cota, Keith Osborne
Absentees:	Chris Cole, Alysha Kane, Ashley Atkins, Ian Degutis, Joe Kelly, Lynn Smiley
Distribution:	Attendees and Absentees

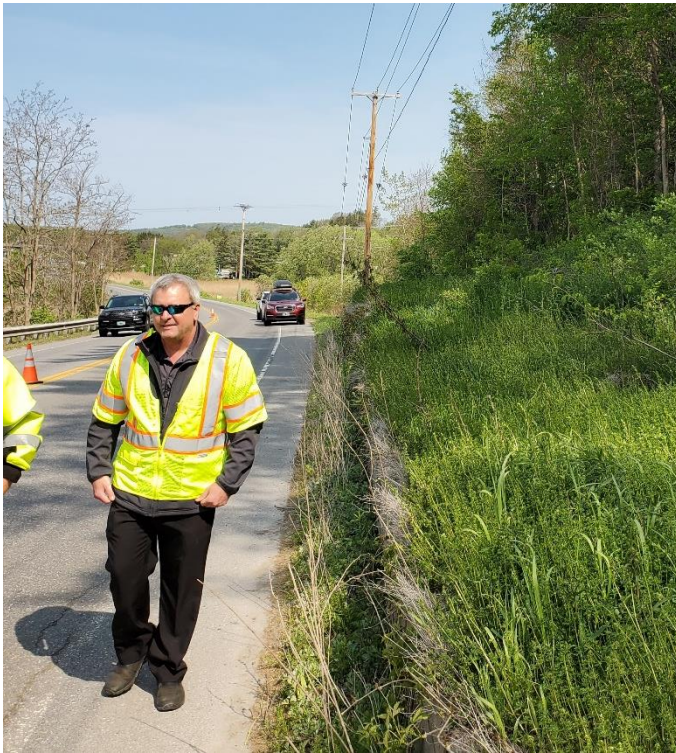
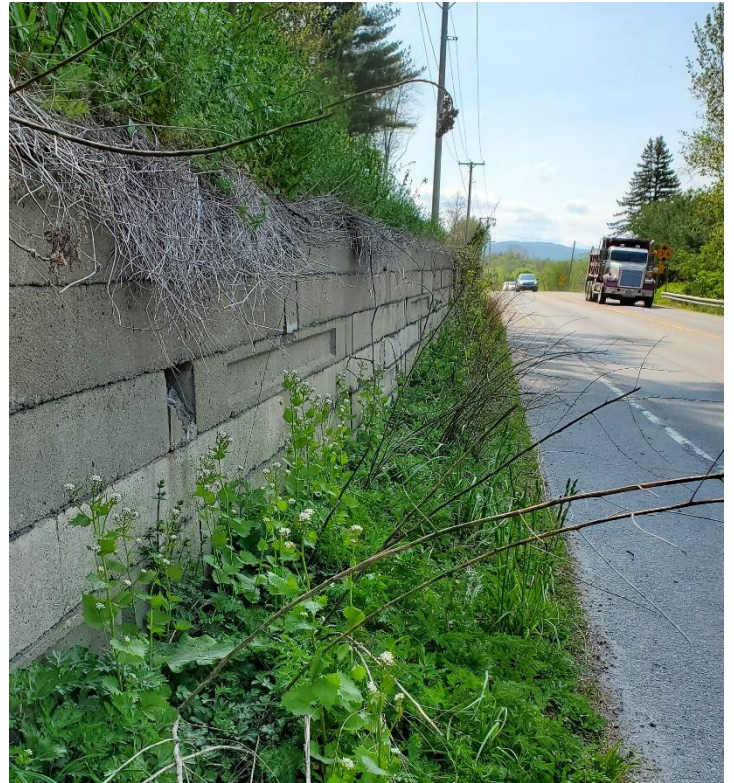
Location 1 STA 79+20 – 81+00, LT. (westbound)

There is an older retaining wall in this section. It is unclear why it's necessary as the slope on top/behind it is minimal. The wall could potentially be removed and converted to a hillside/embankment. District plow trucks are 14 feet wide and would prefer to push snow onto a hill or into a swale versus up against a retaining wall. Another option would be to move the retaining wall back. It would be worth looking into why the wall is there to begin with as, again, it was unclear from field observations.

Looking westbound (left) and eastbound (right) along Location 1

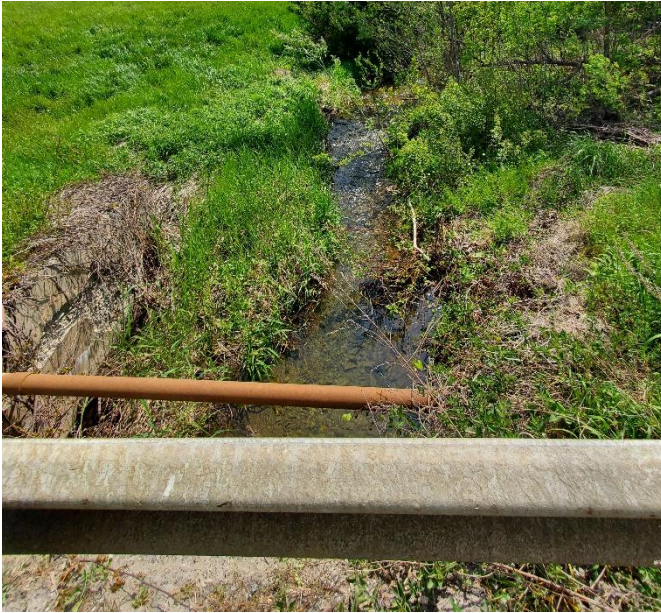
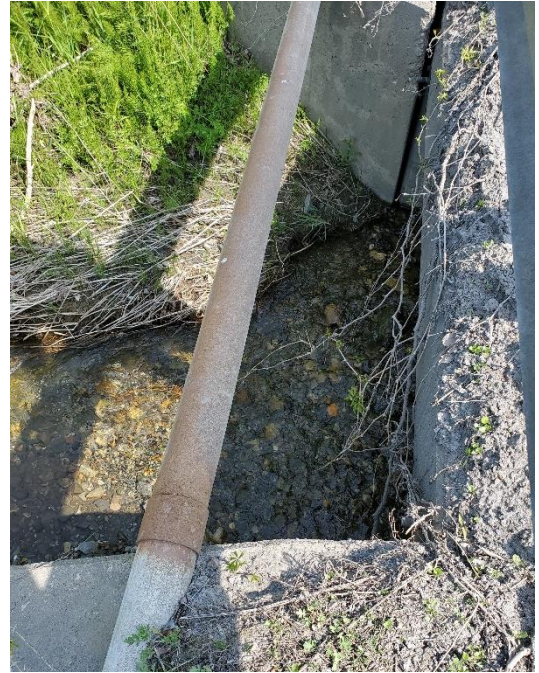
Location 4 & 5 STA 100+33 – 102+58, LT. (westbound) STA 101+46 – 102+03, RT. (eastbound)

There is a concrete box culvert (Bridge #28) at this location with piping across it on both sides of the roadway that is assumed to be carrying a fiber optic line. To accommodate 5' shoulders, the culvert would either need to be widened or replaced. It was thought that widening of the culvert, if feasible, would only be able to happen on the downstream side (eastbound) as the upstream side's wingwalls exhibited signs of deterioration, e.g. spalling. Based on erosion observations, the culvert also appeared to be undersized. US-2 would also need to be widened to accommodate a wider culvert.

Upstream (left) and downstream (right) of culvert

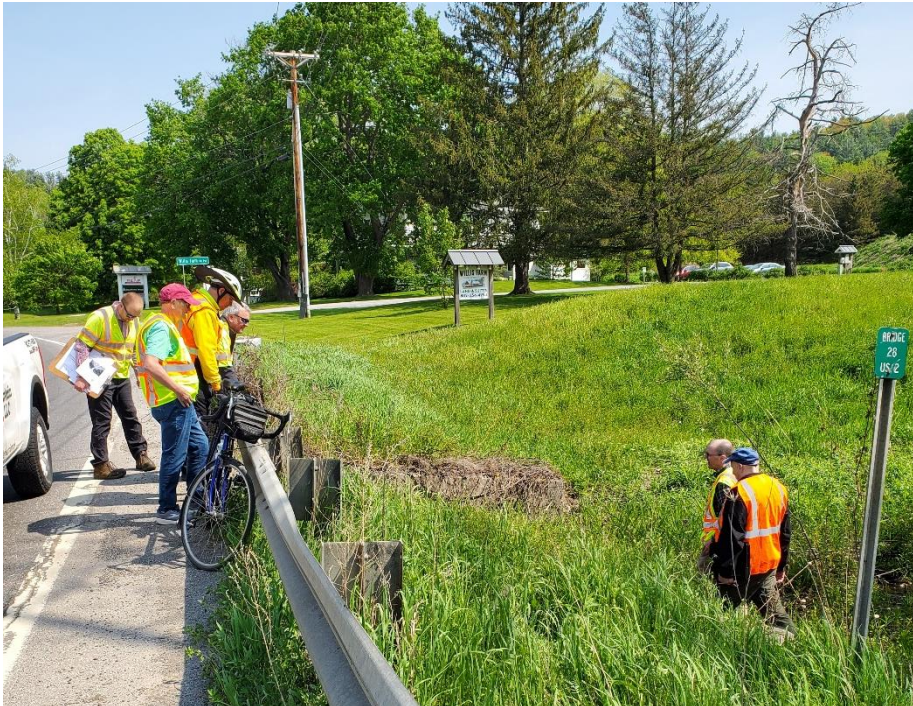
Looking westbound on US-2 towards the culvert.

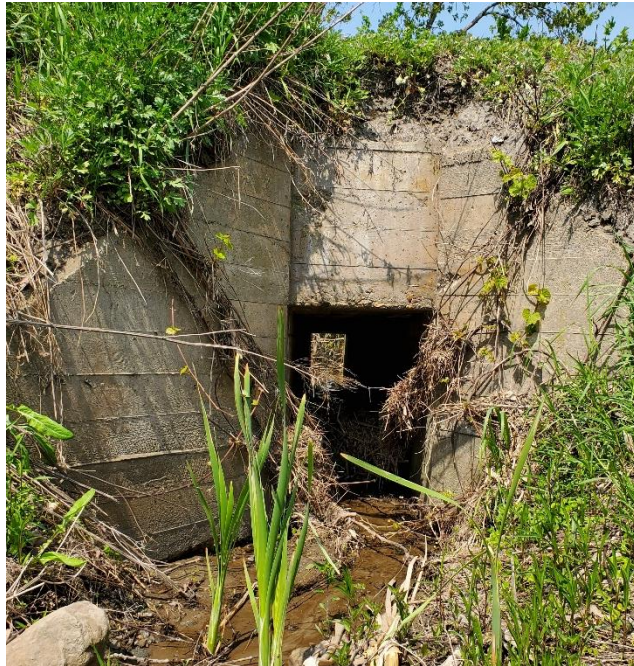
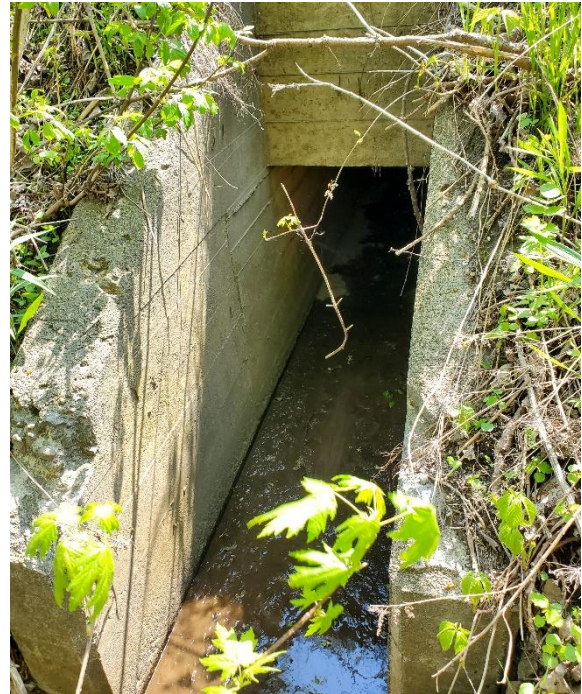
Location 6 & 7 STA 106+18 – 107+08, LT. (westbound) STA 105+95 – 107+05, RT. (eastbound)

Similar to location 4&5, the ability to provide 5' shoulders is also inhibited by a box culvert at this location. The box culvert is much smaller here, roughly 2' by 3', and can be seen below. The thinking of the group was that this culvert is undersized as well. Depending on a hydraulic evaluation, the culvert might be able to be replaced by a pipe or, if required, a larger box. The culvert appeared to be in good shape and the possibility of extending it was discussed as well.

Upstream (left) and downstream (right) of culvert

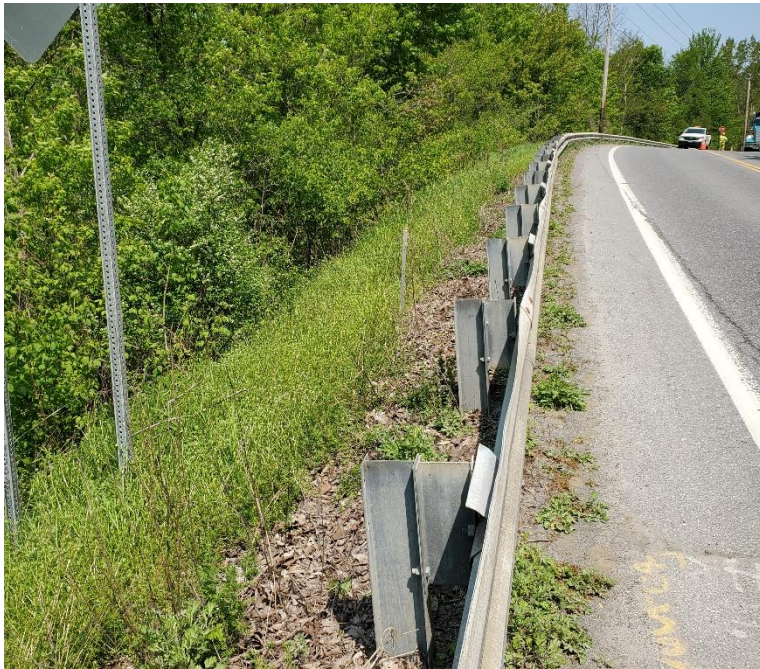
Location 8 STA 115+25 – 117+50, RT. (eastbound)

There are steep slopes on this side of US-2 that drop down 20-30 feet into the nearby floodplain/farm field. The most feasible option to widen the road in the section was sheet piling. A gravity wall was an option but much more expensive/complex with a much larger footprint. The other option would be to widen on the inside of the curve (westbound) by cutting into the hillside. This might encroach into the cemetery property and impact the large trees along the property line.

There was also a discussion about the guardrail. It is planned to be replaced as part of the paving project. It's unclear what type it will be replaced with. It was mentioned that the existing "offset block", as they've been determined to be unnecessary, could be removed to gain 6" of width. A box beam could be an option as well but more of a maintenance burden.

US-2 looking westward

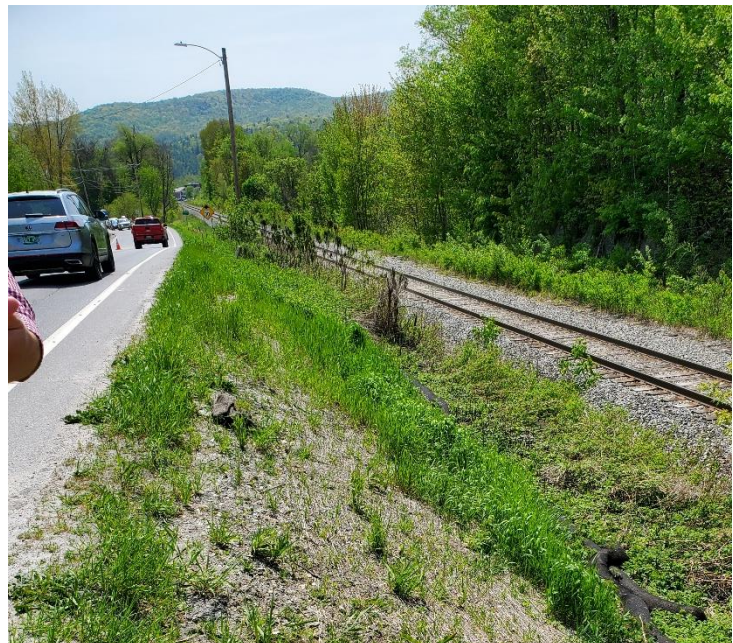
Location 9 STA 120+00 – 121+03, RT. (eastbound)

The steep bank continues at this location but not as far down in elevation. As seen in the photo at right, the railroad tracks are close by and would require close coordination with them. Sheet piling was seen as the most practical alternative to widen the roadway.

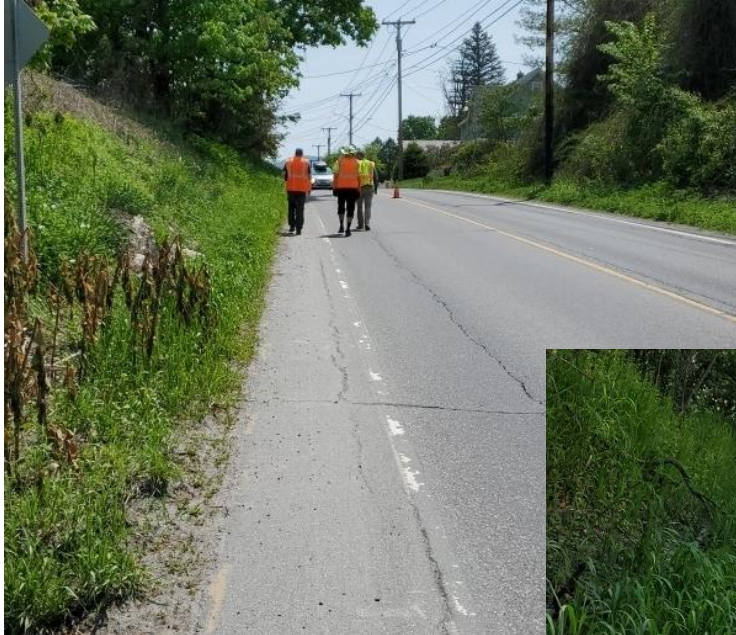
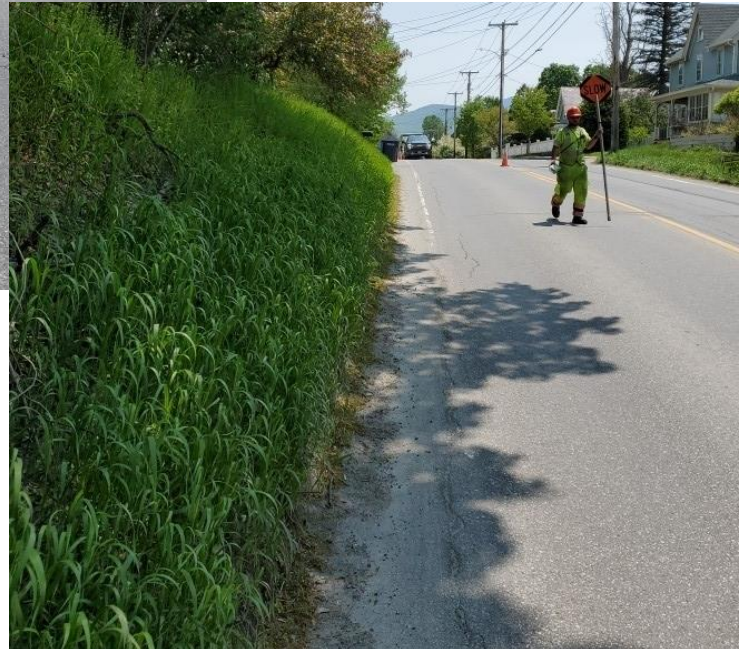
Locat. 10 & 11 STA 130+94 – 133+75, LT (westbound)

Steep hillsides come down to the roadway on both sides of US-2 at this location. This is the entrance to Richmond Village where dense development begins to line each side of the road. Options to widen the road include retaining walls and sheet piling on either side.

Both photos below are looking easterly on US-2
