Richmond Street and Sidewalk Audit

To provide guidance on selecting priority projects for the town Transportation Implementation Plan, the Richmond Transportation Committee conducted a systematic evaluation of walkability of three areas of Richmond in Spring 2022:

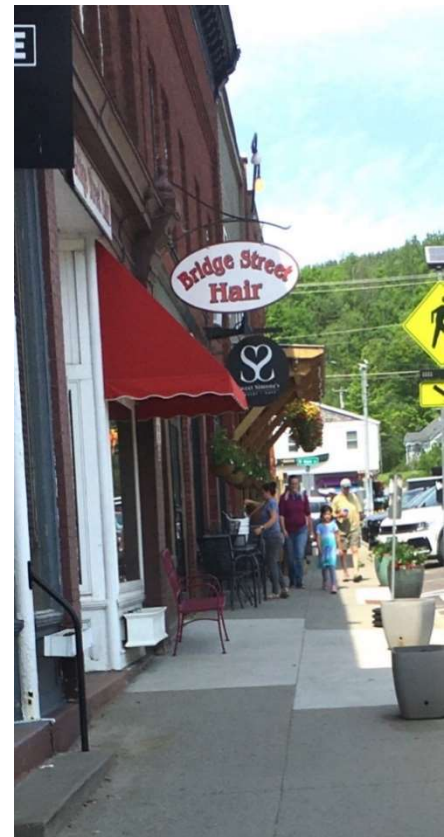
In this section, volunteers observed a range of issues that inhibit pedestrian mobility. Sections of sidewalks along Bridge Street are either too steep or too narrow for wheelchairs and strollers. The curb cuts at the crosswalk on Bridge Street in front of the Town Library are not flush with the road. The sidewalk and roadway in front of the Masonic Block and between Railroad Street and Volunteers Green have many obstructions— including signage, planters, tables, chairs and bicycles in the sidewalks, and utility poles in the Bridge Street roadway and/or sidewalks (as shown in Figure 2). Sidewalk and curbing on Bridge Street are degraded. The midblock placement of the rectangular rapid flashing beacon (RRFB) at the Masonic Block is not adequately visible to drivers. Signage is inadequate on Bridge Street in front of the Town Center and at the Railroad Street intersection.

Figure 2: Bridge Street Commercial Corridor

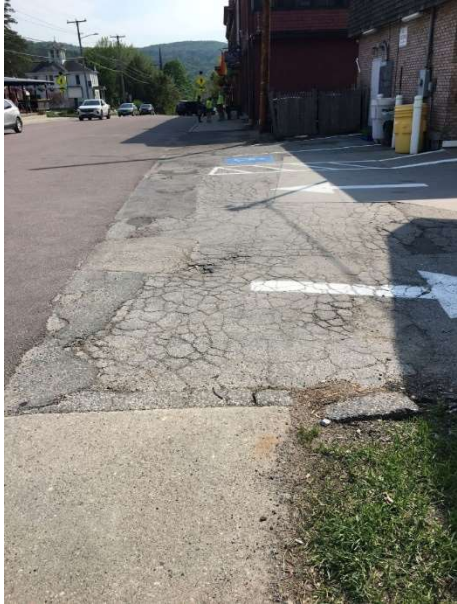
Figure 3: Gap in Sidewalk near Cumberland Farms

The gap in the sidewalk along Bridge Street in front of the Cumberland Farms gas station, as shown in Figure 3 creates a dangerous situation for pedestrians. This section is a large curb cut in which cars enter and exit the gas station, and park between the convenience store and Bridge Street. This segment has no pedestrian facilities and no clear guidance for pedestrians on how to cross the curb cut. Bollards and trash cans keep parked vehicles about two feet from the exterior building wall, leaving a distance of about 20 feet to the edge of the roadway. Parked Vehicles force pedestrians out into the roadway.

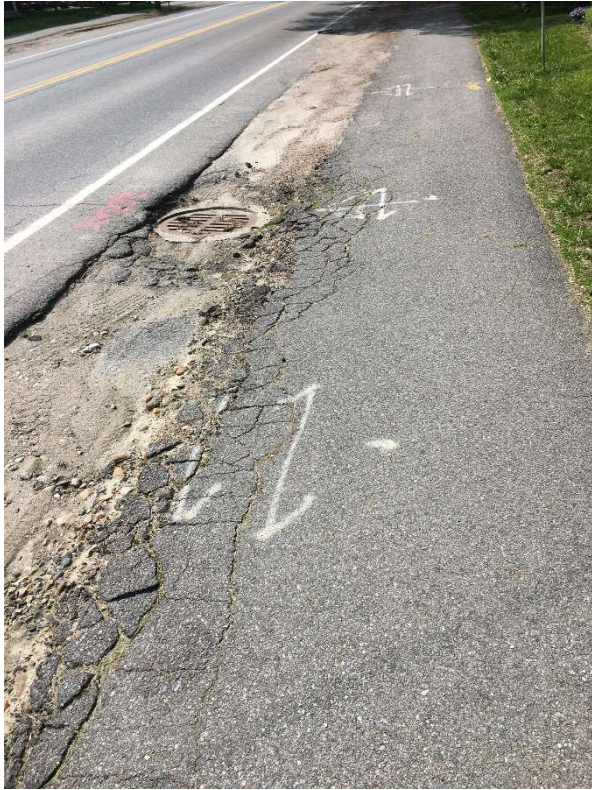
The sidewalks are deteriorating (as shown in Figure 4), thus rendering them inaccessible for some abilities. Speeding issues and drainage issues are also evident and there is a lack of demarcation between the roadway and the sidewalk. At certain points, the sidewalk looks like a shoulder and is used by cars to park (as shown in Figure 5), thereby obstructing pedestrians.

Figure 4: Sidewalk on East Main Street

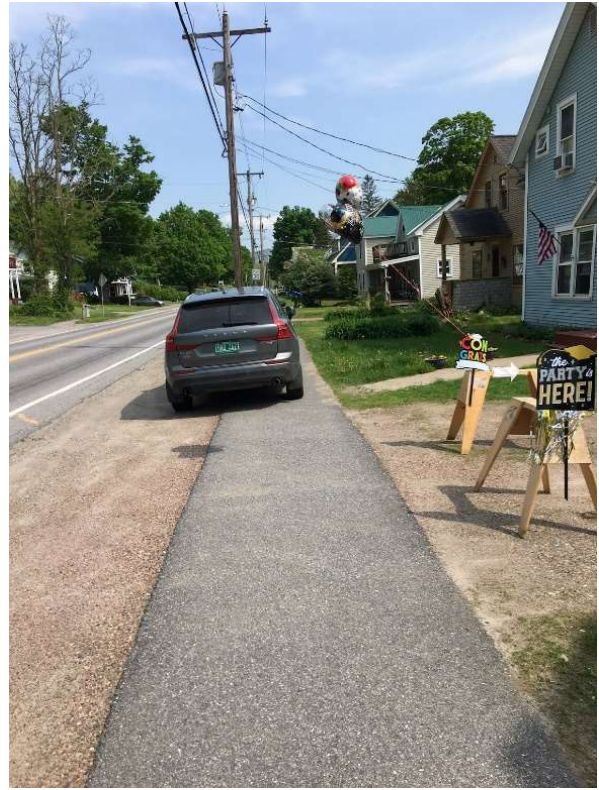
Figure 5: Car parked on the sidewalk on East Main Street

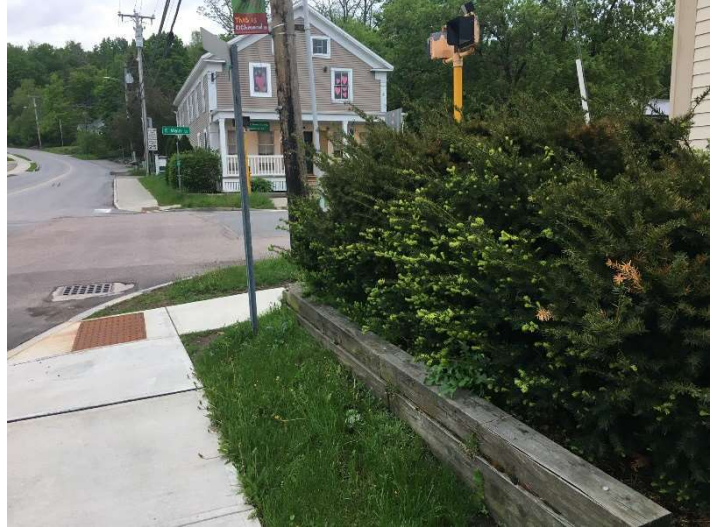
Volunteers observed that the walk signal gives pedestrians a five-second advance before the green light signal for traffic going straight. However, the intersection lacks a “no right turn” signal for vehicles when the walk sign is activated. Volunteers also noted the placement of the crosswalk on East Main Street and the lack of a clear sight line from Bridge Street northbound to East Main Street eastbound.

Figure 6: Bridge St.-Main St. Intersection, from the south side of the intersection and Bridge Street

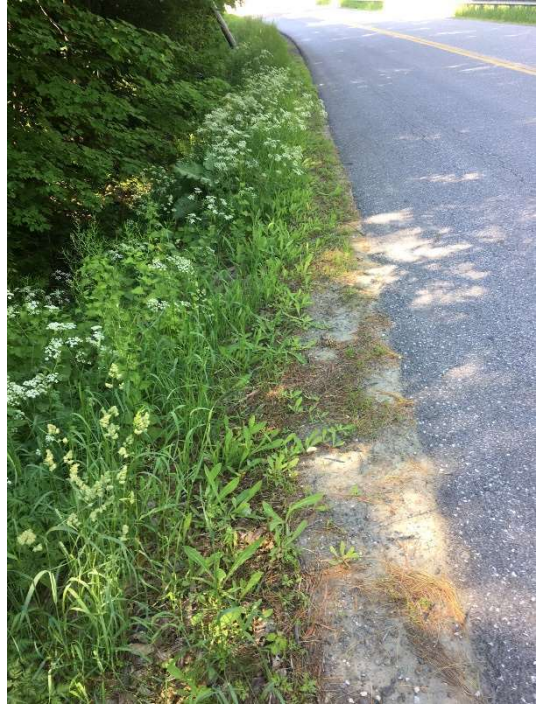
Figure 7: Edge of Jericho Road southbound

Measurements showed that most vehicles were traveling above the posted speed limit. The average speed of the observed traffic traveling northbound and southbound was 39 miles per hour. The maximum speed measured of the observed traffic traveling northbound was 54 miles per hour and the maximum speed measured of the observed traffic traveling southbound was 55 miles per hour.

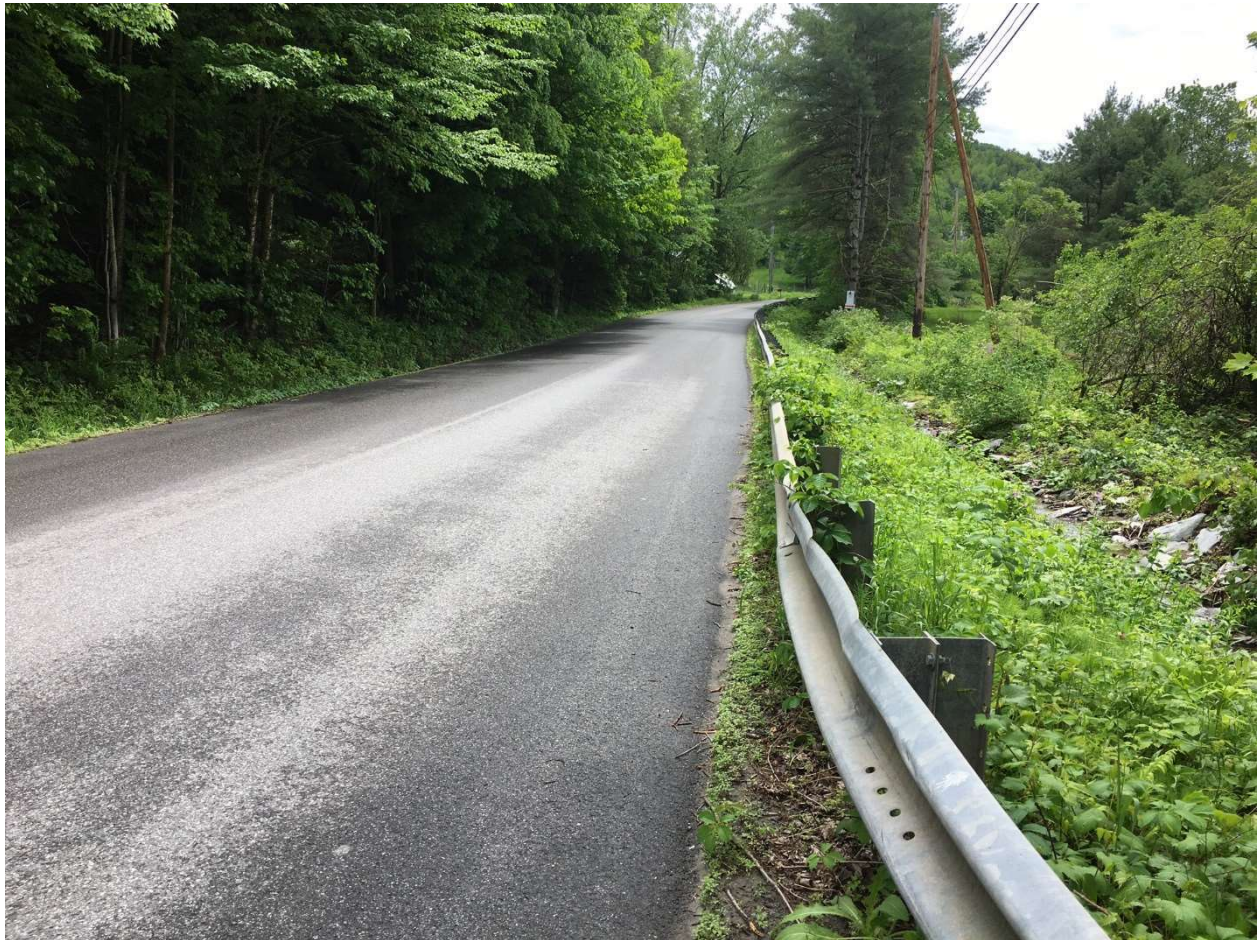
Figure 10: Wes White Hill Road
