Re: Richmond Band Shell
Structural Assessment

EV# 24623

This report is a preliminary structural assessment of the Richmond Band Shell located on the Town Green in Richmond and is based on our proposal dated December 10, 2024 and received executed on January 3, 2025.

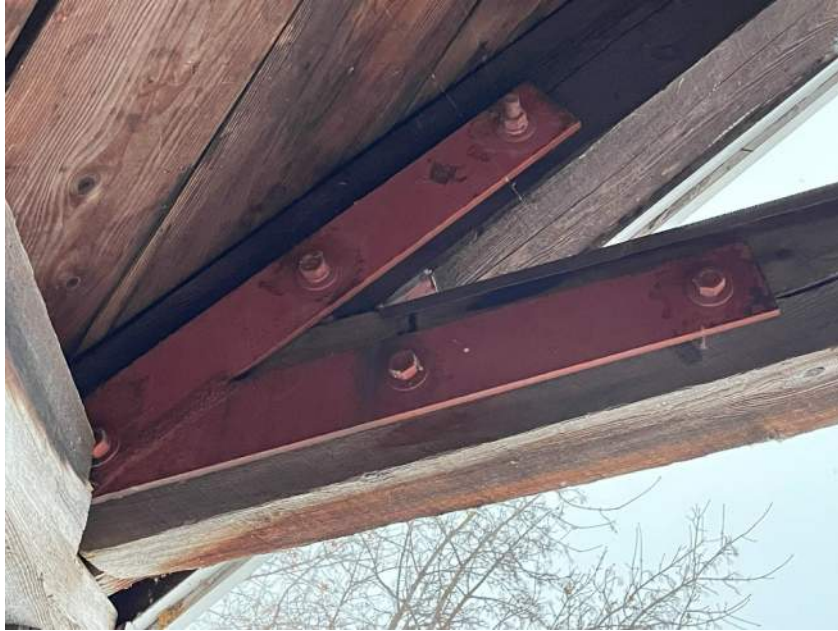
TRUSS HEEL JOINT CONNECTION

The timber scissors truss is in poor condition. There is evidence of deterioration and the connections appear to be separating. We recommend replacing this truss.

- Remove existing truss and associated trim/roofing
- Temporarily shore roof framing
- Replace truss with engineered system
- Replace finishes.
