Richmond Wastewater Treatment Facility 20 Year Evaluation *60% Submittal*

Updated January 11, 2024

Prepared for:
Town of Richmond, Vermont

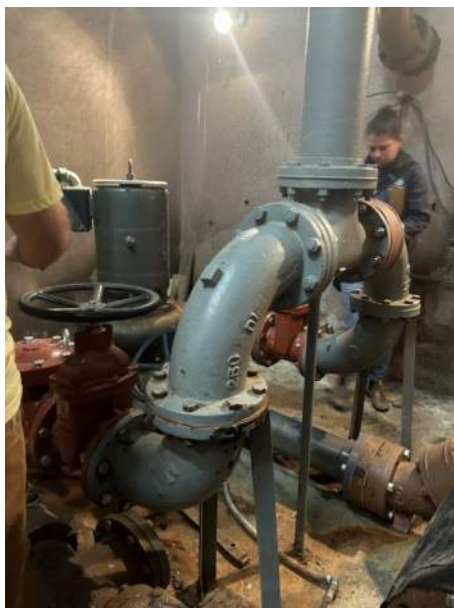
Figure 2-12 Influent Pumping System

Headworks Building where it flows by gravity through the remaining treatment process. An in-line grinder that was part of the original design has been disconnected. There is a magnetic flow meter on the pump discharge header to measure flows. The operators indicated that they do not believe it accurately measures flow. Influent Pump #1 is driven by a 40 HP motor and was installed in 2023 as a temporary replacement for the existing Influent Pump #1 which had failed. Influent Pump #2 is a vertical mounted, flooded suction centrifugal pump driven by a 25 HP motor. Currently, Influent Pump #2 is not in use as it has a leaking seal and sprays the room when operating. The operators indicated that they have replaced both pump discharge check valves recently.

Access to the pumps is problematic with no overhead hatch to hoist pumps through. The operators noted that they have to bring equipment down three flights of stairs if maintenance is required.

The facility experiences significant large solids carried to the wet well through to the influent pumps including large rocks/bricks, large pieces of wood, rag balls greater in diameter than the pumps can pass. These materials often lead to pump clogging, damage to the pump impellers and emergency maintenance of the pumps. The operators indicated that the Town cleaned out the influent collection sewer up to Bridge Street in 2022 to try to mitigate the amount of debris that enters the wet well and pump inlet.

- Influent Pump #1 failed and was replaced with a used emergency pump in 2023. The pump is old and only a temporary solution.
- Influent Pump #2 is original to facility. The pump is in poor condition with a leaking seal. This pump is at risk of imminent failure leaving the facility with no pumping redundancy.
- Influent pumps routinely experience problems such as ragging and bricks/rocks causing damage.

- Influent grinder has been removed.
- Hatch not available for pump removal
- Roof drains are connected to the wet well.
- The concrete of wet well structure was not evaluated. It is recommended that a concrete assessment be conducted.
- Additional flow data is required to select influent pump replacements.

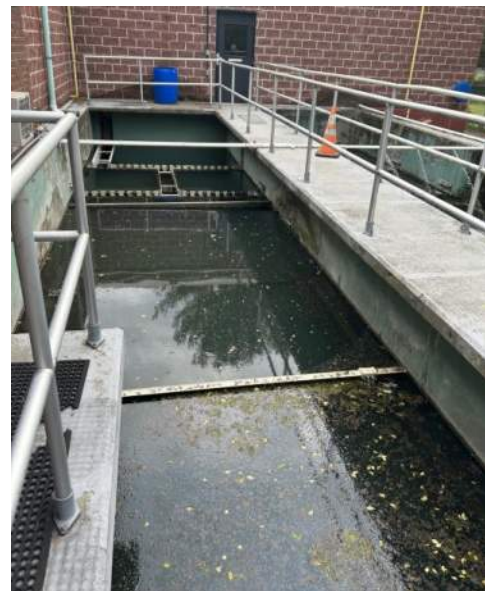
Figure 2-16 Secondary Clarifier

The operators noted that they recently had drained both clarifiers, cleaned, and inspected the flight scrapers and both are in good working condition. Operators also noted that there was no grease skimmer on the clarifiers and that grease routinely passes through to the filters causing fouling of the cloth media.

- Clarifiers are in good working condition.
- Concrete tank structures were not evaluated. It is recommended that a concrete assessment be conducted.
- The surface overflow rate @ PHF meets the TR-16 design standard, assuming MLSS = 3,000 mg/L. If MLSS is greater than 3,000 mg/L, then the SOR standard may be exceeded.
- Lack of MLSS data does not allow for accurate solids loading rate analysis on the secondary clarifiers.

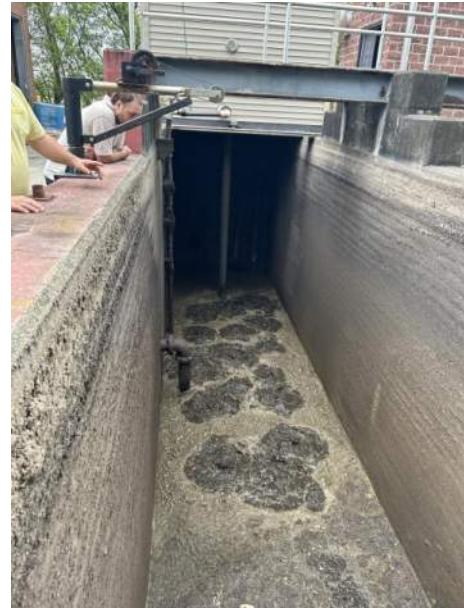
Figure 2-22 Aerobic Sludge Holding Tank

The aerobic sludge holding tank was not drained to evaluate the condition of the concrete tank, nor the existing diffusers. The operators noted that the tank needs to be cleaned as there is an accumulation of rocks, grit, and rags in the tank which are creating plugging issues with the downstream sludge transfer and feed pumps. The non-uniform bubble pattern observed on the surface of the tank contents during the evaluation indicates that some of the diffusers may be clogged and inoperable.

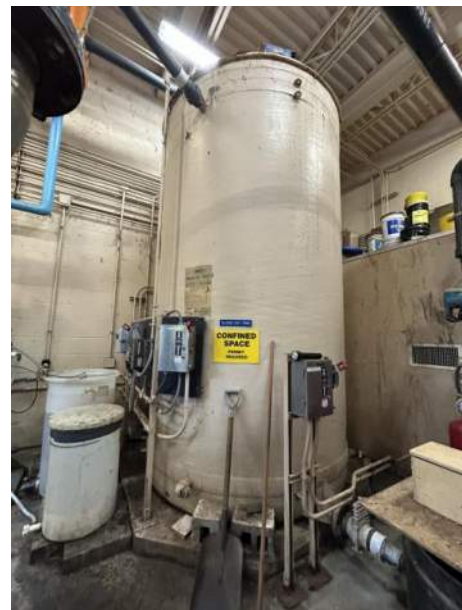
Figure 2-23 Sludge Day Tank

When the dewatering equipment is in operation, sludge is removed from the aerobic sludge holding tank using the sludge transfer pump located in the Dewatering Building which originally discharged through a sludge grinder to the sludge day tank, also located in the Dewatering Building. The sludge grinder has since been removed by the operators.

operators also noted that there is no way to remove the mixer from the day tank as there is no headroom above the tank for the long shaft.

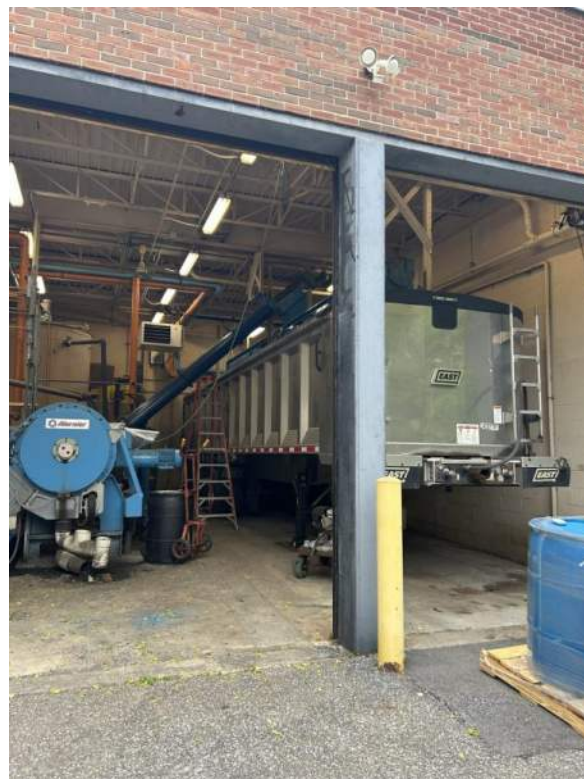
Figure 2-27 Dewatering Building

Additionally, the floor of the dewatering building does not have a rear floor drain, causing difficulties managing drainage from the sludge trailer. Operators expressed interest in a water meter on the water line to

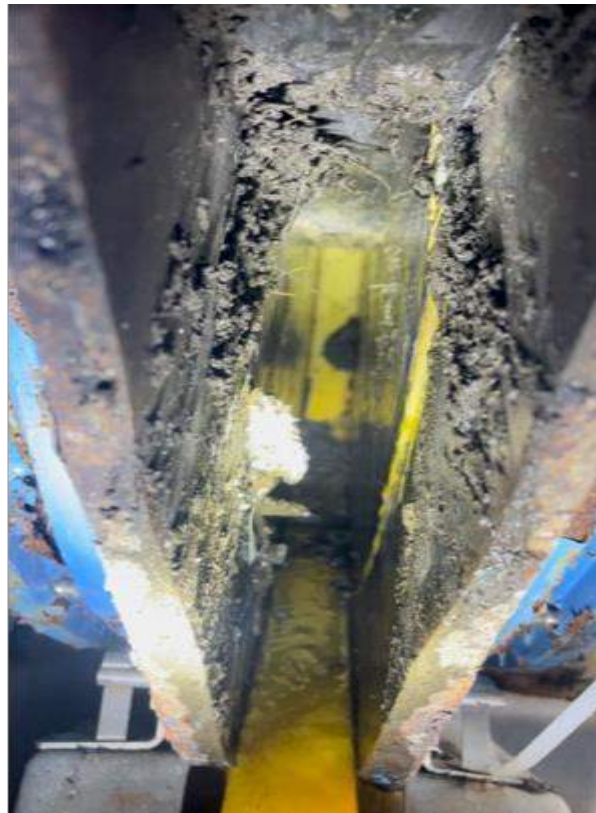
Frames: The frames on the channels were rusting and worn were the restrictor arms moved. You could see the yellow cover seal between the wheel and the frame starting to come through with trash.

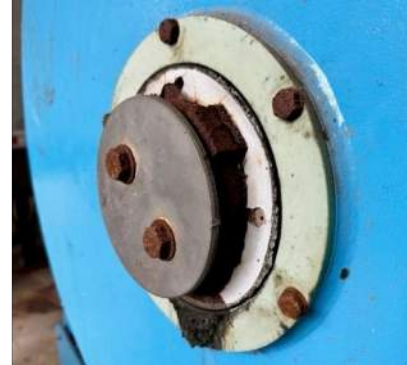
Shaft: The shaft of the press was in ok condition. The shaft only supports one channel on each side, so there was limited exposure to the atmosphere. There is some rust around on the end, however that should not effect the removal.

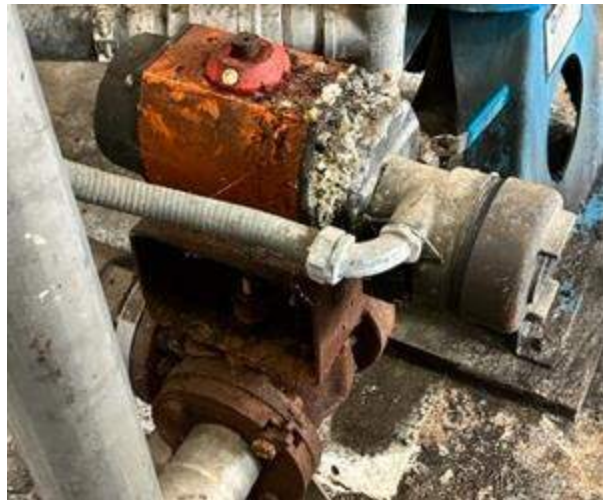
Three-way valve: The existing three-way valve does not work. It has been stuck in the dewatering position and does not turn. This causes problems with a proper startup. Sludge also leaks out of the supply tank, through the sludge pump and, because the valve is stuck in the dewatering position, into the channels.

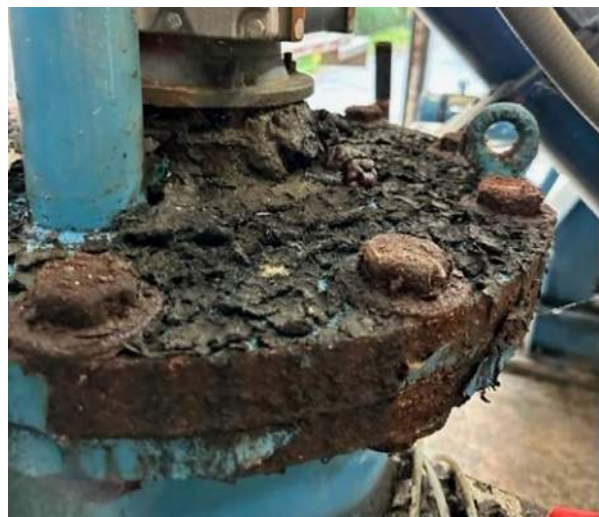
Flocculator: The flocculator seal shaft has been leaking for some time. It's hard to tell the extent of the damage.

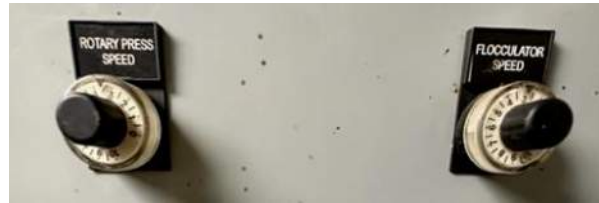
Panel: The panel is the old style with speed dials for the flocculator speed and rotary press speed. The outlet pressure is controlled directly at the channel. If you adjust it on the panel, it doesn't do anything.

3. Panel HMI – The installation of a new panel would make it easier for the operators to use the press. The current old program is outdated and not optimal.
4. Conveyor system – There are a couple holes that need to be patched or sections replaced.

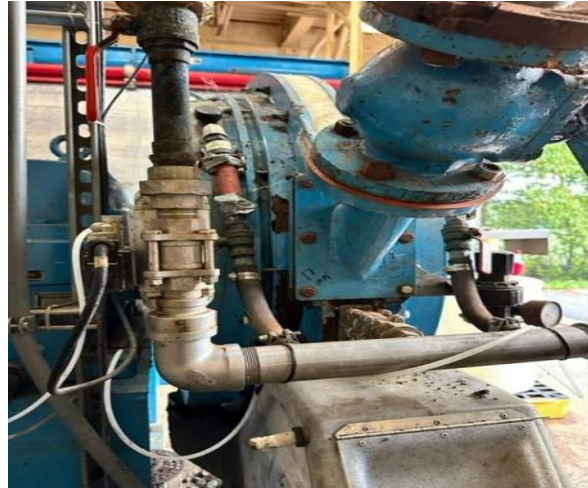
Channel Wash Manifold: The Festo valves on the channel wash manifold do not seem to work. The piping and spray bars are not in good condition.

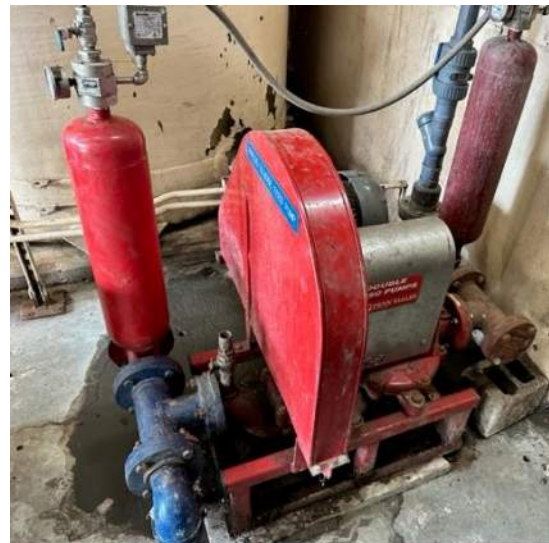
Sludge Pump: The facility has a double disc sludge pump and is in good condition. However, the sludge tank gravity feeds past the pump when it is in the off position.

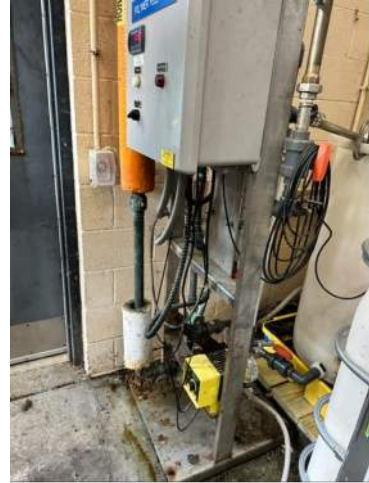
Polymer System: The polymer system does not have an indication of concentration. A batch of diluted polymer is sent to a 50-gallon tank. From there it is pumped to the floccuator at a ratio of the sludge flow.

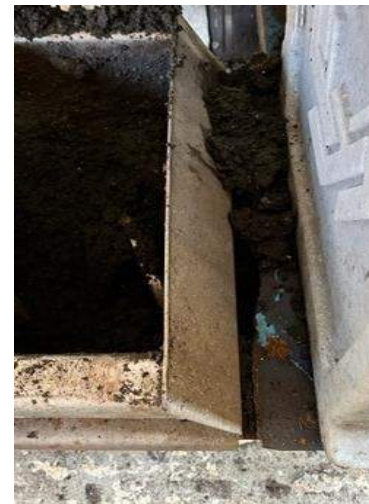
Conveyor System: The conveyor seems to be in good condition apart from a couple rusted out holes in the lower one. Also, on the inclined conveyor it is open at the top. The employees said this was from cake building up due to an unopened slide gate that has since been fixed.

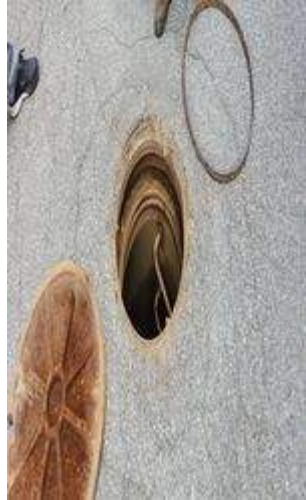
General	
Structural Condition	Fair
Operational Condition	Good
Debris Amount	Slight
Cleaning Needed	No
Standing Water	No
Flow	Trickle
Maintenance Needed	Yes

Notes	
Structural Notes	Loose frame and ring
General Notes

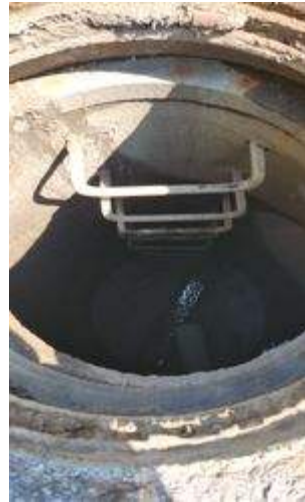
Notes	
Structural Notes	
General Notes	Rags on ladder rung and in channel

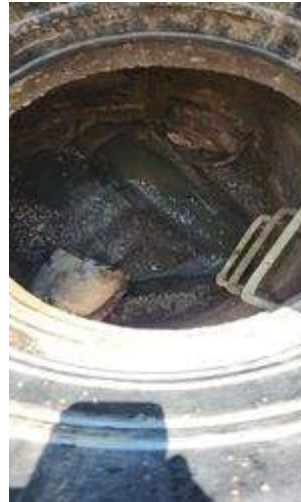
Notes	
Structural Notes	Frame and cover misaligned
General Notes	Bricked off overflow to the river

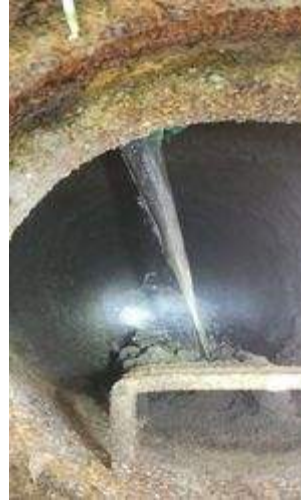
Notes	
Structural Notes	
General Notes	Needs cleaning. Manhole coated in debris

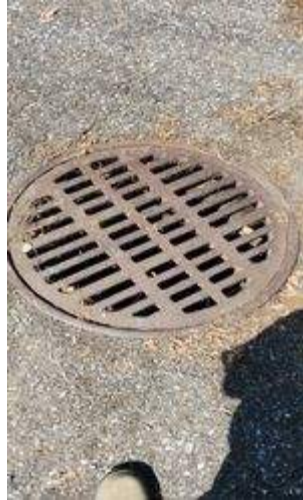
Notes	
Structural Notes	
General Notes	Needs cover replacement
