Subject: Richmond - Bolton STP 2924(1), US2 Reclaim Project, PIN 10C254

1 New Project Summary Purpose:

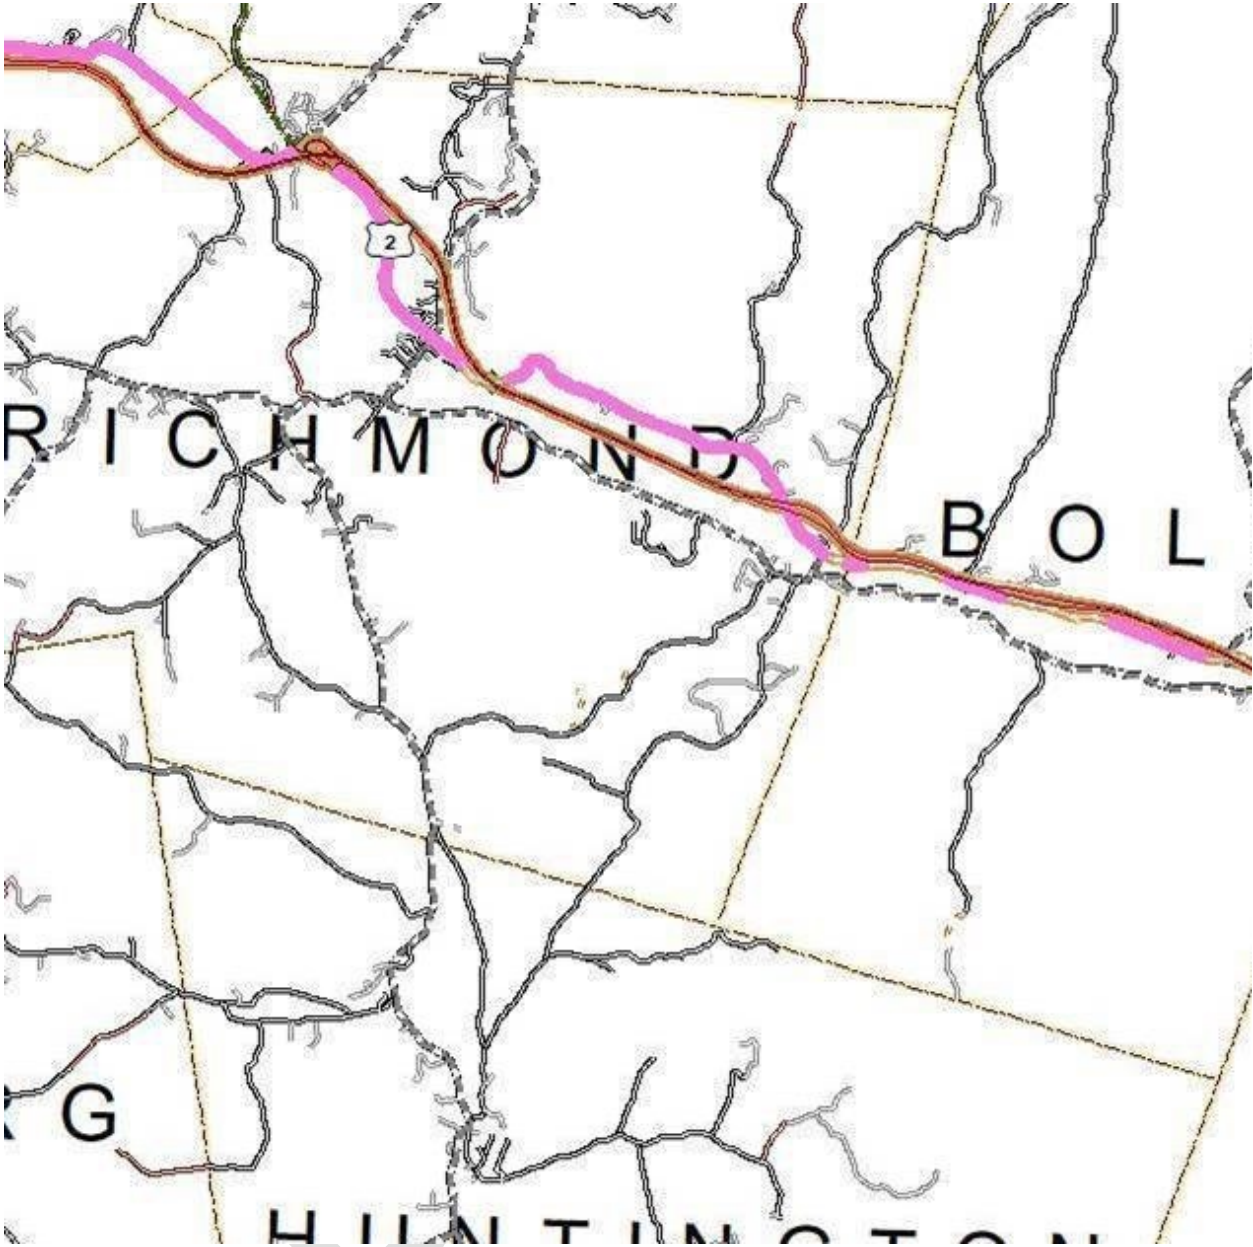
Figure 2 Extents of Buried Concrete Slabs on US2 (Areas where slabs are believed to still exist are indicated in pink)

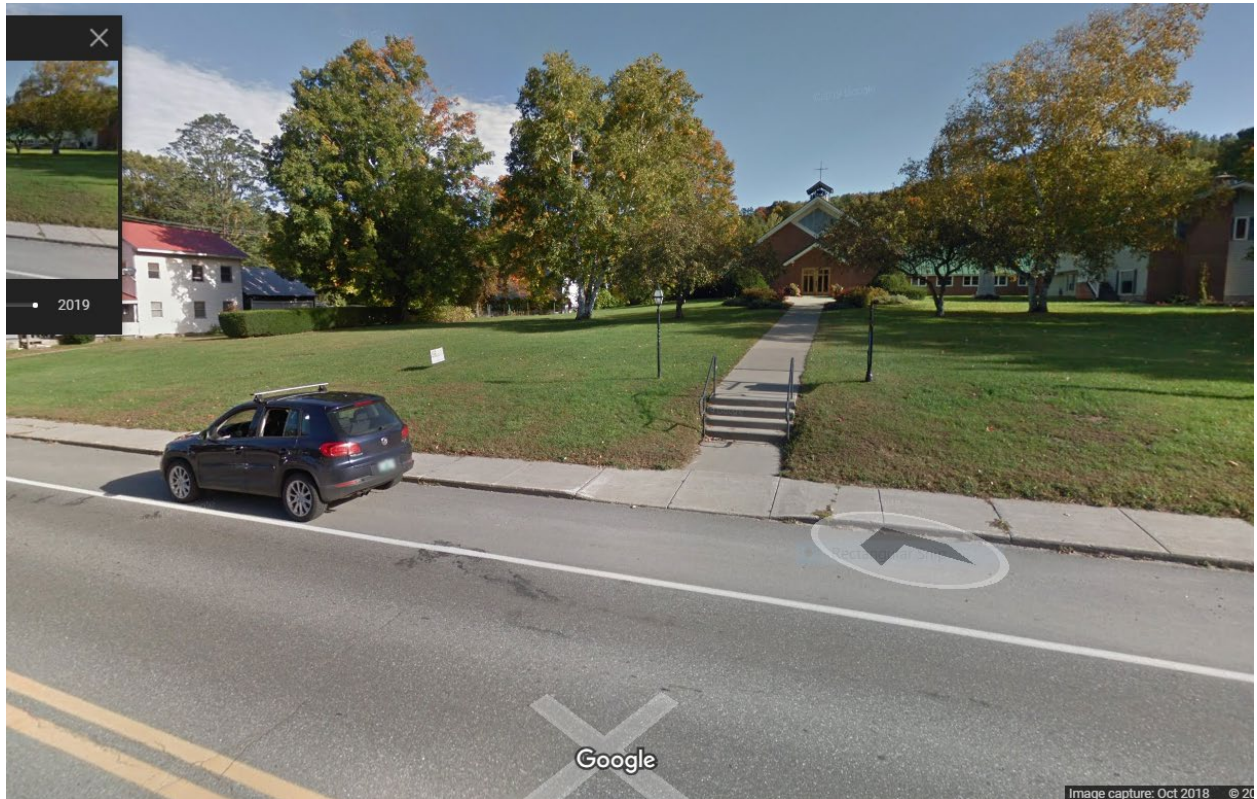
Figure 3 Richmond Parking - West of Intersection – Westbound Side

Section 5.6.5 above includes recommendations to address current parking issues and prevent vehicles from parking on the existing sidewalks between MM 2.71 to MM 2.94.

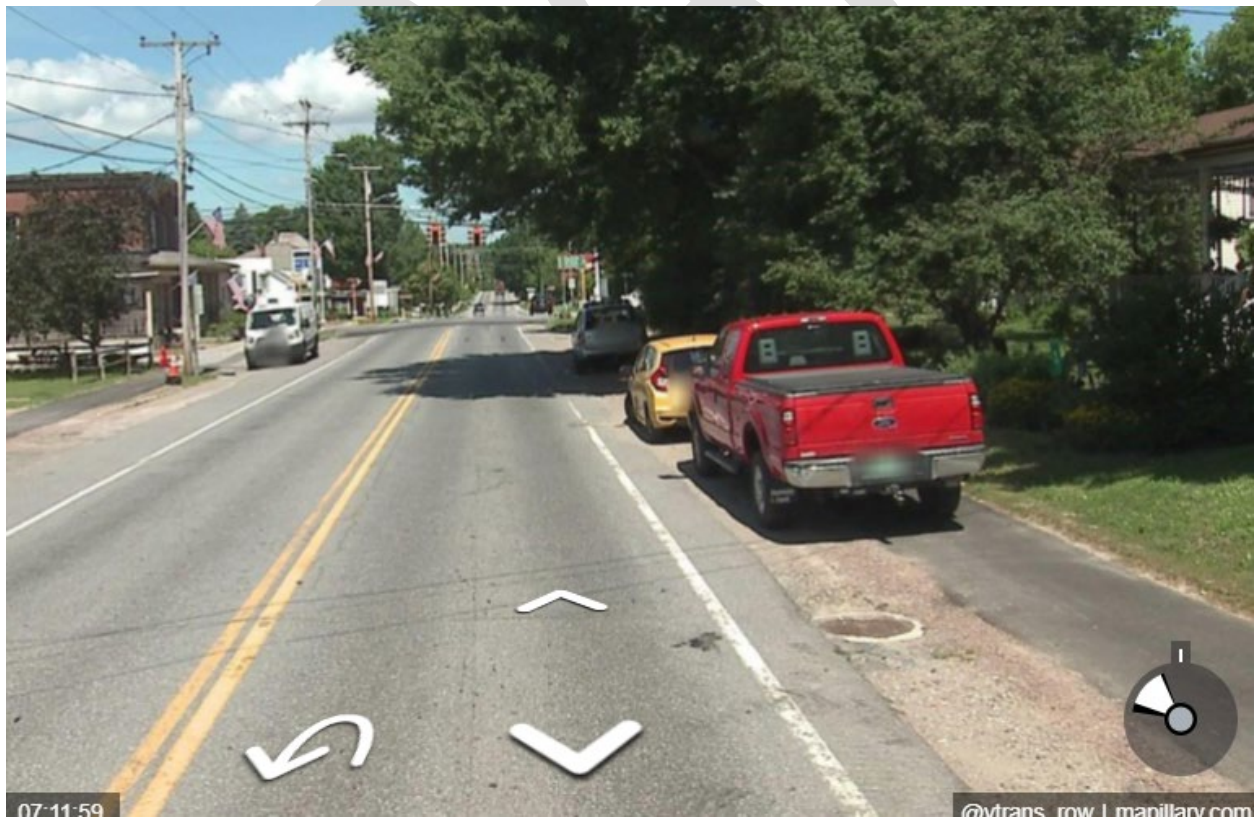
Figure 4 Richmond Parking - East of Intersection – Westbound Side

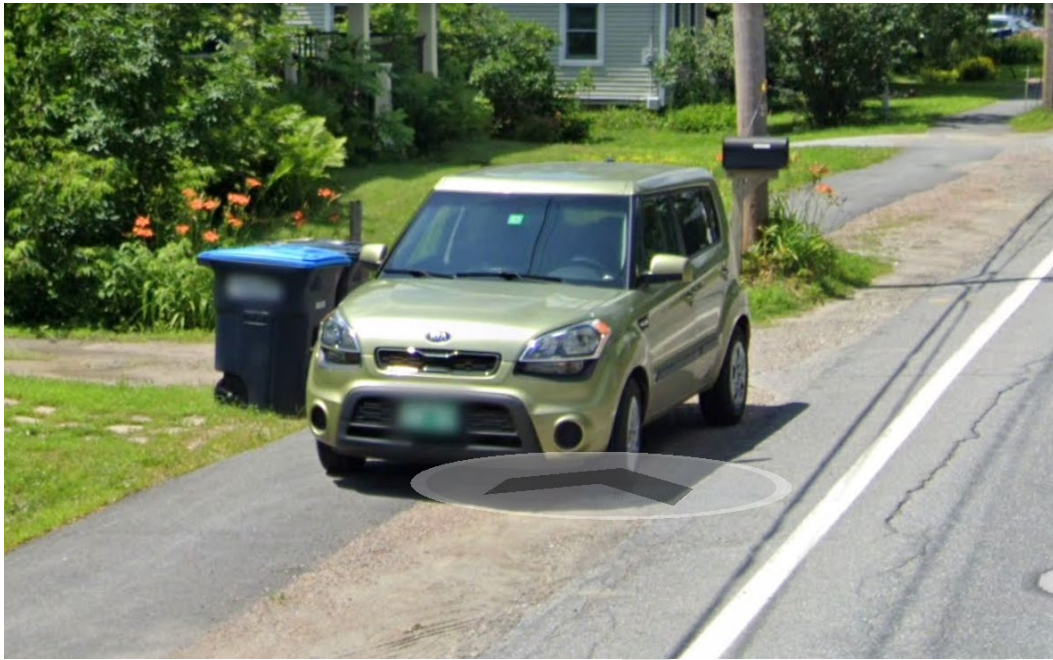
Figure 5 Richmond Parking - East of Intersection - Eastbound

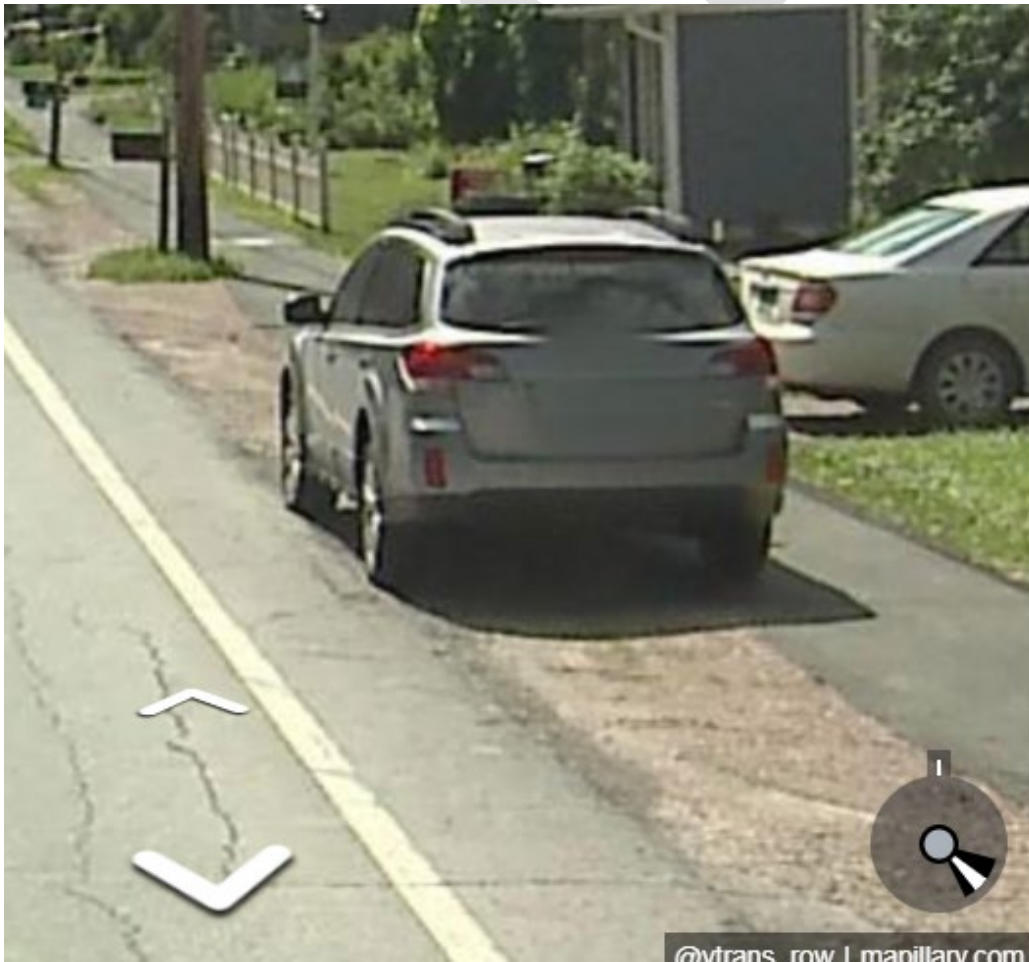
Figure 6 Richmond Parking - East Side of Intersection - Eastbound

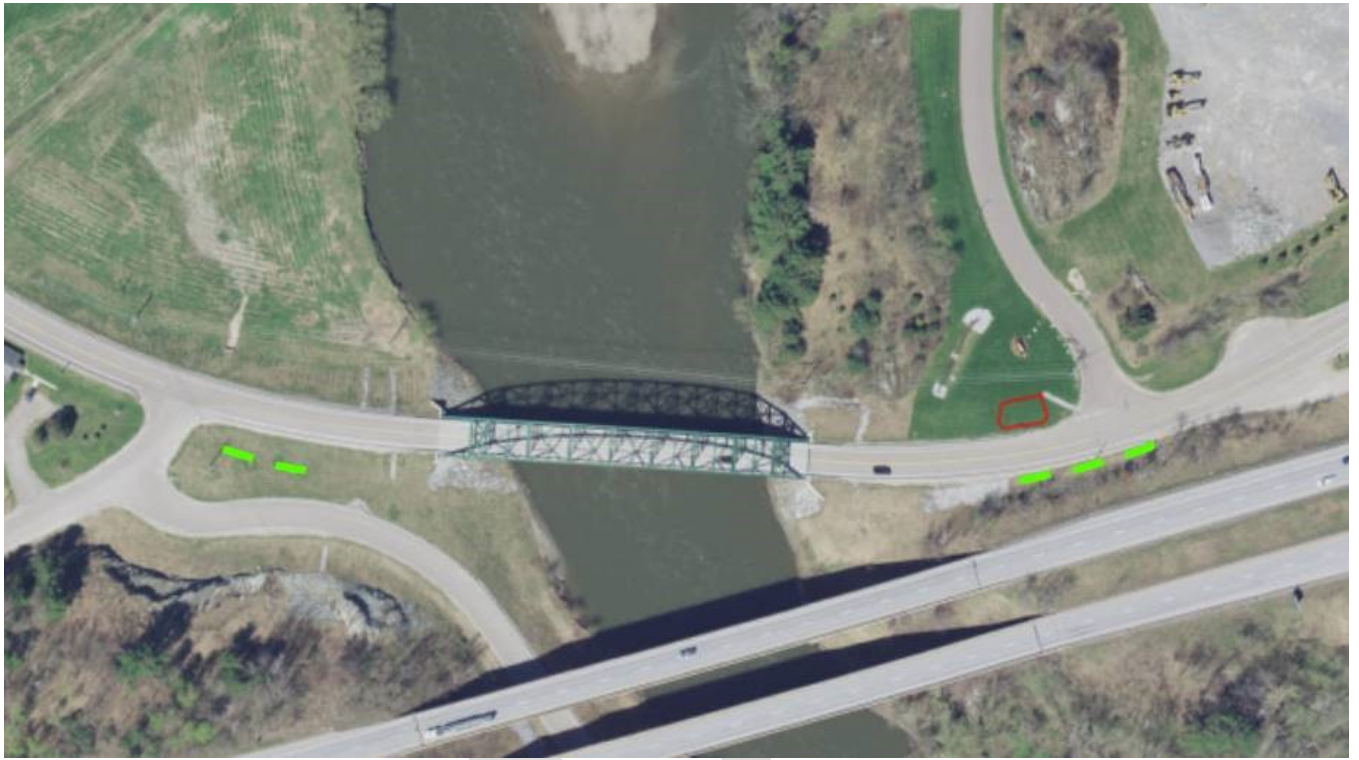
Figure 7 Stormwater Infrastructure near Bridge #24

The first location is generally near Bridge #24, the steel thru truss over the Winooski River at Richmond MM 0.71. There are permitted swales on the south side of the roadway along both the west and east approaches to the bridge. These swales are indicated by the green dashed lines in Figure 7 of the Appendix. There is also a disconnection area (flat grassed area where water sheet flows) on the north side of the roadway to the east of the bridge. This area is circled in red in the previously referenced image. The swales and the disconnection area are required by permit and should not be damaged by roadway reclamation work or by the parking or storage of vehicles or equipment.

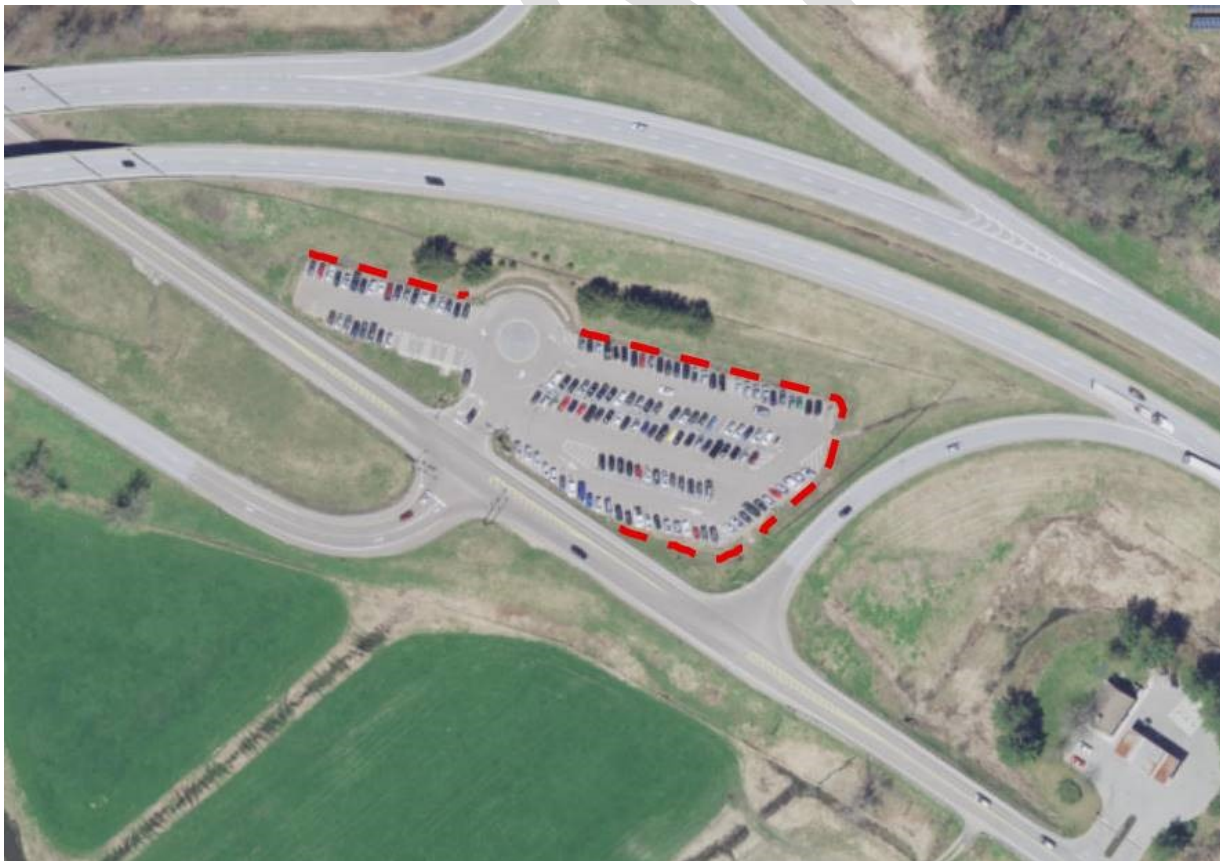
Figure 8 Stormwater Infrastructure Near Park & Ride

The 2nd location is at the Park and Ride at Richmond MM 1.150. This area has a system of permitted swales around much of the perimeter of the parking lot. These swales are indicated by the red dashed lines shown in Figure 8 of the Appendix. These swales are required by permit and should not be damaged by the parking or storage of vehicles or equipment.

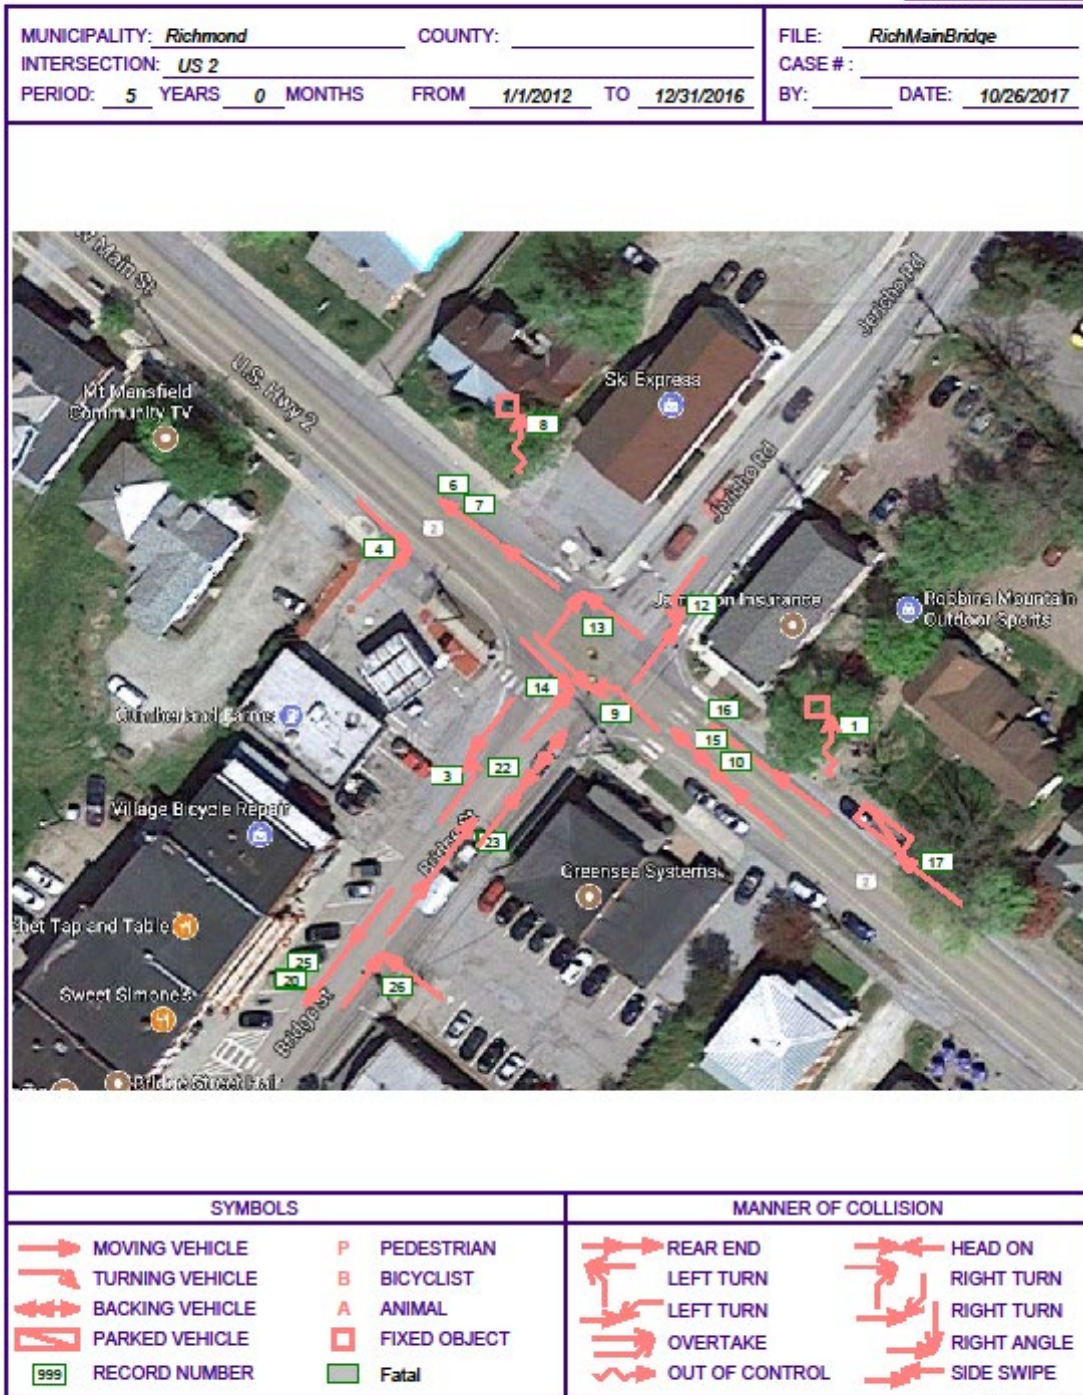
Figure 9 2017 Intersection Collision Diagram

This HCL includes the main intersection in Richmond village of US2 with Bridge Street and Jericho Road. Although this HCL is located at the main intersection in Richmond village, only 9 of the 43 crashes occurred while traveling through the intersection. The remaining crashes occurred while stopped / stopping for the traffic signals or were not directly related to the intersection. (Note: For 4 crashes, a narrative was not included in the crash report). Crash patterns observed in the crashes that are directly related to traveling through the intersection are discussed below.

The most feasible method of providing safety improvements at this HCL is by upgrading the traffic signals. As noted in Section 8.3 below, full replacement of the existing traffic signals infrastructure, including the installation of new mast arms, is recommended at this intersection.

It is recommended that a left turn phase from Bridge St be included in the programming of these new signals.
