Richmond Wastewater Treatment Facility 20 Year Evaluation *90% Submittal*

January 29, 2024

Prepared for: Town of Richmond, Vermont

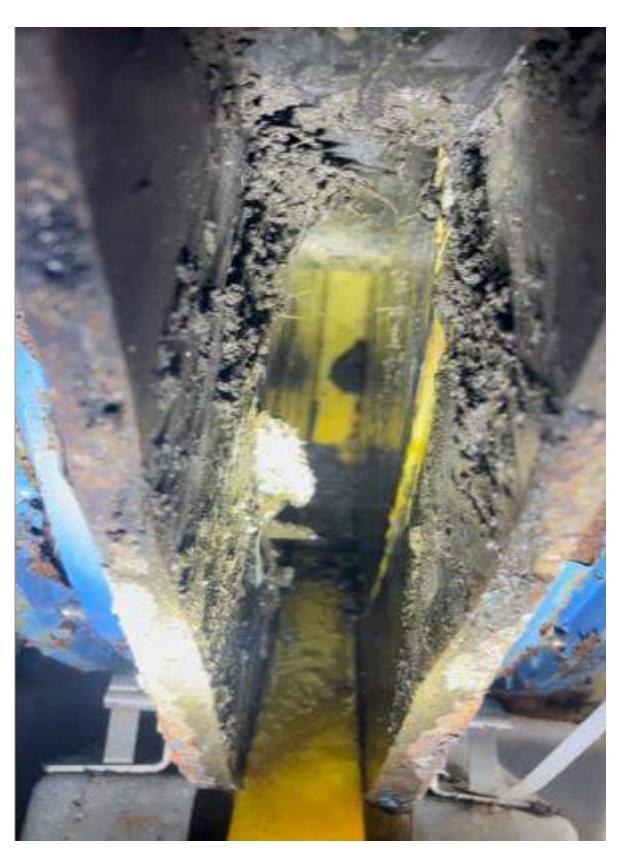
Shaft: The shaft of the press was in ok condition. The shaft only supports one channel on each side, so there was limited exposure to the atmosphere. There is sone rust around on the end, however that should not effect the removal.
