Heritage Engineering, P.C. P.O. Box 255 Perkinsville, VT 05151 802-263-5400 <u>heritageengineering@tds.net</u> www.heritageengineeringvt.com

Friday, January 03, 2025

Subject: Richmond – Cast-In-Place Concrete Potable Water Storage Tank – Visual Condition Assessment

Richmond Water Tank - Photos by Heritage Engineering October 16th 2024 Photos and Exhibits by Others as Referenced

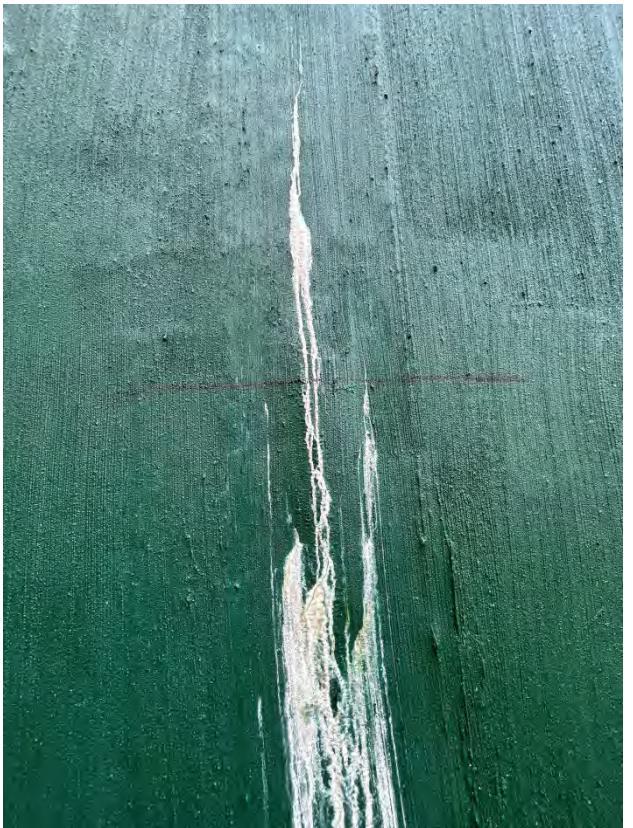
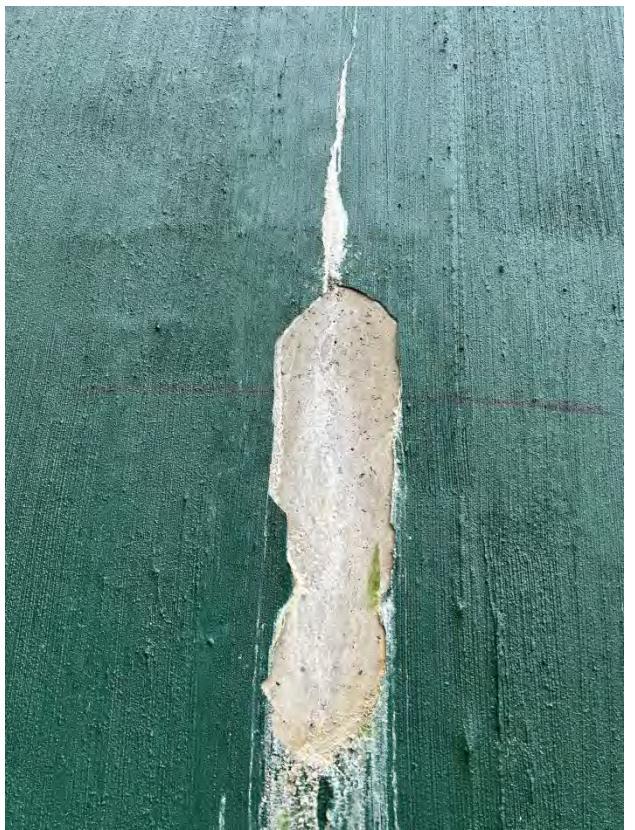
Crack and Leak Example Photos Exterior Wall Near Center of North Wall. Same Location both photos. Photo at left shows bulge of tank coating and leaks pushing through coating. Photo at right is after light tapping of coating showing concrete below and very small crack.

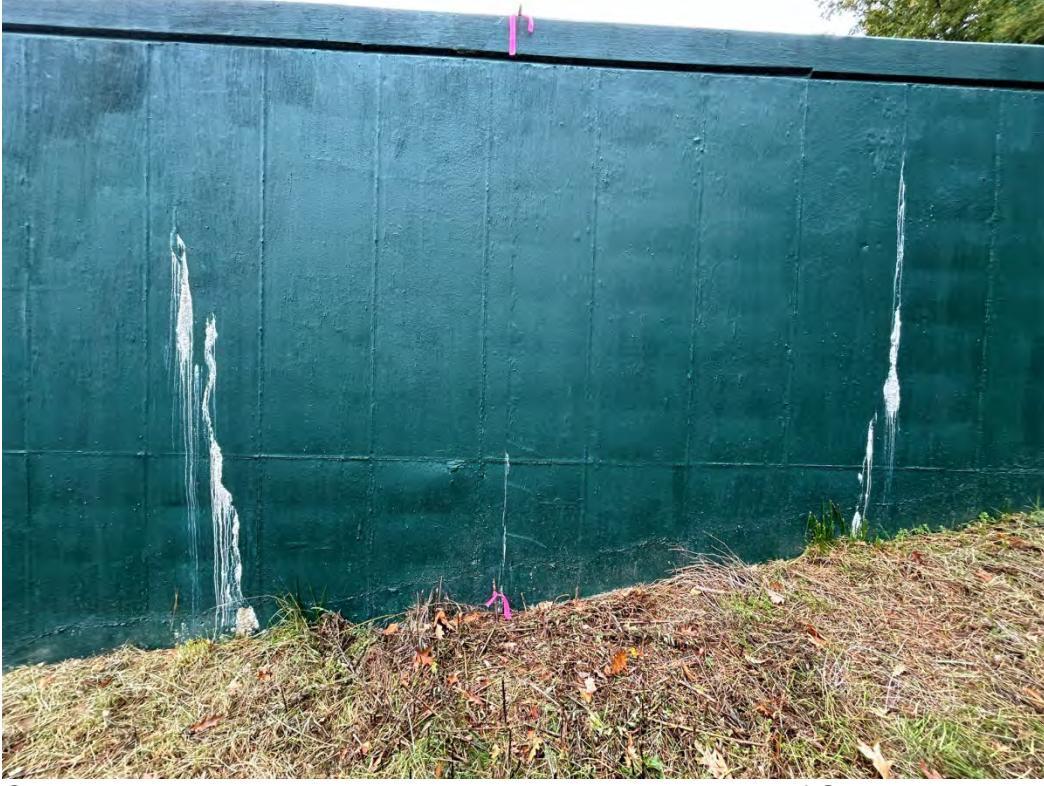
Crack and Leak Example Photo Exterior Wall – Middle of South Wall. Photos show same two locations depicted in Childs report from 2020. Leaks remain similar.

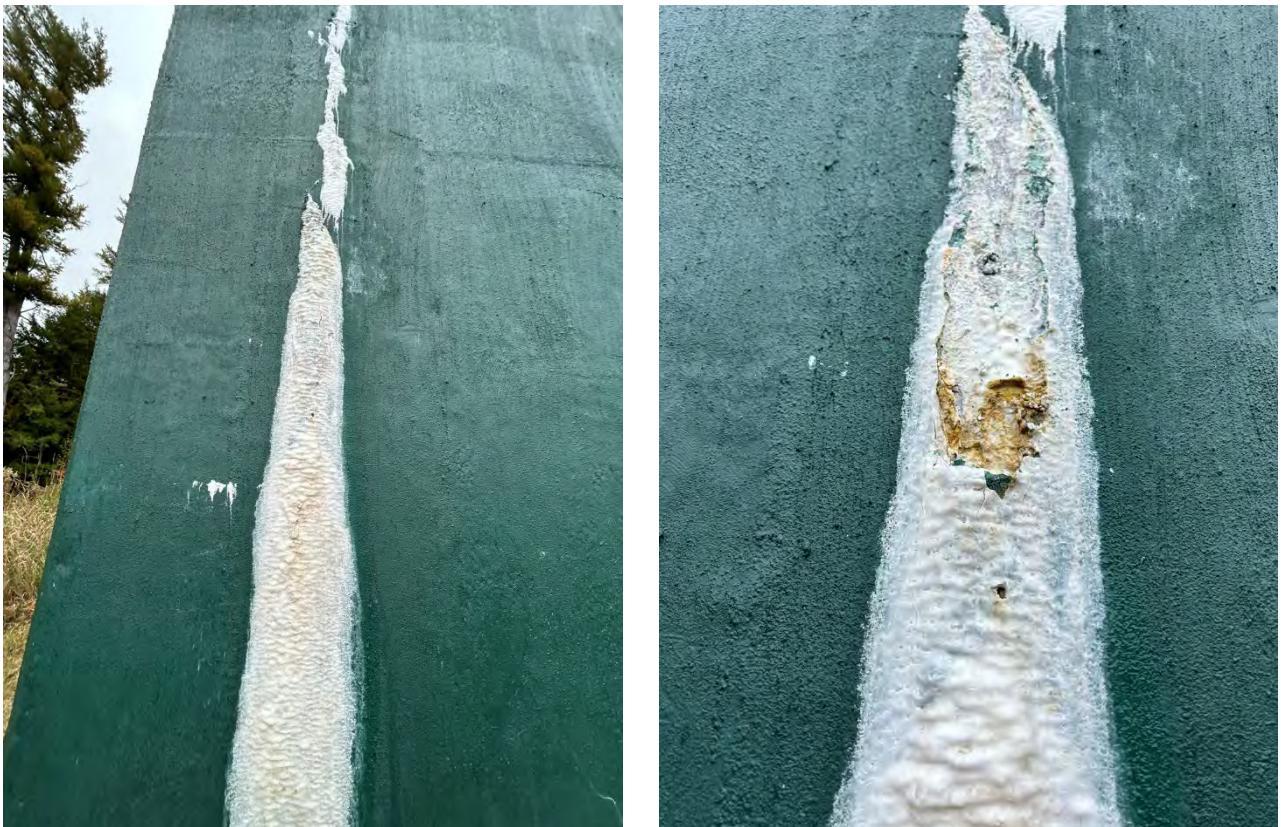
Crack and Leak Example Photos Exterior Wall Left Corner of West Wall. Same Location both photos. Photo at left shows leak, effervescence and yellowish color. Photo at right is after light tapping of the coating showing evidence of previous repairs (round drill holes or form tie holes that were plugged). Active leak.

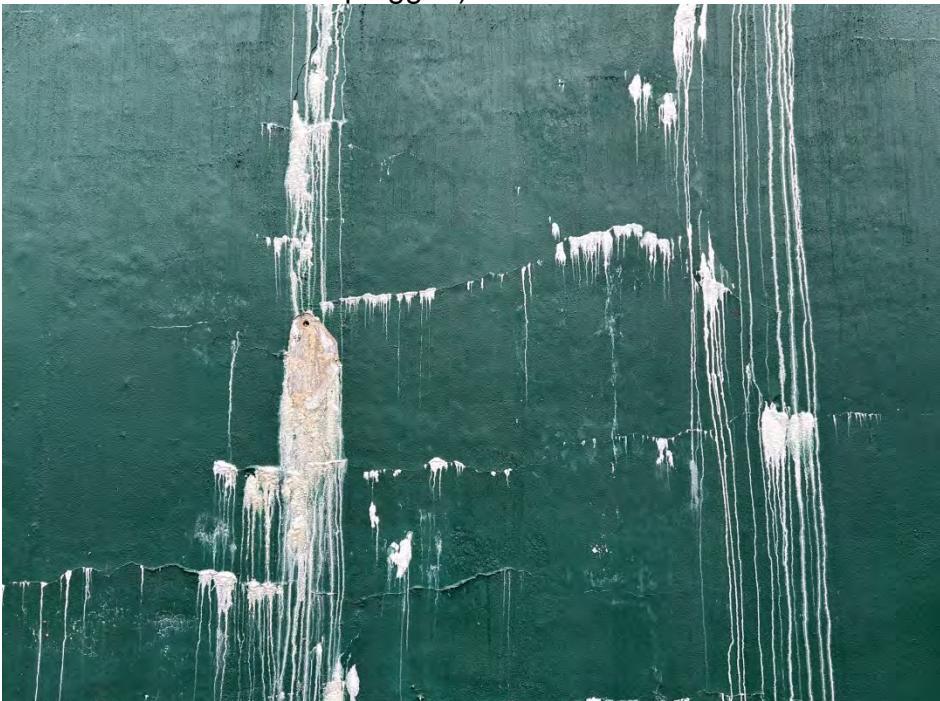
Crack and Leak Example Photos Exterior Wall Middle of West Wall. Evidence of previous repairs that still leak. Horizontal and vertical cracking and leaking. This would have been one of the last walls poured = most restraint = most likely to crack due to concrete shrinkage.

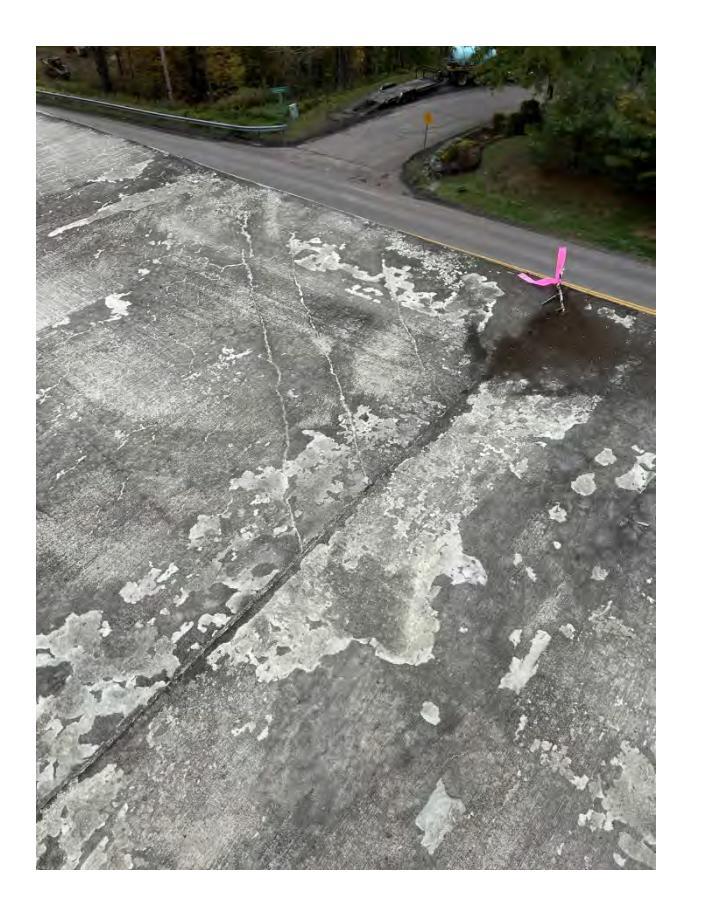
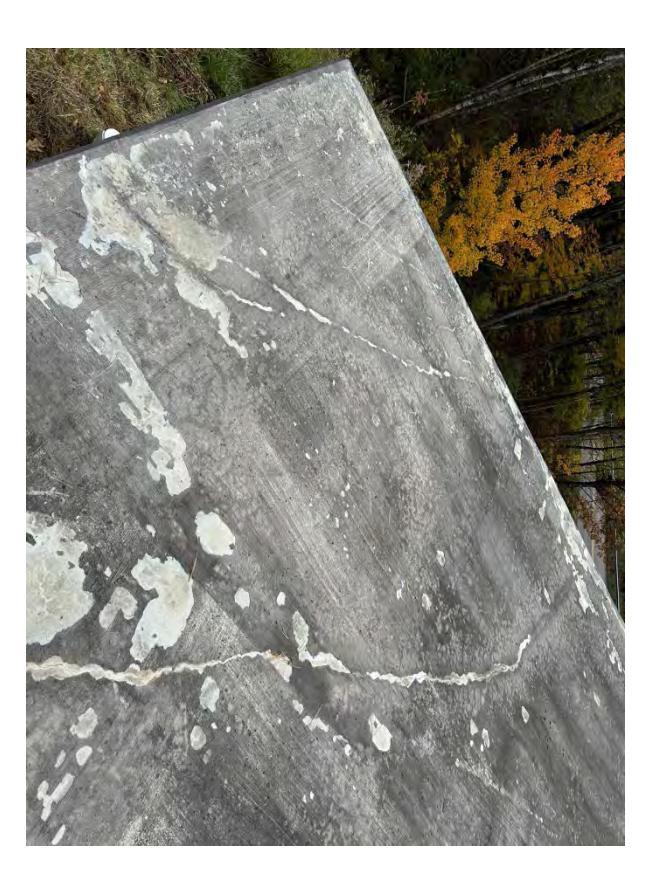
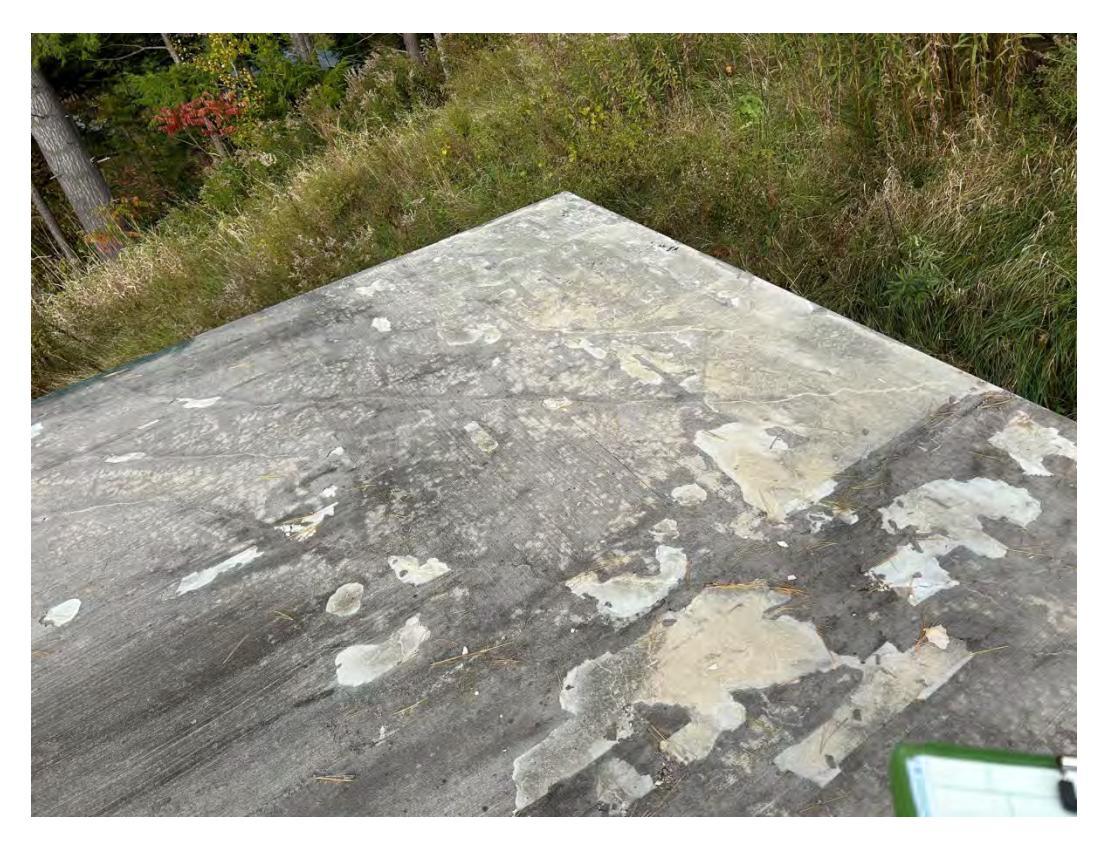
1.2.1.1 Distinct cracks are present on the roof. The shapes and patterns are consistent with temperature- and curing-related shrinkage. The roof cracks are regularly distributed in patterns similar to the walls but also have distinct diagonal cracks at all four corners of the roof and at four of the individual poured segments. Because the roof was poured in six segments, the cracking is much worse at the panels that were installed with the most restraint already in place. In particular, one panel which was poured only attached to one wall (the middle westerly panel) has very little cracking. In contrast, one of the last pours, at a corner (the south westerly panel), is very cracked. These two examples demonstrate the effect that restraint has on the presence of cracks. I took several measurements of cracks on the roof. All the cracks I observed on the roof surface were smaller than 0.005", which is slightly higher than the general performance criteria for concrete used to retain, or in the case of a roof keep out, liquid. Weathering of the edges of the cracks is more distinct on the roof than on the walls, with the crack opening at the top now weathered to as wide as .01". These cracks can be seen easily with the eye. The crack lengths varied from just discernable to many feet. Within the tank, based on the photographs taken by the divers, many of the cracks visible on the exterior roof surface are also present on the interior roof surface. Several of the cracks in the roof extend onto and align with the cracks in the wall below.

1.2.3.2 I did observe that the cracks on the roof are beginning to decay due to freezing and thawing. The exposed corners at the crack edges are wearing down with frost action. The roof can get colder than the walls because it is not exposed to water from inside the tank; therefore, I suspect the roof service conditions are harsher and water in the cracks can freeze and thaw more readily.

1.2.4 Masonry coating. The thin masonry coating that covers the roof is in very poor condition and no longer adheres to the tank roof in many locations. The frost action between the concrete and the coating is more pronounced than the walls and the coating is cracked, broken, missing in many locations and fairly brittle, similar but more pronounced than as discussed in section 1.1.4.

Roof Crack Examples – Multiple locations of diagonal cracking at corners. Masonry coating is loose in many locations and does not seal or protect cracks.

- R1. Provide a roof membrane over the entire roof surface to seal the roof leaks. This will protect the water from contamination from roof leaks, preserve the concrete surface, and increase the service life of the tank's roof. In terms of benefit/cost this recommendation has a high value for the town, given that it will have a meaningful impact on the life of the structure and the potential of contamination. Crack sealing should be completed prior to installation of the membrane. Here the term membrane means a waterproof roof layer system that can accommodate some movement and still provide a watertight layer. The existing masonry coating is in very poor condition and is an impediment to the adhesion of a new roof membrane and associated crack repairs. Therefore I suggest the masonry coating be removed. Crack sealing is likely to include a combination of injection and hand applied epoxy products such as SikaFix HH LV. The roofing/waterproofing system is likely to be a roller-applied liquid roofing product such as Sikagard 62 high-build epoxy coating or similar. A levelling product may be needed to reduce or eliminate the puddles on the roof. Engage a design team to plan this work and a contractor to complete the work. Priority 1 This recommendation should be pursued in the near term.

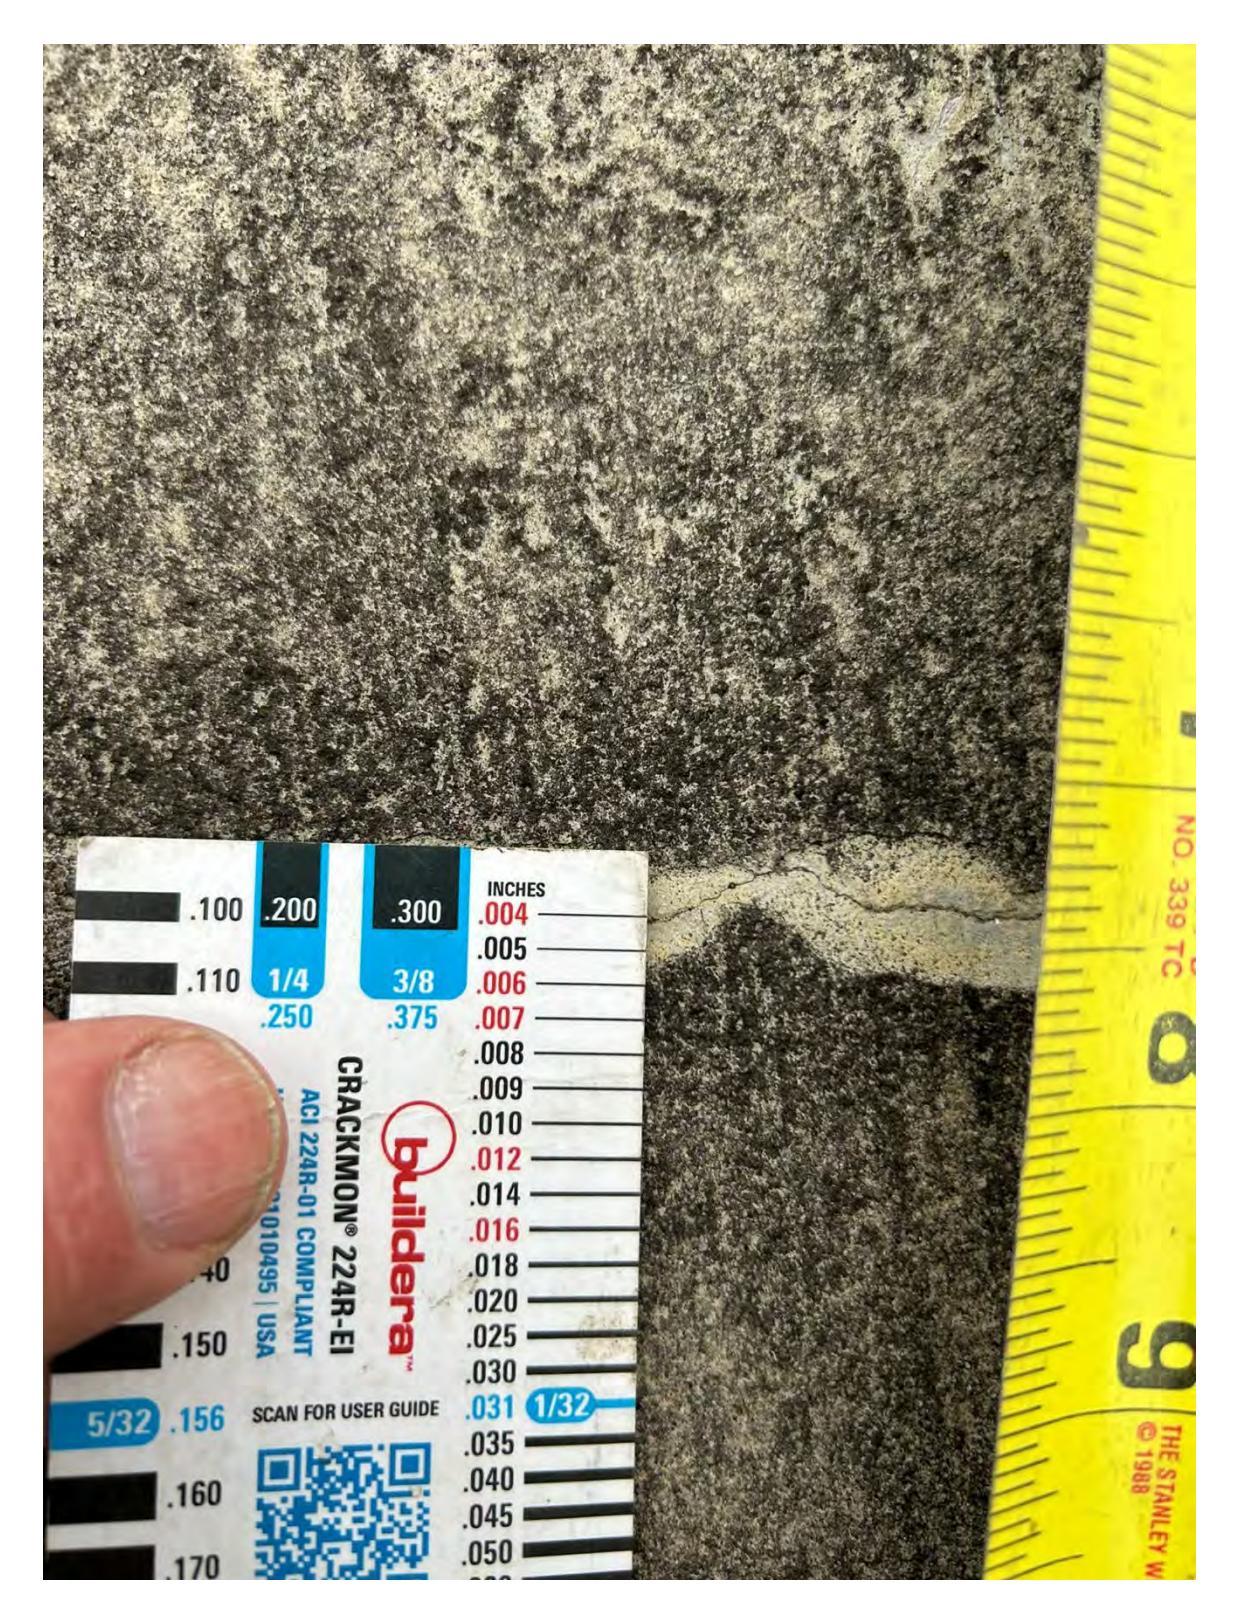
Roof Cracks. Example photo on roof of a typical crack. Note relative size is very small. Handheld crack gauge and ruler in photo for reference.

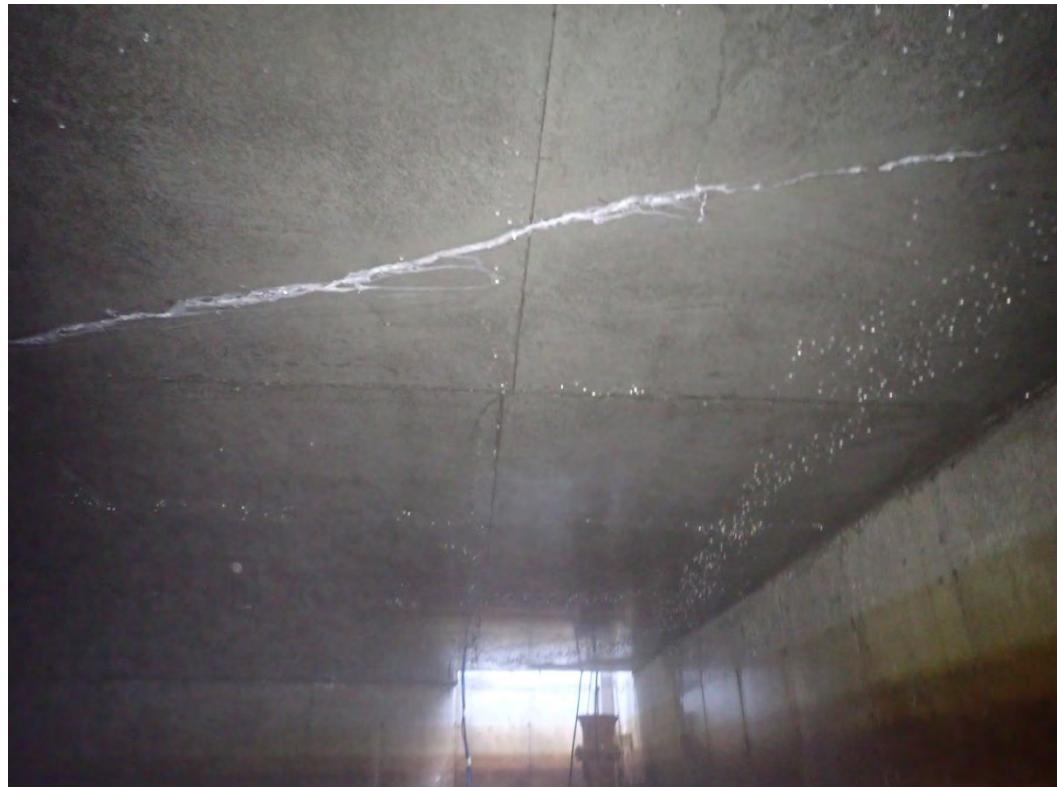
Inside Tank – Diver Photo by Others - Note Efflorescence along diagonal crack. Water on Roof can leak into tank.

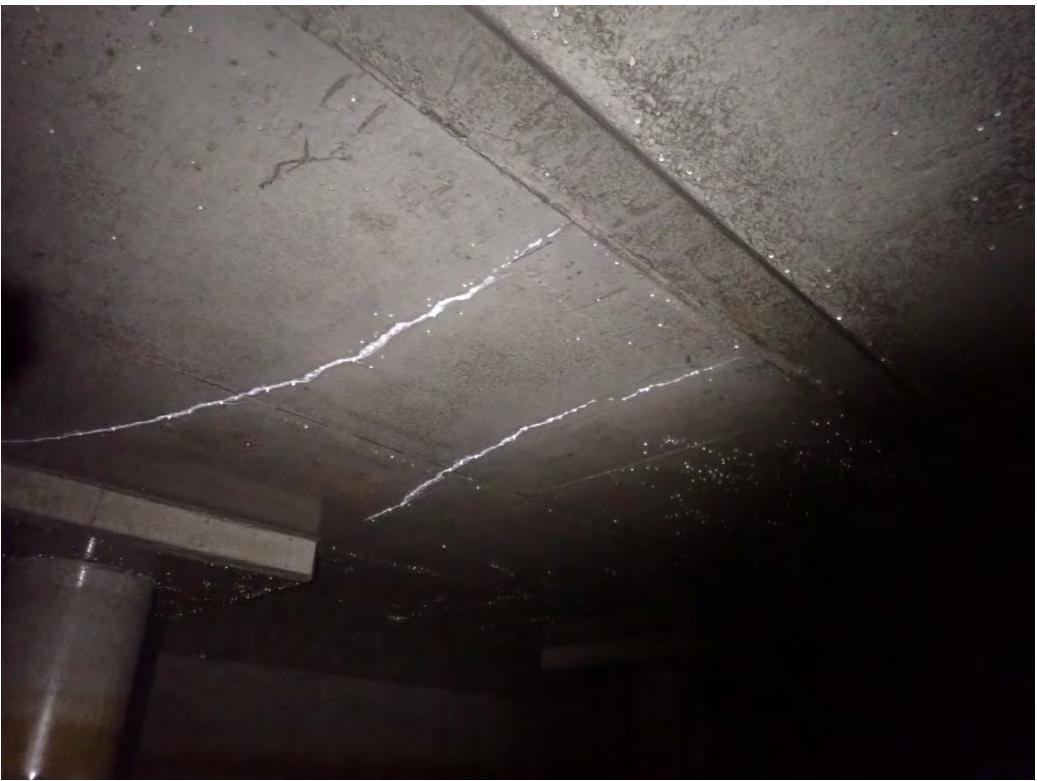
Inside Tank – Diver Photo by Others - Note Efflorescence along diagonal crack. Example location shown, other photos show that this event occurs in multiple locations.

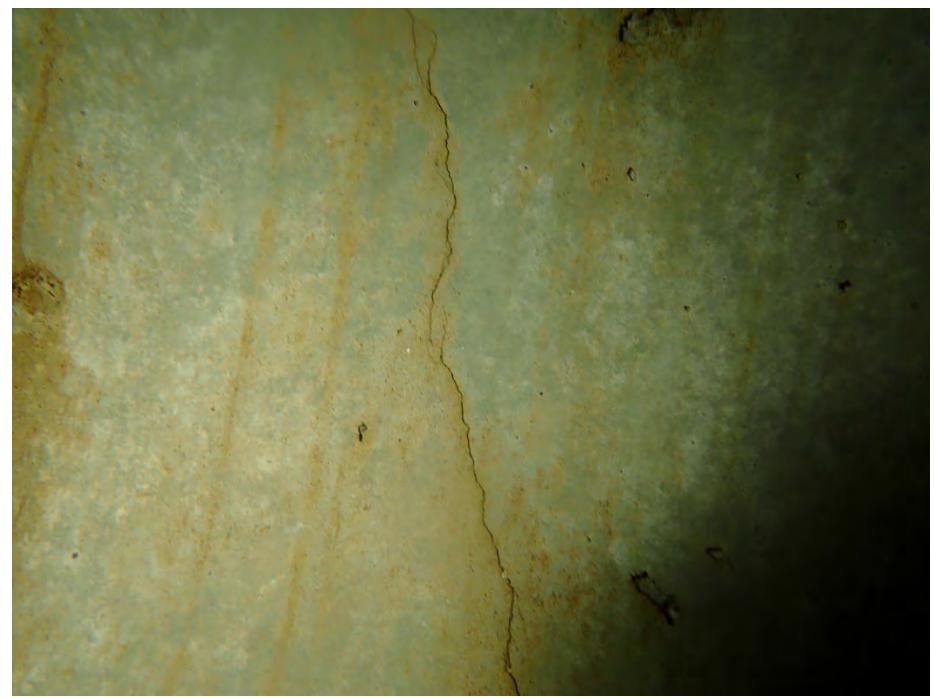
Inside Tank – Diver Photo by Others – Distinct crack in wall. Location, other than wall inside tank, is not known. Other photos show that this event occurs in multiple locations. Likely source of water for leaks observed on outside.

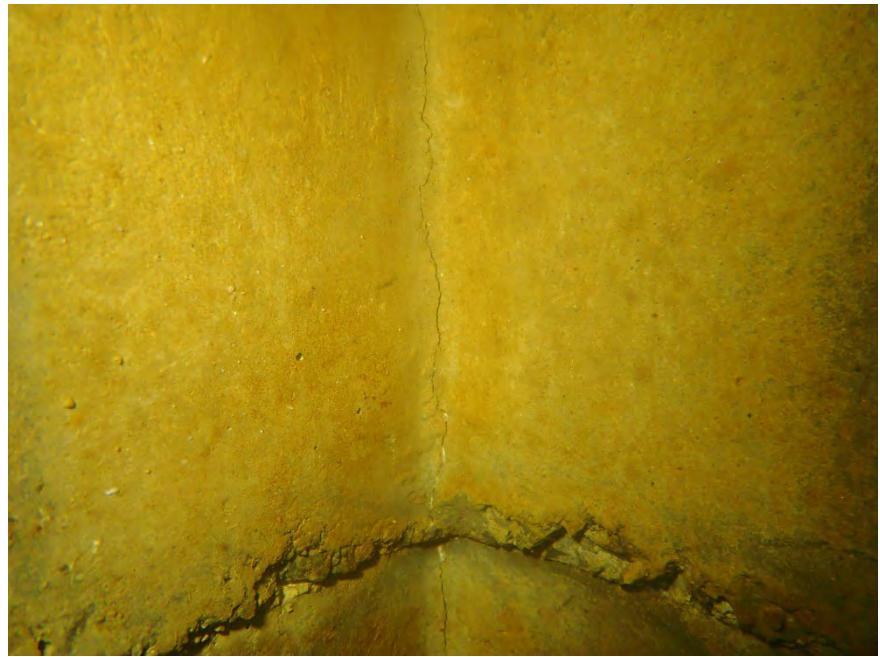
1.1.1.2 Stress Cracks from Loads. Within the tank, based on the photographs taken by the divers, there appear to be cracks on at least two of the inside corners. These would be typical of the tension zone of the wall. Because the cracks appear distinct in the photos of the corners, they are likely slightly larger than the cracks measured on the outside. These cracks are likely the source of the leaks visible on the outside of the walls near the corners.

Inside Tank – Diver Photo by Others – Distinct crack in wall Corner. Location, other than wall corner inside tank, is not known. Other photos show that this event occurs in multiple locations. This crack is likely not a shrinkage crack, but rather a stress crack as described previously. Helps to explain visible leaks at corners outside tank.

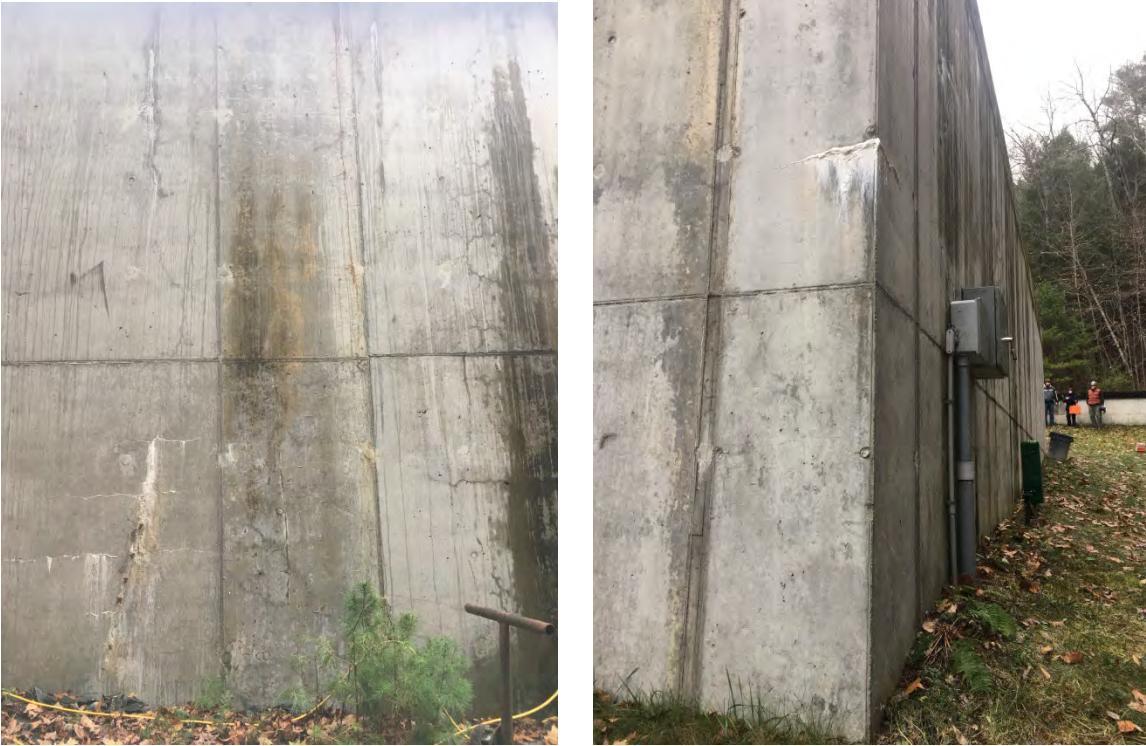
Example photos from an entirely different cast-in-place concrete tank. Provided to show that leaks and repairs can be relatively common. This tank is in VT. Photo at left shows previous injection process to repair crack and several cracks with some fine leaks. Photo at right shows a similar horizontal crack and efflorescence at a tank corner, similar to that occurring at the subject tank. This tank is not intended to be a model tank, just to help Owner understand leaks.

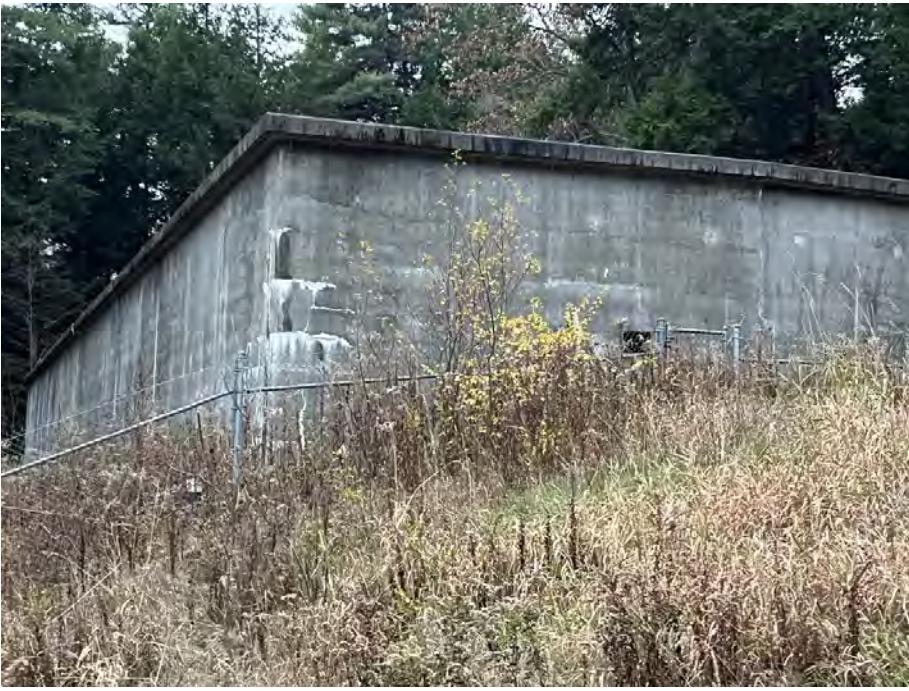
Photo from an entirely different cast-in-place concrete tank, much older but still full, not the same tank as previous photo. Provided to show that leaks and efflorescence are fairly common. This tank is also in VT. This tank is not intended to be a model tank, just to help Owner understand leaks.
