**Town of Richmond Phase I
Stream Geomorphic Assessment Report
DRAFT**

September 19, 2007

Chittenden County Regional Planning Commission
South Burlington, Vermont

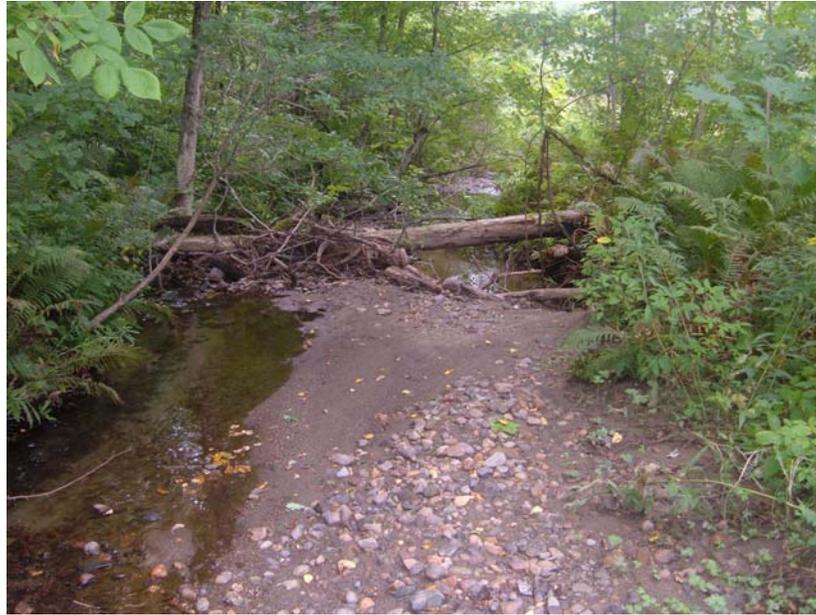
- **R8.S1.03:** This mainstem reach is found to the east of Governor Peck Road upstream of an area of historic beaver activity. The reach is characterized by a moderate-gradient, gravel-bottomed channel with C-type geometry. This reach has received a high impact rating due to the observed changes in planform (28% of the reach has been straightened),

and the road encroachment which has led to a reduced floodplain and corridor. Some depositional features were observed during the field visit (Figure 1), indicating the potential for future lateral adjustments.

Figure 1. Depositional feature in reach R8.S1.03

- **Governor Peck Road Tributary:** Seven reaches are recommended for further Phase 2 assessment in this watershed:
 - **Reaches R8.S1.01 to R8.S1.03 (high priority)** should be investigated in further detail to determine the impacts of historic straightening and a lack of vegetative buffer, and to evaluate the potential for stream corridor protection given the encroachment of agricultural, commercial, and residential land uses. This effort would also involve landowner outreach to assess the social constraints to stream restoration.

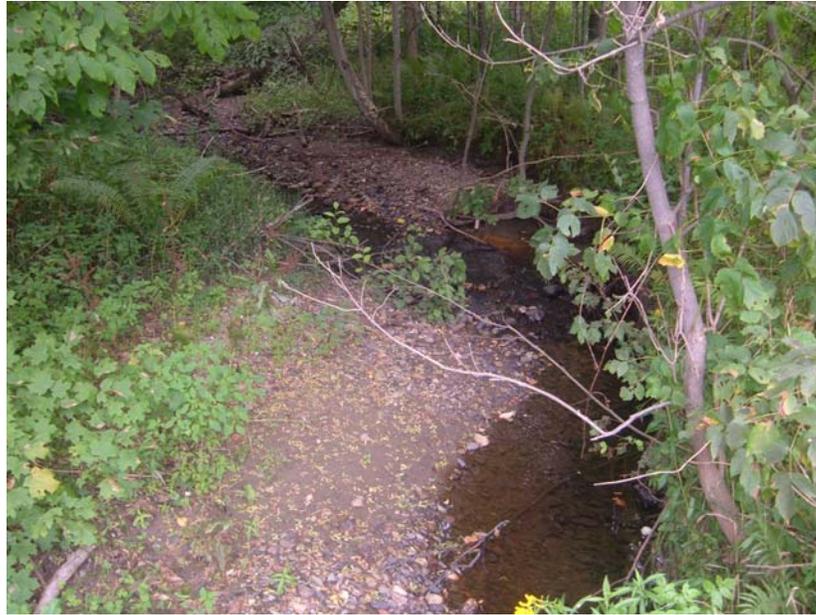
- **R8.S1.05:** This mainstem reach is found along Governor Peck Road from the confluence with the subtributary upstream to where the channel bends to the east away from the road. The reach is characterized by a moderate-gradient, gravel-bottomed channel with C-type geometry. This reach has received a high impact rating due to the encroachments, stormwater discharges, and undersized culverts associated with Governor Peck Road. Two culvert crossings appear to be inadequately sized, resulting in aggradation of sediment above the structure and scour below. One roadside drainage along Governor Peck Road enters main channel in upper reach and delivers significant amounts sediment to the downstream section. Numerous depositional features were observed during the field visit (Figure 2), indicating the potential for future lateral adjustments. Despite these impacts, numerous brook trout were observed in the reach in plunge pools (at the culvert outfalls) during August, indicating that reach provides important cold water refugia for trout in late summer.

Figure 2. Depositional features in reach R8.S1.05

- **Reach R8.S1.05 (high priority)** contains two culvert beneath Governor Peck Road which appear to be undersized. The culverts should be assessed to determine whether they are a priority for the replacement by the Town of Richmond. In addition, one problematic stormwater discharge was noted (previously described), and multiple depositional features were noted throughout the reach.

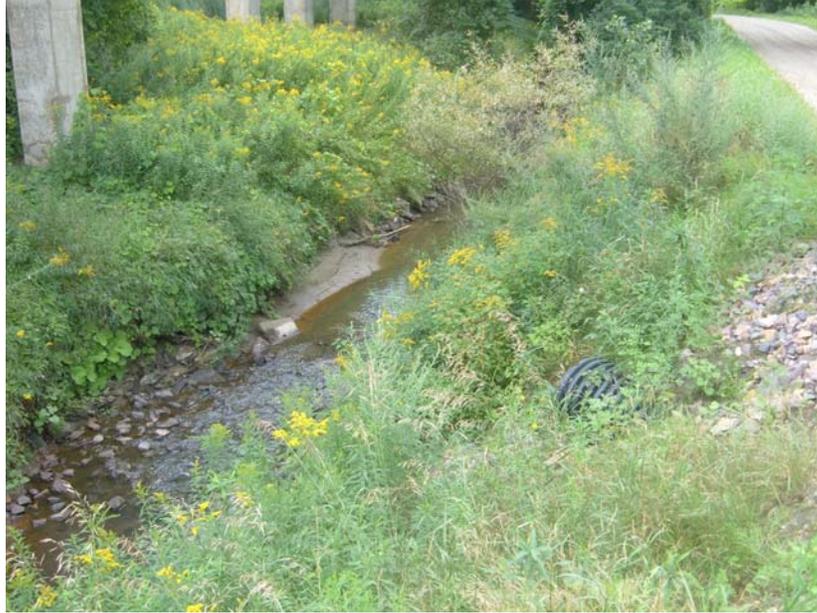
- **R8.S1.01:** This mainstem reach is found from the outlet to the Winooski River up to the reach break approximately 250 feet upstream of the I-89 culvert inlet. This reach has had severe historic impacts to the planform (44% of the channel has been straightened). In addition, a section of the reach in the vicinity of the I-89 crossing lacks a vegetative buffer greater than 25 feet, which likely elevates surface water temperatures during the summer months due to lack of canopy cover.

Figure 3. Stormwater outfall and lack of woody vegetative buffer in R8.S1.01

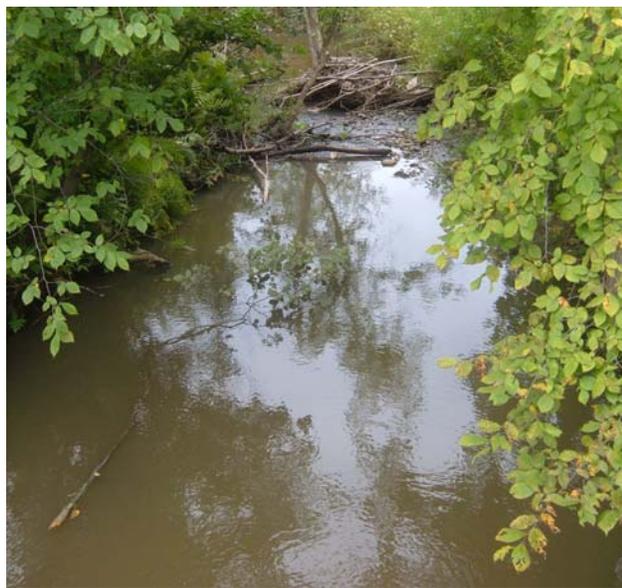
- **R8.S1.02:** This reach is found from the reach break with R8.S1.01 up to an area of historic beaver activity along Governor Peck Road. Although this reach has had limited direct impacts to the channel boundary conditions (channel straightening in 15% of reach), its changes in planform and abundant depositional features indicate that it is undergoing significant lateral migration. Additionally, the adjacent commercial and industrial land use in the lower reach is causing significant fine sediment delivery to the channel (Figure 4).

Figure 4. Suspended sediments in lower R8.S1.02 during baseflow conditions.

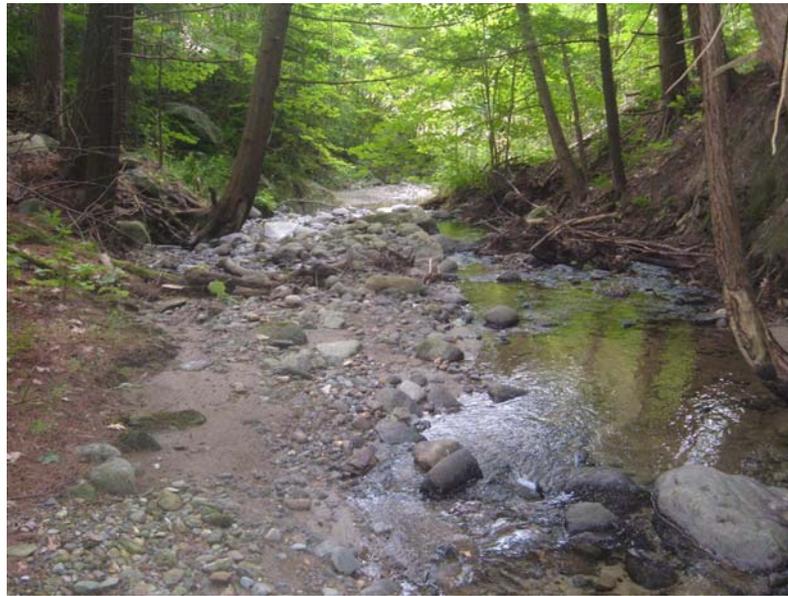
Figure 5. Deposition of fine sediments in R8.S2.02

- **Reaches R8.S2.02 to R8.S2.04 (medium priority)** should be assessed to investigate the sedimentation impacts from road and ATV trail encroachment and failing valley side slopes that were observed during the windshield survey. In addition, the I-89 culvert should be evaluated for impediments to fish passage, given that no brook trout were observed in this tributary during August (unlike in the Governor Peck Road tributary).

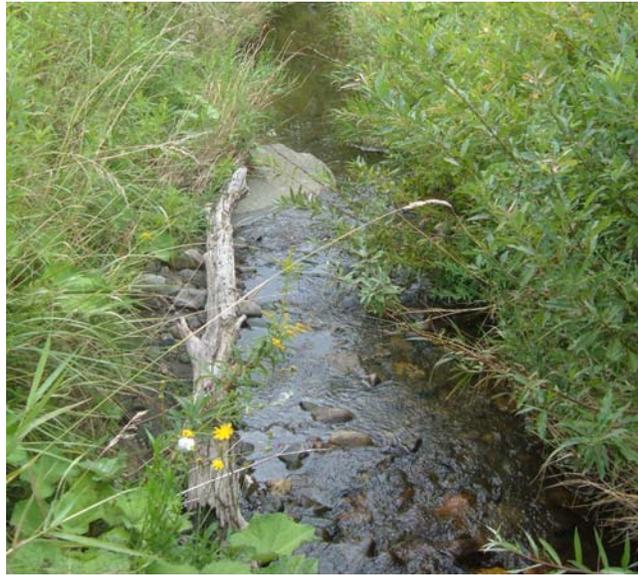
Figure 6. Coarse substrate downstream of Rt. 2 crossing in reach R8.S2.01

- **R8.S2.01:** This mainstem reach is found from the outlet to the Winooski River up to the reach break approximately 150 feet downstream of the I-89 culvert outlet. The channel is characterized by E-type geometry with sand substrates, with the exception of an area of coarse substrate downstream of the Route 2 crossing (Figure 6). This reach has had severe historic impacts to the planform (68% of the channel has been straightened). In addition, much of the reach lacks a vegetative buffer greater than 25 feet, which likely contributes to the direct input of sediment and nutrients from the adjacent agricultural fields, and also elevates surface water temperatures during the summer months due to lack of canopy cover.

- **Jericho Road Tributary:** Six reaches are recommended for further Phase 2 assessment in this watershed:
 - **Reach R8.S2.01 (high priority)** should be investigated in further detail to determine the impacts of historic straightening and a lack of vegetative buffer, and to evaluate the potential for stream corridor protection given the encroachment of agricultural and residential land uses. This effort would also involve landowner outreach to assess the social constraints to stream restoration.

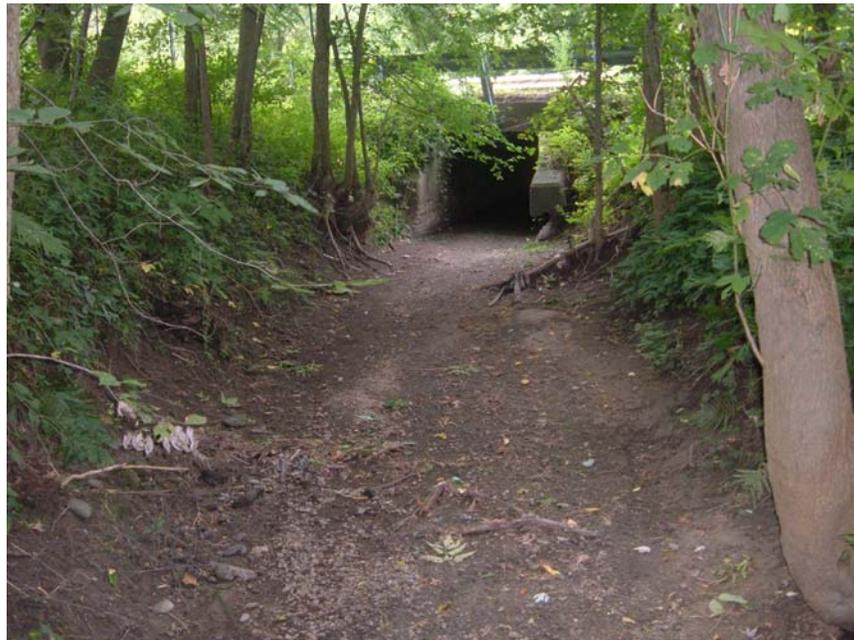
- **R9.S2.01:** This reach is found from the tributary outlet up to a 90 degree bend in the channel at the upstream reach break. The reach is characterized by a low-gradient, sand and gravel-bottomed channel with C-type geometry. This reach has received a high impact rating due to the observed changes in planform (20% of the reach has been straightened), the encroachment on the corridor by adjacent agricultural and residential land, and the depositional features causing lateral channel migration. In addition, the channel was observed to be dry during the field visit in August, 2007 (Figure 7).

Figure 7. Dry channel below Rt. 2 box culvert in reach R9.S2.01

- **Stage Road Tributary:** Three reaches are recommended for further Phase 2 assessment in this watershed:
 - **Reach R9.S2.01 & R9.S2.03 (high priority)** should both be investigated in further detail to determine the impacts of historic straightening and a lack of vegetative buffer, and to evaluate the potential for stream corridor protection given the encroachment of agricultural and residential land uses. This effort would also involve landowner outreach to assess the social constraints to stream restoration.
 - **Reaches R9.S2.02 (high priority)** should also be assessed to determine if fluvial erosion hazards exist downstream of the I-89 culvert outfall.
