**Lake Iroquois
Association**

2021 UPDATE

Highly Significant Decrease in Phosphorus Levels Continues

IROQUOIS - data through 2020

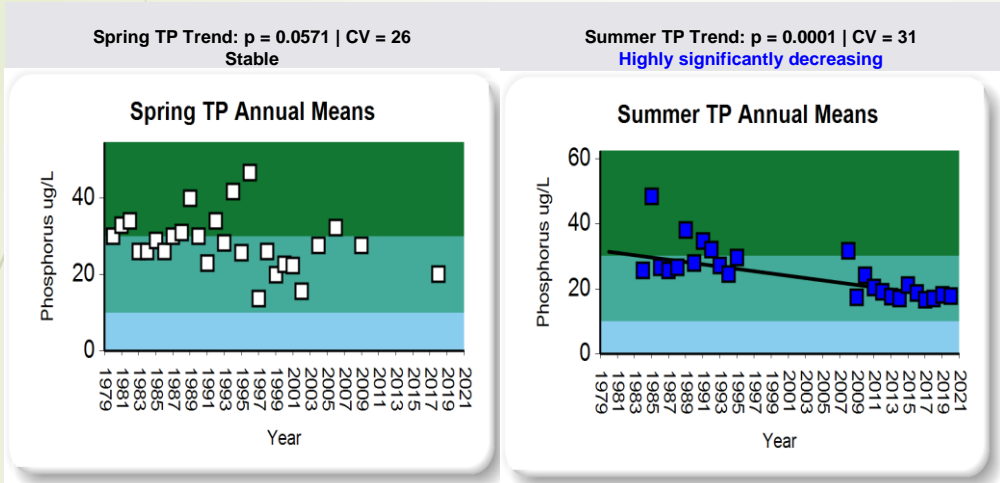
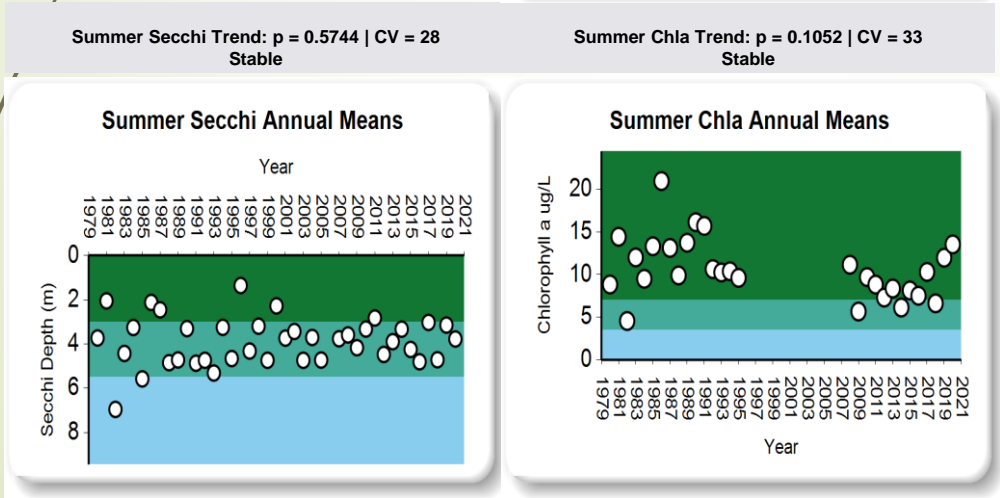
Mean Spring TP:
28.2 ug/L

Mean Summer TP:
25 ug/L

Mean Summer Chla:
10.7 ug/L

Mean Summer Secchi:
3.8 meters

Hypereutrophic
Eutrophic
Mesotrophic
Oligotrophic

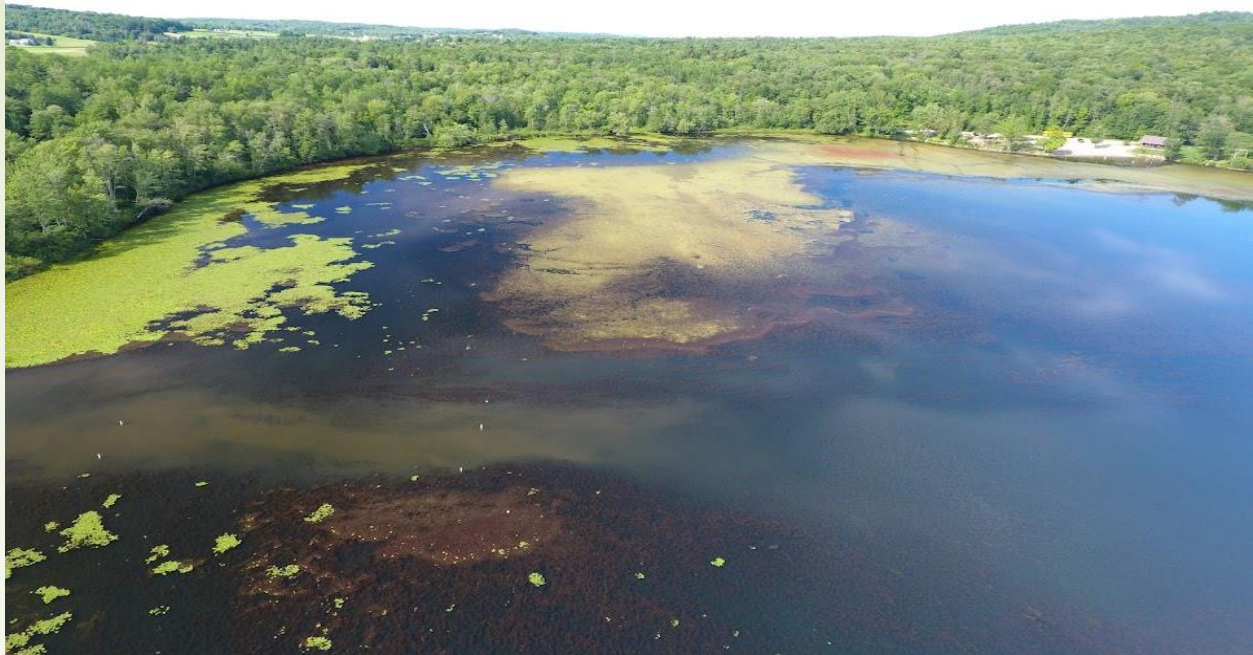
**Summer
2018**

- **Eurasian Watermilfoil**
 - Solitude applied aquatic herbicide June 28th
 - Treated 40% of impacted area
 - Below detectable limit within 48 hours
- **Deployed channel markers to maintain clear boat channel**
- **Diver-Assisted Suction Harvesting (DASH)**
 - None performed this year
- **Benthic Mats**
 - None emplaced this year
