PROJECT NO. PREPARED FOR:

17-061-A

## Stormwater Master Plan Town of Richmond, Vermont

Cover: Gully erosion identified at the north end of the Richmond Elementary / Camel's Hump Middle School campus; and concept design for a regenerative conveyance retrofit to provide both water quality treatment and safe conveyance for runoff from both the school campus and a portion of I-89.

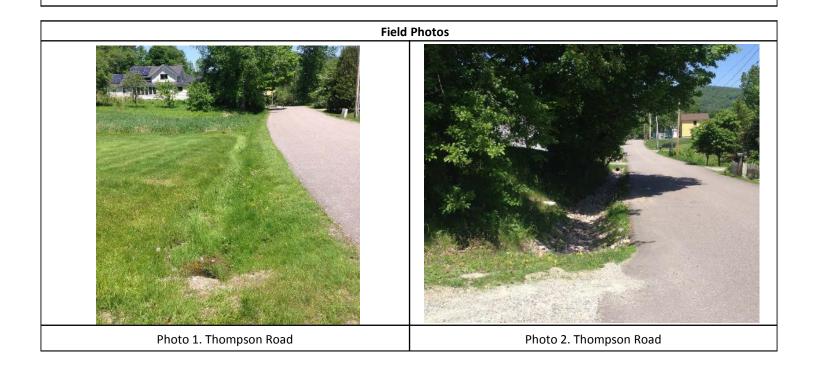
There is currently no treatment, and very little drainage infrastructure, for managing stormwater flow from Thompson Road. This presents an opportunity to capture and treat stormwater runoff before it enters the Winooski River.

Р	roblem Area ID: WR-02	Latitude: 44.39821°	Longitude: -72.99781°
Watershed:	Winooski River		
Location:	Cochran Road		Total and
Problem Type:	Water Quality		The Old Round Church Stone Corral/Brewery
Identification Source:	SWMP Field Assessments	Humbagton Rd	
Ownership:	Town of Richmond		Sterling House of Richmond
Classification:	6	Richmond - A Cathedral	nd Terrace
Base P Load:	6.52 lbs/yr	Ri	Richmońd
Soil Type	A	Highway	Richmonfd (m)
– Feasible BMPs –	Bioswale/bioretention, grass swale, surface infiltration	The second	1.1
Max. P Reduction	6.39 lbs/yr

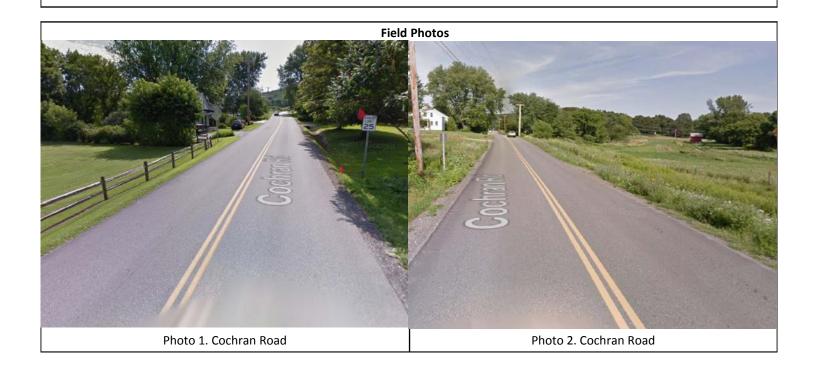
There is currently no treatment, and very little drainage infrastructure, for managing stormwater flow from Cochran Road. This presents an opportunity to capture and treat stormwater runoff before it enters the Winooski River.

Pro	oblem Area ID: WR-03	Latitude: 44.40077°	Longitude:	-72.99863°
Watershed:	Winooski River	A Reality of the second	2	Contraction of the second seco
Location:	Wet Pond	Winooski River	Volunteer	atraan"
Problem Type:	Water Quality	and the second	and the second	
Identification Source:	SWMP Field Assessments	a company	antes .	1 Strange
Ownership:	Town of Richmond/Private	12		
Classification:	6	Martin Contraction		
Base P Load:	3.63 lbs/yr	Jericho Settlers The Old	Round Church	
Soil Type	C	Jericho Settlers Farm • Farmstand		AN VON
Feasible BMPs	Retrofit Existing Wet Pond			Winoose
Max. P Reduction	1.89 lbs/yr	_		
Date of Field Data	Collection: October 5, 20	17

WR-02	Cochran Road	Retrofit opportunity	Install bioswales along the shoulders of Cochran Road capturing and treating all roadway runoff, as well as the majority of residential runoff from the south side of the road. Soils in the area are conducive to infiltration, so bioswales should be treated as infiltrating bioswales without underdrain. It is important to provide separation between the roadway shoulder and edge of BMP as postal couriers pull off the shoulder to deliver mail.	A	1	2	3	2	1	9	С	L	Y	М	Village - 10	
WR-03	South Bridge Street	Retrofit existing BMP	There is already a pond here, soils are mapped as HSG C but appear to be infiltrating the collected runoff as there is no pond outlet. It is possible to increase the storage capacity of the pond to capture larger storm events.	с	2	2	1	2	2	9	С	М	Ν	L	Village - 11	
WR-04	Volunteers Green Parking Lot	Retrofit opportunity	Install underground infiltration chambers, or underground storage with controlled outlet to the Winooski River, dependent upon what is discovered about the site's infiltrative capabilities. This would require rerouting the existing drainage network in one location, but would effectively capture and treat all runoff from Bridge Street, and a portion of the neighborhood from the center of the Winooski River north to the railroad tracks. Also install a rain garden in the vacinity of the parking lot to treat surface flows from the lot and demonstrate improved water quality.	В	3	3	2	2	1	11	С	Н	Y	Н	Village - 5

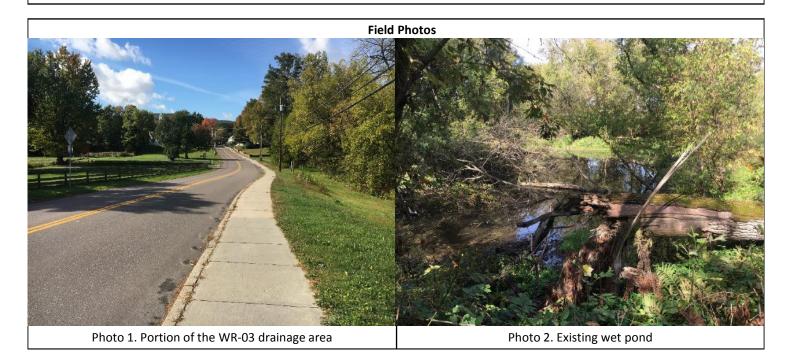
Stormwater runoff from Bridge Street, Round Barn Road, and portions of Thompson Road and Huntington Road is collected within a closed stormwater drainage network that outlets to an existing wet pond. Soils are mapped as HSG C, but appear to be infiltrating the collected runoff; there is no visible pond outlet. It may be feasible to increase the storage capacity of the pond to capture larger storm events.

I	Problem Area ID: WR-04	Latitude:	44.40203°	Longitude:	-72.99649°
Watershed:	Winooski River		A Charles	Congre	gational Church
Location:	Volunteers Green Parking Lot				Richmond Free Library
Problem Type:	Water Quality	and the		ne Radish	
Identification Source:	SWMP Field Assessments	No h			United States Postal Service
Ownership:	Town of Richmond (Volunteers Green)	Ban	Volunteer	s Green	
Classification:	6	1020		No.	12.5
Base P Load:	4.46 lbs/yr	a 111 Marcala		A last	and the town it has
Soil Type	В	18 man	and the second second	1	
Feasible BMPs	Underground Infiltration, Underground Storage				ALL A
Max. P Reduction	4.37 lbs/yr

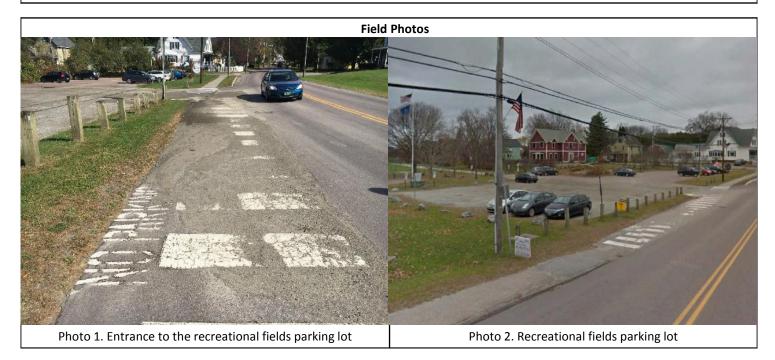
The existing closed drainage system conveys stormwater from Bridge Street, as well as portions of Esplanade and Church Streets, to the Winooski River. The outlet pipe from this drainage network passes under the recreational fields parking area. It may be possible to access the drainage system in this location and install chambers or underground storage (dependent upon soil infiltrative capacity). It would also be possible to install a rain garden in the vicinity of the parking lot, whether near the entrance or near the gravel road to access the recreational fields.

Pre	oblem Area ID: WR-05	Latitude: 44.40213°	Longitude: -72.99481°
Watershed:	Winooski River		Richmond Free Library
Location:	USPS / Richmond Free Library		
Problem Type:	Water Quality and Erosion	- One Radish	United States Postal Service
Identification Source:	SWMP Field Assessments	Volunteers Green	and the second second
Ownership:	Town of Richmond		
Classification:	4		at which have a first
Base P Load:	4.15 lbs/yr		
Soil Type	В	and the second	ATT AND
Feasible BMPs	Bioretention		
	3.15 lbs/yr	-

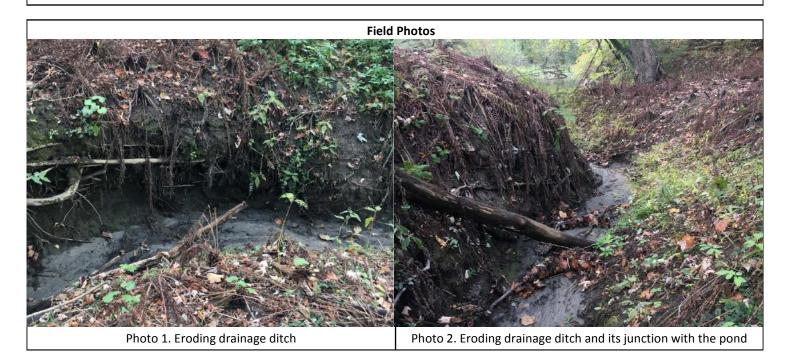
Stormwater flows overland from the USPS and library roofs and parking lot to a collection point at the southeast corner of the parking lot. From there, drainage is conveyed via a closed pipe and a drainage ditch that outlets to a natural pond, and then to the Winooski River. There is substantial erosion occurring in the drainage ditch; if stormwater flow were reduced by installation of a bioretention basin or bioswale, stabilization of the currently eroding channel may also be possible.

Pr	oblem Area ID: WR-06	Latitude: 44.40558°	Longitude:	-72.99800°
Watershed:	Winooski River	Richmond Rescue		Holy Rosary Church
Location:	Richmond Rescue	Richm	and Home	Family Medicin
Problem Type:	Water Quality and Erosion			2 PSM
Identification Source:	SWMP Field Assessments	E sorian an a la f		Hatchet Tap and Table
Ownership:	Private	A DATA C	s	Richmond Food
Classification:	4			Richmond Market & Beverages
Base P Load:	68.2 lbs/yr	Con	Richmond gregational Church	
Soil Type	C			
Feasible BMPs	Wet Pond / Created Wetland		<sup>9</sup> 9- Rich	mond Free Library
Max. P Reduction	35.5 lbs/yr	_

WR-05	USPS / Richmond Free Library	Retrofit opportunity	Install a bioretention basin to the southeast of the municipal parking lot. The roughly 1.25 acre drainage area is mostly impervious and already drains to a single collection point in the northeast corner.	В	2	3	2	2	2	11	С	М	Y	Μ	Village - 6	
WR-06	Richmond Rescue	Retrofit opportunity	Install a wet pond/created wetland at the outlet adjacent to Richmond Rescue within the existing drainage pattern. There is not much capicity for infiltration at the site, though there is also no serious risk associated with overtopping the wet pond/created wetland that will convey stormwater to the Winooski River. The outfall is within the 100 year floodplain, which may preclude BMP implementation.	с	4	4	2	2	3	15	С	Н	Y	Н	Village - 1	*
WR-07	Railroad Tracks	Retrofit opportunity	Install a gravel wetland to treat stormwater from from a 120+-acre drainage area; even without the ability to fully infiltrate, substantial treatment is feasible. Floodplain and potential wetland constraints may preclude implementation.	A/D	3	5	1	1	3	13	В	Н	Y	Н	Village - 2	*

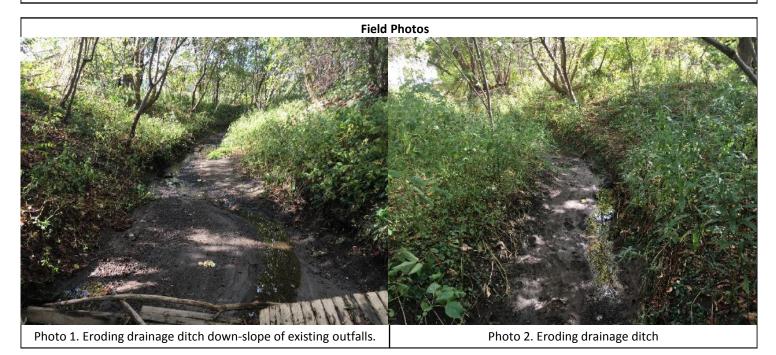
Stormwater runoff from an approximately 90-acre drainage area is conveyed via a closed drainage system and overland flow to a ditch to the southwest of Richmond Rescue. The ditch, which is actively eroding and filled with sediment, carries the stormwater to the Winooski River. Sufficient open land is present at the outlet of the closed drainage system to construct a sediment forebay and a water quality treatment practice, wet pond or created wetland. About 40 acres of the contributing drainage area can be managed by a separate water quality practice at WR-11 (Millet Street).

I	Problem Area ID: WR-07	Latitude: 44.40321°	Longitude:	-72.99320°
Watershed:	Winooski River	CAPTAN C	Hatchet Tap ar	Id Table
Location:	Railroad Tracks	CLAPORA I	Richmond Food Shelf & Thrift Store	Papa McKee's Pizzeria
Problem Type:	Water Quality, Erosion, and Damaged Infrastructure		Shelf & Thrift Store Richmond Market & Beverage	
Identification Source:	SWMP Field Assessments			
Ownership:	Private	Richmond Congregational Church	and the second	
Classification:	3	Rid	nmond Free Library	
Base P Load:	70.8 lbs/yr		Soft-	3-1
Soil Type	A / D	One Radish Unite Post	d States al Service	and the second second
Feasible BMPs	Gravel Wetland		A AL	
Max. P Reduction	43.19 lbs/yr

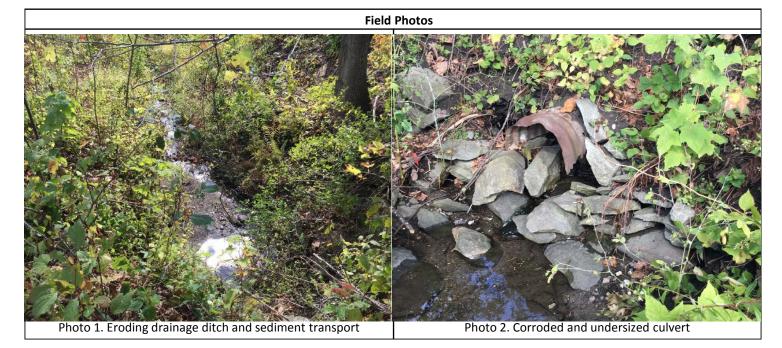
Stormwater from an approximately 122-acre drainage area is conveyed via a closed drainage system and overland flow to a ditch south of the railroad tracks. The ditch, which is actively eroding and filling with sediment, carries stormwater to a natural pond that then drains to the Winooski River. Sufficient area likely exists for construction of end-of-pipe retrofit practices, including pre-treatment gravel wetlands, in at least two separate locations. Both the culvert that carries water beneath the railroad tracks, and the box culvert that carries water beneath the private drive are badly damaged and in need of replacement. Planned waterline replacement on Main Street and replacement of the drainage network between Main Street and the railroad tracks may represent a strategic opportunity to "bundle" needed improvements that benefit this larger drainage area.

Р	roblem Area ID: WR-08	Latitude: 44.40653°	Longitude:	-72.99310°
Watershed:	Winooski River	HMC Advertisi		
Location:	Our Lady of the Holy Rosary Church	Parting Our L	ady of the Rosary Church	
- Problem Type:	Water Quality	Holy	Rosary Church	
- Identification Source:	SWMP Field Assessments	- 10 <sup>-28</sup> -20-3	Family Medicine	1 Barn
Ownership:	Private		Ski Ex	press
- Classification: -	6	Hatchet Tap and Tat	le Greenser	Svetoms
Base P Load:	1.51 lbs/yr		Papa MCKee's Pizze	The second s
Soil Type	A / D	Richmond Food Shelf & Thrift Store	Cont.	to the
Feasible BMPs	Bioretention, Infiltration Trench	Richmond Market & Beverage		
- Max. P Reduction	1.15 lbs/yr

Stormwater from an approximately 122-acre drainage area is conveyed via a closed drainage system and overland flow to a ditch south of the railroad tracks. The ditch is actively eroding and filling with sediment, and carrying stormwater to a natural pond that then drains to the Winooski River. Sufficient area likely exists for construction of end-of-pipe retrofit practices, including gravel wetlands, in at least two separate locations. Both the culvert that carries water beneath the railroad tracks, and the box culvert that carries water beneath the private drive are badly damaged and in need of replacement. Planned waterline replacement on Main Street and replacement of the drainage network between Main Street and the railroad tracks may represent a strategic opportunity to "bundle" needed improvements that benefit this larger drainage area. Constraints on the northern-most of the two sites, however, include proximity to the railroad tracks and right-of-way and active construction of Phase 1 improvements at the Richmond Creamery redevelopment project at 74 Jolina Court, on the parcel just south of the railroad tracks.

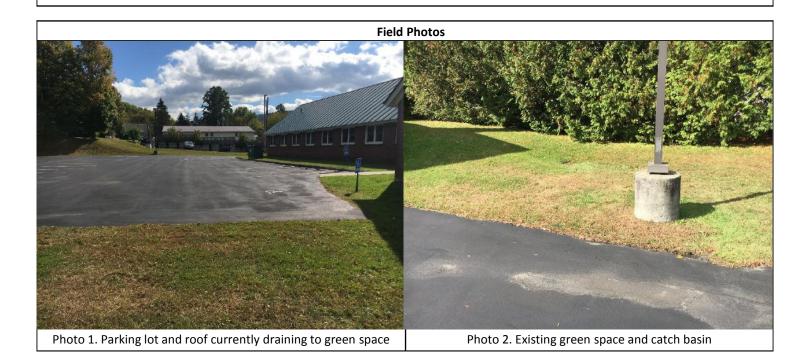
Stormwater from the church roof and parking lot flows overland to the northwest, where existing green space could be utilized for stormwater capture and treatment. Opportunity to disconnect runoff from closed drainage system that outfalls at WR-07 project location.

Pro	blem Area ID: WR-09	Latitude: 44.40259°	Longitude: -72.99585°
Watershed:	Winooski River		Richmond Free Library
Location:	Bridge Street Sidewalk		
Problem Type:	Water Quality	One Radish	United States Postal Service
Identification Source:	SWMP Field Assessments	Volunteers Green	
Ownership:	Town of Richmond		
Classification:	6		an and the second second
Base P Load:	1.79	_	
Soil Type	A / D		A STANDAR
Feasible BMPs	Bioretention, Tree Trench		and the second second
Max. P Reduction	1.36

WR-08	Our Lady Church	Retrofit opportunity	There is opportunity to utilize green space to the northwest of the parking lot for infiltration/bioretention. The parking lot already slopes that direction so capture and treatment can be achieved with relative ease.	A/D	2	2	2	2	2	10	А	L	Y	Μ	Village - 8	*

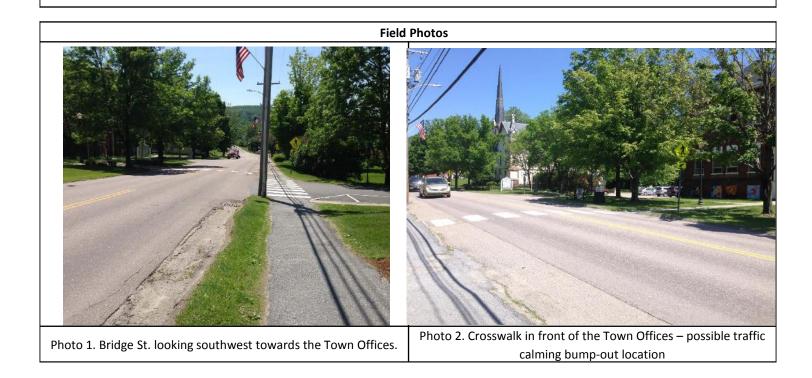
There is an opportunity to incorporate BMP installation with the planned sidewalk replacement project on Bridge Street. BMPs may include traffic calming bump-outs with rain gardens, tree wells, and/or underground infiltration beneath the new sidewalk.

F	Problem Area ID: WR-10	Latitude: 44.40469°	Longitude:	-72.99211°
Watershed:	Winooski River	HMC Advertis	ing	
Location:	Main Street Water Line Replacement	Parties Sour	Lady of the Rosary Church	
Problem Type:	Water Quality	Holy	10	
Identification Source:	SWMP Field Assessments	- 10 <sup>-0</sup>	Richmond Family Medicine	
Ownership:	Private	CARLAN A	Ski Ex	press
Classification:	6	Hatchet Tap and Ta		Systems
Base P Load:	2.86		Papa McKee's Pizz	
Soil Type	A / D	Richmond Food		Day 10
Feasible BMPs	Bioretention	Richmond Market & Beverage		2
Aax. P Reduction	2.17

#### 5.1.4. WR-09, Bridge Street Sidewalks (Subsurface Infiltration)

There is an opportunity to integrate stormwater management improvements with planned sidewalk replacement project on Bridge Street, including into green space and mini-park amenities originally envisioned in the *Bridge Street Bicycle & Pedestrian Feasibility Study* (Broadreach Consulting et. al. 2010). At this location, runoff from an approximately 1-acre drainage area centered on Bridge Street between Railroad Street and Volunteer's Green enters a closed drainage system without treatment, and ultimately is discharged to the Winooski River. Installing water quality treatment retrofits that can ideally infiltrate some portion of the runoff would reduce the volume and improve quality of runoff currently flowing to the river.

Initially, a series of surface bioretention basins were envisioned to manage runoff in the right-of-way. However, the limited space available to site surface practices led the team to instead propose an "invisible green infrastructure" concept consisting of traffic calming bump-outs with surface bioretention only in key locations (primarily at the crosswalk leading from the west side of Bridge Street to the Town Offices). Most water quality treatment is provided by deep-sump catch basins providing pre-treatment, followed by infiltration and water quality treatment in subsurface infiltration chambers with gravel reservoirs sited beneath new sidewalks or the roadway, with overflow to the existing closed drainage system. The design standard used for this retrofit was best-fit treatment of the water quality volume for the contributing drainage area (1.01 acres). Full compliance with the WQv treatment standard would manage 1.0" of rain in a 24-hour period; this practice has the potential to prevent 1.36 lbs/year of total phosphorus from entering receiving waters (Table 4) At this site, it is possible to site a series of infiltration chambers that will manage 100% of the WQv or 1,700 ft<sup>3</sup> of runoff. A 30% design plan is provided in Appendix E.

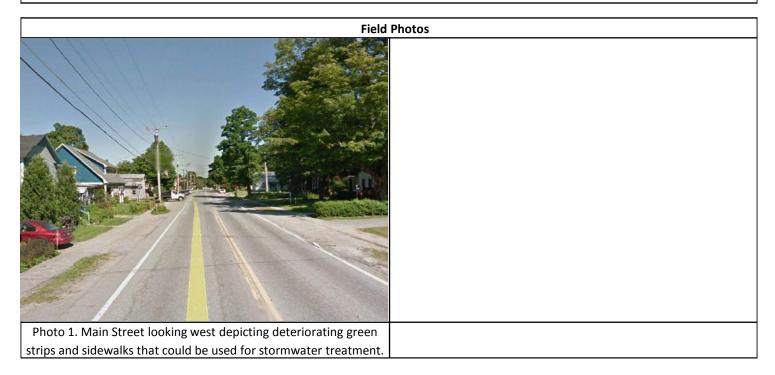
There is an opportunity to incorporate BMP installation with the planned water line replacement project on Main Street. If soils are deemed infiltrative, reduce the paved width and/or remove one sidewalk and install bioswales along the southern edge of the roadway where space allows. If infiltration is not possible, consider installing grass swales to provide filtration before the stormwater enters the closed drainage network. The same treatment may be applied to the northern edge of the roadway to create additional capacity.

Problem Area ID: WR-11	Latitude: 44.40736°	Longitude:	-72.99245°
Watershed:	Winooski River			
Location:	Millet Street		TildentAve	
Problem Type:	Water Quality, Infrastructure Protection	1 1 1 1 1 1 1 1 1 1 1 1 1 1 1 1 1 1 1	Tildon)	
Identification Source:	SWIMP Field Assessments			Patho Rd
Ownership:	Private		C LINS	No.
Classification:	6			
Base P Load:	18.05 lbs/yr	ichmond Home Supply Inc	2 mars	
Soil Type	A / D			Papa McKee's Pizzeria
Feasible BMPs	Infiltration, Bioretention		Richmond Market	
Max. P Reduction	13.72 lbs/yr

WR-10	Main Street Water Line Replacement	Retrofit opportunity	There is an opportunity to incorporate BMP installation with the planned water line replacement project along Main Street. If soils are deemed infiltrative, install bioswale along the Main Street cooridor. If infiltration is not possible, consider a grass swale conveyance system to filter stormwater before it enters the closed drainage network.	A/D	3	2	1	2	2	10	A	L	Y	Н	Village - 7	
WR-11	Millet Street	Retrofit opportunity	Install an infiltration basin, or other water quality BMP, at the corner of Millet Street and Tilden Avenue. At this location, the existing drainage enters a subsurface closed drainage network that outlets at Richmond Rescue.	A/D	4	3	1	2	3	13	A	М	Y	Н	Village - 3	*
WR-12	School Entrance	Retrofit opportunity	Along the north side of the existing campus entrance is a non-paved unvegetated drainage swale, much of which is used for overflow parking. The area could be stabilized with a porous pavement or grass pavers, with a gravel reservoir for infiltration and filtering beneath.	А	2	2	3	2	3	12	С	L	Y	М	School - 5

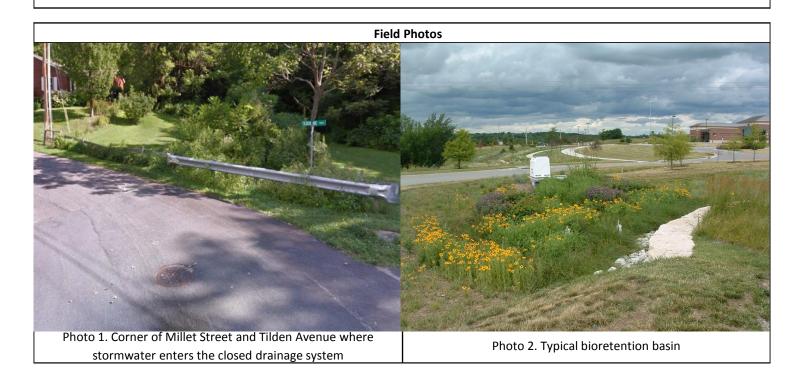
At this location, runoff from an approximately 39-acre drainage area enters the closed drainage system that outlets southwest of Richmond Rescue. Installing a water quality treatment practice, ideally one that can infiltrate some portion of the runoff reaching this location, would reduce the volume and improve quality of runoff currently causing damage at WR-07.

I	Problem Area ID: WR-12	Latitude: 44.41257°	Longitude:	-72.99240°
Watershed:	Winooski River			
Location:	School Campus Entrance Road			11 189
Problem Type:	Water Quality, Erosion			
Identification Source:	SWMP Field Assessments, School Meetings		8	
Ownership:	USD 17			
Classification:	4			
Base P Load:	1.81 lbs/yr		THE F	
Soil Type	А			
Feasible BMPs	pervious asphalt or grass pavers with infiltration volume beneath	all and the second		
Max. P Reduction	1.36 lbs/yr

At this location, runoff from an approximately 39-acre drainage area enters the closed drainage system that outlets southwest of Richmond Rescue (WR-07). Installing a water quality treatment practice, ideally one that can infiltrate some portion of the runoff reaching this location, would reduce the volume and improve quality of runoff currently causing damage at the Richmond Rescue site.

The proposed retrofit for this site is a bioretention area just upstream from the existing inlet to the closed drainage system immediately north of the Millet Street – Tilden Avenue intersection to provide water quality treatment and limited infiltration capacity, with overflow to the existing closed drainage system and ultimately to the outlet at WR-07. The design standard used for this retrofit was best-fit treatment of the water quality volume for the contributing drainage area (39.1 acres). Full compliance with the WQv treatment standard would manage 1.0" of rain in a 24-hour period and at full water quality treatment, this practice has the potential to prevent 13.72 lbs/year of total phosphorus from entering receiving waters (Table 4) At this site, it is possible to site a bioretention area that will manage over 100% of the WQv or a total of 20.300 ft<sup>3</sup> of runoff. A 30% design plan is provided in Appendix E.

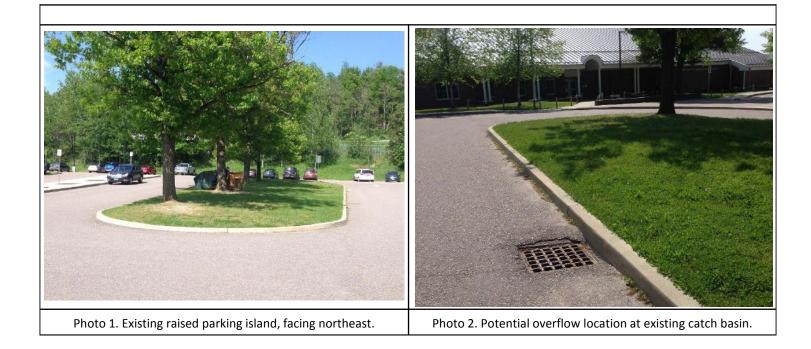
P	roblem Area ID: WR-14	Latitude: 44.41422°	Longitude:	-72.99440°
Watershed:	Winooski River	AND DEC.		
Location:	School Campus Northwest Ravine			
– Problem Type:	Water Quality, Erosion, Property Damage	at a strand		
_ Identification Source: _	SWMP Field Assessments, School Meetings		IEg	7
Ownership:	USD 17	the test and		A BEACH
Classification:	5	12 to state in	8806 20130	18870 33 3
Base P Load:	9.5 lbs/yr		1.0	
Soil Type	C/D		X	1 1 1 1 1 1 1 1 1 1 1 1 1 1 1 1 1 1 1
– Feasible BMPs –	Stabilize gully and culvert outlet, provide scour protection.			
Max. P Reduction	TBD lbs/yr		. 3111111

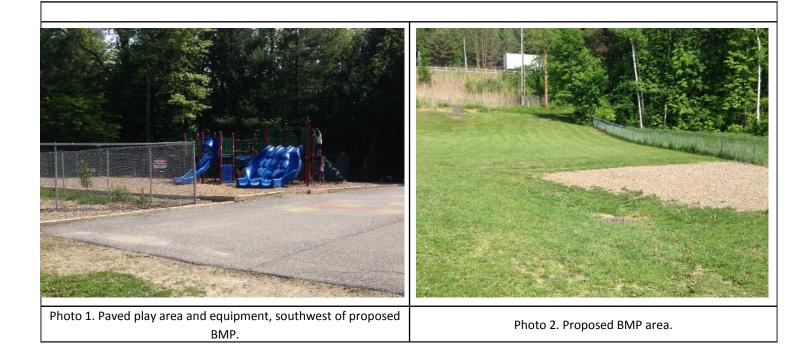
The rooftop on the northeast side of the elementary school could be effectively disconnected into an infiltration trench along the roof's drip edge.

Р	roblem Area ID: WR-17	Latitude: 44.41241°	Longitude: -72.99289°
Watershed:	Winooski River		
- Location:	School Campus Elementary School		6
– Problem Type:	Water Quality		
_ Identification Source:	SWMP Field Assessments, School Meetings		
Ownership:	USD 17		
- Classification:	6		
Base P Load:	1.97 lbs/yr		
Soil Type	А	A Start	
Feasible BMPs	Gravel wetland	a large the	Share - Y - Y
– Max. P Reduction	1.20 lbs/yr

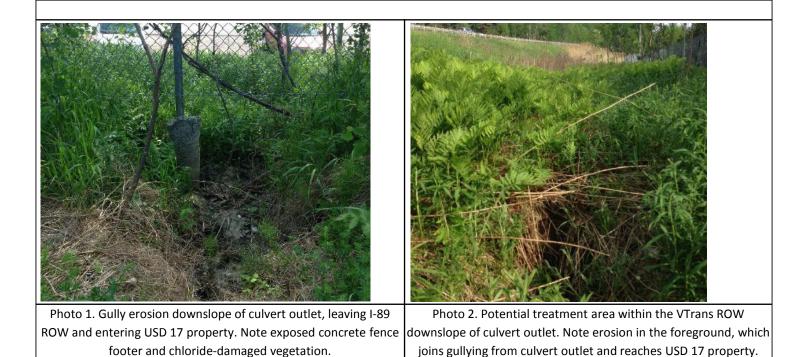
Strategic retrofit to treat runoff from I-89 NB and SB, and a limited amount of VTrans-owned pervious surface associated with I-89. The proposed BMP treats and detains runoff that discharges northeast across I-89 north of the school property. Though this portion of I-89 is adjacent to the school property, this runoff is not contributing to the erosion issue at WR-14.

Problem Area ID: WR-19	Latitude:	Longitude:
Watershed:	Winooski River		
Location:	I-89 ROW, D5 Drainage Area, Interstate and Median	C. House Carl	
Problem Type:	Water Quality, Erosion, Property Damage		
Identification Source:	SWMP Field Assessments, School Meetings		
Ownership:	Vermont Agency of Transportation		
Classification:	4		
Base P Load:	2.16 lb./year		
Soil Type	В		
Feasible BMPs	Gravel Wetland, potentially infiltration		
Max. P Reduction	1.32 lb./year
