10 East Main St, Richmond

Creemee Stand Removal and Facade Improvement

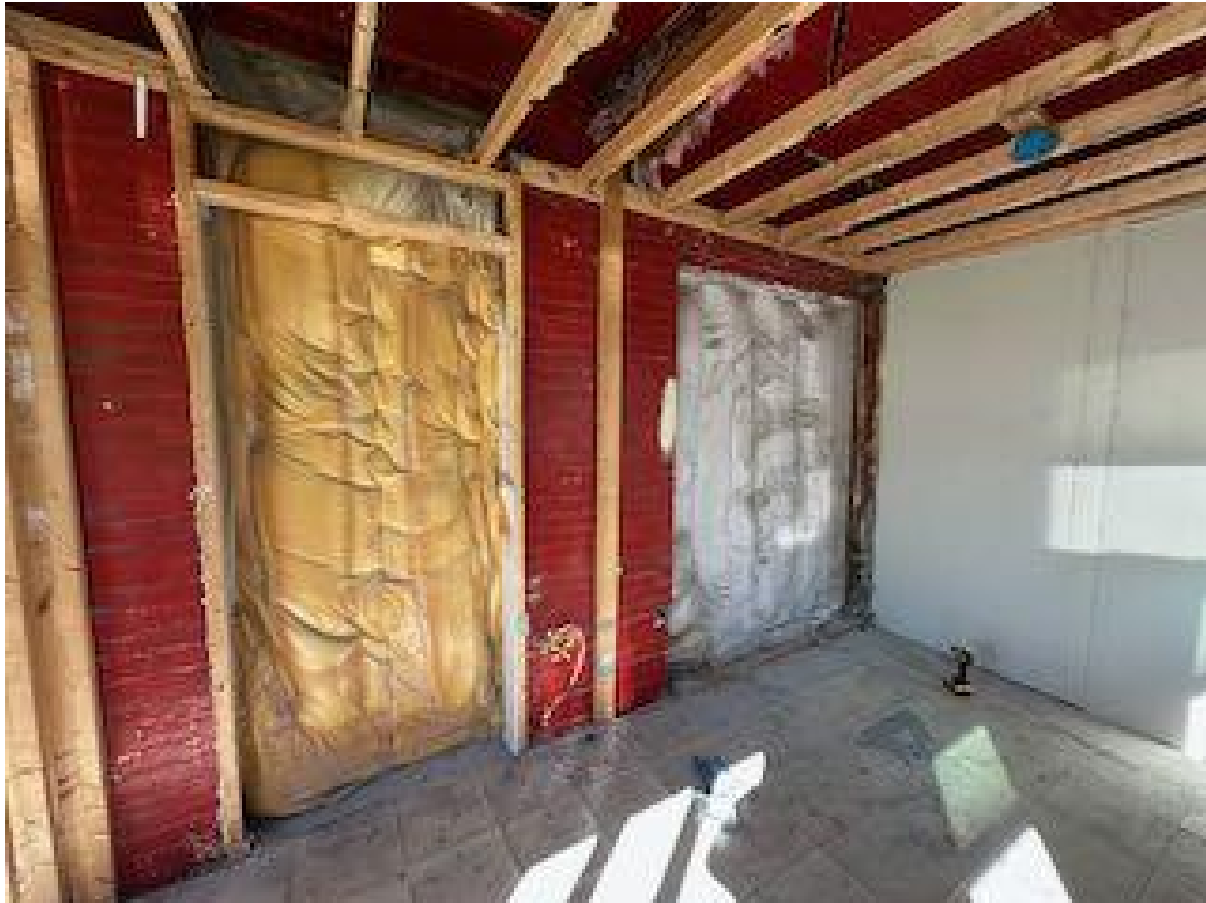
After removing the walls covering the facade of the building, we have deemed that it is not feasible to bring the existing brick back to original. The brick is covered with multiple layers of paint and sand blasting or removing the paint would damage the brick. We consulted with the mason doing the work on the West Wall and he confirmed that the current brick is not salvageable. Additionally, there are many holes within the brick, from old doorways, so even if we were able to remove the paint, it would be impossible to match the old brick with new. A patch job would be forever noticeable.

Please see the photos below that highlight the current condition of the original brick wall:

- Wall under porch roof will be covered with a Corten product of 7/8" Raw Steel that will Patina with time. The Corten is discrete and matches the old feel of the building, while allowing us to cover the damaged, unrepairable, brick.
- The existing hardee board siding that is currently grey, will be painted a navy blue
- Trim will be painted black to match the trim of neighboring buildings and businesses
- Railings will be replaced with black metal railings

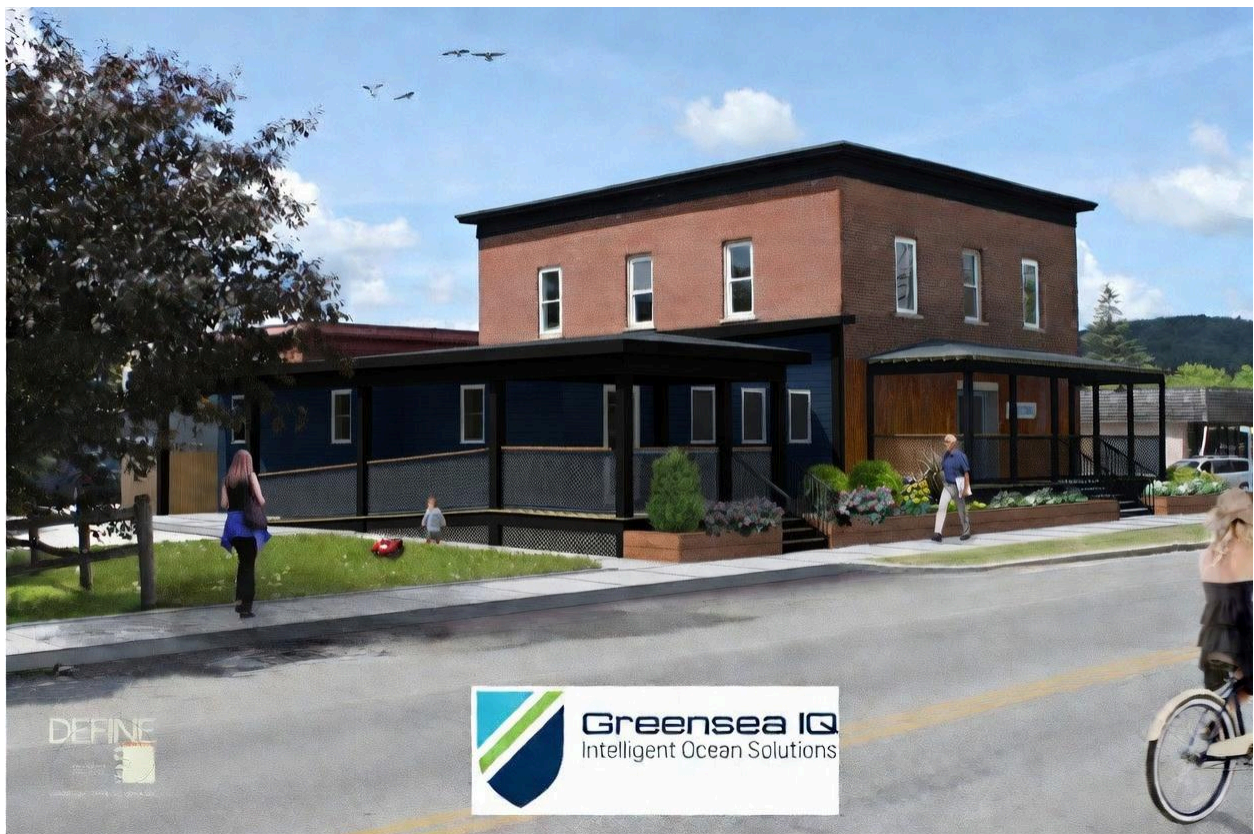
Rendering of new design, from the perspective of Main St.

One Note: The rendering depicts stairs coming off the front of the porch. The current stairs come off the side, to the east. We plan to keep the current location of the stairs.
