# Richmond Wastewater Treatment Facility 20 Year Evaluation *30% Submittal*

**October 2023**

Prepared for:  
Town of Richmond, Vermont

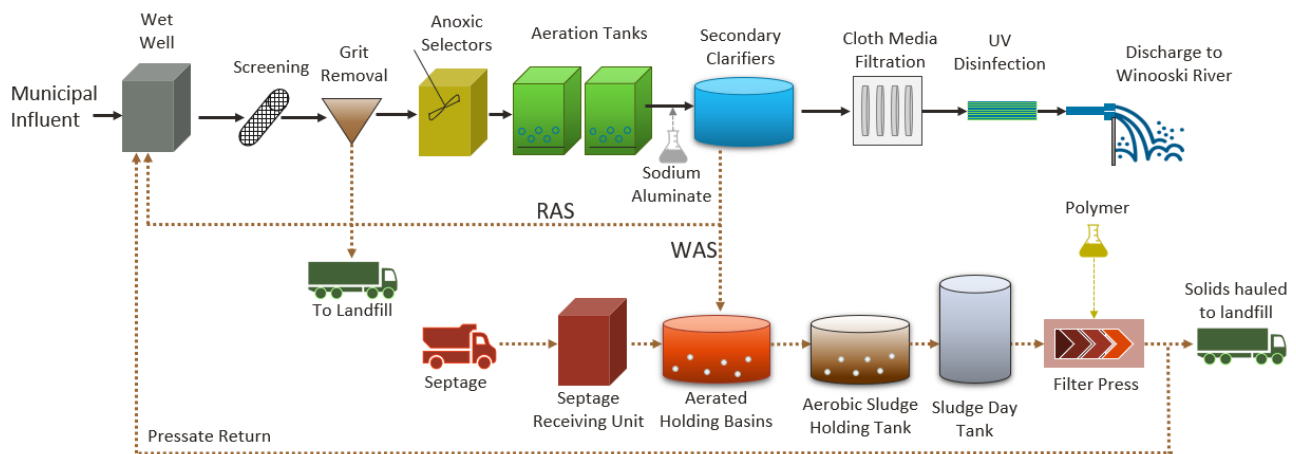
Figure 1-1. Process Flow Diagram

The Richmond Wastewater Treatment Facility (WWTF) operates under NPDES Permit No. 3-1173 effective December 21, 2020. The Richmond Wastewater Treatment Facility is a 0.222 MGD activated sludge treatment facility that incorporates the use of an anoxic selector. In general, the treatment processes at the facility involve the use of screening, grit removal, anoxic selectors, aeration basins, secondary clarification, filtration, and disinfection. The solids train includes septage receiving, aerated sludge holding, and dewatering. A process flow diagram is located below in Figure 1-1.

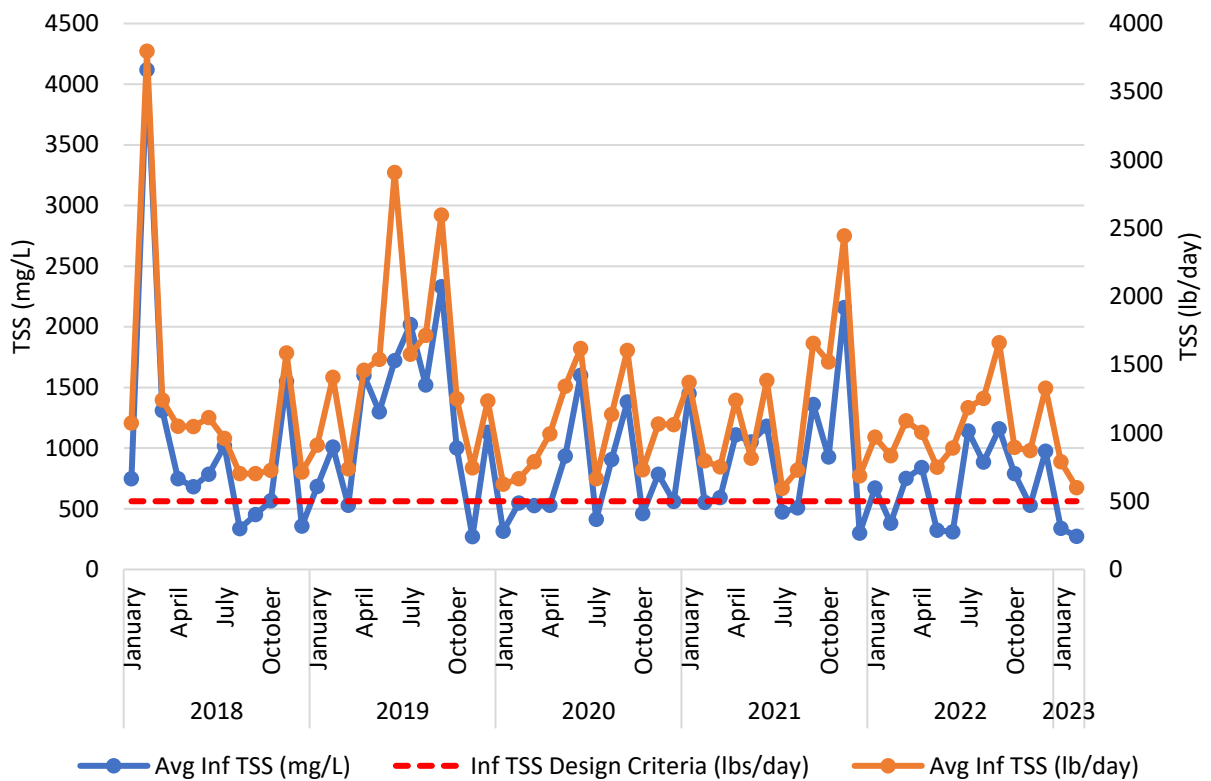
**Figure 2-4 Historical Influent TSS Data**

Influent TSS concentrations from January 2018 to February 2023 ranged from 271 to 4,120 mg/L with an average of 932 mg/L, which is well above the 2003 influent TSS loading design criteria concentration of 272.5 mg/L. The variability in TSS concentration may be impacted by the volume of septage received and subsequently dewatered when the grab sample is collected, however it is suspected that there may be significant industrial users on the collection system that are contributing to the high TSS concentration seen in the influent samples. The average TSS load was 680.5 lb/day TSS which is 1.36 times the 2003 design influent TSS load. Note, the influent TSS loading design criteria does not include side streams included in the influent sampling (RAS, pressate).

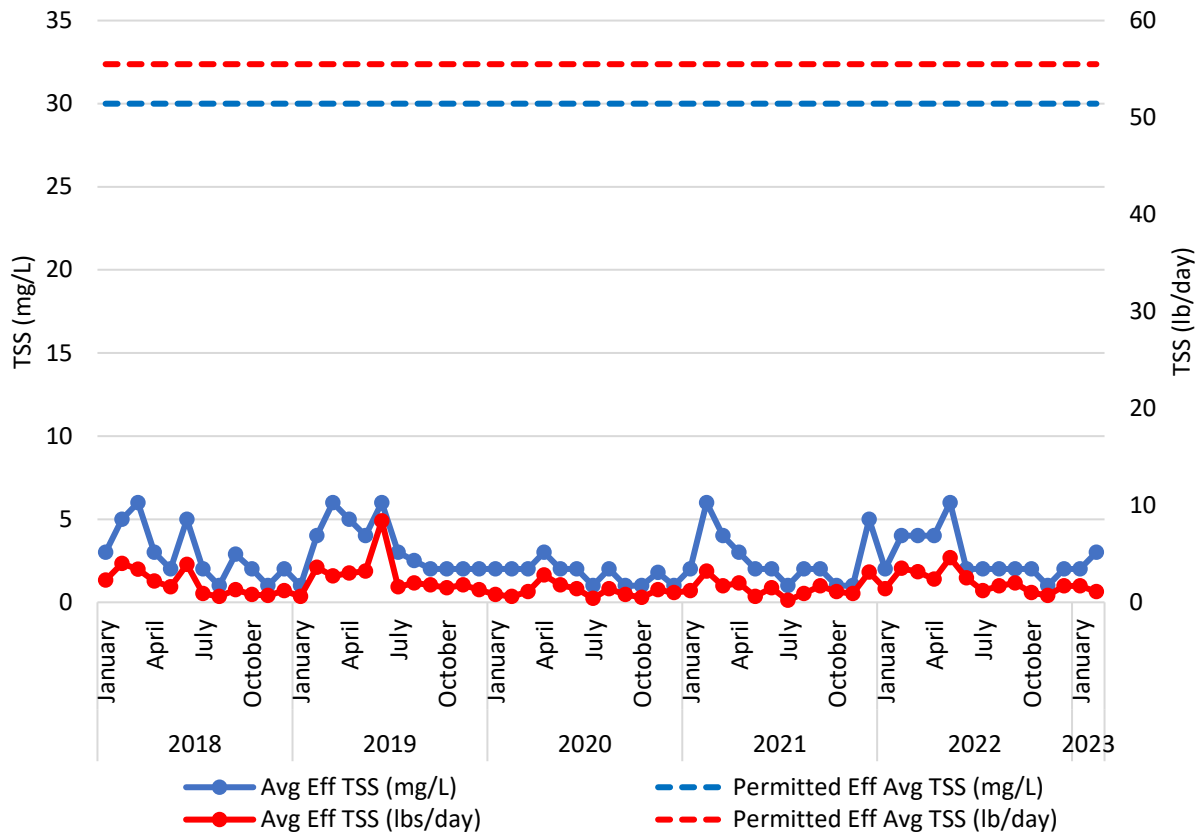
Figure 2-5 Historical Effluent TSS Data

The Richmond WWTF has been performing well and removes between 98.15-99.95+% of TSS. From January 2018 to February 2023, the effluent TSS concentration ranged from 1.00 to 6.00 mg/L, with an average of 2.65 mg/L, which is well below the permitted monthly effluent TSS concentration of 30 mg/L. The average effluent TSS load from January 2018 to February 2023 was 1.86 lb/day which is also well below the permitted monthly effluent TSS load of 55.5 lb/day. Data indicates the WWTF has the capacity to treat the current TSS load.

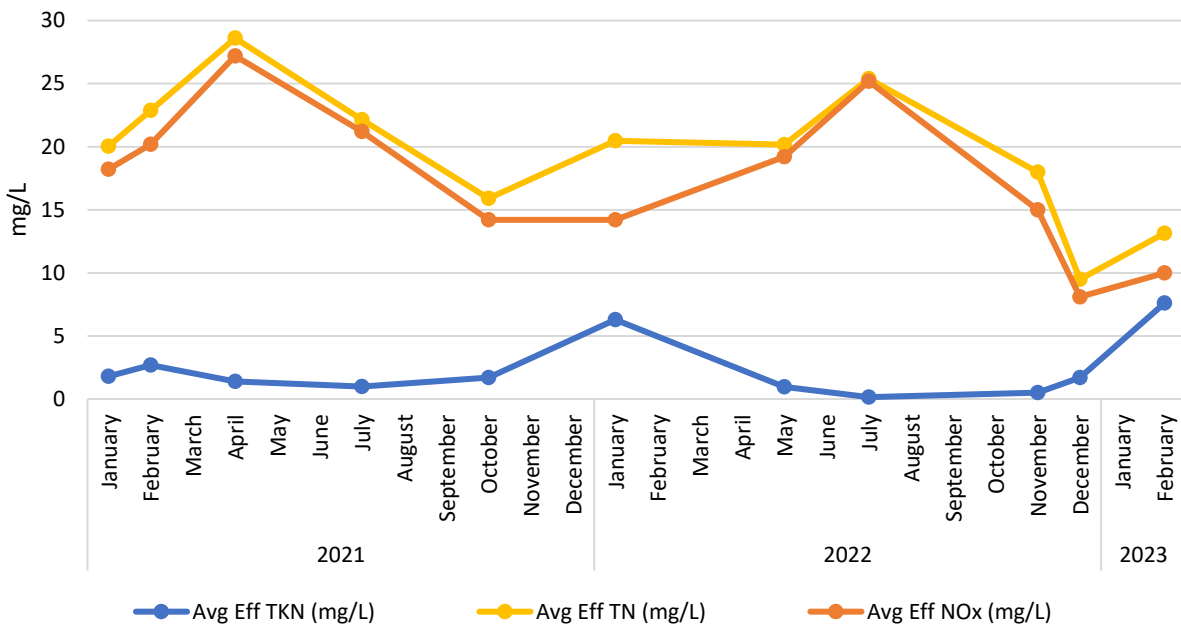
**Figure 2-6 Historical Effluent Nitrogen**

Richmond WWTF’s permit requires quarterly reporting of effluent total nitrogen (TN), total Kjeldahl nitrogen (TKN), and nitrite and nitrate (NOx). In addition to these monitoring requirements, effluent ammonia is tested periodically. Data available for nitrogenous species monitoring is from January 2021 through February 2023.

Effluent TN concentrations ranged from 9.49 to 28.60 mg/L with an average of 19.66 mg/L indicating that the system has some potential for denitrification. Effluent NOx concentrations ranged from 8.10 to 27.20 mg/L with an average of 17.52 mg/L. Effluent TKN concentrations ranged from 0.15 to 7.60 mg/L with an average of 2.35 mg/L indicating the system maintains effective nitrification.

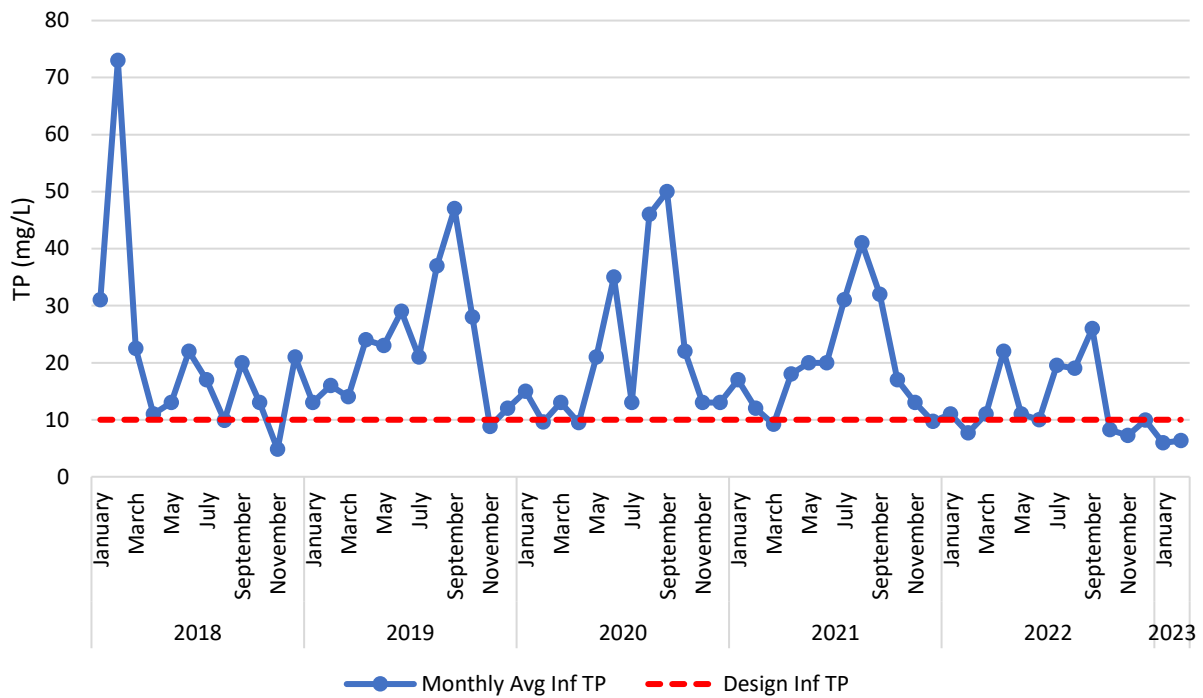
**Figure 2-7 Historical Influent Phosphorus Data**

Influent total phosphorus (TP) concentrations from January 2018 to February 2023 ranged from 4.8 to 73 mg/L with an average of 19.45 mg/L. Pressate total phosphorus concentrations can be high strength, which can contribute to the total phosphorus concentration in the wet well if samples were collected on days when the press was running, however it is suspected that there may be significant industrial users on the collection system that are contributing to high TP concentrations seen in the influent samples. The historical influent TP concentration of 19.45 mg/L exceeds the existing influent TP design criteria is 10 mg/L.

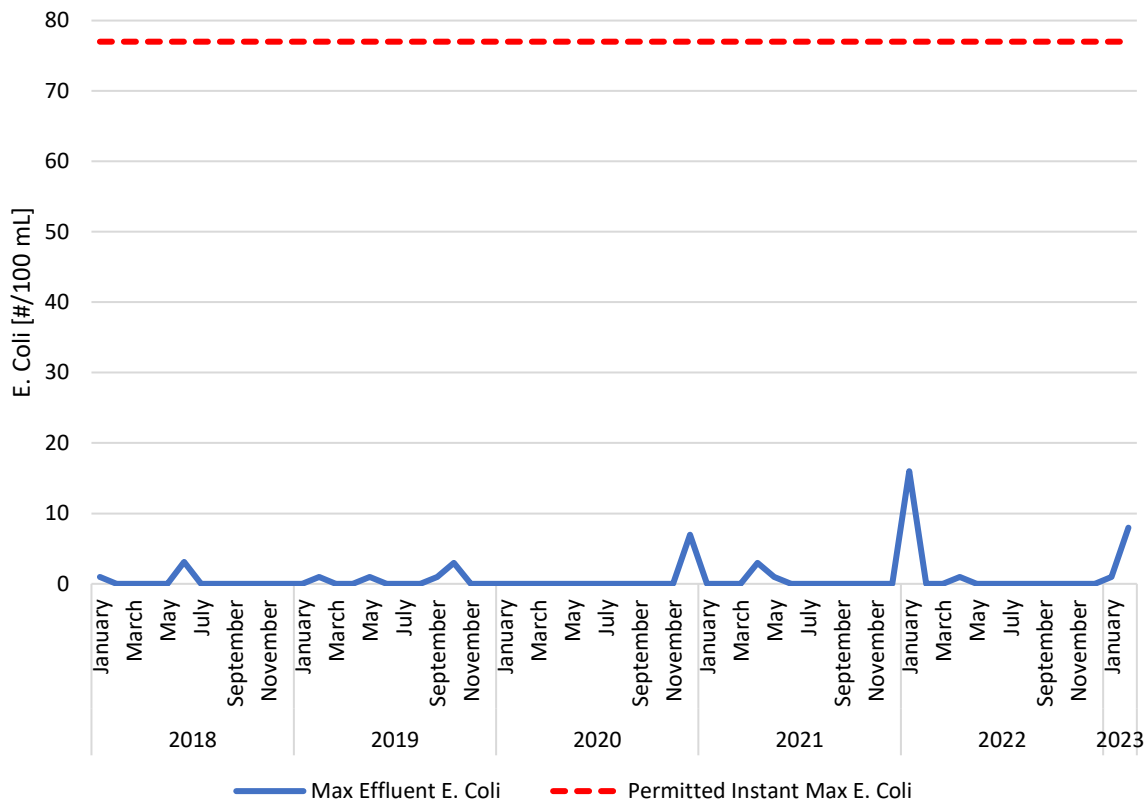
Figure 2-9 Effluent E. Coli

The Richmond WWTF had no exceedances of the permitted instantaneous maximum e. coli limit of 77 counts per 100 mL as displayed in Figure 2-9. From January 2018 to February 2023, maximum effluent e. coli ranged from <0.10 to 16 counts per 100 mL.

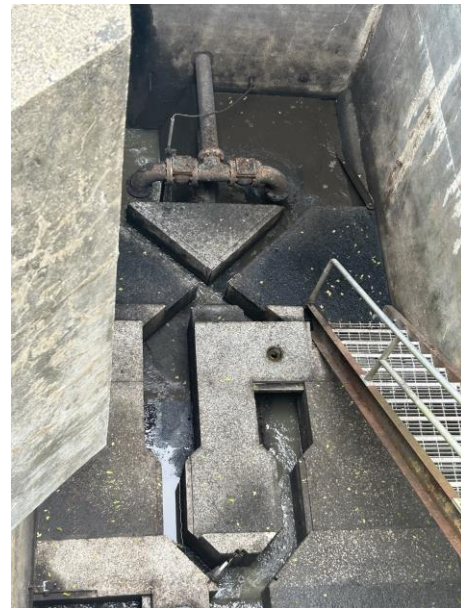
Figure 2-11 Influent Wet Well

Raw wastewater from the collection system enters the Richmond WWTF at the influent wet well, located next to the Operations Building, where it is mixed with RAS, pressate, and filter backwash. The roof drains for the Operations Building also drain to the wet well. The wet well is divided into two cells and the operators indicated that only one side of the wet well is being used due to problems with rags, bricks and stones that make their way through the collection system. A level transmitter in the wet well controls the pumping speed of the influent pumps which are located inside the Operations Building basement. The concrete of the wet well structure was not inspected during the field visit and the condition of the structure is unknown.

- Influent grinder has been removed.
- Hatch not available for pump removal
- Roof drains are connected to the wet well.
- The concrete of wet well structure was not evaluated. It is recommended that a concrete assessment be conducted.
- Additional flow data is required to select influent pump replacements.

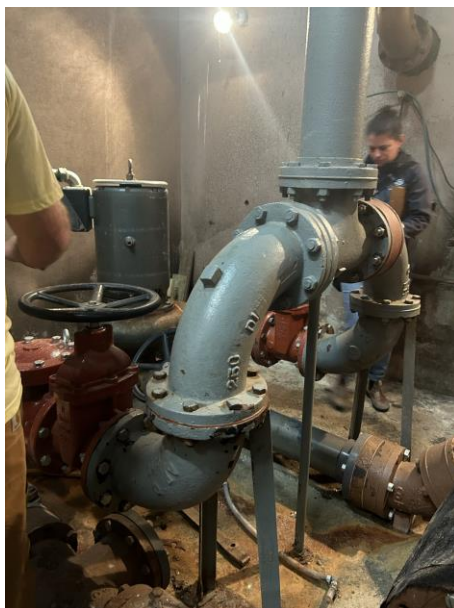
Figure 2-12 Influent Pumping System

The influent pumping system consists of two influent pumps located in the lower level of the Operations Building. Influent pumping transfers wastewater from the wet well to the

Headworks Building where it flows by gravity through the remaining treatment process. An in-line grinder that was part of the original design has been disconnected. There is a magnetic flow meter on the pump discharge header to measure flows. The operators indicated that they do not believe it accurately measures flow. Influent Pump #1 is driven by a 40 HP motor and was installed in 2023 as a temporary replacement for the existing Influent Pump #1 which had failed. Influent Pump #2 is a vertical mounted, flooded suction centrifugal pump driven by a 25 HP motor. Currently, Influent Pump #2 is not in use as it has a leaking seal and sprays the room when operating. The operators indicated that they have replaced both pump discharge check valves recently.

Access to the pumps is problematic with no overhead hatch to hoist pumps through. The operators noted that they have to bring equipment down three flights of stairs if maintenance is required.

The facility experiences significant large solids carried to the wet well through to the influent pumps including large rocks/bricks, large pieces of wood, rag balls greater in diameter than the pumps can pass. These materials often lead to pump clogging, damage to the pump impellers and emergency maintenance of the pumps. The operators indicated that the Town cleaned out the influent collection sewer up to Bridge Street in 2022 to try to mitigate the amount of debris that enters the wet well and pump suction.

- Influent Pump #1 failed and was replaced with a used emergency pump in 2023. The pump is old and only a temporary solution.
- Influent Pump #2 is original to facility. The pump is in poor condition with a leaking seal. This pump is at risk of imminent failure leaving the facility with no pumping redundancy.
- Influent pumps routinely experience problems such as ragging and bricks/rocks causing damage.

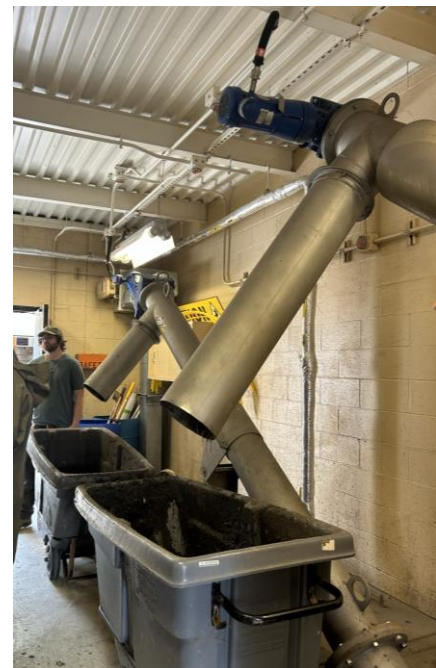
**Figure 2-13 Grit Removal**

Screening and grit removal consists of a package unit located in the Headworks Building. Screening and grit removal is accomplished using a combination unit that uses a rotary-type mechanical fine screen and an aerated grit removal chamber with a grit dewatering screw to screen inorganics and remove grit from the process stream. Wastewater is pumped to the unit via the influent pumps. Wastewater flows into the unit’s screening basket where solids are retained. Screened material is removed from the screening basket and is spray washed to return organics to the process stream. The screened material is then transported up the unit’s central screw conveyor, compacted, dewatered, and discharged to storage containers. The wastewater that flows through the screening basket passes directly into a grit removal chamber. Grit settles to the floor of the grit chamber and a grit transport screw moves the settled grit to a lateral sump. A grit dewatering screw transports the settled grit out of the lateral sump and dewateres the grit before it is discharged into storage containers. Air for the aerated grit chamber is fed from a new blower located in the one-room structure located over the aerobic sludge digester tank. Flow

from the grit chamber is discharged directly into the first anoxic selector. The headworks can be bypassed by pumping directly to the aeration basins.

The rotary-type fine screen shaft has significant wear and while the screen does catch some rags, the operators indicate that it doesn't work well. The grit auger has significant wear and has been patched over the years. The operators indicated that grit that is captured is not being properly dewatered resulting in a product with a mud-like consistency. The operators have also noted a leak in the stainless steel package unit tank, which they have been patching regularly.

- The stainless tank of the package screening and grit unit is leaking.
- The effectiveness of screening and grit removal is poor.
- Grit auger is worn and has been repeatably patched.
- Grit is not properly dewatering, creating a mud-like consistency.
- Gas detection in the building is inoperable.
- Existing ventilation may not provide adequate air changes.
- No drain in the sump where package unit sits. Operators must use a trash pump to drain if level gets too high.

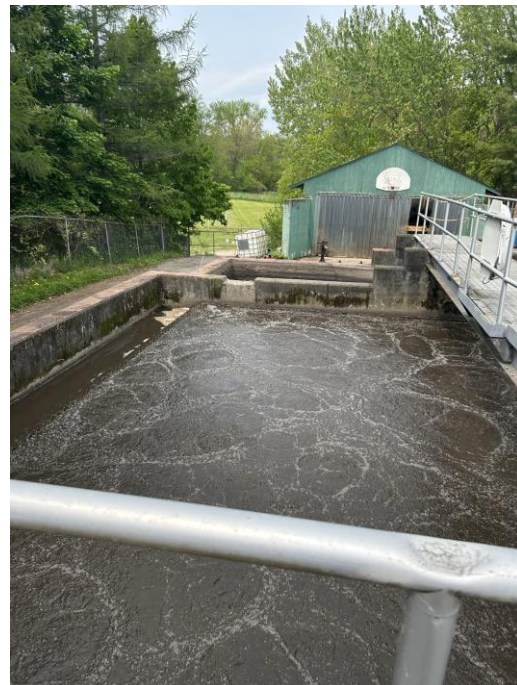
**Figure 2-14 Biological Aeration Tank**

Flow from the third anoxic selector is designed to split between two parallel aeration tanks, each having a volume of 150,000 gallons. Typical operation consists of one aeration tank in operation at a time. The aeration tanks have a fine bubble diffused air system and are fed air from two (2) 25 HP positive displacement blowers, each with a capacity of 450 scfm, located in the Process Building upper level. A single dissolved oxygen (D.O.) probe is provided but is not connected to SCADA for blower operation. The operators indicated they would like one D.O. probe for each tank. The outdoor intake for the aeration blowers has been disconnected due to noise complaints, and air for the blowers is drawn from the septage holding tank in the Operations Building Garage. This air has significant hydrogen sulfide concentration for the air space above a non-aerated sludge holding tank. Blower control is cycled on/off from SCADA; however, D.O. concentration in the

aerated basin is not being used to inform the aeration schedule.

The aeration tanks are original to the Richmond WWTF and were constructed in 1972. The concrete of the tank structures was not evaluated during the site visit. The diffusers were not inspected during the site visit, however a uniform bubble pattern in the operating tank suggests that the diffusers are functioning as intended. The operators noted that Aeration Tank #1 was drained and cleaned out recently, however, Aeration Tank #2 has not been cleaned since the upgrade. The operators indicated that it is difficult to balance air in the air header between the tanks using manually operated butterfly valves and would like to see dedicated air lines from each blower to each aeration tank.

- Only mixers in anoxic selectors #2 and #3 are operable, and only one mixer has an explosion-proof motor.
- Aeration Tank #2 has not been cleaned out since the 2005 upgrade.
- Blowers cycle on/off from SCADA but are not controlled by the D.O. probe in the active aeration basin. New D.O. probes needed.
- Blower intake is from a sealed aerated solids holding tank and shows significant signs of corrosion in the garage, outdoor air intake was disconnected due to noise complaints.
- Air balance to the aeration tanks is challenging due to manually operated butterfly valves.
- The concrete tank structures of the anoxic tanks nor aeration tanks were not evaluated. It is recommended that a concrete assessment be conducted.
- Data on mixed liquor suspended solids (MLSS) is not collected at the facility.

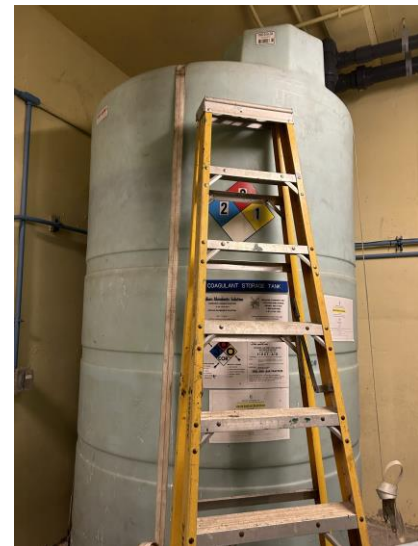
**Figure 2-15 Sodium Aluminate Storage**

There is one (1) 1,500 gallon sodium aluminate storage tank and two (2) positive displacement diaphragm type feed pumps located in the basement of the Process Building, though only one (1) feed pump is in use and the other is in storage. Secondary containment is provided in the form of a 3-ft high concrete retaining wall around the coagulant storage tank. An emergency eyewash station is located next to the coagulant storage tank; however, there is no emergency shower. The original design allowed for coagulant to be pumped to the aeration tank effluent channel and/or into both clarifier effluent pipes prior to the filter units. Typical operation is consistently dripping sodium aluminate through a 2" line into the aeration tank effluent channel and is based on an operator feed rate that is determined by effluent pH levels.

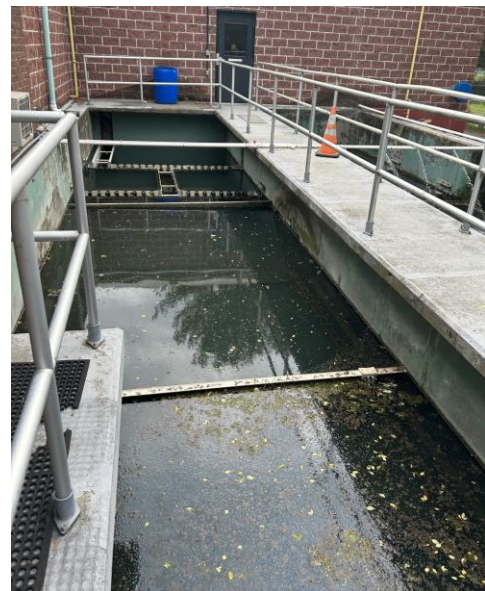
**Figure 2-16 Secondary Clarifier**

The operators noted that they recently had drained both clarifiers, cleaned, and inspected the flight scrapers and both are in good working condition. Operators also noted that there was no grease skimmer on the clarifiers and that grease routinely passes through to the filters causing fouling of the cloth media.

- Clarifiers are in good working condition.
- Concrete tank structures were not evaluated. It is recommended that a concrete assessment be conducted.
- The surface overflow rate @ PHF meets the TR-16 design standard, assuming MLSS = 3,000 mg/L. If MLSS is greater than 3,000 mg/L, then the SOR standard may be exceeded.
- Lack of MLSS data does not allow for accurate solids loading rate analysis on the secondary clarifiers.

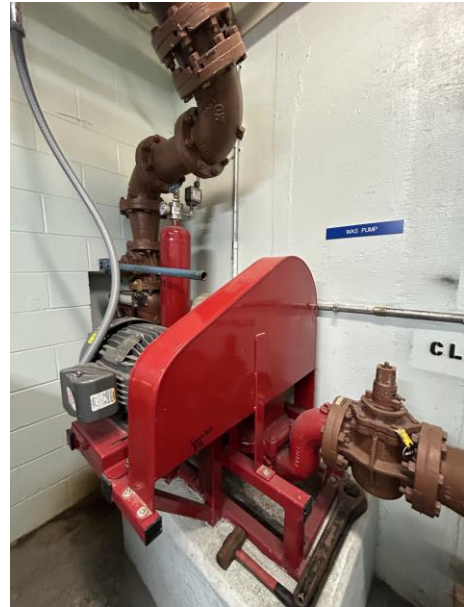
Figure 2-17 WAS Pump

There is one (1) waste activated sludge (WAS) pump located in the Pump Room in the lower level of the Operations Building. The WAS pump is a 7.5 HP Penn Valley Pump double disc, positive displacement pump rated for 150 gpm at 18 ft TDH. The WAS pump moves sludge to the aerated holding basins. The original design also allowed for the WAS to be pumped to the Aerobic Sludge Holding Tank. Operators indicated that many of the valves on the discharge piping are frozen, although they are systematically rebuilding them one at a time. WAS is wasted two (2) times per day for 1-hour intervals and is controlled by a timer. Operators indicate that the pump model is obsolete, and it is hard to get parts.

- The WAS pump is obsolete and parts are hard to obtain.
- The RAS pinch valve and flow meter operate well, however should be inspected for wear.
- There is only one (1) WAS pump with no redundancy provided.
- Multiple WAS plug valves are frozen.

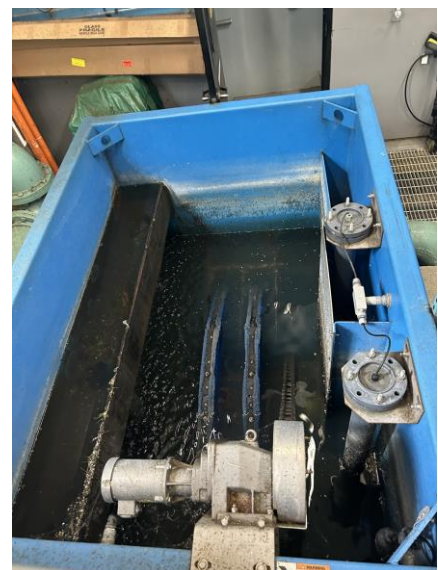
**Figure 2-18 Filtration Tank**

Flow entering the filtration tank passes through the cloth membrane by gravity. Filtered water then enters the internal portion of the disk where it flows through the center-tube to an effluent box. Solids collected from the bottom of the tank are pumped via a 3 HP sludge removal pump to a drain line that drains back to the influent sewer. Filtered effluent flows by gravity via a 12" pipe to the UV disinfection system.

During the site visit, corrosion of the steel tanks was observed.

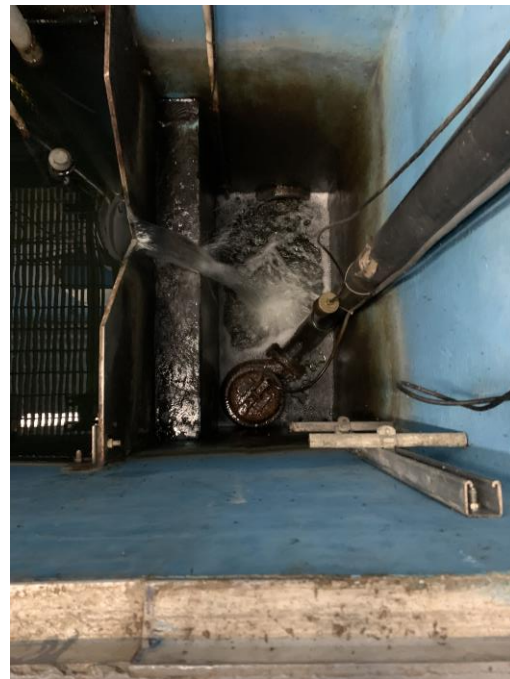
**Figure 2-20 Effluent Wet Well & V-Notch**

Flow leaving the UV disinfection system flows from the UV outlet transition box through a 12-inch pipe into the effluent wet well. Effluent flow measurement is achieved by the use of a 90° v-notch weir and an ultrasonic level detector in the wet well. The 90° v-notch weir can accurately measure up to 1.616 MGD with 1.0 feet of head above the bottom of the v-notch according to Isco Open Channel Flow Measurement Handbook, 3rd Edition. Historical operating data suggested that the open channel Sigma 980 effluent flow meter seems to max out at 0.66 MGD, which would indicate a calibration issue or a malfunctioning flow meter. To solve this issue, the effluent flow meter was corrected and recalibrated. Additional effluent flow data collection beginning in October 2023 will help inform design criteria.

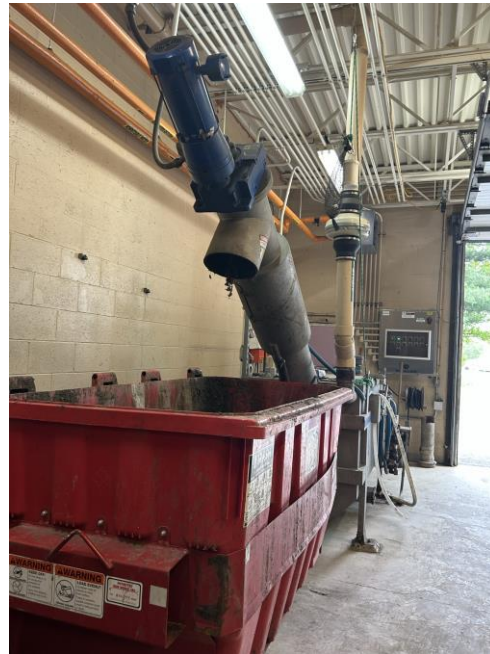
**Figure 2-21 Septage Receiving Unit**

The Richmond WWTF has the ability to accept up to 2,000,000 gallons of septage per year. Septage receiving facilities consist of a septage receiving unit located on the upper level of the Processing Building with two (2) aerated holding basins below. The septage receiving unit consists of a cylindrical bar screen complete with screen basket, rotating rake, cleaning comp, screw conveyor, dewatering screw, screenings press with drive unit mounted in a stainless-steel tank, tank spray wash system, motorized inlet valve, and liquid level sensing system. Septage haulers manually record the volumes discharged. The Town has indicated that they would prefer to have a flow meter on the discharge to allow for more accurate record keeping.

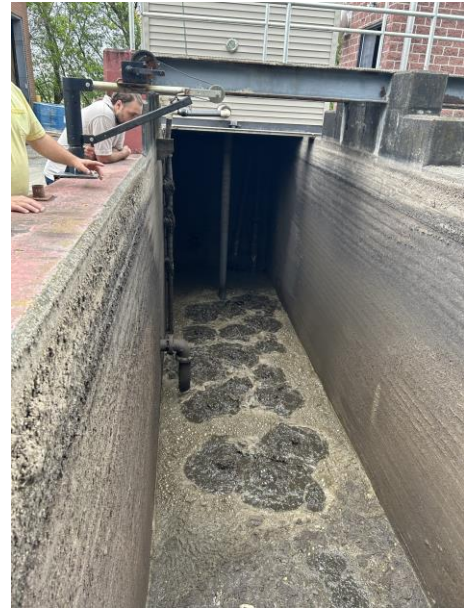
Figure 2-22 Aerobic Sludge Holding Tank

The aerobic sludge holding tank was not drained to evaluate the condition of the concrete tank, nor the existing diffusers. The operators noted that the tank needs to be cleaned as there is an accumulation of rocks, grit, and rags in the tank which are creating plugging issues with the downstream sludge transfer and feed pumps. The non-uniform bubble pattern observed on the surface of the tank contents during the evaluation indicates that some of the diffusers may be clogged and inoperable.

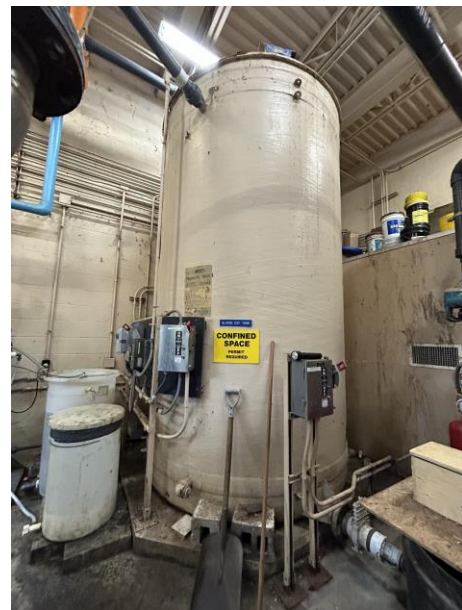
**Figure 2-23 Sludge Day Tank**

When the dewatering equipment is in operation, sludge is removed from the aerobic sludge holding tank using the sludge transfer pump located in the Dewatering Building which originally discharged through a sludge grinder to the sludge day tank, also located in the Dewatering Building. The sludge grinder has since been removed by the operators.

operators also noted that there is no way to remove the mixer from the day tank as there is no headroom above the tank for the long shaft.

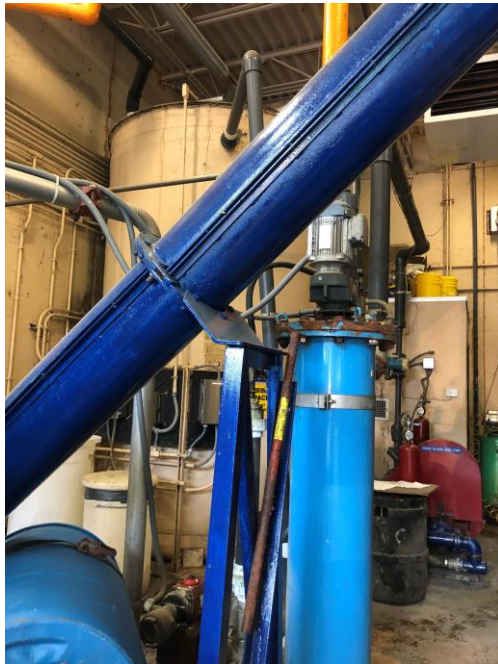
**Figure 2-26 Inclined Conveyor**

A conveyor system is used to transfer dewatered sludge cake from the rotary press to a roll-off container

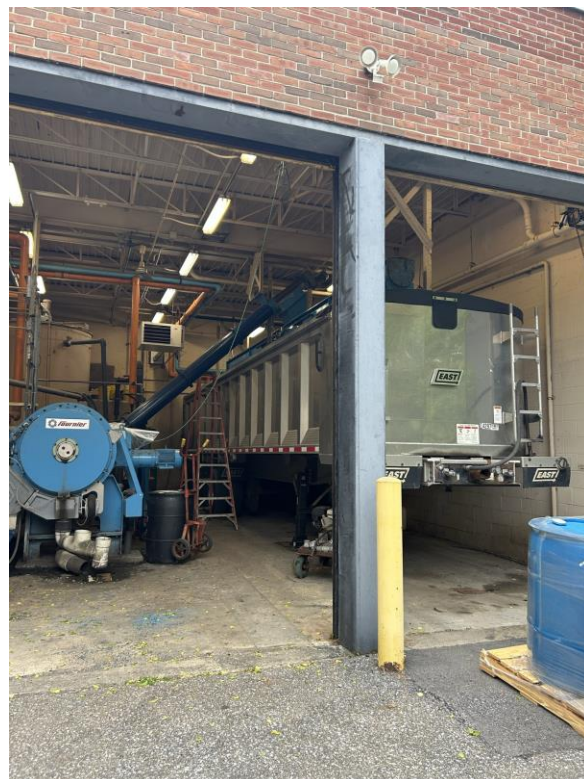
**Figure 2-27 Dewatering Building**

Additionally, the floor of the dewatering building does not have a rear floor drain, causing difficulties managing drainage from the sludge trailer. Operators expressed interest in a water meter on the water line to

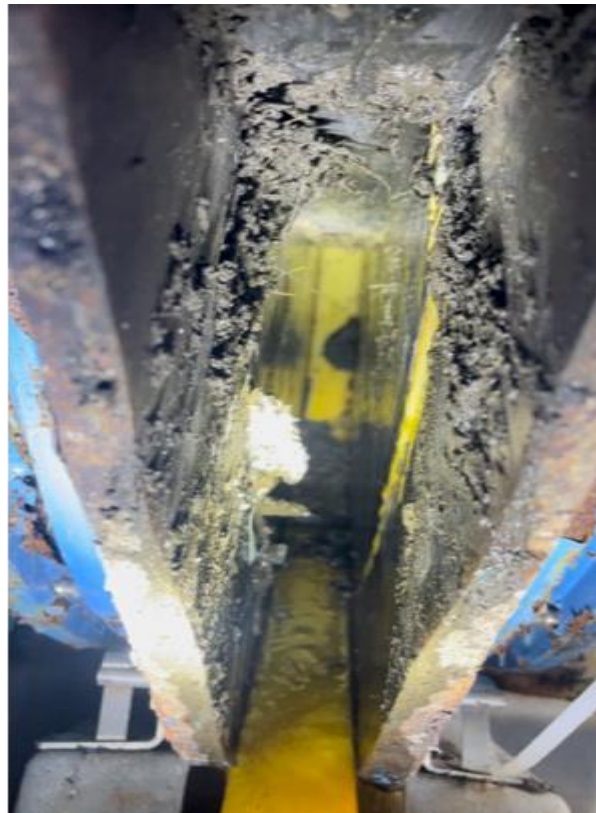
**Frames:** The frames on the channels were rusting and worn were the restrictor arms moved. You could see the yellow cover seal between the wheel and the frame starting to come through with trash.

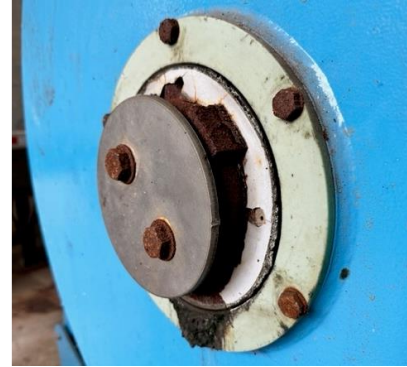
**Shaft:** The shaft of the press was in ok condition. The shaft only supports one channel on each side, so there was limited exposure to the atmosphere. There is some rust around on the end, however that should not effect the removal.

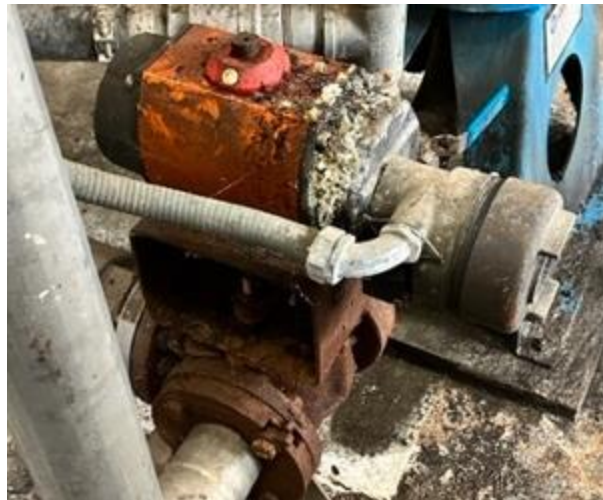
**Three-way valve:** The existing three-way valve does not work. It has been stuck in the dewatering position and does not turn. This causes problems with a proper startup. Sludge also leaks out of the supply tank, through the sludge pump and, because the valve is stuck in the dewatering position, into the channels.

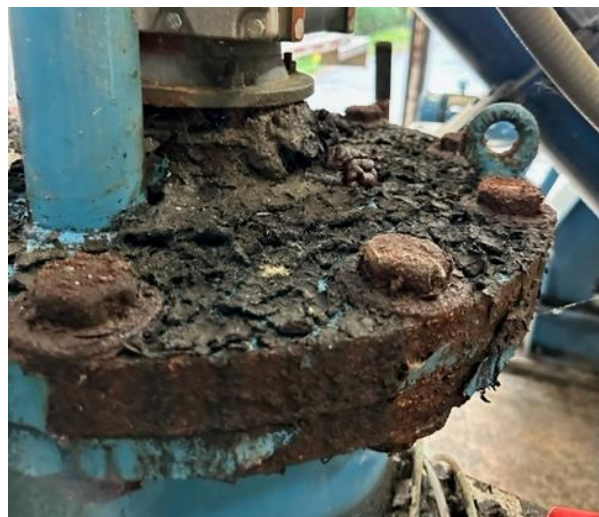
**Flocculator:** The flocculator seal shaft has been leaking for some time. It's hard to tell the extent of the damage.

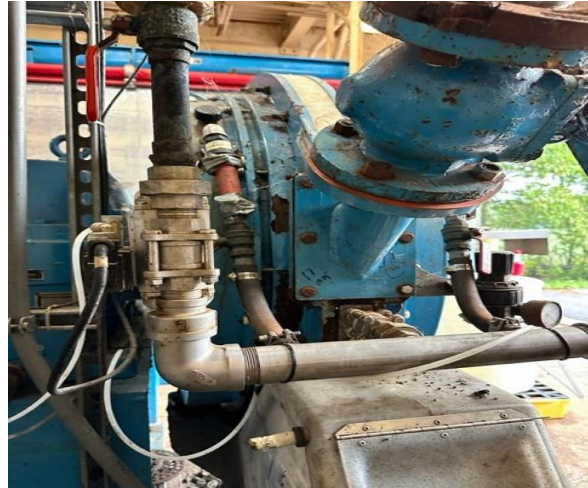
**Channel Wash Manifold:** The Festo valves on the channel wash manifold do not seem to work. The piping and spray bars are not in good condition.

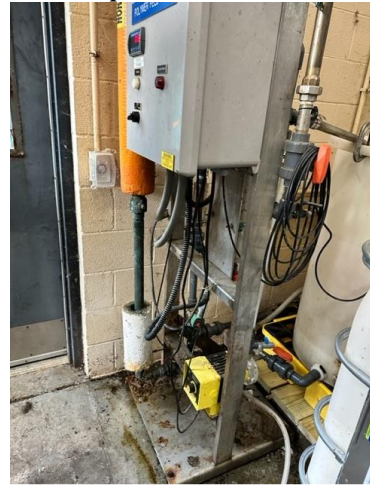
**Polymer System:** The polymer system does not have an indication of concentration. A batch of diluted polymer is sent to a 50-gallon tank. From there it is pumped to the floccuator at a ratio of the sludge flow.

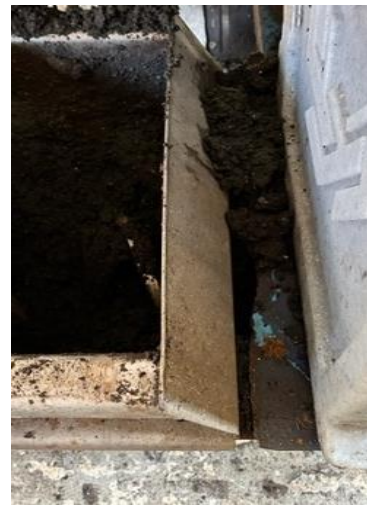
**Conveyor System:** The conveyor seems to be in good condition apart from a couple rusted out holes in the lower one. Also, on the inclined conveyor it is open at the top. The employees said this was from cake building up due to an unopened slide gate that has since been fixed.

3. Panel HMI – The installation of a new panel would make it easier for the operators to use the press. The current old program is outdated and not optimal.
4. Conveyor system – There are a couple holes that need to be patched or sections replaced.
