## **Richmond Town Center**

### **Proposed Project**

### **Concrete Blocking on East Wall Along Post Office Ramp**

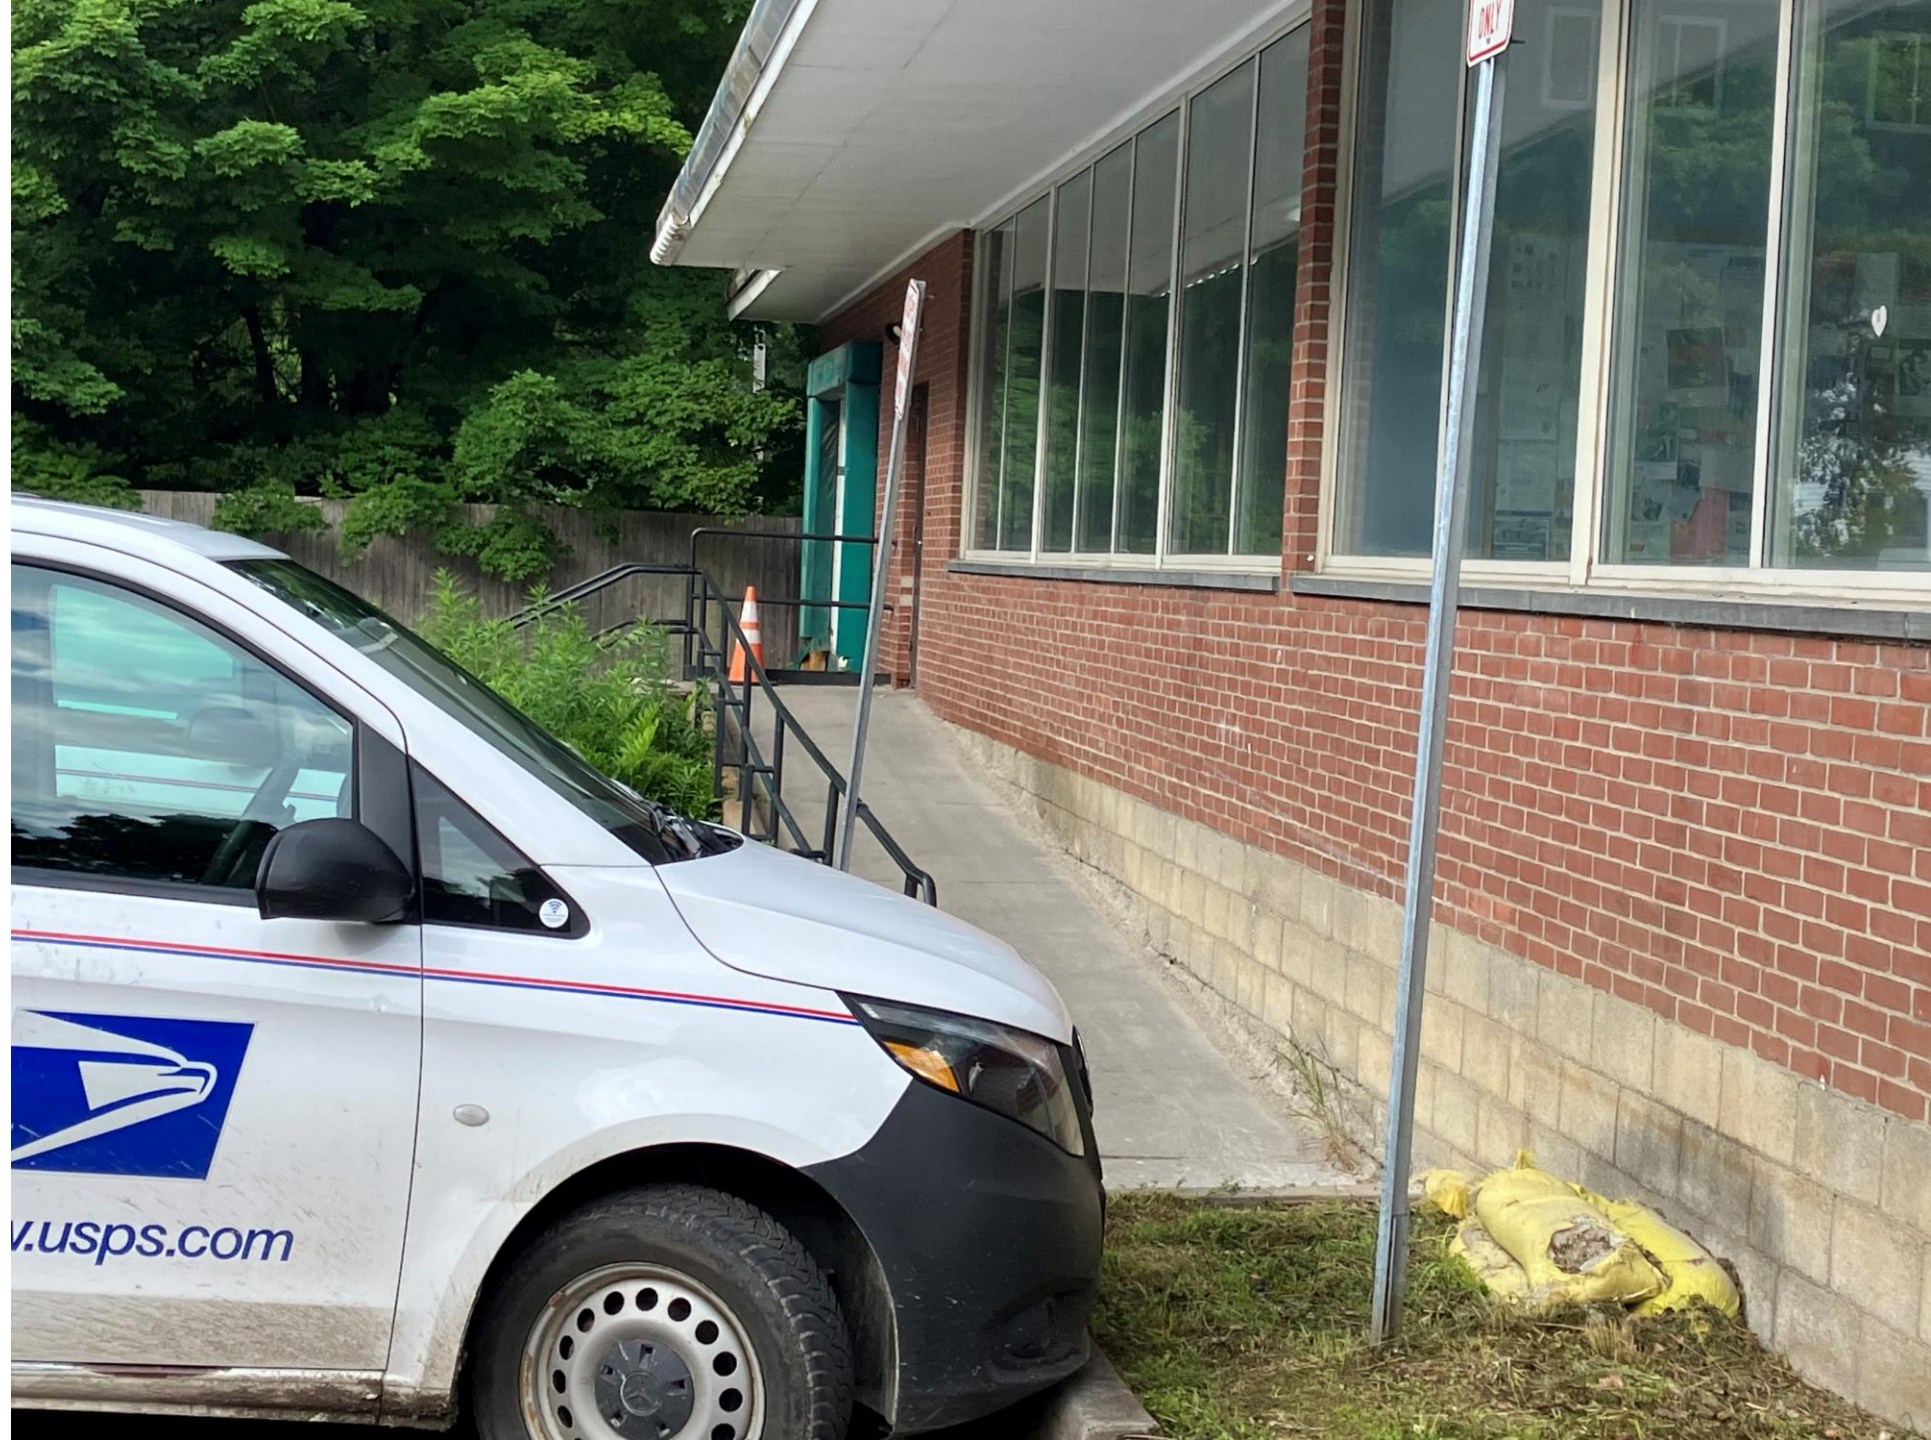
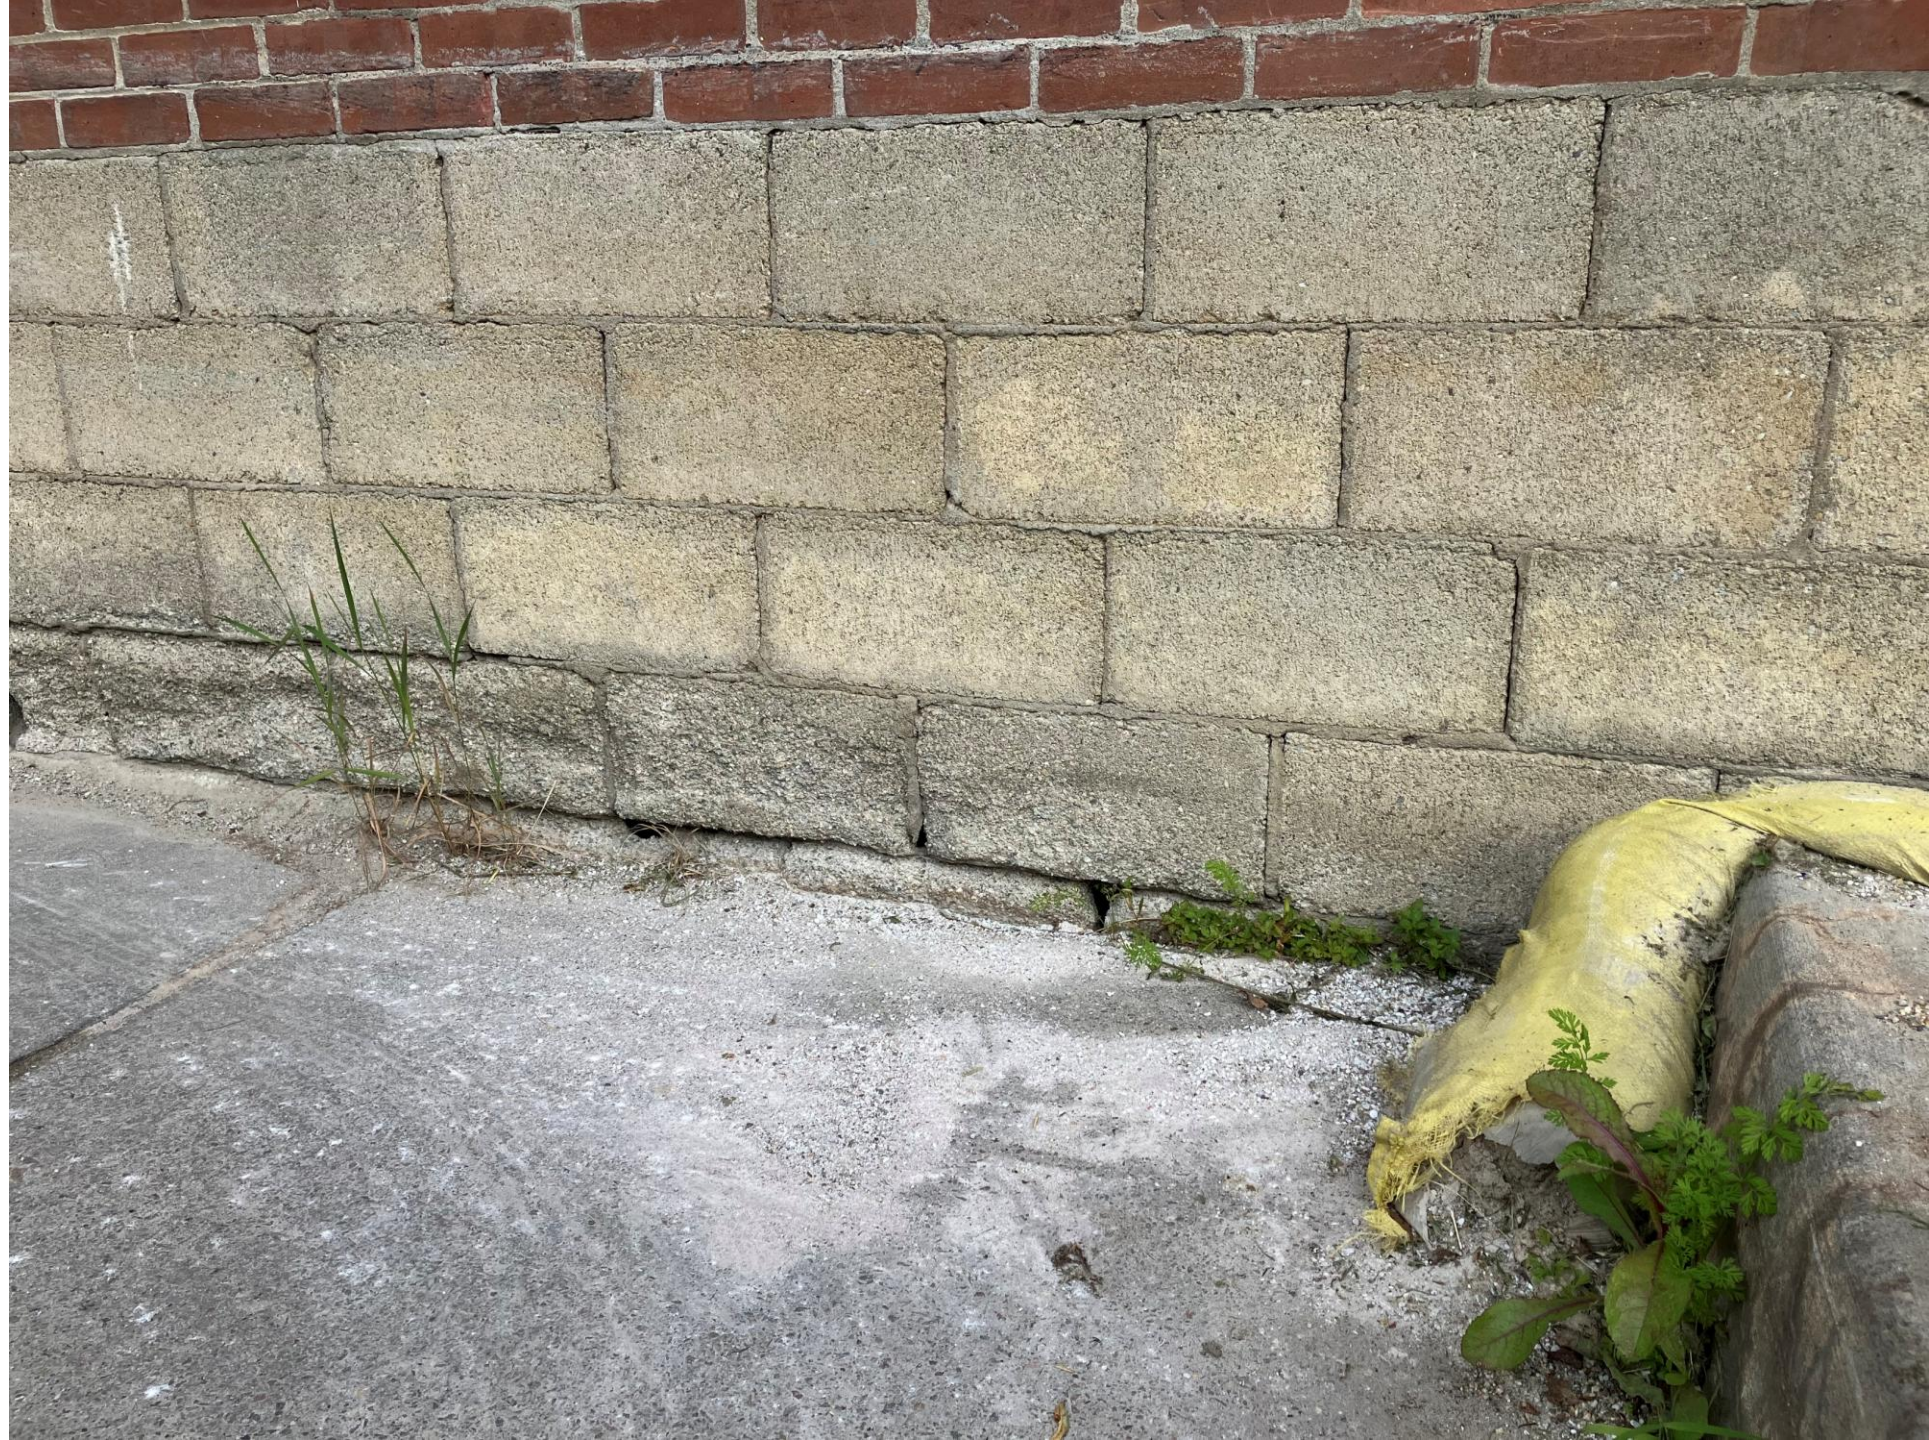
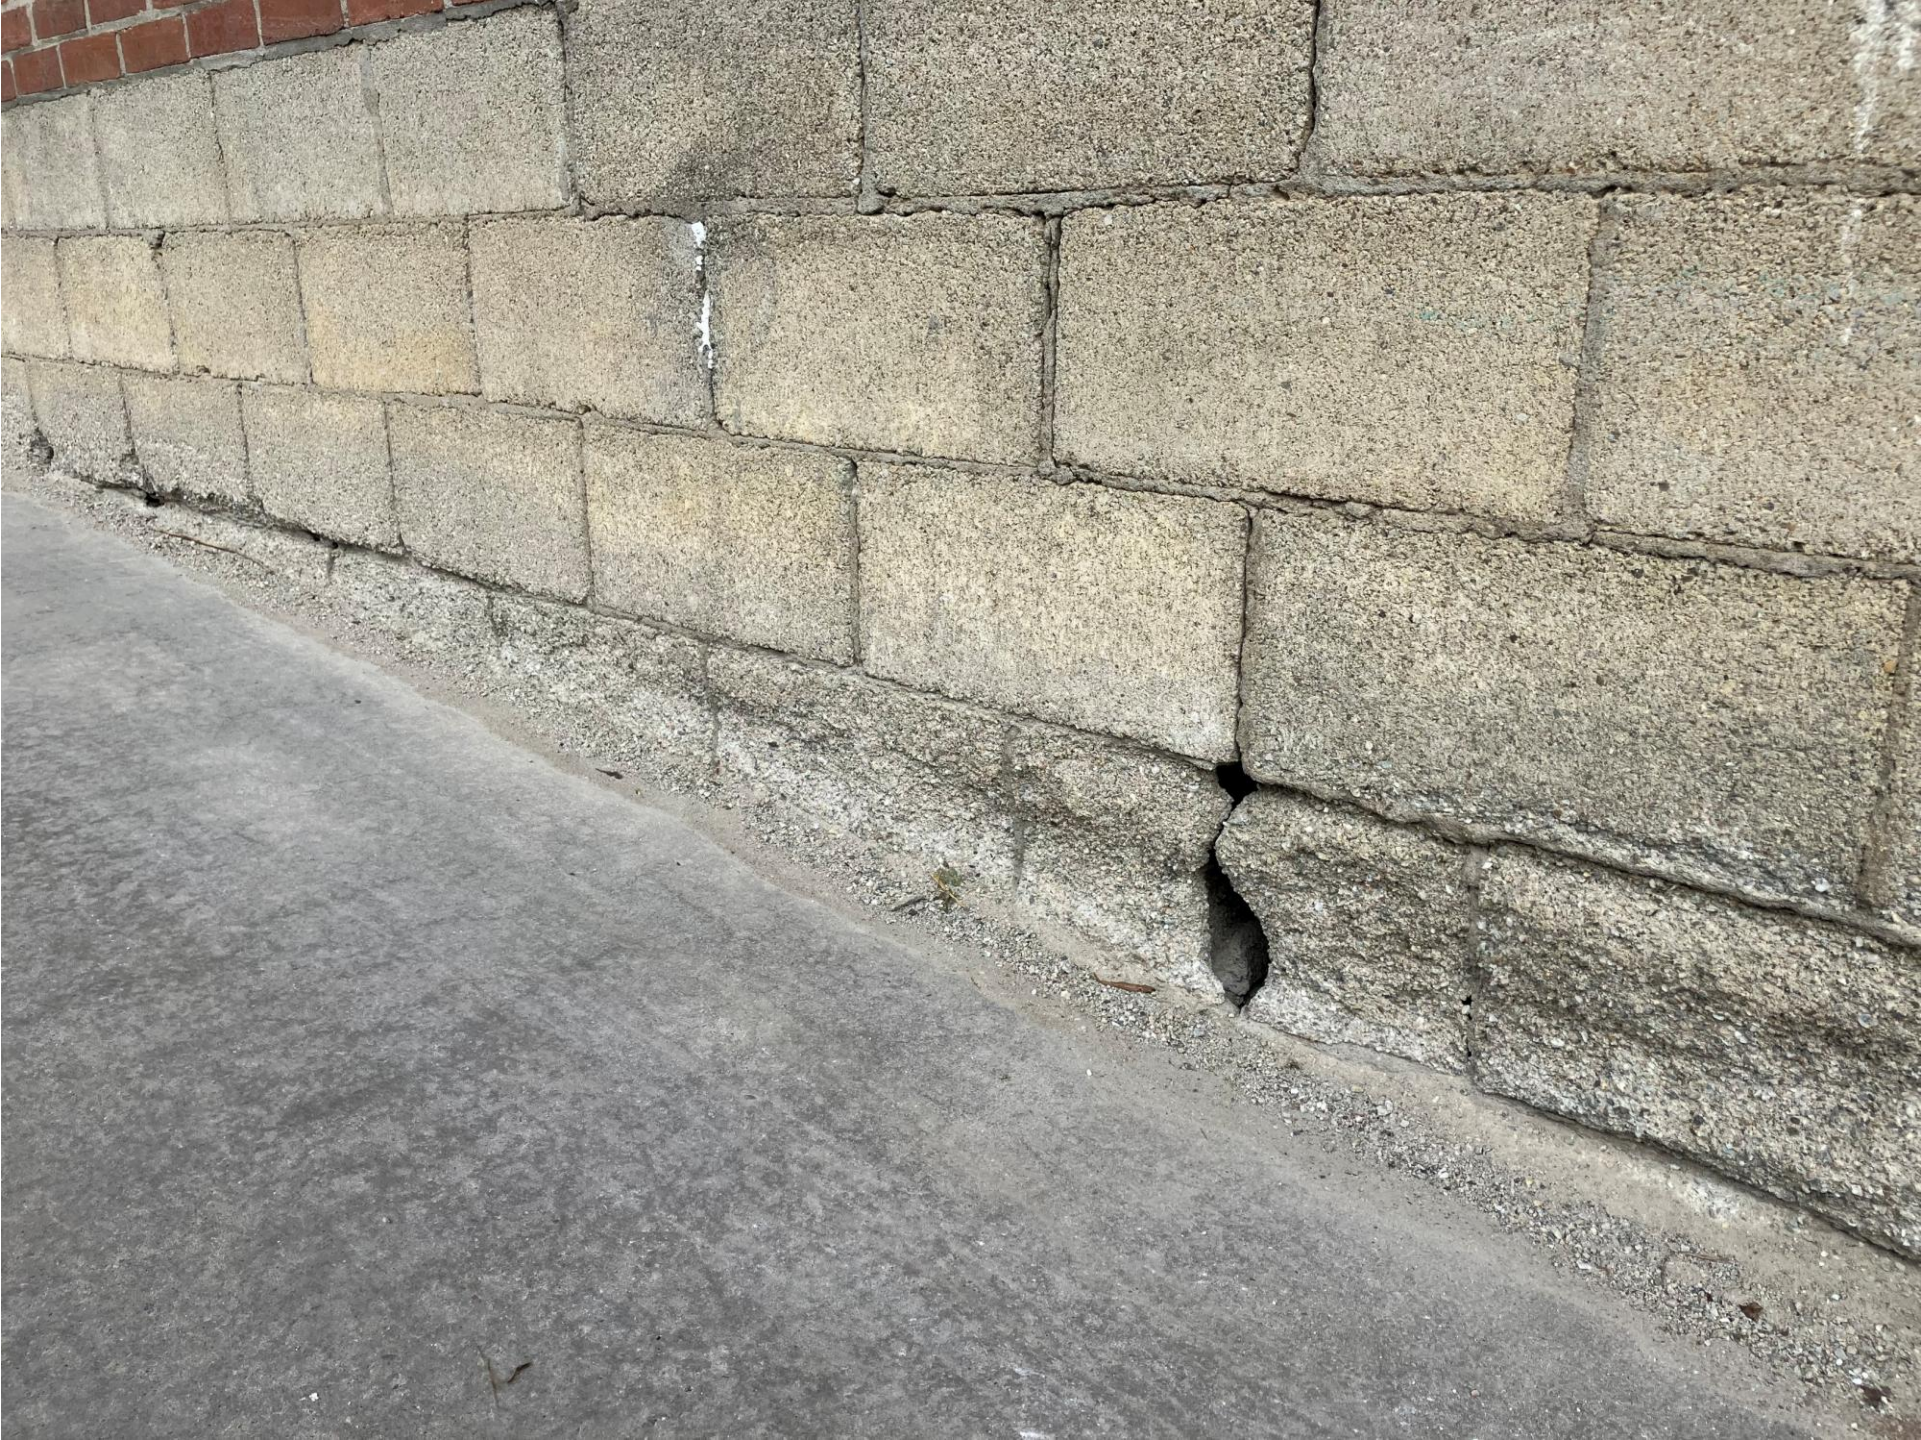
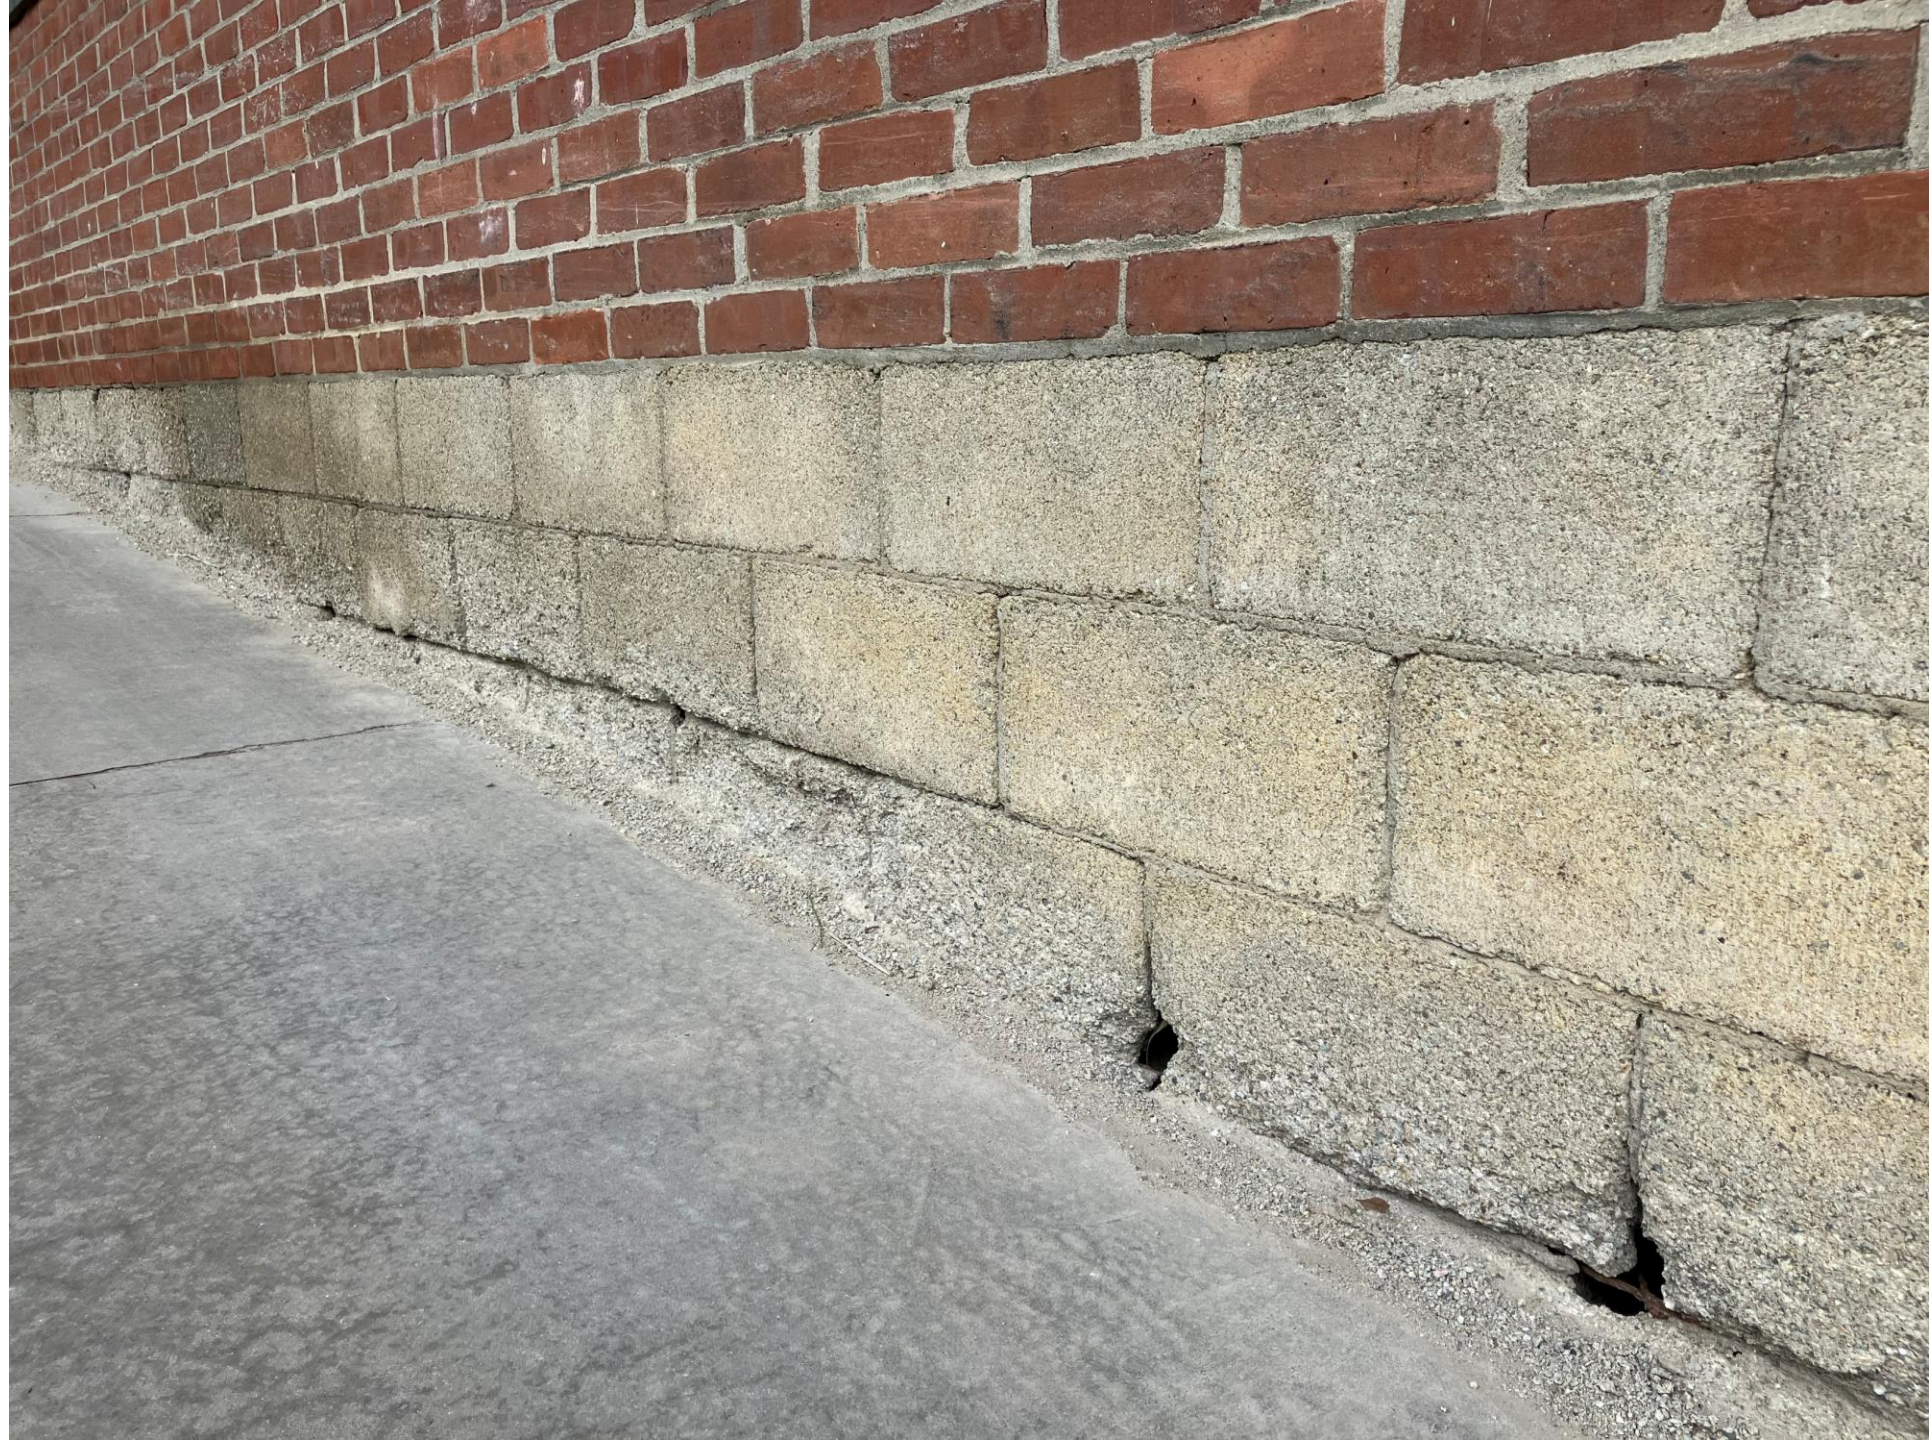
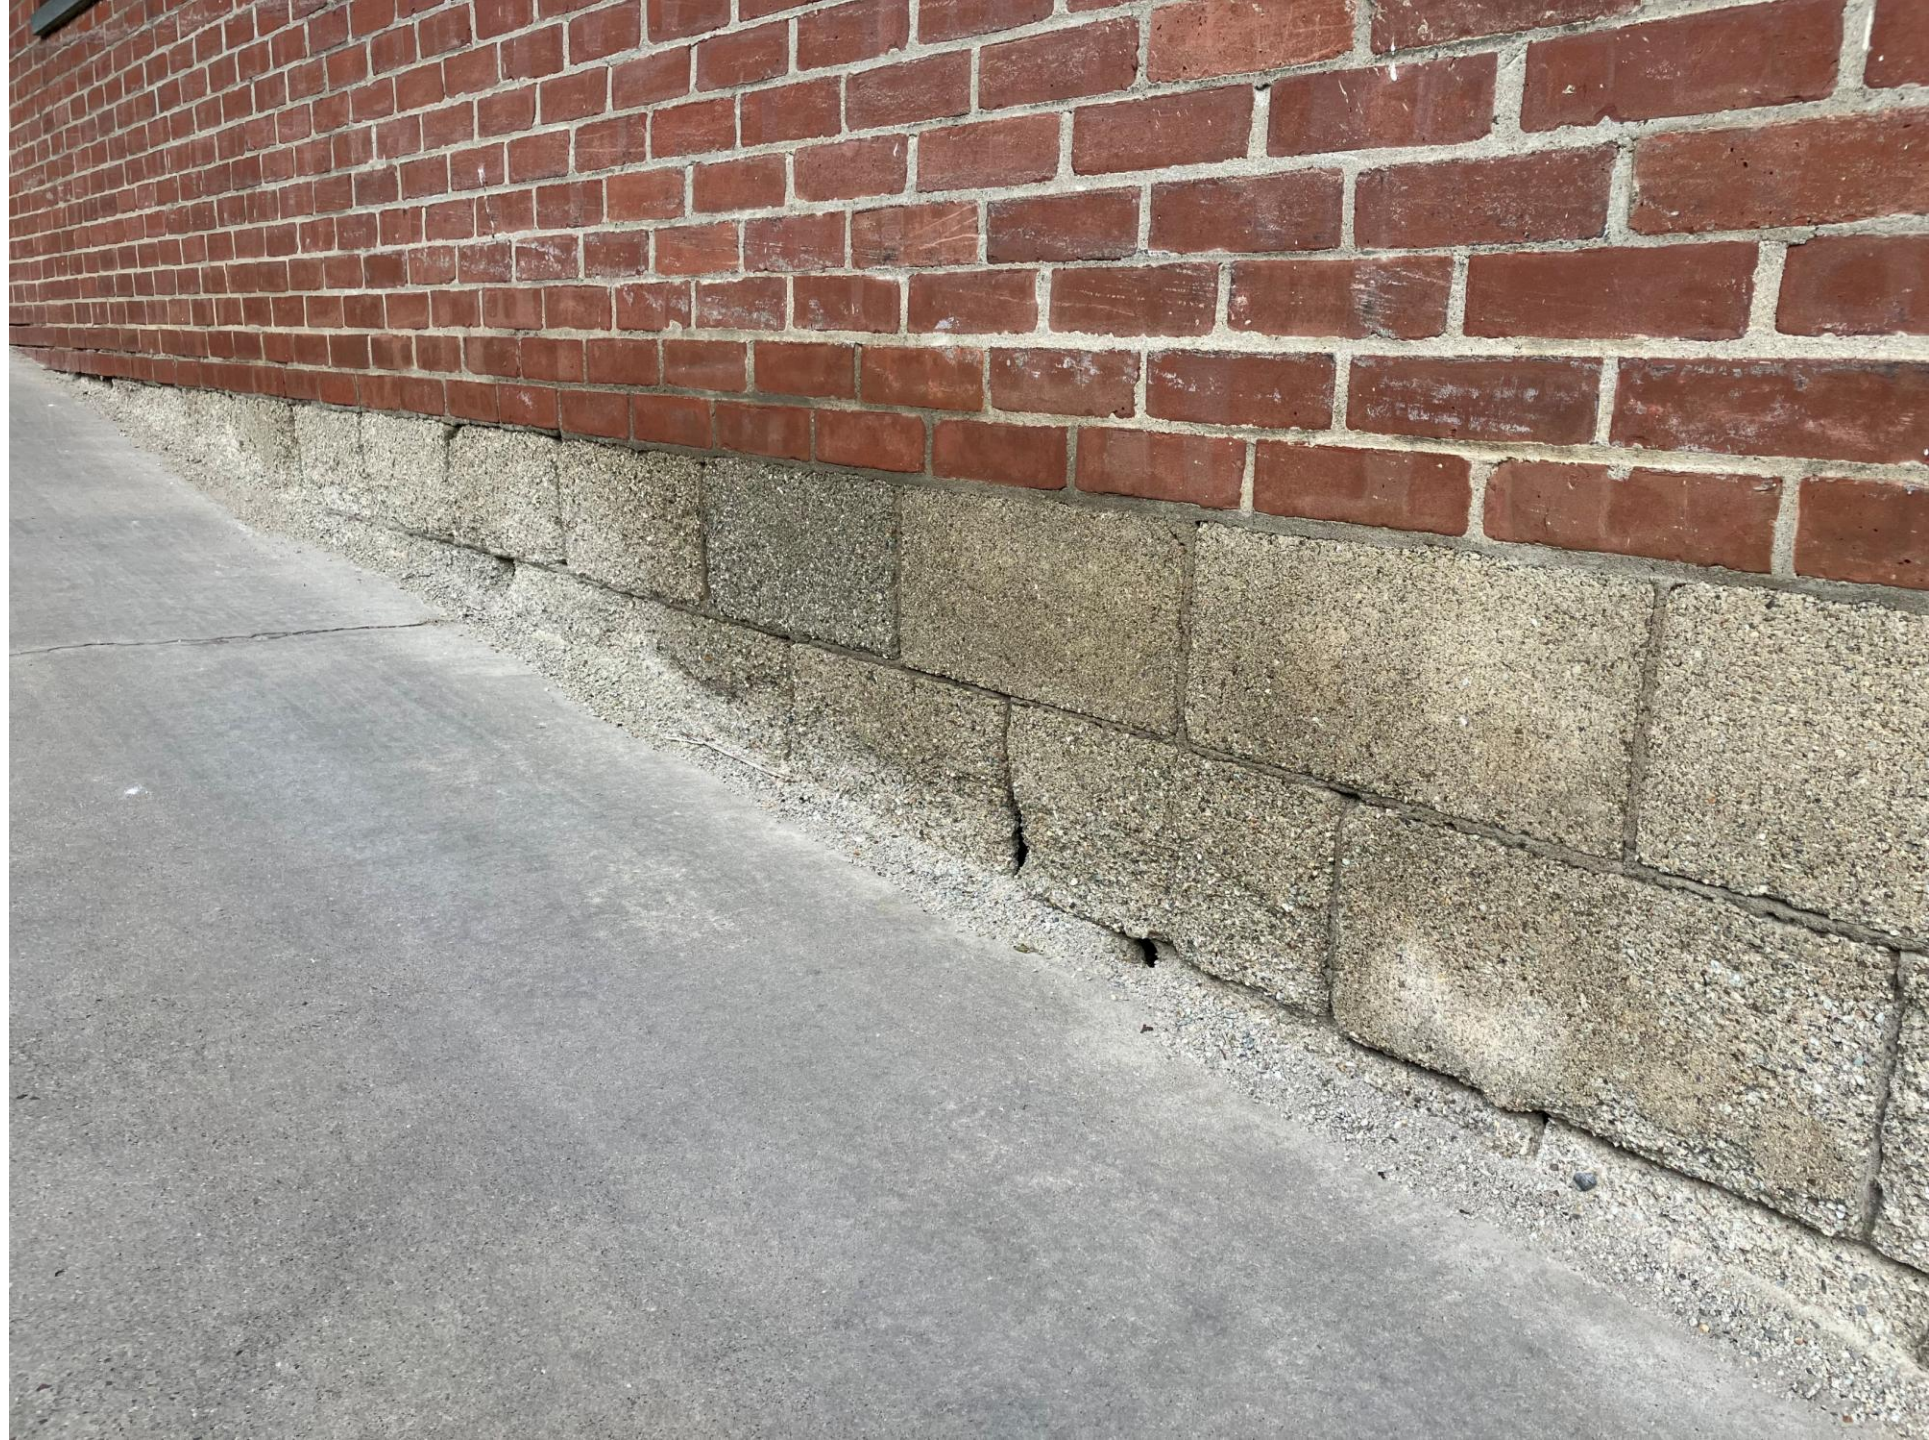
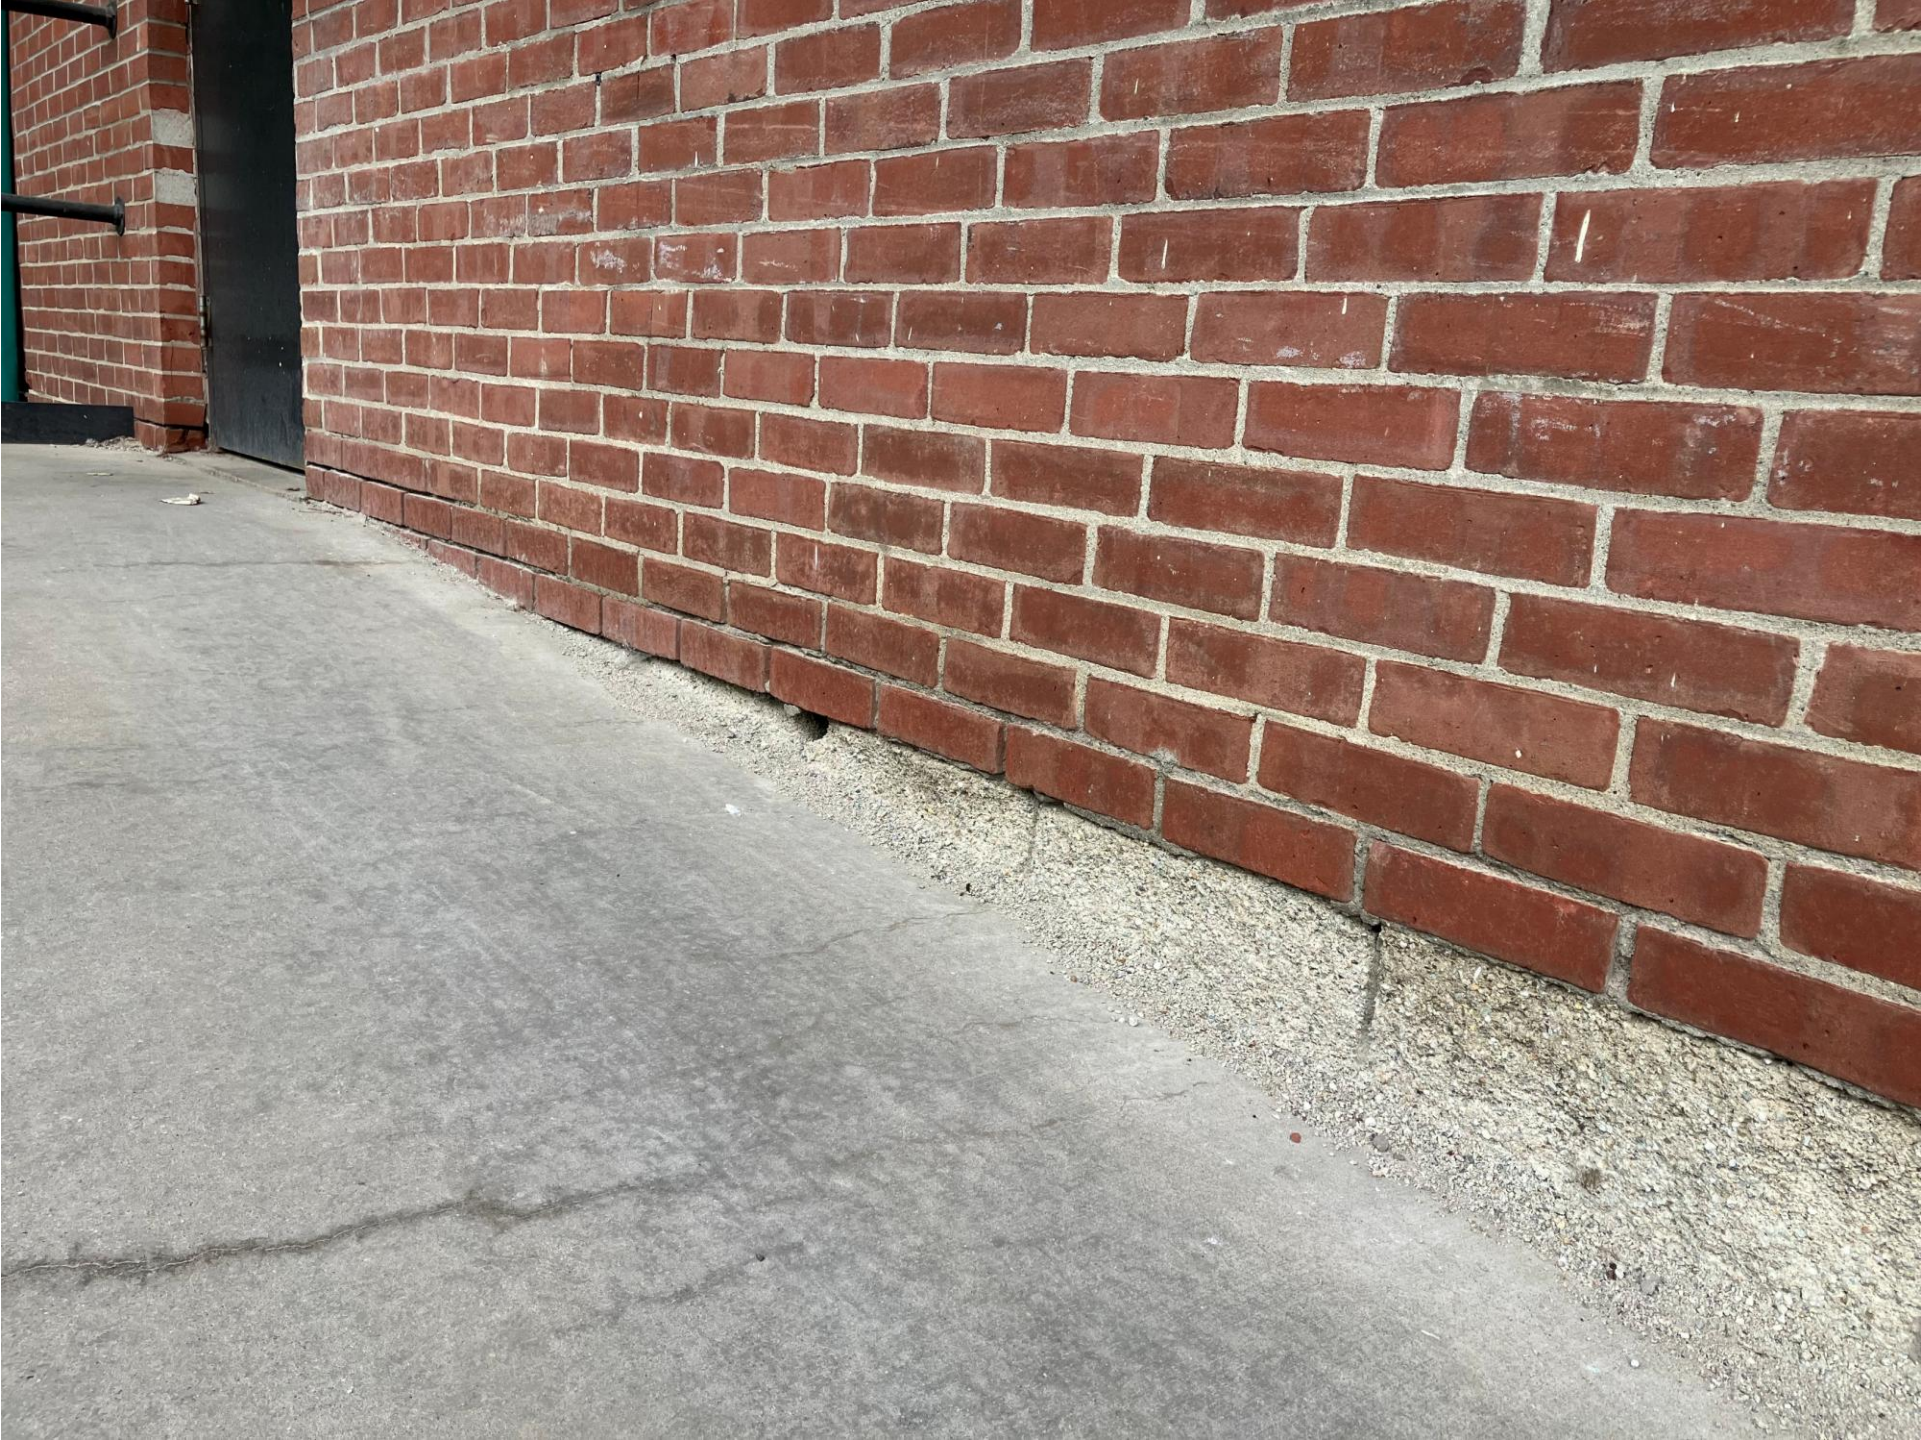
The concrete block foundation on the east wall of the Town Center building, along the ramp is deteriorating due to the salt used to melt the ice in the winter.

Peter Cahill consulted with Jim Lawrence of JL Masonry, a reputable masonry contractor who has done work in town on 10 East Main St (Greensea IQ) and Shelburne Farms, and he advised that the concrete blocking is not repairable nor fit for patching measures. The sodium chloride has eaten into the concrete and has opened holes into the foundation below. In his estimation, the only solution is to remove and replace the concrete blocking. New blocking can be treated biannually to combat the damage from the salt.

- Remove all brick from the facade that resides over the deteriorated concrete block
  - The block is holding the brick
- Remove all concrete blocking from beside the ramp
- Unknown, but likely, the concrete ramp will need to be removed as the block extends below the ramp and the salt may have worked its way down into lower courses of block below the ramps surface.
- Prep and repair demoed structure
- Replace concrete blocking with new blocks
- Replace existing brick work above the blocks to recover the facade

JL Masonry Rough Estimate - \$50,000 for the brick work

Estimate does not include the demolition and rebuilding of the concrete ramp
