Richmond Vermont

Visit Summary

The purpose of this visit was to inspect the condition of the two channel Rotary Press located in Richmond Vermont and provide operational assistance to the personnel. The press has an estimated 45,000hrs on it. This is a two 36" channel press, model number 2-900/2000, and serial number PR-09-0/99.

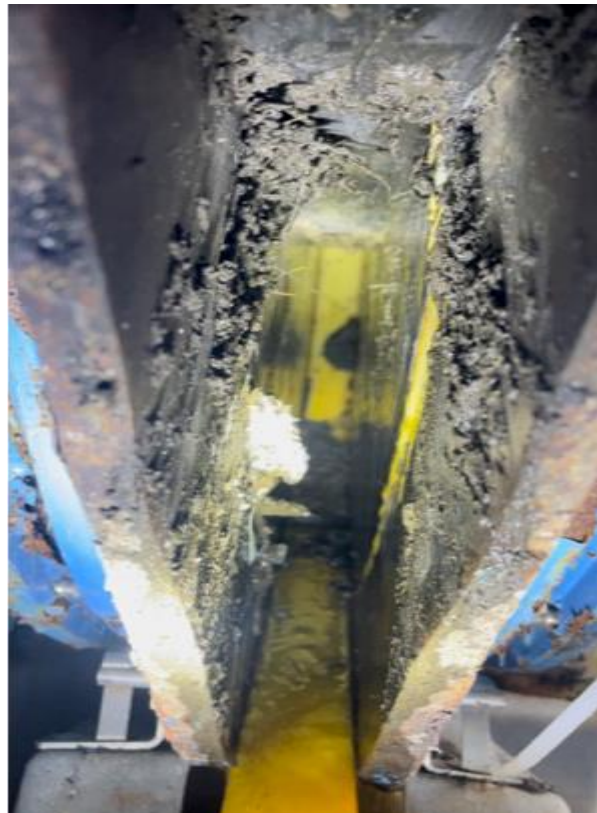
Screens: The facility only runs sludge through one channel and has recently complained about the filtrate quality. They do not run on the other channel due to damaged screens. Opening the restrictor arms on both channels and cleaning the channels out to inspect, I discovered that all four screens were very worn.

Frames: The frames on the channels were rusting and worn were the restrictor arms moved. You could see the yellow cover seal between the wheel and the frame starting to come through with trash.

1. New Channels – Everything on the channels needs replacement so I would recommend whole new channels. Even if you could spare some parts, we might need to cut the wheels from the shaft.
2. New Flocculator Assembly – The top of the floccuator need to be dismantled and probably everything needs to be replaced below the gearbox.
3. Three-way Valve – I would suggest they replace them with two two-way valves.
4. Channel Wash Valves – If it doesn't already come with the new channels.
5. Air supply – A new air regulator needs to be installed. As of right now I do not believe they have air going to the three-way valve and they only have it to the bellows.

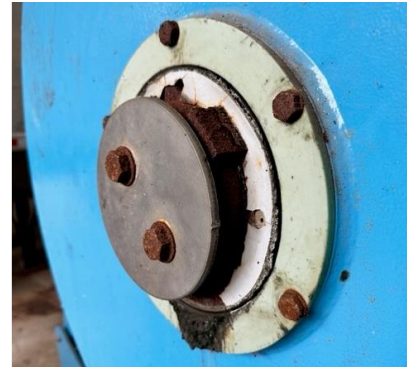
Shaft: The shaft of the press was in ok condition. The shaft only supports one channel on each side, so there was limited exposure to the atmosphere. There is some rust around on the end, however that should not effect the removal.

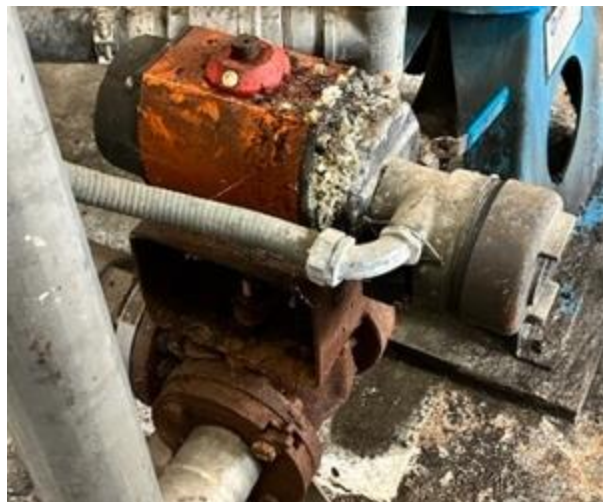
Three-way valve: The existing three-way valve does not work. It has been stuck in the dewatering position and does not turn. This causes problems with a proper startup. Sludge also leaks out of the supply tank, through the sludge pump and, because the valve is stuck in the dewatering position, into the channels.

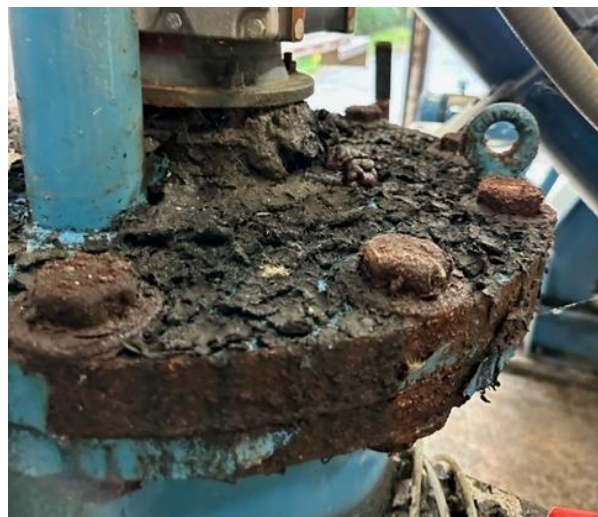
Flocculator: The flocculator seal shaft has been leaking for some time. It's hard to tell the extent of the damage.

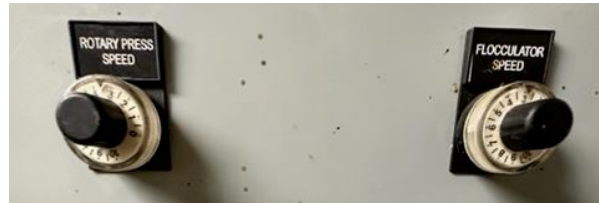
Panel: The panel is the old style with speed dials for the flocculator speed and rotary press speed. The outlet pressure is controlled directly at the channel. If you adjust it on the panel, it doesn't do anything.

3. Panel HMI – The installation of a new panel would make it easier for the operators to use the press. The current old program is outdated and not optimal.
4. Conveyor system – There are a couple holes that need to be patched or sections replaced.

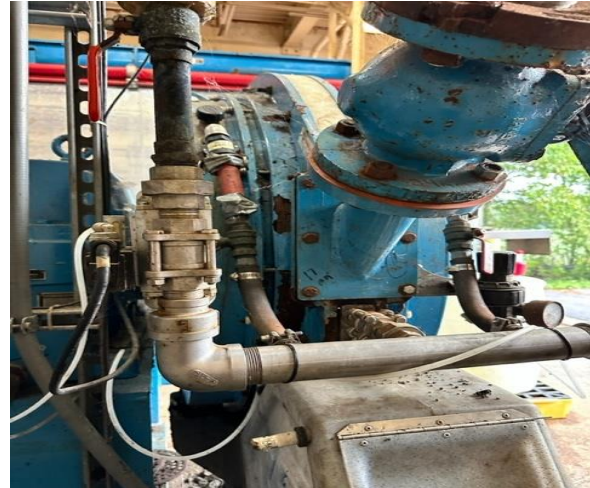
Channel Wash Manifold: The Festo valves on the channel wash manifold do not seem to work. The piping and spray bars are not in good condition.

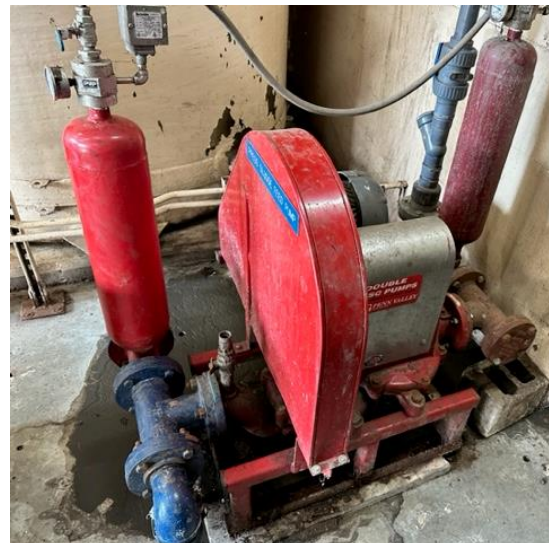
Sludge Pump: The facility has a double disc sludge pump and is in good condition. However, the sludge tank gravity feeds past the pump when it is in the off position.

1. Sludge pump - The sludge supply tank feeding the pump is gravity feeding through it. The pump may just need new interior parts. Or the sludge valve needs to be closed off when the press is not running.
2. Polymer system – We determined the polymer was making down a batch of 0.25% concentration, with a polymer to sludge ratio of 8% and a consumption of 26 active lbs/dry ton. An upgrade of the polymer system could produce lower consumption.

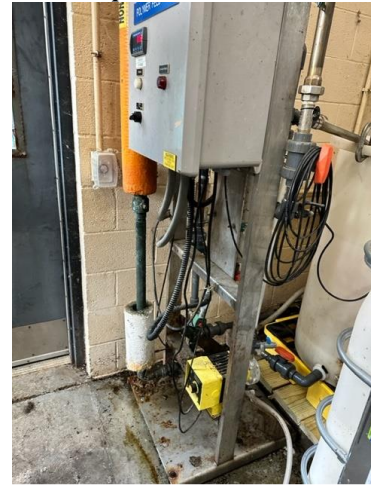
Polymer System: The polymer system does not have an indication of concentration. A batch of diluted polymer is sent to a 50-gallon tank. From there it is pumped to the floccuator at a ratio of the sludge flow.

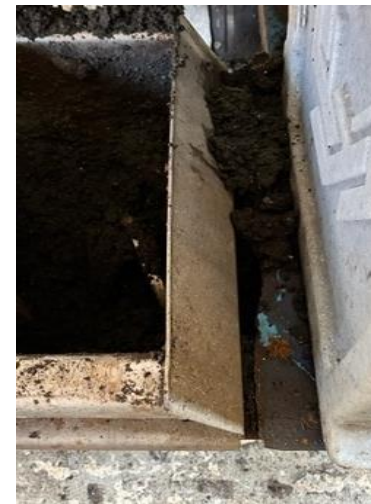
Conveyor System: The conveyor seems to be in good condition apart from a couple rusted out holes in the lower one. Also, on the inclined conveyor it is open at the top. The employees said this was from cake building up due to an unopened slide gate that has since been fixed.
