2018 Town of Richmond, VT Facilities Assessment

BreadLoaf

Executive Summary

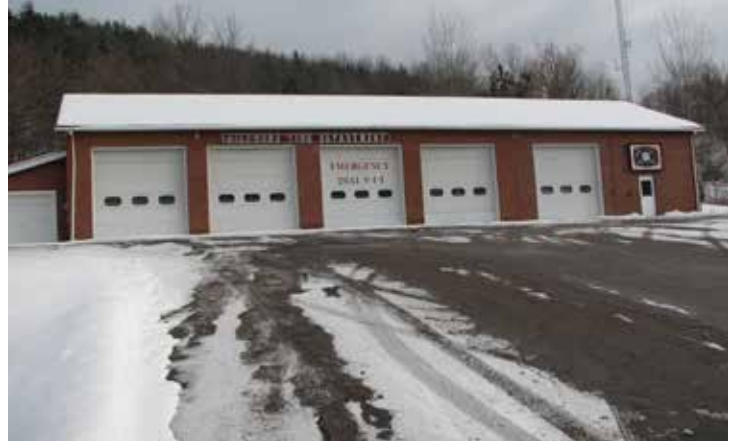
The asphalt apron slopes steeply away from the building to its intersection with Route 2. This creates a steep approach angle at the overhead doors and makes it difficult for maneuvering apparatus against the slope. The asphalt is in poor condition and there is an ongoing problem with a section of pavement near the Meeting Room entrance that continually sinks. The absence of a proper swale or drain at the intersection of Route 2 and the apron make it susceptible to icing in the winter.

Steep apron approach from Route 2

9. Replace asphalt shingle roof and gutters. *(HW)*
2019 BUDGET: \$30,000
10. Remove existing apron paving, compact soil at sewage pump station and repave. *(FR)* 2019 BUDGET: \$9,000

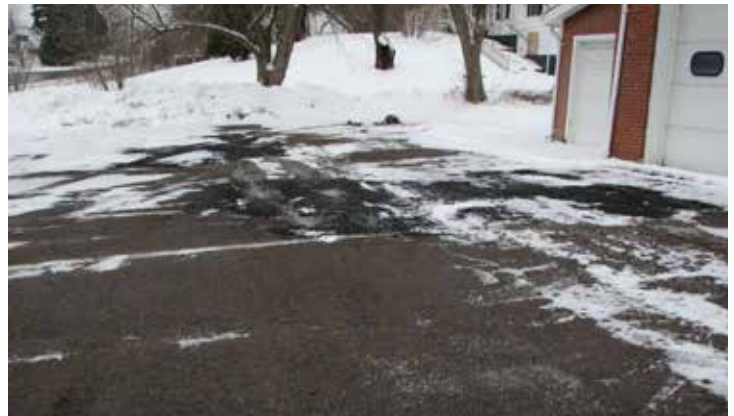
Patched sink hole

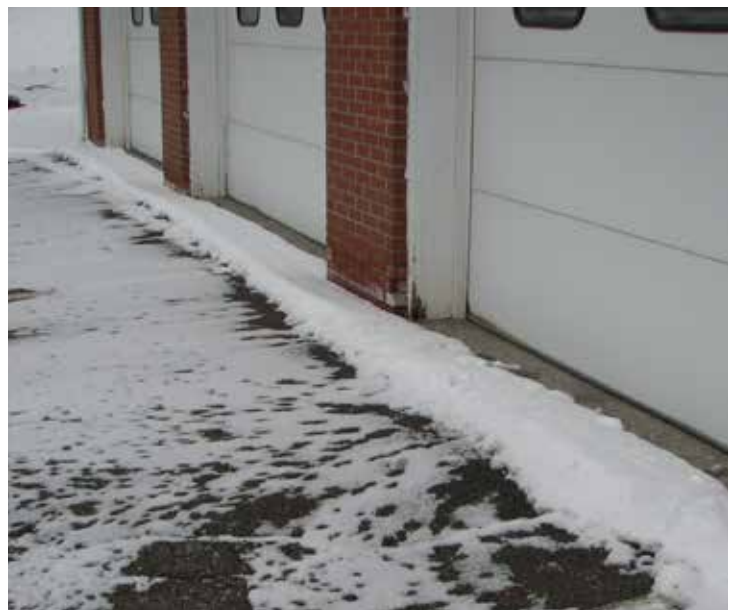
Ice build up at overhead doors

The asphalt shingles appear to be in fair condition. Existing gutters are falling off of fascia board causing water to fall in front of overhead doors causing ice build up during winter months.

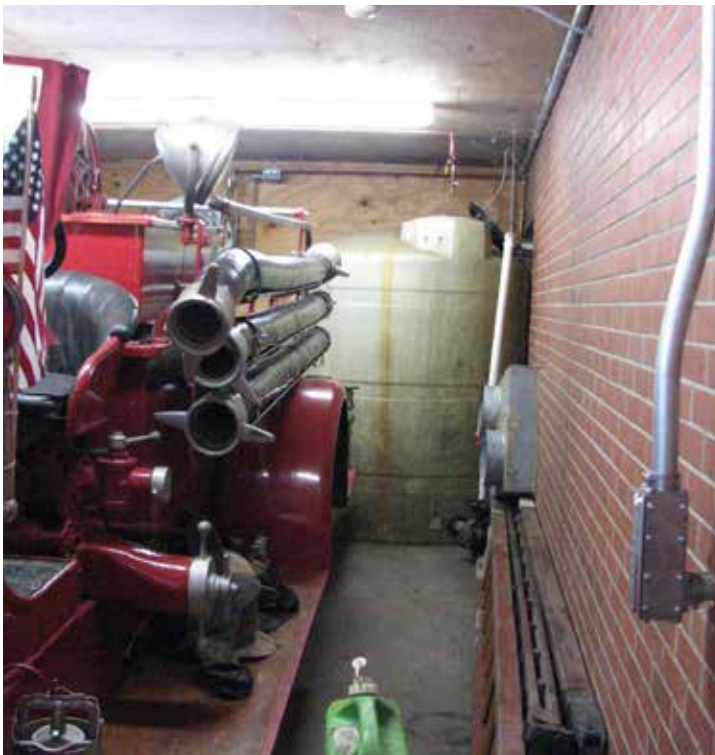
Existing, undersized truck fill tank

The building is fed via a ¾" town water service to a 1,000 gallon plastic storage tank. The fill system is 1.5" PVC and is failing. The PVC line should be replaced in the near future. Upon discussion with the Town of Richmond water authority, it was determined that the water service is protected by a backflow preventer in the exterior meter pit. Domestic hot water is provided by a SuperStor SSU-30 indirect water heater fed from the building boiler zone #4. The indirect heater is less than one year old and has an anticipated service life of 20 plus years. The system has a code compliant mixing valve. The domestic hot water piping however is uninsulated and should be insulated to meet current energy codes. The piping system is in fair condition but will require repairs over the next 10 years due to corrosion of pipe and fitting.

11. Increase size of water service line to the building TO 4" with new STORZ connection. for truck fill. (FR)
2019 BUDGET: \$16,200
12. Replace all interior lighting with LED fixtures. (FR)
2019 BUDGET: \$6,500
13. Install new automatic lighting controls. (FR)
2019 BUDGET: \$2,600
14. Install new Energy Recovery Unit for Meeting Room and Office Area. (LSC) 2019 BUDGET: \$9,600
15. Replace and insulate domestic water distribution piping. (HW) 2019 BUDGET: \$5,400
16. Insulate heating hot water distribution piping. (HW) 2019 BUDGET: \$1,800
- 17a. Replace PVC fill piping with schedule 80 PVC. (HW) 2019 BUDGET: \$4,000
- 17b. Replace PVC fill piping with copper piping. (HW) 2019 BUDGET: \$6,000
18. Replace jamb trim at existing overhead doors. (FR) 2019 BUDGET: \$2,000
19. Add mezzanine above new apparatus bay. (FR) 2019 BUDGET: \$27,000

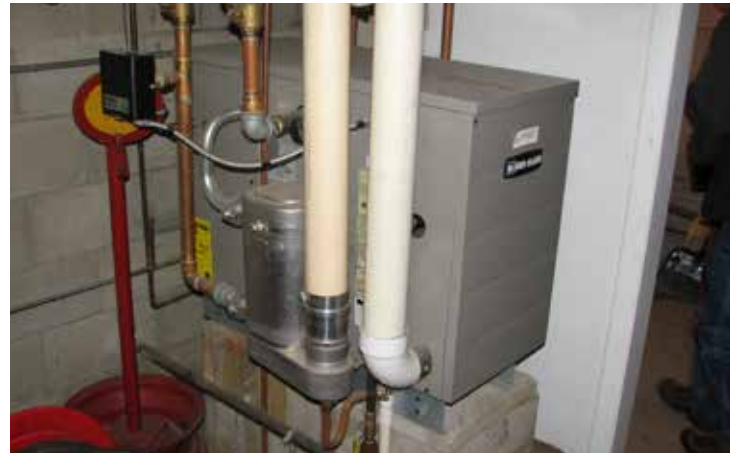
Boiler in apparatus bay

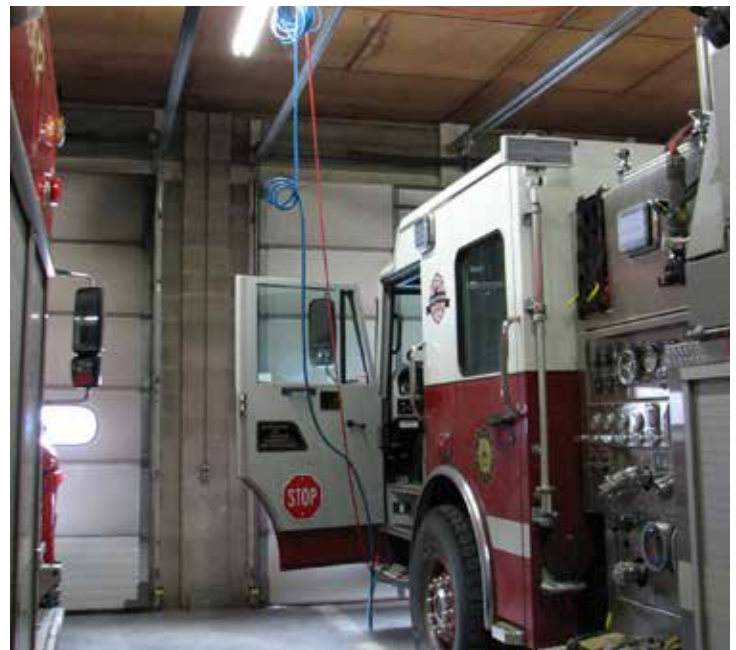
None of the heating hot water copper piping distribution system is insulated and should be a future consideration. The piping system is in fair condition but will require repairs over the next 10 years due to corrosion of pipes and fittings. The building has a toilet exhaust fan venting to the outside. No outside air or ventilation air is provided. Four ceiling de-stratification fans serve the apparatus bays. Fans are on manual control. Compressed air is provided by a portable air compressor and tied into a copper compressed air distribution system via a flexible air hose.

Air and power supply from apparatus bay ceiling

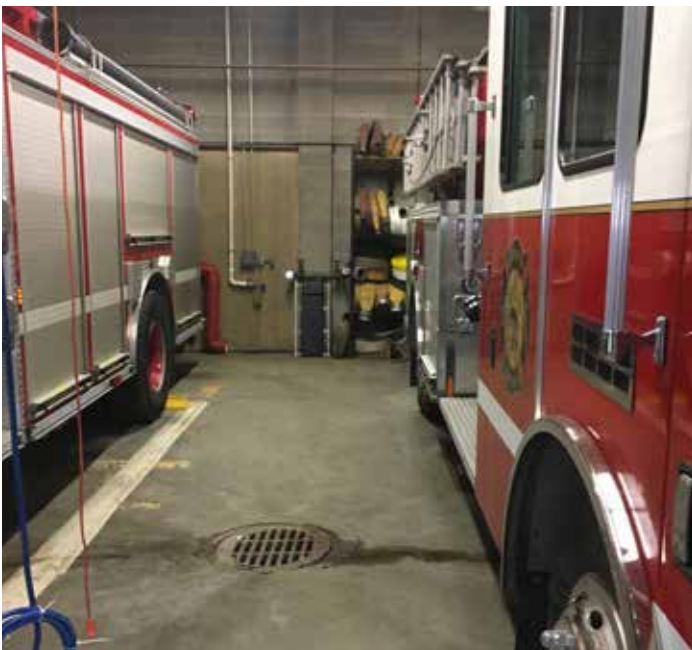
Floor drain in apparatus bay

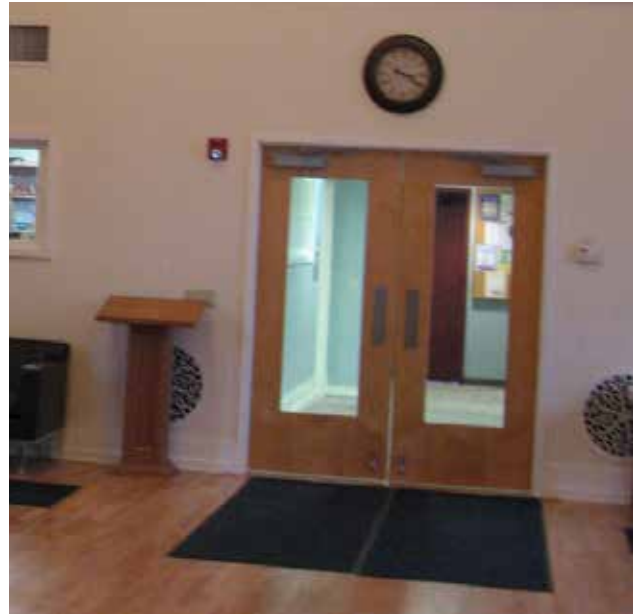
- Sections of exterior sidewalk leading from handicap parking spaces have heaved, creating a difference in height of walking surface over 1/2".
- Double doors at south end of Community Room do not have required exit signage.
- Open exit stair at north side of Community Room needs to be enclosed with a one-hour fire rated barrier per NFPA to meet requirements as the second means of egress from the Community Room, which has a design occupant load of 199 people.
- Additional emergency light fixtures required in second floor corridor and egress stair.

No exit sign at community room doors

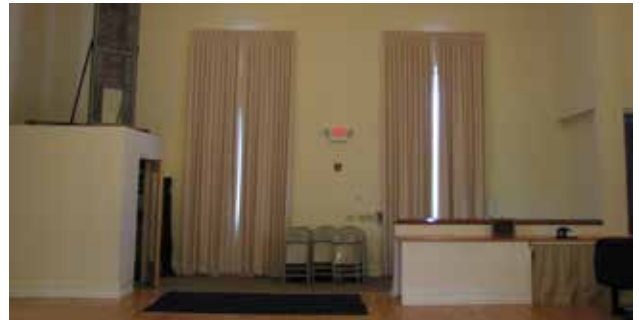
Open exit stair from community room

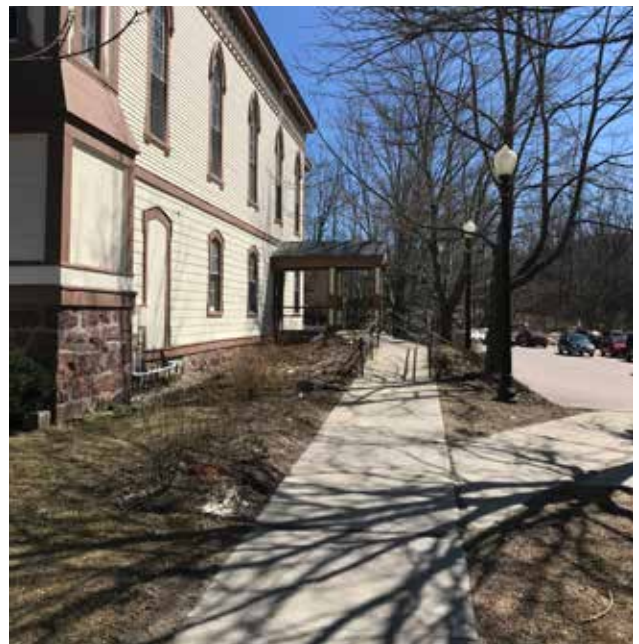
The Richmond Free Library is located on the same site as the Town Center Building. There is shared parking for both buildings. There are two handicap parking spaces provided off Bridge Street. A concrete sidewalk and ramp provides ADA access to the building. There are metal handrails provided and the slope appears to be compliant. The overall condition of the sidewalk is good, however, there are a few sections of the sidewalk that have heaved.

ADA accessible sidewalk to main entrance

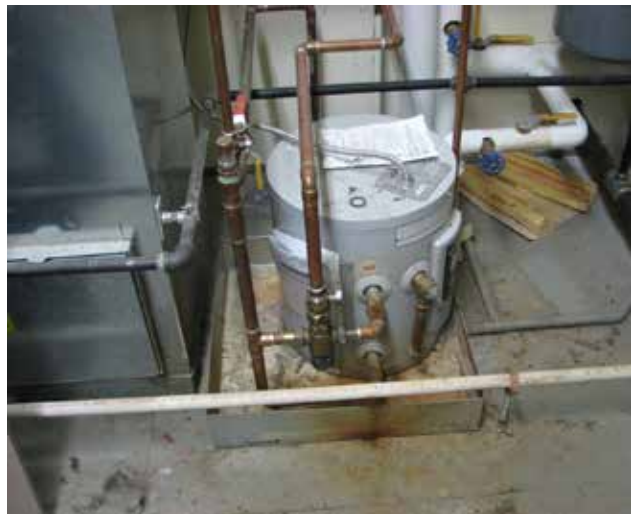
Third floor hot water heater

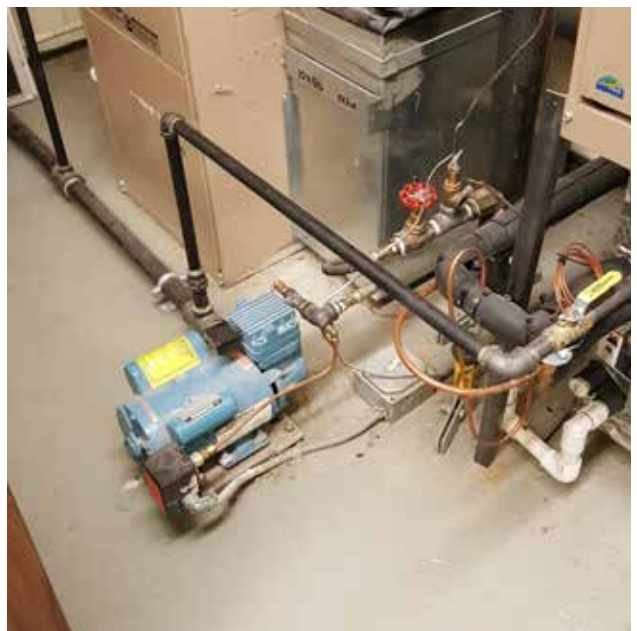
Third Floor Sprinkler system pump

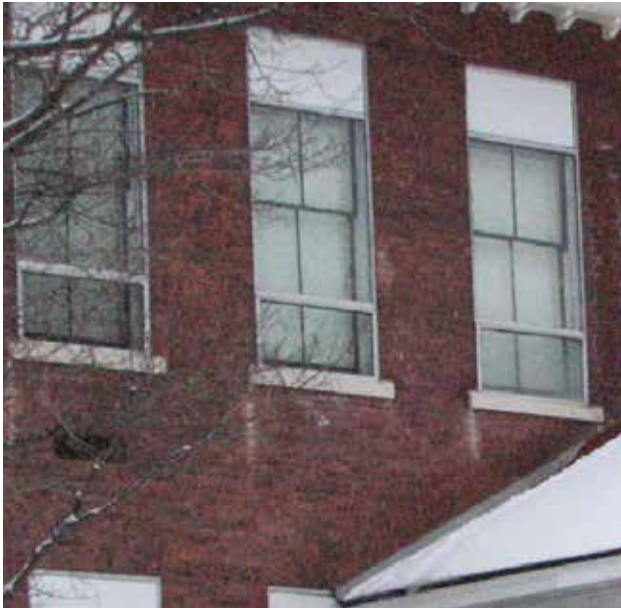
Efflorescence at window sill

The exterior brick veneer is in fair condition. Efflorescence is visible under window sills and in multiple other locations on all sides of the building. Several areas in the brick veneer will need repointing. A washing of all the brick is recommended. There is also new evidence of brick spalling occurring at the southeast corner of the building near the main entrance for the town offices. This may be related to the recent roof replacement and extended drip line which is leading to water falling onto the sidewalk and splashing up against the brick. This condition should be monitored going forward.

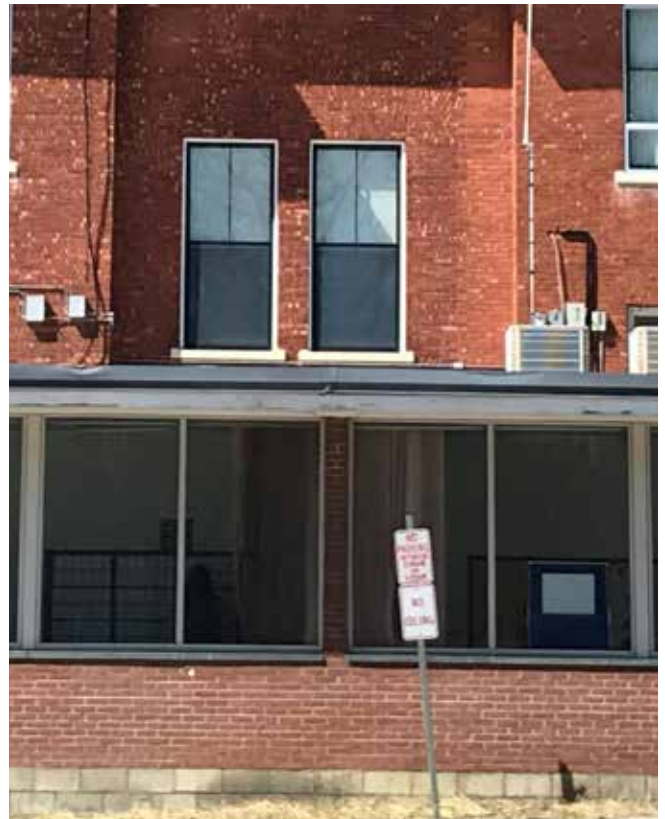
Only the exterior of the Post Office was part of this survey. The brick veneer appears to be in good condition. The aluminum storefront frames are in good condition as well. There are a few locations where there may be some air infiltration. The wood fascia and soffit has some rot damage and peeled paint and will need to be scraped and repaired as required.

Post Office storefront and soffit

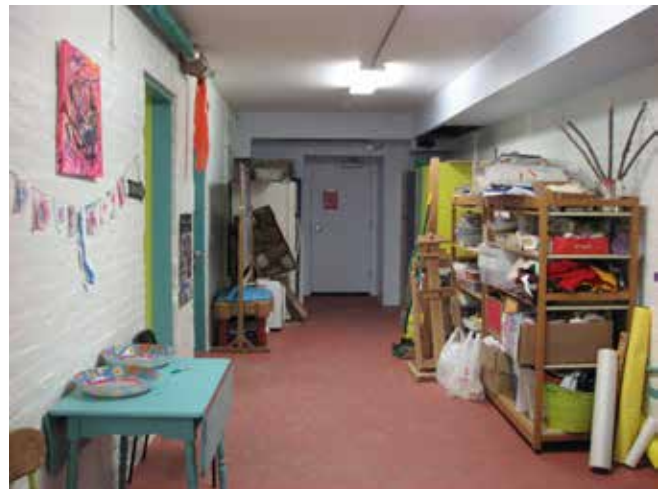
Lower floor level corridor

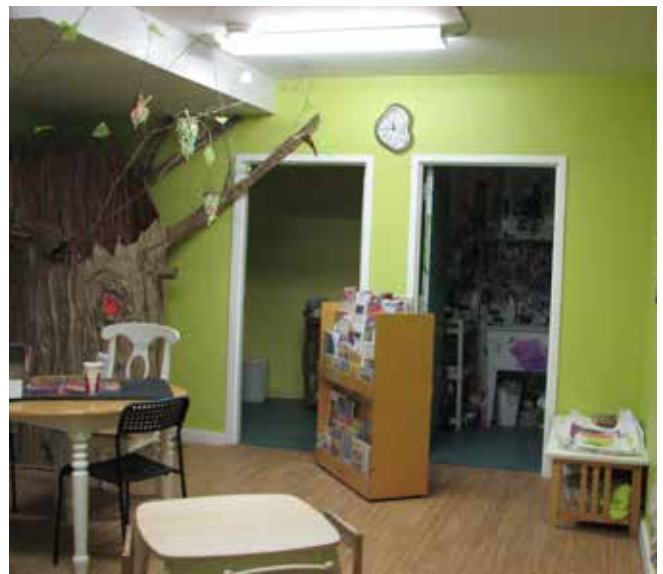
The mechanical room is not ADA accessible and the elevator access for the lower level is within this space. By code, there needs to be an accessible route from the elevator to the remainder of the basement space and it needs to be separated from the mechanical room by a 1-hr fire rated barrier. There are two crawl spaces off the mechanical room which have dirt floors. There are multiple locations in these spaces where daylight was visible through the foundation resulting in air infiltration. There is one bathroom on this level that does not have an accessible path to it, nor does it meet ADA compliance for required clear floor space.

Non ADA accessible classroom

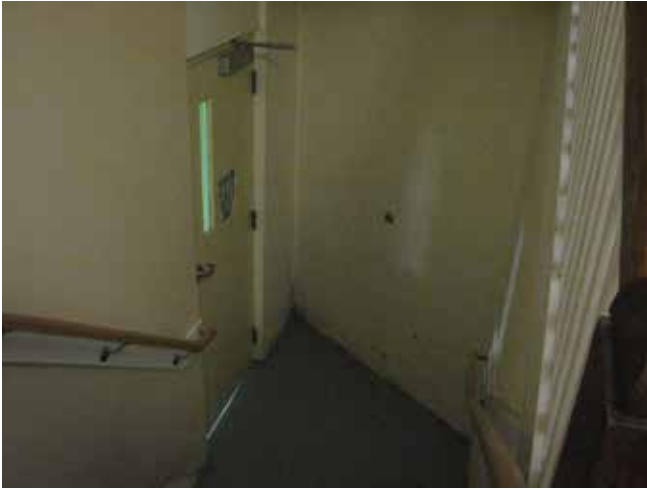
Exit door in lower level cannot open to 90 degrees

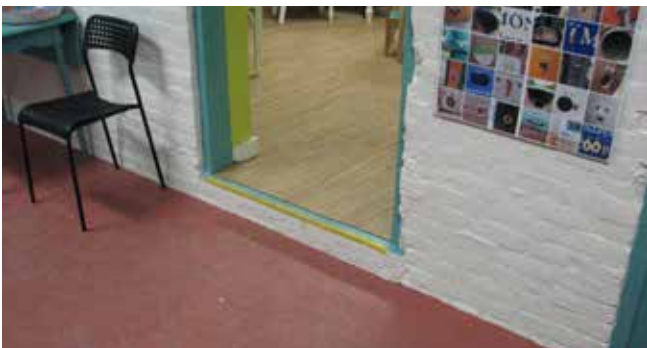
Non ADA accessible classroom space in lower level

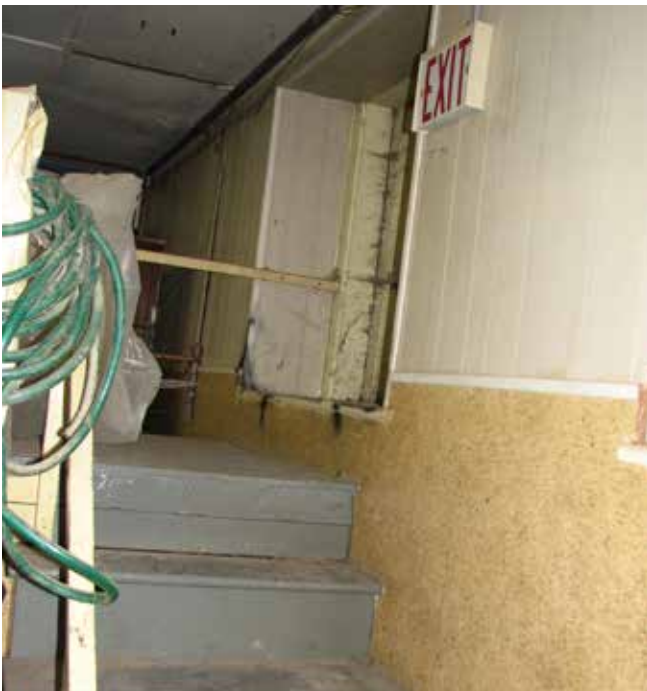
Non compliant egress stair from storage in lower level

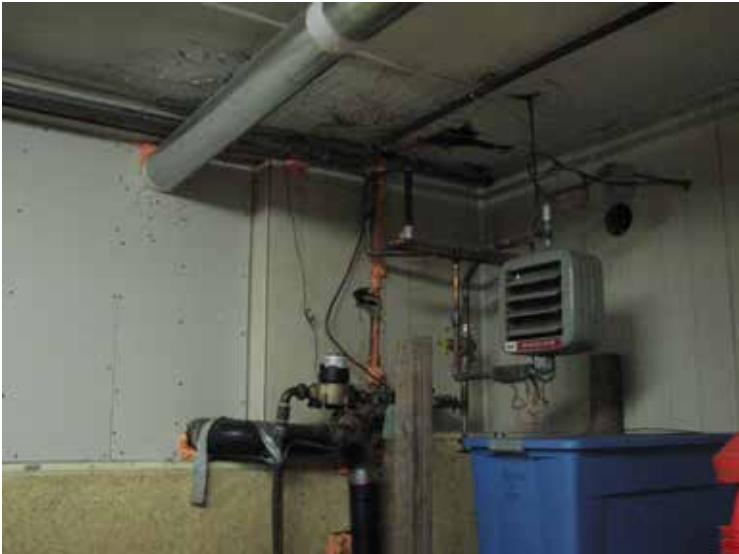
Water service entrance

The building is served via a 1" city water line complete with a water meter, backflow device, and pressure-reducing valve. It appears the water entrance and the sanitary sewer lines are in the same trench coming into the building and are not separated by the current code recommended distances (10'). Domestic hot water is served by a series of electric tank type water heaters. Some of the water heaters observed are missing code mandated mixing valves and most likely have a set point below the recommended temperature of 140° to prevent Legionella. A 6" cast iron sanitary line serves the building. ADA compliant water coolers should be provided in any future major renovations. Mixing valves are needed on all water heaters.
