Road Safety Audit Review
Fays Corner
Town of Richmond

July 8, 2004

Fays Corner, Richmond

Road Safety Audit Review Review Report

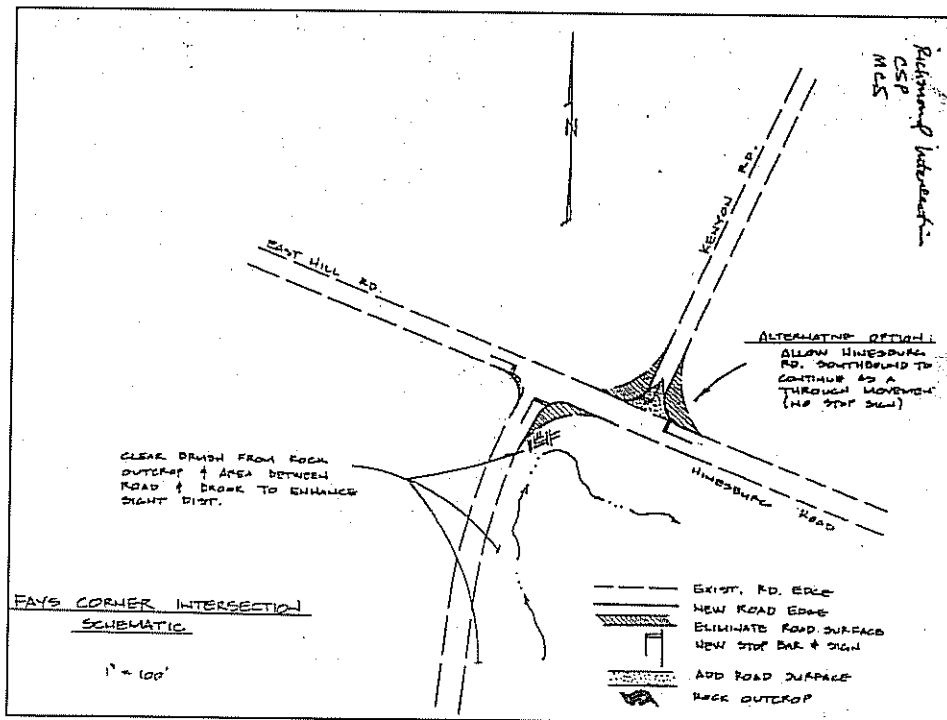
Figure 4. Mike Weisel's Intersection Schematic (not to scale)

CCMPO contracted with the engineering firm Dufresne-Henry to provide technical assistance to the Town of Richmond with a number of intersections including the one at Fays Corner. In this memo, Dufresne-Henry supports the intersection schematic that was developed by Mike Weisel and which is shown in Figure 4. The following points were made:

- a) Create a four-way stop, or three-way stop condition.
- b) If a 4 way-stop is desired, we recommend regrading the east approach to achieve a suitable grade at the new stop bar (-3%). This would require raising and repaving the road.

- c) Eliminate the large radius on the SE corner, and the "Y" configuration on the north approach.
- d) Leave / allow 40 ft. corner radii (and one foot shoulders where paved) for large trucks and plows.
- e) Place warning signage on the south approach (stop ahead symbol - see W3 -1 A on attached detail E- I 50M) 300 ft. before the intersection.
- f) Place a flashing beacon on this sign post. (see attached Standard Detail E- 1 5 OM).
- g) Place a double arrow warning sign at the intersection opposite the south approach.
- h) Clear the brush and regrade the adjacent area as much as possible on the east side of the south approach.
- i) Place / affix 2 orange flags on each new stop sign. Maintain these for at least a year.
- j) Add road name signage for Hinesburg Rd.

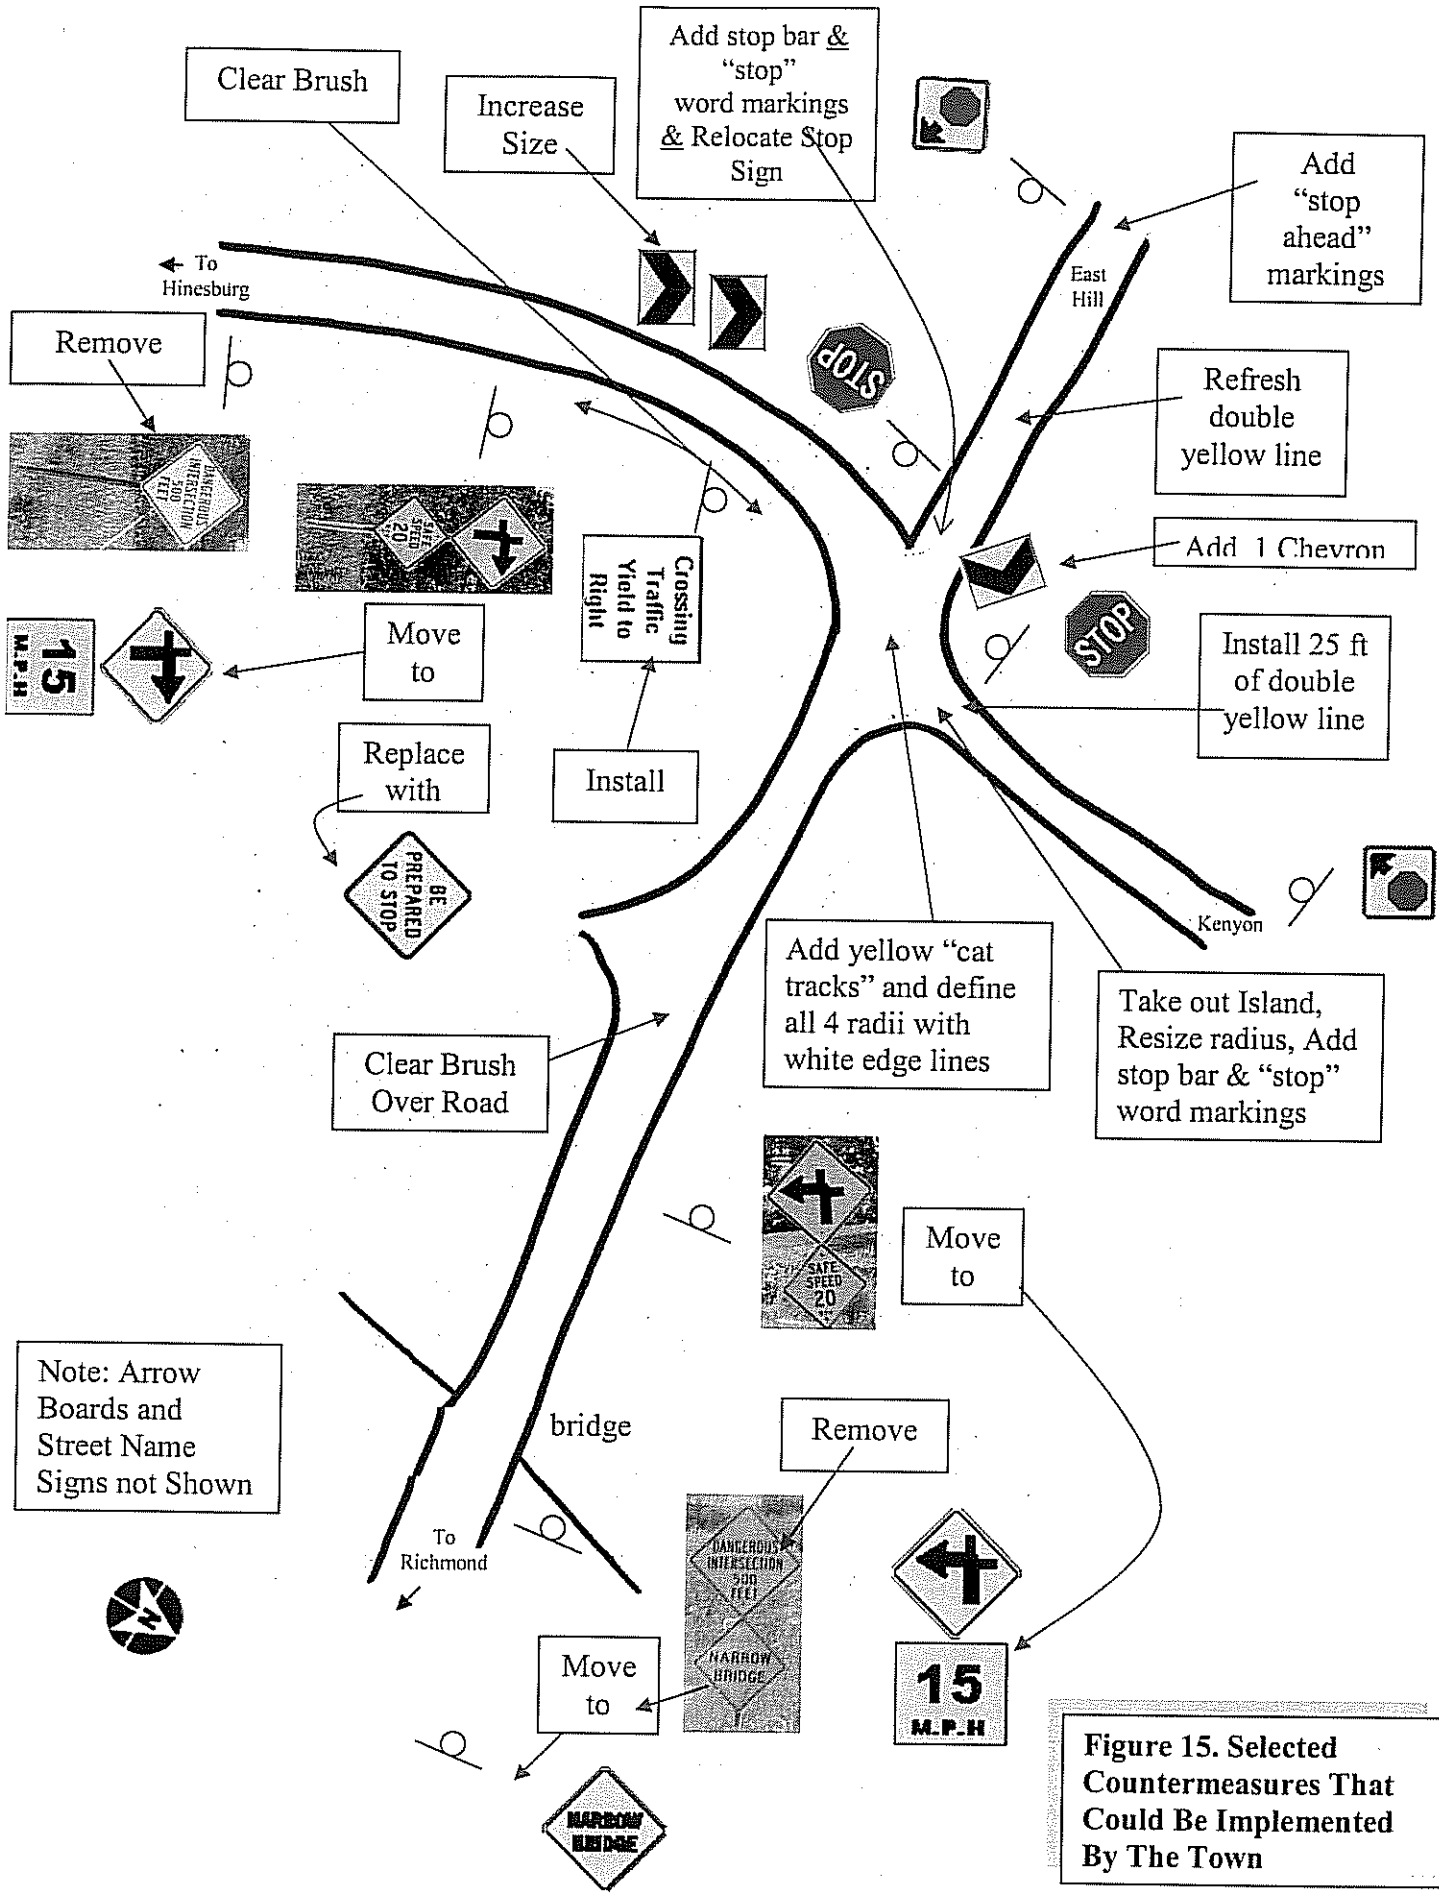
Figure 15. Selected Countermeasures That Could Be Implemented By The Town

<p>Speeds are perceived to be high.</p> <p>Sight restrictions, conflict points, the bridge, grades, curves, and the drives are conditions that could lead to a reduction in speed limit.</p>	√	√							<p>The Town should consider conducting a study to reduce the travel speed. The MPO could possibly help with this.</p>
<p>Motorists lack guidance when traveling towards Richmond.</p> <p>A guide sign could be installed before the intersection.</p>		√							<p>The Town could consider adding a guide sign.</p>
<p>Sign assembly next to East Hill Rd provides too much information.</p> <p>The arrow board should be on its own posts.</p>		√							<p>The Town should consider separating the signs, keeping the street name signs with the stop sign and leaving the arrow sign by itself.</p>

Observations & Possible Countermeasures	Responsible Entities								Strategy
	MPO	Town	AOT Traffic Ops						
There exists a major conflict: traffic going straight on Kenyon from Hinesburg (from the Hinesburg direction) do not have to stop and traffic going straight on East Hill or continuing on Hinesburg from Hinesburg (from Richmond direction) do not have to stop either.		√							The option in Figure 4 could possibly result in more rear-end crashes. A stop sign on the south leg should be a last resort. Not everybody needs to stop, only those going straight to Kenyon or turning left on East Hill. Yielding to the right is the action sought in this case. Consider one of the options shown in Appendix A.

improvements. These tables are found at the end of the report. Selected possible countermeasures for which the Town would be responsible are illustrated in Figure 15.
