## MEMORANDUM

To: Josh Arneson; Town of Richmond  
From: Jason Charest, PE, PTP; CCRPC  
Date: September 24, 2025  
Re: Fay's Corner Safety Audit

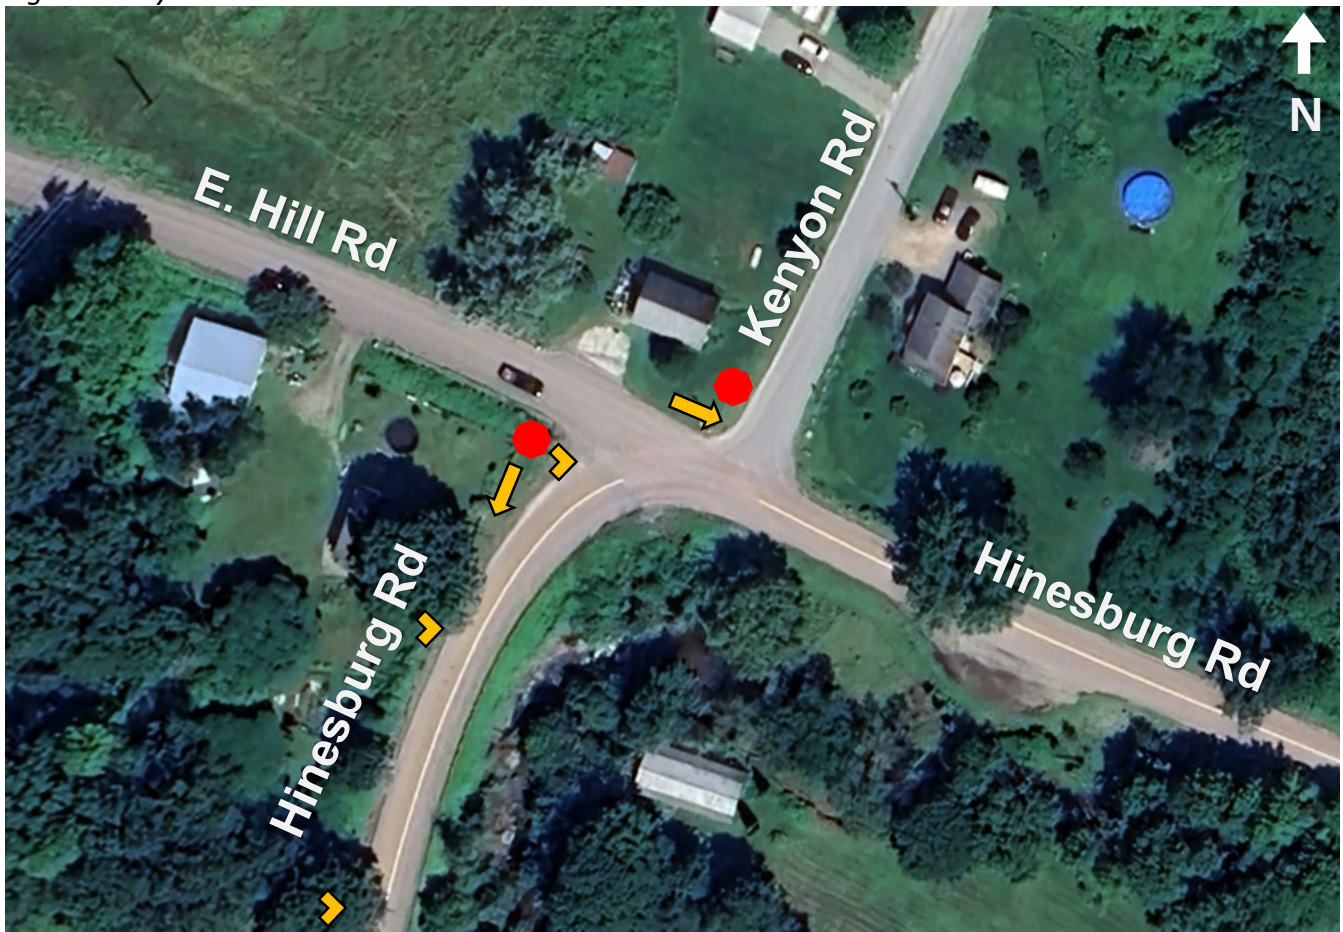
Figure 1: Fay's Corner

Fay's Corner consists of the intersection of East Hill, Kenyon, and Hinesburg Roads in Richmond, VT. Hinesburg Road is functionally classified as a major collector that comes from the south and rounds a ninety-degree corner to proceed eastward toward Richmond Village. East Hill and Kenyon Roads are controlled by STOP signs. Hinesburg Road approaches are uncontrolled and curve signage is present to aid vehicles in navigating the corner. The curve signage consists of chevrons for northbound vehicles approaching the intersection and large arrow plaques for both Hinesburg Road approaches. There is also advanced curve warning signage in both directions with advisory speed plaques of 15 mph (See Figure 1 above, and 2 and 3 below). The posted speed limit on Hinesburg Road is 40 mph.
