Re: Richmond Band Shell
Structural Assessment

EV# 24623

This report is a preliminary structural assessment of the Richmond Band Shell located on the Town Green in Richmond and is based on our proposal dated December 10, 2024 and received executed on January 3, 2025.

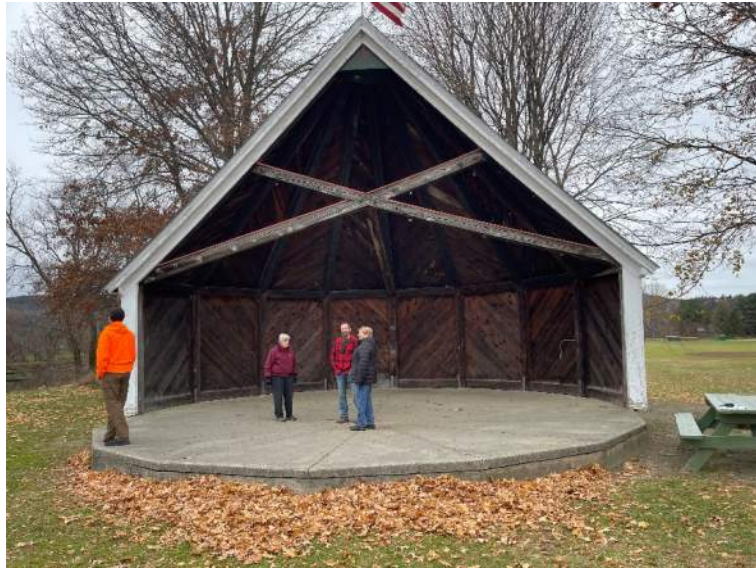
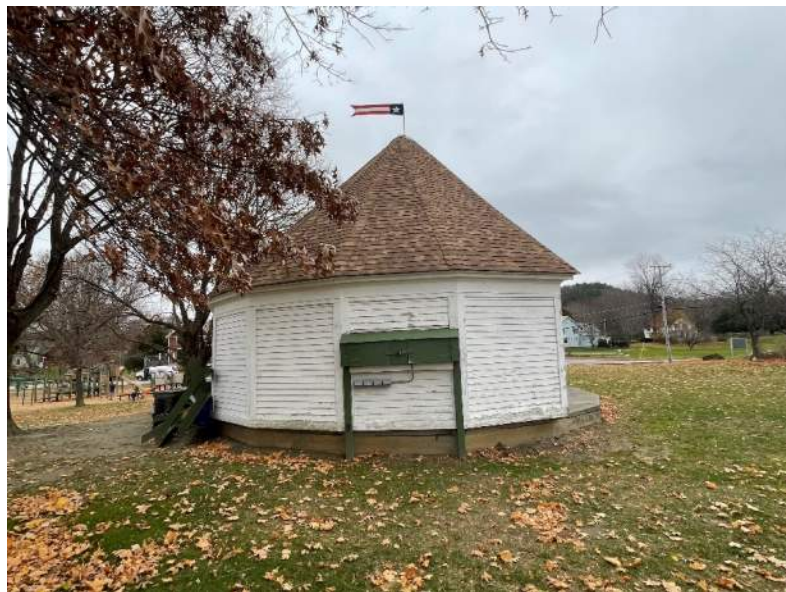
The slab at the stage level is in poor condition with significant cracking and settling. There appears to be a low point at the center that collects surface water. During a January follow up visit, there was an ice puddle at this location. The slab appears to be about 4"-5" thick and rests on the exterior foundation wall. This slab should be replaced.

- Demo and dispose of existing concrete slab
- Temporarily shore frame as needed
- Saw cut front end of concrete wall to allow new slab to pitch for drainage
- Investigate subsurface conditions and modify as needed
- Review embedded steel connections and repair/replace as needed
- Place new slab

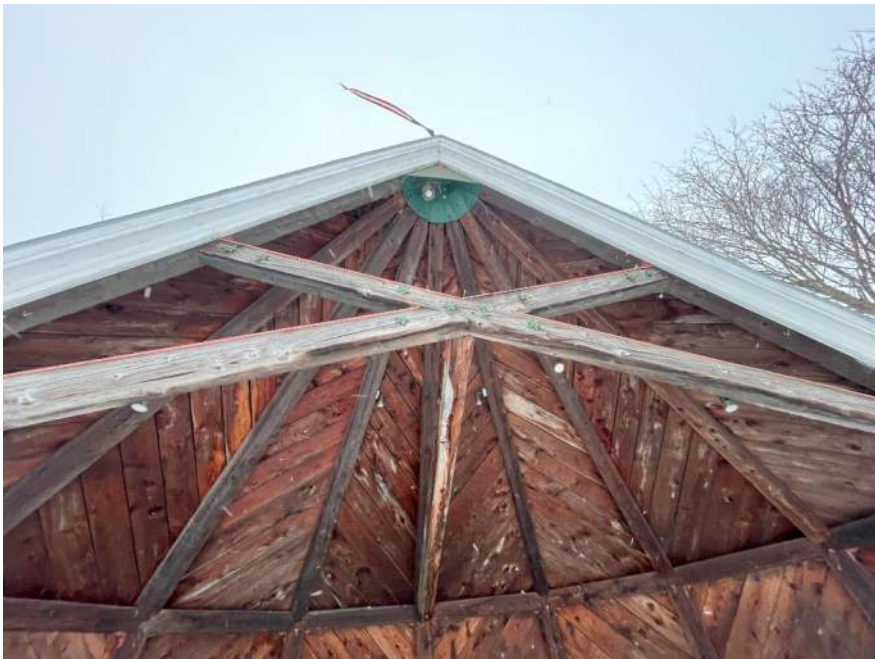
TRUSS HEEL JOINT CONNECTION

The timber scissors truss is in poor condition. There is evidence of deterioration and the connections appear to be separating. We recommend replacing this truss.

- Remove existing truss and associated trim/roofing
- Temporarily shore roof framing
- Replace truss with engineered system
- Replace finishes.

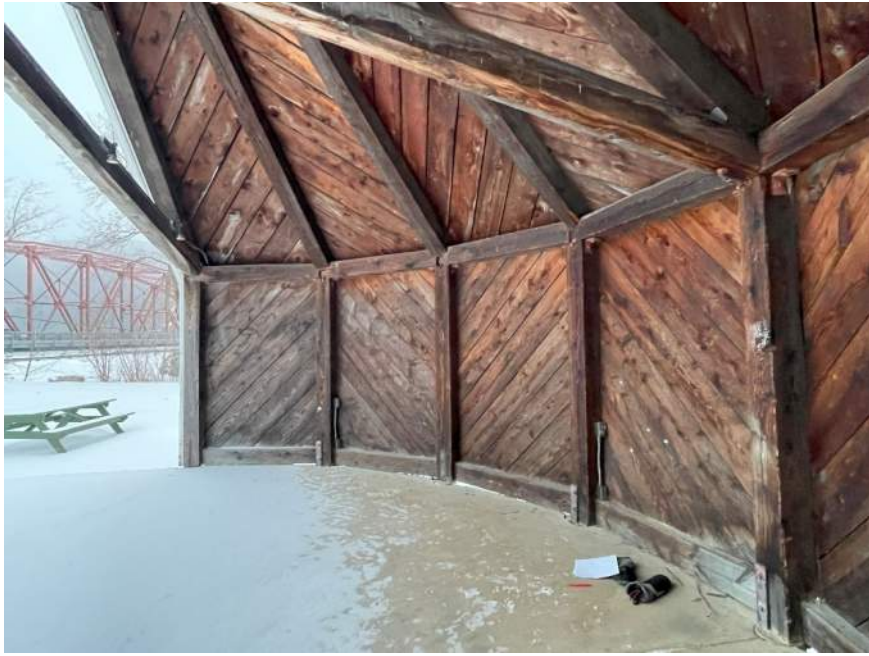
POST SUPPORTS

The timber post to foundation connection is not completely clear. The posts are offset from the concrete slightly and are supported on short cantilevered sections of steel channel. The channels sit on a short concrete pier of about 8-10" diameter. There is a steel strap bolted to the posts that appears to be embedded into the concrete or tied to the steel channel. The steel channels are only primed instead of painted for exterior exposure and are in fair condition.
