Richmond Wastewater Treatment Facility 20 Year Evaluation *60% Submittal*

Updated January 11, 2024

Prepared for:
Town of Richmond, Vermont

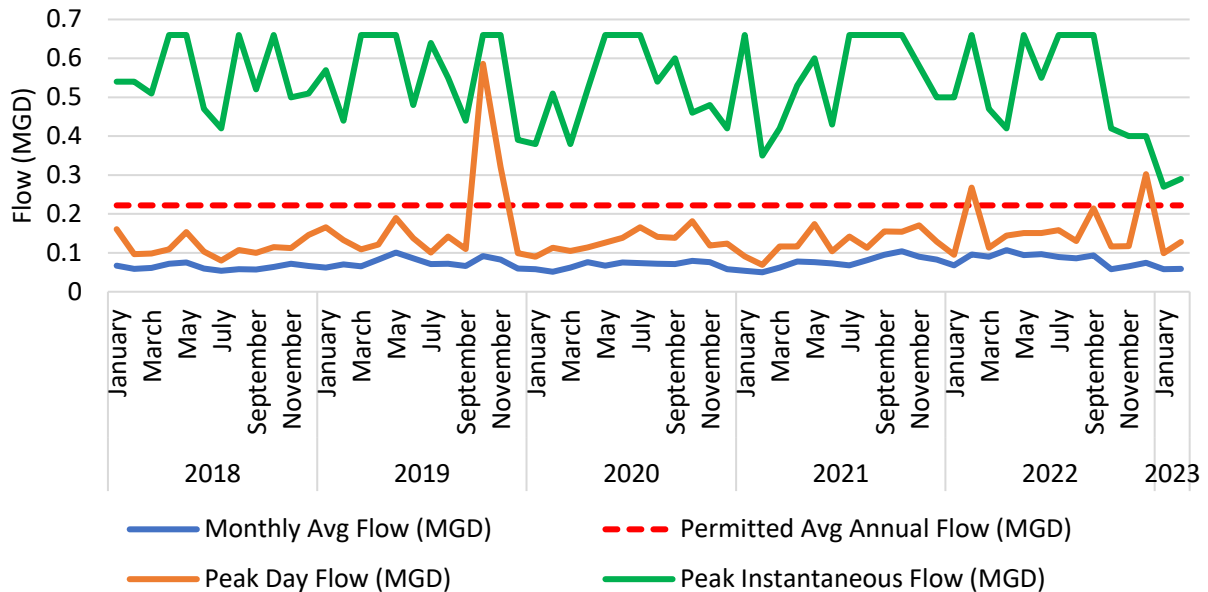
Figure 2-1 Historical Effluent Flow Data

Historical operating data suggested that the effluent flow meter maxes out at 0.66 MGD, which would indicate a calibration issue or a malfunctioning flow meter. To solve this issue, the effluent flow meter was corrected and recalibrated in early October 2023. Flow data was monitored after October 2023 to monitor peak flows. During the rain event on December 18, 2023, the flow meter recorded a peak instantaneous flow of 2.3 MGD.

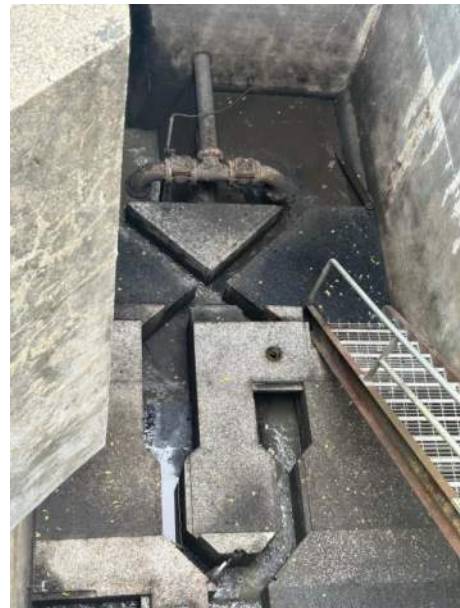
Figure 2-11 Influent Wet Well

Raw wastewater from the collection system enters the Richmond WWTF at the influent wet well, located next to the Operations Building, where it is mixed with RAS, pressate, and filter backwash. The roof drains for the Operations Building also drain to the wet well. The wet well is divided into two cells and the operators indicated that only one side of the wet well is being used due to problems with rags, bricks and stones that make their way through the collection system. A level transmitter in the wet well controls the pumping speed of the influent pumps which are located inside the Operations Building basement. The concrete of the wet well structure was not inspected during the field visit and the condition of the structure is unknown.

- Influent grinder has been removed.
- Hatch not available for pump removal
- Roof drains are connected to the wet well.
- The concrete of wet well structure was not evaluated. It is recommended that a concrete assessment be conducted.
- Additional flow data is required to select influent pump replacements.

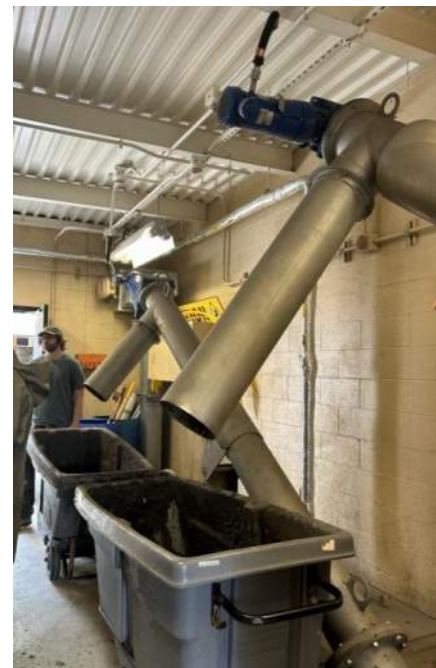
Figure 2-13 Grit Removal

The rotary-type fine screen shaft has significant wear and while the screen does catch some rags, the operators indicate that it doesn't work well. The grit auger has significant wear and has been patched over the years. The operators indicated that grit that is captured is not being properly dewatered resulting in a product with a mud-like consistency. The operators have also noted a leak in the stainless steel package unit tank, which they have been patching regularly.

- The stainless tank of the package screening and grit unit is leaking.
- The effectiveness of screening and grit removal is poor.
- Grit auger is worn and has been repeatably patched.
- Grit is not properly dewatering, creating a mud-like consistency.
- Gas detection in the building is inoperable.
- Existing ventilation may not provide adequate air changes.
- No drain in the sump where package unit sits. Operators must use a trash pump to drain if level gets too high.

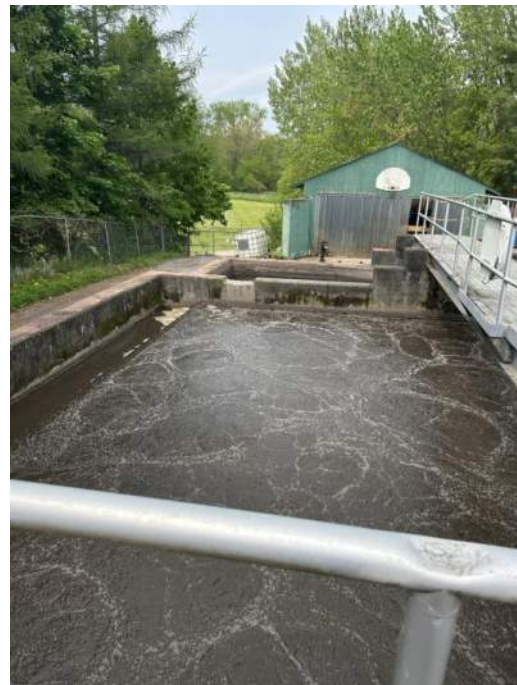
Figure 2-14 Biological Aeration Tank

The aeration tanks are original to the Richmond WWTF and were constructed in 1972. The concrete of the tank structures was not evaluated during the site visit. The diffusers were not inspected during the site visit, however a uniform bubble pattern in the operating tank suggests that the diffusers are functioning as intended. The operators noted that Aeration Tank #1 was drained and cleaned out recently, however, Aeration Tank #2 has not been cleaned since the upgrade. The operators indicated that it is difficult to balance air in the air header between the tanks using manually operated butterfly valves and would like to see dedicated air lines from each blower to each aeration tank.

- Only mixers in anoxic selectors #2 and #3 are operable, and only one mixer has an explosion-proof motor.
- Aeration Tank #2 has not been cleaned out since the 2005 upgrade.
- Blowers cycle on/off from SCADA but are not controlled by the D.O. probe in the active aeration basin. New D.O. probes are needed.
- Blower intake is from a sealed aerated solids holding tank and shows significant signs of corrosion in the garage, outdoor air intake was disconnected due to noise complaints.
- Air balance to the aeration tanks is challenging due to manually operated butterfly valves.
- The concrete tank structures of the anoxic tanks nor aeration tanks were not evaluated. It is recommended that a concrete assessment be conducted.
- Data on mixed liquor suspended solids (MLSS) is not collected at the facility.

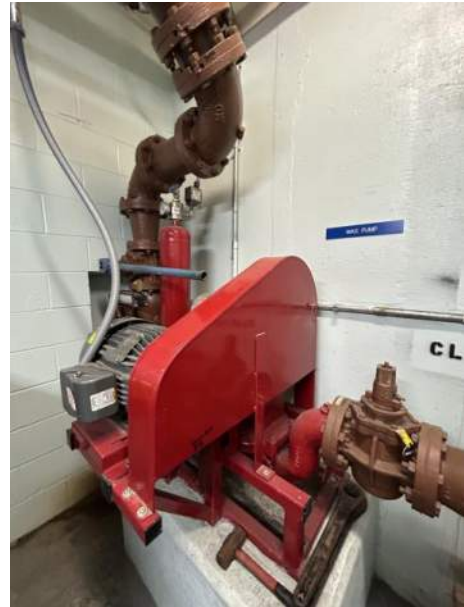
Figure 2-17 WAS Pump

There is one (1) waste activated sludge (WAS) pump located in the Pump Room in the lower level of the Operations Building. The WAS pump is a 7.5 HP Penn Valley Pump double disc, positive displacement pump rated for 150 gpm at 18 ft TDH. The WAS pump moves sludge to the aerated holding basins. The original design also allowed for the WAS to be pumped to the Aerobic Sludge Holding Tank. Operators indicated that many of the valves on the discharge piping are frozen, although they are systematically rebuilding them one at a time. WAS is wasted two (2) times per day for 1-hour intervals and is controlled by a timer. Operators indicate that the pump model is obsolete, and it is hard to get parts.

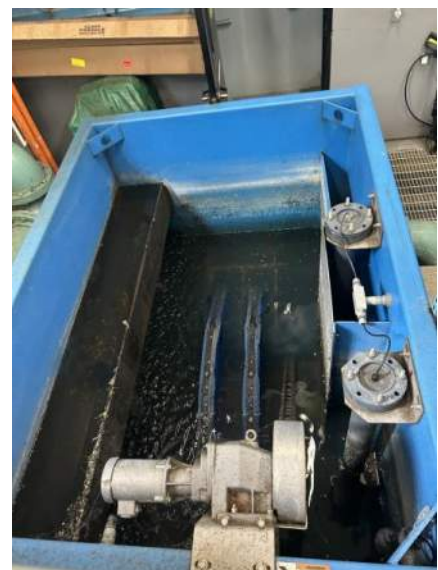
Figure 2-18 Filtration Tank

During the site visit, corrosion of the steel tanks was observed.

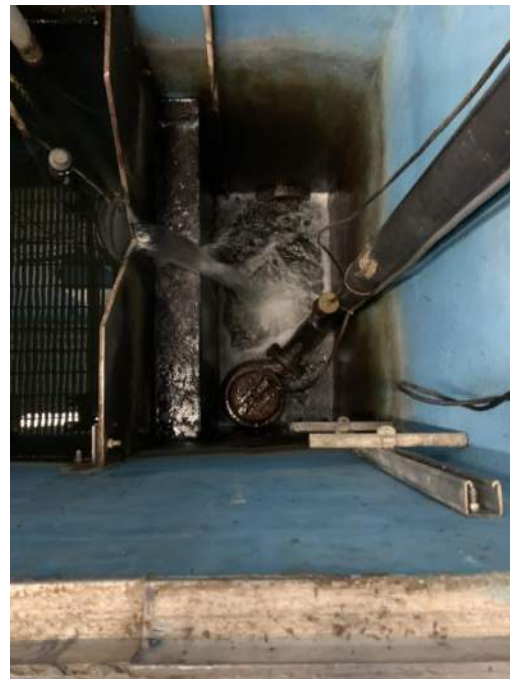
Figure 2-20 Effluent Wet Well & V-Notch

Flow leaving the UV disinfection system flows from the UV outlet transition box through a 12-inch pipe into the effluent wet well. Effluent flow measurement is achieved by the use of a 90° v-notch weir and an ultrasonic level detector in the wet well. The 90° v-notch weir can accurately measure up to 1.616 MGD with 1.0 feet of head above the bottom of the v-notch according to Isco Open Channel Flow Measurement Handbook, 3rd Edition. Historical operating data suggested that the open channel Sigma 980 effluent flow meter seems to max out at 0.66 MGD, which would indicate a calibration issue or a malfunctioning flow meter. To solve this issue, the effluent flow meter was corrected and recalibrated. Additional effluent flow data collection beginning in October 2023 will help inform design criteria.

The TR-16 Standard is to accurately measure peak flows at the 25-year flood elevation and protect against the 100-year flood. As discussed in Section 1.4.2, the 100-year and 500-year flood elevations at the Richmond WWTF site are EL. 310.50 ft and EL. 313.77 ft, respectively. The invert of the v-notch weir is EL. 306.14 ft, which is below the updated 100-year flood elevation. A check valve is located on the effluent line to prevent water from hydraulically backing up the outfall during a 100-year or 500-year flood event. During the recent July 2023 flooding event, emergency use of a sump pump to lift flows to an external discharge point was used to prevent flooding of the Filter/UV Room. While the sump pump was able to keep up with flows during the most recent flooding event, it has not been properly sized to handle peak flows and provide redundancy.

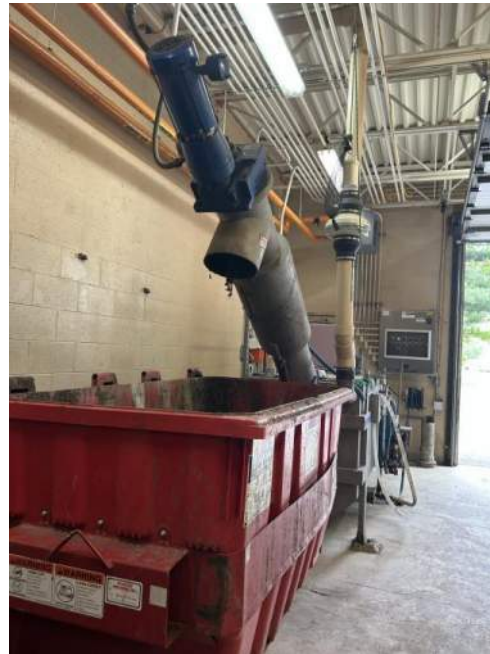
Figure 2-21 Septage Receiving Unit

The Richmond WWTF has the ability to accept up to 2,000,000 gallons of septage per year. Septage receiving facilities consist of a septage receiving unit located on the upper level of the Processing Building with two (2) aerated holding basins below. The septage receiving unit consists of a cylindrical bar screen complete with screen basket, rotating rake, cleaning comp, screw conveyor, dewatering screw, screenings press with drive unit mounted in a stainless-steel tank, tank spray wash system, motorized inlet valve, and liquid level sensing system. Septage haulers manually record the volumes discharged. The Town has indicated that they would prefer to have a flow meter on the discharge to allow for more accurate record keeping.

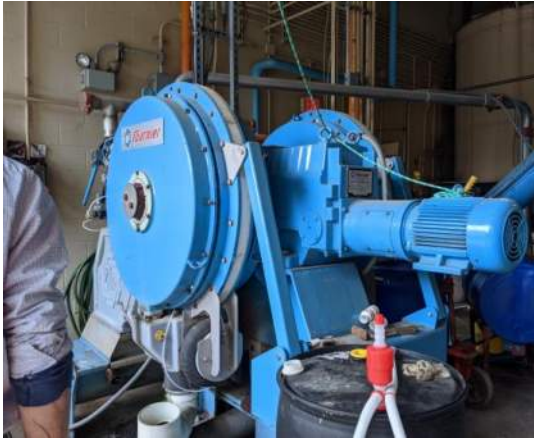
Figure 2-24 Rotary Press

The sludge feed pump pumps sludge directly to the dewatering equipment, specifically the flocculator, where sludge is mixed with polymer from the polymer feed system. This pump is directly controlled by the rotary press PLC. The inspection report noted that sludge gravity flows through the pump from the day tank, either indicating that new pump interior parts are needed, or sludge valves need replacing.

pump. Conditioned sludge then enters a manifold and is divided into a series of circular channels. In the channel, sludge is sandwiched between two (2) low speed rotating perforated screens. The operators noted that maintenance on the rotary press has lapsed, resulting in operational issues. It was noted that regular cleaning is necessary every six months at a minimum. Currently, only one (1) channel in the two (2) channel rotary press is operational. The manufacturer's report indicates that the one inoperable channel has significant damage to its screen, however all four screens are very worn.

- Significant wear and damage to the screens of the dewatering press screens was observed by the manufacturer’s technician during the September 30th site visit. Significant repairs are warranted to keep dewatering operations functional.

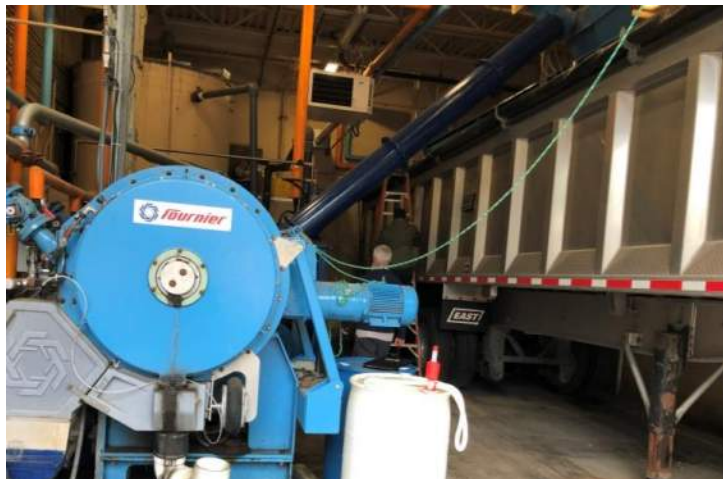
Figure 2-25 Rotary Press Conveyor System

A conveyor system is used to transfer dewatered sludge cake from the rotary press to a roll-off container where it is taken off-site for final disposal.

3. Panel HMI – The installation of a new panel would make it easier for the operators to use the press. The current old program is outdated and not optimal.
4. Conveyor system – There are a couple holes that need to be patched or sections replaced.

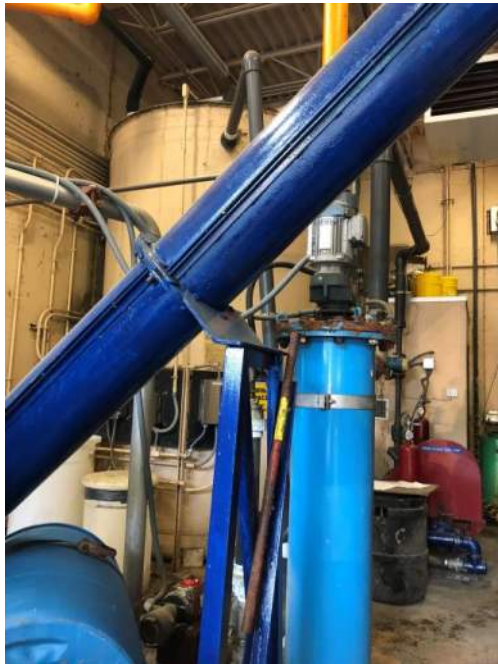
Figure 2-26 Inclined Conveyor

The conveyor consists of three parts: a discharge conveyor, the inclined conveyor, and the distributing conveyor. All three are hollow flight screw type conveyors. The discharge conveyor runs horizontally for 9 feet from the discharge chutes of both channels of the rotary press to the inclined conveyor. The inclined conveyor is 20 feet in length with an approximate slope of 37 degrees. This conveyor brings dewatered cake up to the middle of the distributing conveyor. The distributing conveyor is approximately 32 feet in length and is elevated over the parked roll-off container. The distributing conveyor has openings at either end, and two pneumatically operated slide gates to distribute dried cake evenly within the container. The hollow flight conveyor within the distributing conveyor has a reversing motor to allow cake to be discharged to either end. The operators noted that both the auger and screw were replaced in the Spring of 2022, and that the screw broke again in December of 2022. During the repair, staff noted that the liner needed to be replaced.

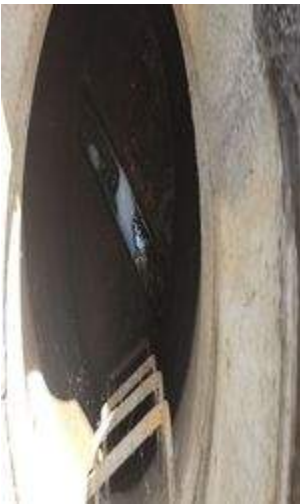
Asset ID
BK 01

Notes	
Structural Notes	
General Notes	Needs cleaning sewage in channel blocking flow at the outlet.

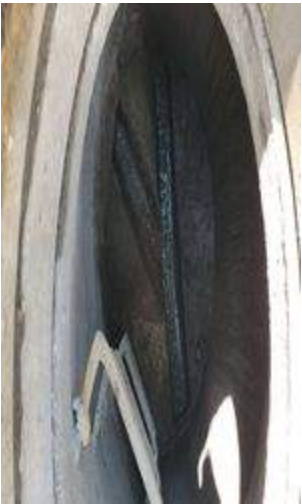
Asset ID
BR 01

Manhole Condition	
What is the cover condition?	Serviceable
Other notes on the cover?	
What is the ring and frame condition?	Serviceable
Other notes on the ring and frame?	Rusted
What is the cone and riser condition?	Serviceable
Other notes on the cone and riser?	
What is the barrel condition?	Serviceable
What is the ladder condition?	Serviceable
What is the bench condition?	Serviceable
Other notes on the bench?	
What is the channel condition?	Serviceable
Other notes on the channel?

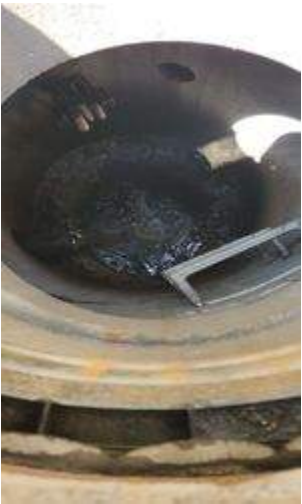
Asset ID
BR 02

General	
Structural Condition	Good
Operational Condition	Good
Debris Amount	Moderate
Cleaning Needed	Yes
Standing Water	No
Flow	Heavy
Maintenance Needed	No

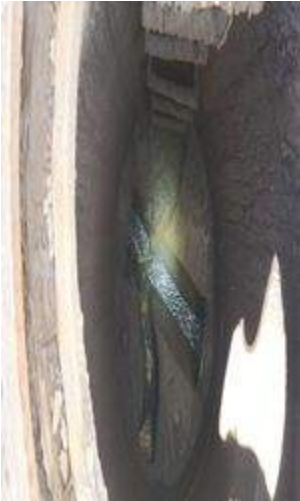
Asset ID
BR 06

General	
Structural Condition	Good
Operational Condition	Good
Debris Amount	Moderate
Cleaning Needed	Yes
Standing Water	No
Flow	Steady
Maintenance Needed	No

Notes	
Structural Notes	
General Notes	Signs of previous infiltration

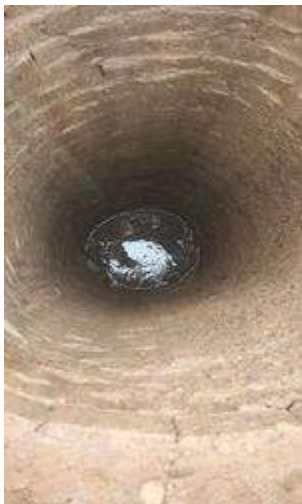
Asset ID
BR 08

Hydraulics	
Indication of surcharge?	Minor
Issues related to surcharge?	Silt
Level of infiltration?

General	
Structural Condition	Good
Operational Condition	Good
Debris Amount	None
Cleaning Needed	No
Standing Water	Yes
Flow	Steady
Maintenance Needed	No

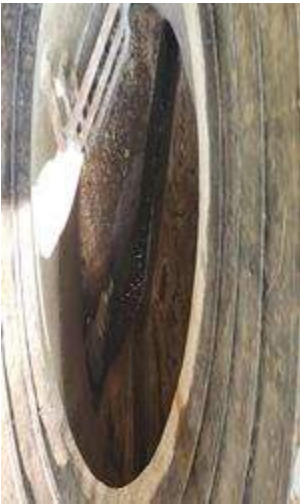
Asset ID
 BU 01

Manhole Condition	
What is the cover condition?	Serviceable
Other notes on the cover?	
What is the ring and frame condition?	Serviceable
Other notes on the ring and frame?	
What is the cone and riser condition?	Serviceable
Other notes on the cone and riser?	
What is the barrel condition?	Serviceable
What is the ladder condition?	Serviceable
What is the bench condition?	Serviceable
Other notes on the bench?	
What is the channel condition?	Serviceable, Obstructed
Other notes on the channel?	Need to remove the detached reducer.

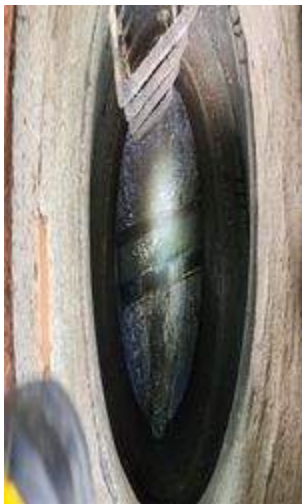
Asset ID
CH 01

Manhole Condition	
What is the cover condition?	Serviceable
Other notes on the cover?	
What is the ring and frame condition?	Serviceable
Other notes on the ring and frame?	
What is the cone and riser condition?	Serviceable
Other notes on the cone and riser?	
What is the barrel condition?	Serviceable
What is the ladder condition?	Serviceable
What is the bench condition?	Serviceable
Other notes on the bench?	Debris buildup on bench from inlet at 3 o'clock
What is the channel condition?	Serviceable
Other notes on the channel?

General	
Structural Condition	Good
Operational Condition	Good
Debris Amount	Moderate
Cleaning Needed	Yes
Standing Water	No
Flow	Trickle
Maintenance Needed	No

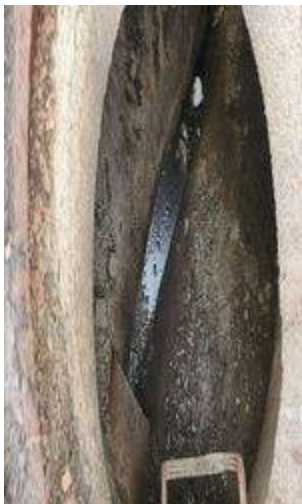
Asset ID
CH 04

Manhole Condition	
What is the cover condition?	Serviceable
Other notes on the cover?	
What is the ring and frame condition?	Serviceable
Other notes on the ring and frame?	
What is the cone and riser condition?	Serviceable
Other notes on the cone and riser?	
What is the barrel condition?	Serviceable
What is the ladder condition?	Serviceable
What is the bench condition?	Serviceable
Other notes on the bench?	Debris on bench
What is the channel condition?	Serviceable
Other notes on the channel?	Standing water and debris

General	
Structural Condition	Good
Operational Condition	Good
Debris Amount	Slight
Cleaning Needed	No
Standing Water	Yes
Flow	None
Maintenance Needed	No

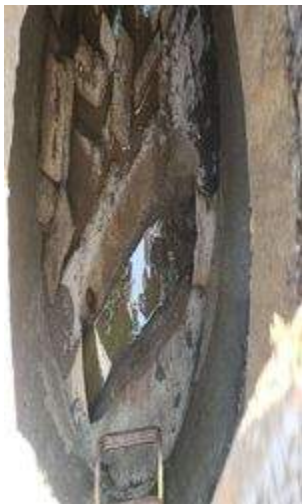
Manhole Condition	
What is the cover condition?	Serviceable
Other notes on the cover?	
What is the ring and frame condition?	Serviceable
Other notes on the ring and frame?	Some rust
What is the cone and riser condition?	Serviceable
Other notes on the cone and riser?	
What is the barrel condition?	Serviceable
What is the ladder condition?	Serviceable
What is the bench condition?	Serviceable
Other notes on the bench?	Heavy debris
What is the channel condition?	Serviceable
Other notes on the channel?

General	
Structural Condition	Good
Operational Condition	Good
Debris Amount	Heavy
Cleaning Needed	Yes
Standing Water	Yes
Flow	None
Maintenance Needed	No

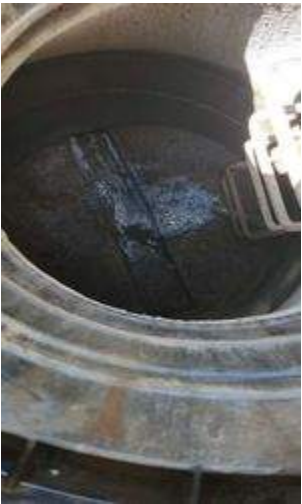
Asset ID
CO 01

Hydraulics	
Indication of surcharge?	Minor
Issues related to surcharge?	Debris, Silt
Level of infiltration?

Manhole Condition	
What is the cover condition?	Servicable
Other notes on the cover?	
What is the ring and frame condition?	Serviceable
Other notes on the ring and frame?	
What is the cone and riser condition?	Serviceable
Other notes on the cone and riser?	
What is the barrel condition?	Serviceable
What is the ladder condition?	Serviceable
What is the bench condition?	Serviceable
Other notes on the bench?	
What is the channel condition?	Serviceable
Other notes on the channel?	Debris

General	
Structural Condition	Good
Operational Condition	Good
Debris Amount	Slight
Cleaning Needed	No
Standing Water	No
Flow	None
Maintenance Needed	No

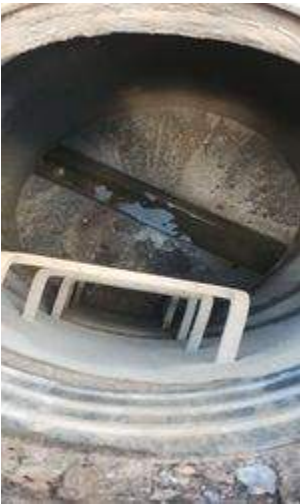
Asset ID
CO 02

Hydraulics	
Indication of surcharge?	None
Issues related to surcharge?	
Level of infiltration?

Manhole Condition	
What is the cover condition?	Serviceable, Damaged
Other notes on the cover?	Rusting
What is the ring and frame condition?	Serviceable
Other notes on the ring and frame?	Rusting
What is the cone and riser condition?	Serviceable
Other notes on the cone and riser?	
What is the barrel condition?	Serviceable
What is the ladder condition?	Serviceable
What is the bench condition?	Serviceable
Other notes on the bench?	
What is the channel condition?	Serviceable
Other notes on the channel?	Slow moving

General	
Structural Condition	Good
Operational Condition	Good
Debris Amount	Slight
Cleaning Needed	No
Standing Water	Yes
Flow	Trickle
Maintenance Needed	No

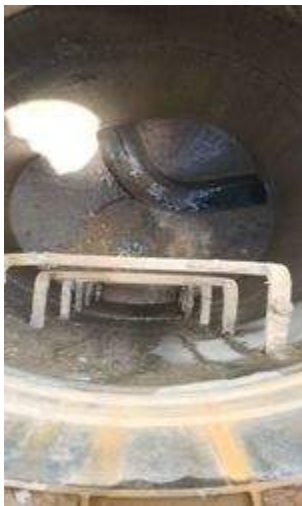
Asset ID
CO 03

Manhole Condition	
What is the cover condition?	Serviceable
Other notes on the cover?	
What is the ring and frame condition?	Serviceable
Other notes on the ring and frame?	
What is the cone and riser condition?	Serviceable
Other notes on the cone and riser?	
What is the barrel condition?	Serviceable, Infiltration
What is the ladder condition?	Serviceable
What is the bench condition?	Serviceable
Other notes on the bench?	
What is the channel condition?	Serviceable
Other notes on the channel?

General	
Structural Condition	Good
Operational Condition	Good
Debris Amount	None
Cleaning Needed	No
Standing Water	No
Flow	Trickle
Maintenance Needed	No

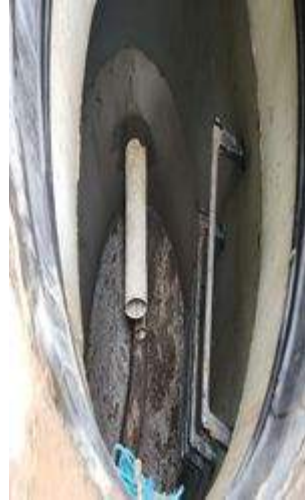
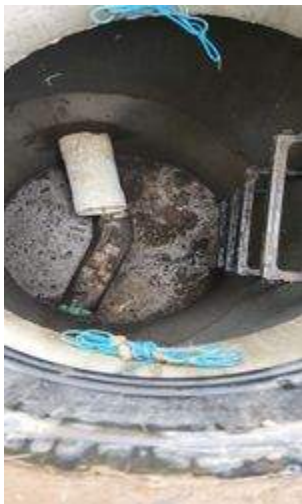
Asset ID
 DP 01

Manhole Condition	
What is the cover condition?	Serviceable
Other notes on the cover?	
What is the ring and frame condition?	Serviceable, Missing Grout
Other notes on the ring and frame?	
What is the cone and riser condition?	Serviceable
Other notes on the cone and riser?	
What is the barrel condition?	Serviceable
What is the ladder condition?	Serviceable
What is the bench condition?	Serviceable
Other notes on the bench?	
What is the channel condition?	Serviceable
Other notes on the channel?

General	
Structural Condition	Good
Operational Condition	Good
Debris Amount	Slight
Cleaning Needed	No
Standing Water	No
Flow	None
Maintenance Needed	No

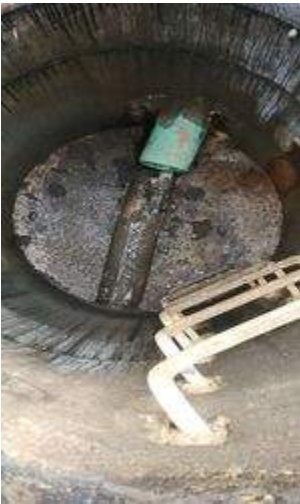
Asset ID
DP 02

Hydraulics	
Indication of surcharge?	Minor
Issues related to surcharge?	Grease, Debris
Level of infiltration?

Manhole Condition	
What is the cover condition?	Serviceable
Other notes on the cover?	
What is the ring and frame condition?	Serviceable
Other notes on the ring and frame?	
What is the cone and riser condition?	Serviceable
Other notes on the cone and riser?	
What is the barrel condition?	Serviceable
What is the ladder condition?	Serviceable
What is the bench condition?	Serviceable
Other notes on the bench?	
What is the channel condition?	Serviceable
Other notes on the channel?

General	
Structural Condition	Good
Operational Condition	Good
Debris Amount	None
Cleaning Needed	No
Standing Water	No
Flow	Trickle
Maintenance Needed	No

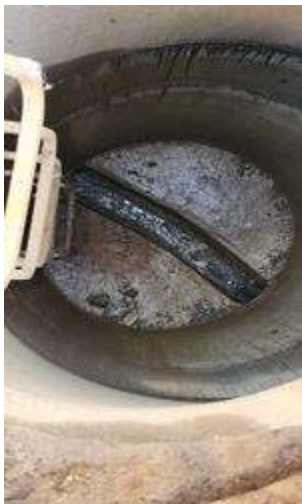
Asset ID
DP 07

Manhole Condition	
What is the cover condition?	Serviceable
Other notes on the cover?	
What is the ring and frame condition?	Serviceable
Other notes on the ring and frame?	Some rust
What is the cone and riser condition?	Serviceable, Misaligned
Other notes on the cone and riser?	
What is the barrel condition?	Serviceable
What is the ladder condition?	Serviceable
What is the bench condition?	Serviceable
Other notes on the bench?	
What is the channel condition?	Serviceable
Other notes on the channel?

General	
Structural Condition	Good
Operational Condition	Good
Debris Amount	None
Cleaning Needed	No
Standing Water	No
Flow	Trickle
Maintenance Needed	No

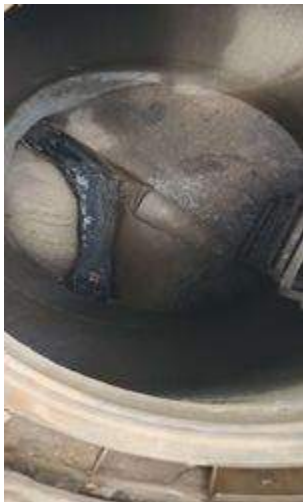
Asset ID
 ES 01

Manhole Condition	
What is the cover condition?	Servicable
Other notes on the cover?	
What is the ring and frame condition?	Loose, Displaced
Other notes on the ring and frame?	Cover is stuck inside ring.
What is the cone and riser condition?	Serviceable
Other notes on the cone and riser?	
What is the barrel condition?	Serviceable
What is the ladder condition?	Serviceable
What is the bench condition?	Serviceable
Other notes on the bench?	
What is the channel condition?	Serviceable
Other notes on the channel?	Small amount of debris in channel

General	
Structural Condition	Fair
Operational Condition	Good
Debris Amount	Slight
Cleaning Needed	No
Standing Water	No
Flow	Trickle
Maintenance Needed	Yes

Notes	
Structural Notes	Loose frame and ring
General Notes

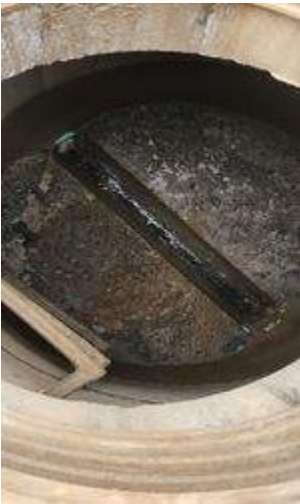
Asset ID
ES 02

Manhole Condition	
What is the cover condition?	Serviceable
Other notes on the cover?	
What is the ring and frame condition?	Serviceable
Other notes on the ring and frame?	
What is the cone and riser condition?	Serviceable, Misaligned
Other notes on the cone and riser?	
What is the barrel condition?	Serviceable
What is the ladder condition?	Serviceable
What is the bench condition?	Serviceable
Other notes on the bench?	
What is the channel condition?	Serviceable
Other notes on the channel?

General	
Structural Condition	Good
Operational Condition	Good
Debris Amount	Slight
Cleaning Needed	No
Standing Water	No
Flow	None
Maintenance Needed	No

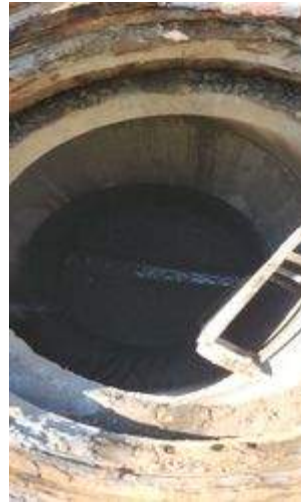
Asset ID
 HU 02

Manhole Condition	
What is the cover condition?	Serviceable
Other notes on the cover?	
What is the ring and frame condition?	Serviceable
Other notes on the ring and frame?	
What is the cone and riser condition?	Serviceable
Other notes on the cone and riser?	
What is the barrel condition?	Serviceable
What is the ladder condition?	Serviceable
What is the bench condition?	Serviceable
Other notes on the bench?	
What is the channel condition?	Serviceable
Other notes on the channel?	Bit of debris looks like rags

General	
Structural Condition	Good
Operational Condition	Good
Debris Amount	Slight
Cleaning Needed	No
Standing Water	No
Flow	Steady
Maintenance Needed	No

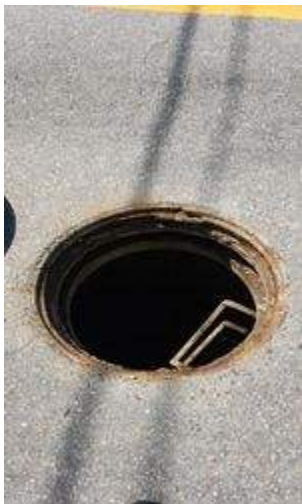
Asset ID
JO 01

Manhole Condition	
What is the cover condition?	Serviceable
Other notes on the cover?	
What is the ring and frame condition?	Serviceable
Other notes on the ring and frame?	
What is the cone and riser condition?	Serviceable
Other notes on the cone and riser?	
What is the barrel condition?	Serviceable
What is the ladder condition?	Serviceable
What is the bench condition?	Serviceable
Other notes on the bench?	
What is the channel condition?	Serviceable, Obstructed
Other notes on the channel?

General	
Structural Condition	Good
Operational Condition	Good
Debris Amount	Slight
Cleaning Needed	No
Standing Water	No
Flow	Trickle
Maintenance Needed	No

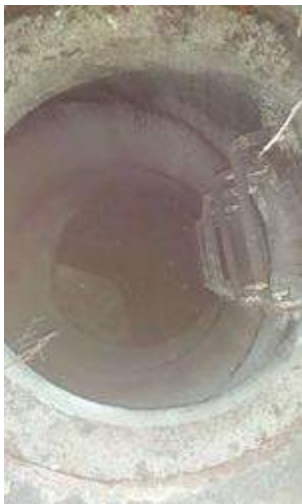
Asset ID
 NM 02

Manhole Condition	
What is the cover condition?	Serviceable
Other notes on the cover?	
What is the ring and frame condition?	Serviceable
Other notes on the ring and frame?	Rusted but functional
What is the cone and riser condition?	Serviceable
Other notes on the cone and riser?	
What is the barrel condition?	Serviceable
What is the ladder condition?	Serviceable
What is the bench condition?	Serviceable
Other notes on the bench?	
What is the channel condition?	Serviceable
Other notes on the channel?

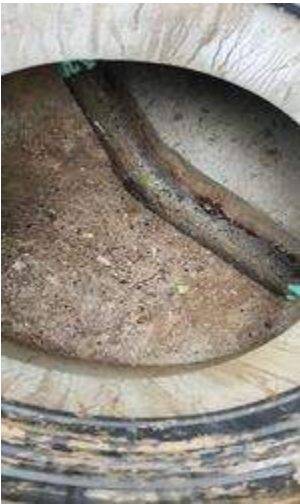
Asset ID
 NM 04

Hydraulics	
Indication of surcharge?	Minor
Issues related to surcharge?	Debris, Infiltration
Level of infiltration?	Some

Manhole Condition	
What is the cover condition?	Serviceable
Other notes on the cover?	
What is the ring and frame condition?	Serviceable
Other notes on the ring and frame?	Rusted
What is the cone and riser condition?	Serviceable
Other notes on the cone and riser?	Missing bricks
What is the barrel condition?	Serviceable
What is the ladder condition?	Serviceable
What is the bench condition?	Serviceable
Other notes on the bench?	
What is the channel condition?	Serviceable
Other notes on the channel?

General	
Structural Condition	Good
Operational Condition	Good
Debris Amount	Moderate
Cleaning Needed	No
Standing Water	No
Flow	Steady
Maintenance Needed	Yes

Notes	
Structural Notes	Missing bricks in riser and bricks/debris in the channel
General Notes

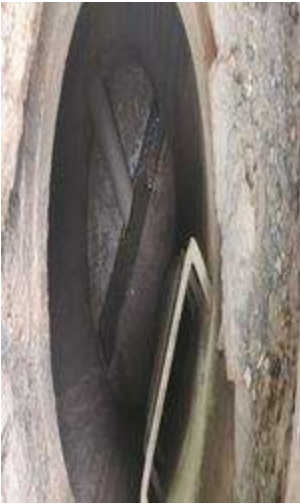
Asset ID
 NM 05

Manhole Condition	
What is the cover condition?	Serviceable
Other notes on the cover?	
What is the ring and frame condition?	Serviceable
Other notes on the ring and frame?	
What is the cone and riser condition?	Serviceable, Misaligned
Other notes on the cone and riser?	Missing some bricks
What is the barrel condition?	Serviceable
What is the ladder condition?	Serviceable
What is the bench condition?	Serviceable
Other notes on the bench?	
What is the channel condition?	Serviceable, Obstructed
Other notes on the channel?

General	
Structural Condition	Good
Operational Condition	Good
Debris Amount	Moderate
Cleaning Needed	Yes
Standing Water	No
Flow	Steady
Maintenance Needed	Yes

Notes	
Structural Notes	Need to replace bricks in riser
General Notes	Need to clean and remove debris in channel

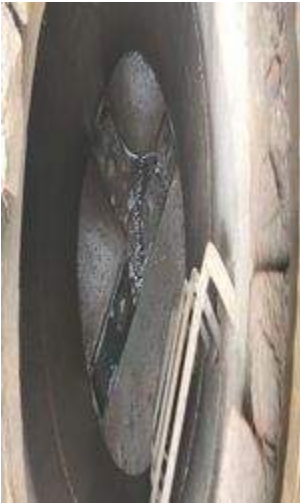
Asset ID
 NM 06

Manhole Condition	
What is the cover condition?	Serviceable
Other notes on the cover?	
What is the ring and frame condition?	Serviceable
Other notes on the ring and frame?	
What is the cone and riser condition?	Serviceable
Other notes on the cone and riser?	Missing bricks in riser
What is the barrel condition?	Serviceable
What is the ladder condition?	Serviceable
What is the bench condition?	Serviceable, Cracked/Broken
Other notes on the bench?	Some missing pieces but doesn't affect operation
What is the channel condition?	Serviceable, Obstructed
Other notes on the channel?	Bricks from the riser in the channel

Notes	
Structural Notes	Some missing bricks in riser but okay for now
General Notes

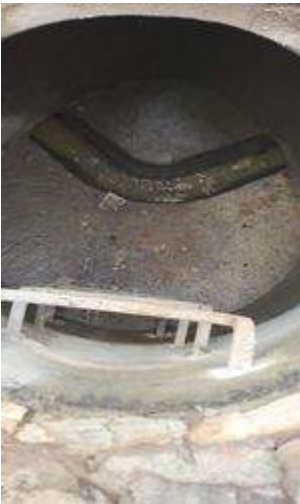
Asset ID
 NM 08

Manhole Condition	
What is the cover condition?	Serviceable
Other notes on the cover?	
What is the ring and frame condition?	Serviceable
Other notes on the ring and frame?	
What is the cone and riser condition?	Serviceable
Other notes on the cone and riser?	
What is the barrel condition?	Serviceable
What is the ladder condition?	Serviceable
What is the bench condition?	Serviceable
Other notes on the bench?	A lot of debris on bench.
What is the channel condition?	Serviceable, Obstructed
Other notes on the channel?	Full of sewage. Needs cleaning.

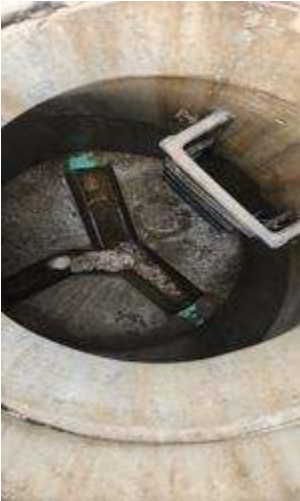
Asset ID
RR 02

Manhole Condition	
What is the cover condition?	Serviceable
Other notes on the cover?	
What is the ring and frame condition?	Serviceable
Other notes on the ring and frame?	
What is the cone and riser condition?	Serviceable
Other notes on the cone and riser?	
What is the barrel condition?	Serviceable
What is the ladder condition?	Serviceable
What is the bench condition?	Serviceable
Other notes on the bench?	
What is the channel condition?	Obstructed
Other notes on the channel?	Debris in the channel. Needs to be cleaned.

General	
Structural Condition	Good
Operational Condition	Fair
Debris Amount	Moderate
Cleaning Needed	Yes
Standing Water	Yes
Flow	Trickle
Maintenance Needed	No

Notes	
Structural Notes	
General Notes	Needs cleaning. Water backing up.

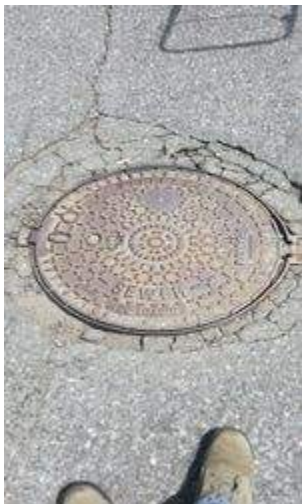
Asset ID
RR 04

Notes	
Structural Notes	
General Notes	Unable to open

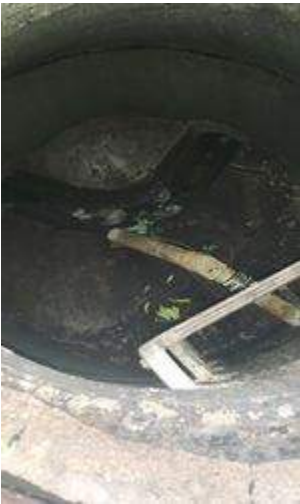
Asset ID
SM 01

Manhole Condition	
What is the cover condition?	Serviceable
Other notes on the cover?	
What is the ring and frame condition?	Serviceable
Other notes on the ring and frame?	
What is the cone and riser condition?	Serviceable
Other notes on the cone and riser?	
What is the barrel condition?	Serviceable
What is the ladder condition?	Serviceable
What is the bench condition?	Serviceable
Other notes on the bench?	
What is the channel condition?	Serviceable, Obstructed
Other notes on the channel?	Rags in the channel

General	
Structural Condition	Good
Operational Condition	Good
Debris Amount	None
Cleaning Needed	Yes
Standing Water	No
Flow	Trickle
Maintenance Needed	No

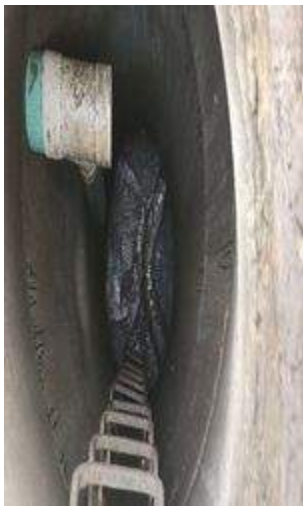
Asset ID
SM 02

Manhole Condition	
What is the cover condition?	Serviceable
Other notes on the cover?	
What is the ring and frame condition?	Serviceable
Other notes on the ring and frame?	
What is the cone and riser condition?	Serviceable, Cracked/Broken
Other notes on the cone and riser?	
What is the barrel condition?	Serviceable
What is the ladder condition?	Serviceable
What is the bench condition?	Serviceable
Other notes on the bench?	
What is the channel condition?	Serviceable
Other notes on the channel?

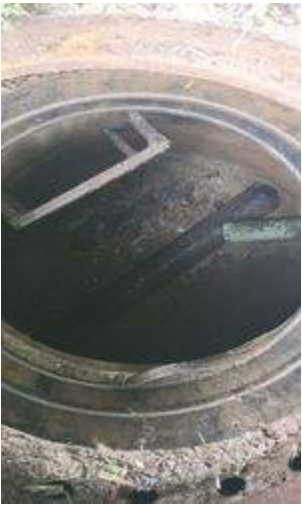
Asset ID
SM 03

Manhole Condition	
What is the cover condition?	Serviceable
Other notes on the cover?	
What is the ring and frame condition?	Serviceable
Other notes on the ring and frame?	
What is the cone and riser condition?	Serviceable, Misaligned
Other notes on the cone and riser?	
What is the barrel condition?	Serviceable
What is the ladder condition?	Serviceable
What is the bench condition?	Serviceable
Other notes on the bench?	
What is the channel condition?	Serviceable
Other notes on the channel?

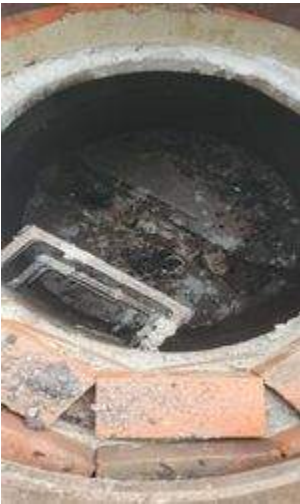
Asset ID
SM 04

Manhole Condition	
What is the cover condition?	Serviceable
Other notes on the cover?	
What is the ring and frame condition?	Serviceable
Other notes on the ring and frame?	
What is the cone and riser condition?	Serviceable, Misaligned
Other notes on the cone and riser?	
What is the barrel condition?	Serviceable
What is the ladder condition?	Serviceable
What is the bench condition?	Serviceable
Other notes on the bench?	Some debris
What is the channel condition?	Serviceable
Other notes on the channel?	Sewage in the channel

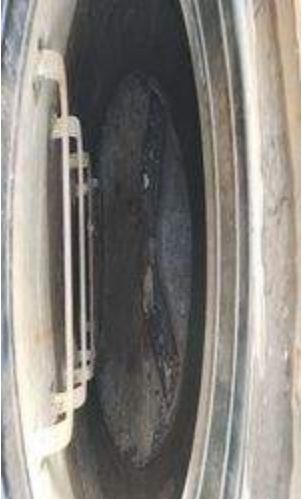
Asset ID
 TD 06

Notes	
Structural Notes	Ring and frame needs replacing
General Notes	Lots of debris in channel.

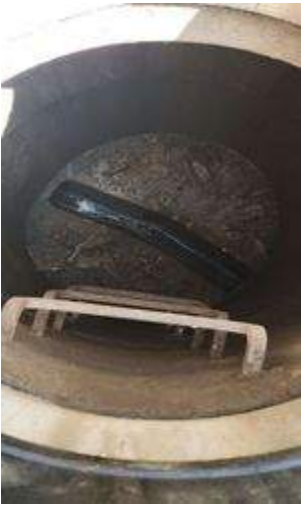
Manhole Condition	
What is the cover condition?	Servicable
Other notes on the cover?	
What is the ring and frame condition?	Serviceable
Other notes on the ring and frame?	
What is the cone and riser condition?	Serviceable
Other notes on the cone and riser?	
What is the barrel condition?	Serviceable
What is the ladder condition?	Serviceable
What is the bench condition?	Serviceable
Other notes on the bench?	Some debris
What is the channel condition?	Serviceable, Obstructed
Other notes on the channel?	Some rags in the channel.

General	
Structural Condition	Good
Operational Condition	Good
Debris Amount	Slight
Cleaning Needed	No
Standing Water	No
Flow	Trickle
Maintenance Needed	No

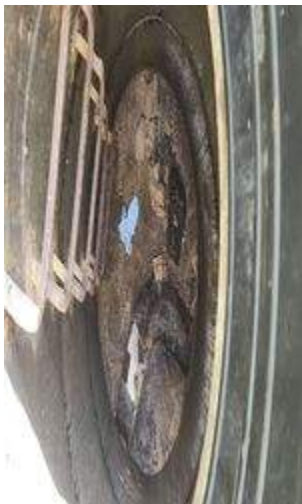
Asset ID
 TD 08

Manhole Condition	
What is the cover condition?	Serviceable
Other notes on the cover?	
What is the ring and frame condition?	Serviceable
Other notes on the ring and frame?	
What is the cone and riser condition?	Serviceable
Other notes on the cone and riser?	
What is the barrel condition?	Serviceable
What is the ladder condition?	Serviceable
What is the bench condition?	Serviceable
Other notes on the bench?	Some debris
What is the channel condition?	Serviceable, Obstructed
Other notes on the channel?	Debris blocking channel

General	
Structural Condition	Good
Operational Condition	Good
Debris Amount	Moderate
Cleaning Needed	Yes
Standing Water	Yes
Flow	Trickle
Maintenance Needed	No

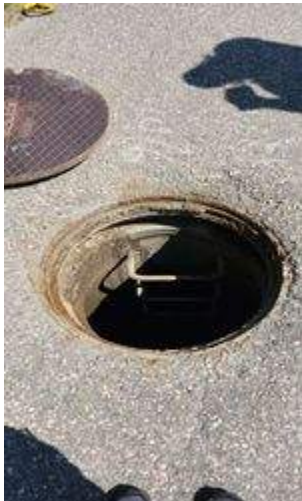
Asset ID
 TH 06

Hydraulics	
Indication of surcharge?	Minor
Issues related to surcharge?	Debris
Level of infiltration?

Manhole Condition	
What is the cover condition?	Serviceable
Other notes on the cover?	
What is the ring and frame condition?	Serviceable
Other notes on the ring and frame?	
What is the cone and riser condition?	Serviceable
Other notes on the cone and riser?	
What is the barrel condition?	Serviceable
What is the ladder condition?	Serviceable
What is the bench condition?	Serviceable
Other notes on the bench?	
What is the channel condition?	Obstructed
Other notes on the channel?	Rags in channel

General	
Structural Condition	Good
Operational Condition	Good
Debris Amount	Slight
Cleaning Needed	Yes
Standing Water	No
Flow	Steady
Maintenance Needed	No

Notes	
Structural Notes	
General Notes	Rags on ladder rung and in channel

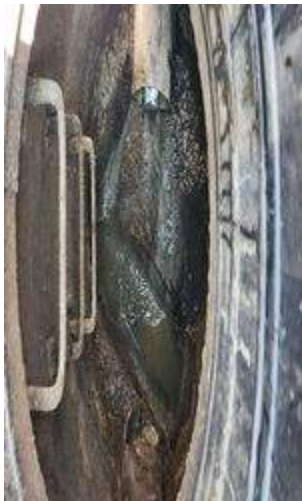
Asset ID
VG 02

Manhole Condition	
What is the cover condition?	Servicable, Damaged
Other notes on the cover?	Rusted
What is the ring and frame condition?	Servicable
Other notes on the ring and frame?	
What is the cone and riser condition?	Servicable, Misaligned
Other notes on the cone and riser?	
What is the barrel condition?	Servicable
What is the ladder condition?	Servicable
What is the bench condition?	Servicable
Other notes on the bench?	Could use some work
What is the channel condition?	Servicable
Other notes on the channel?

General	
Structural Condition	Good
Operational Condition	Good
Debris Amount	None
Cleaning Needed	No
Standing Water	No
Flow	Steady
Maintenance Needed	Yes

Notes	
Structural Notes	Frame and cover misaligned
General Notes	Bricked off overflow to the river

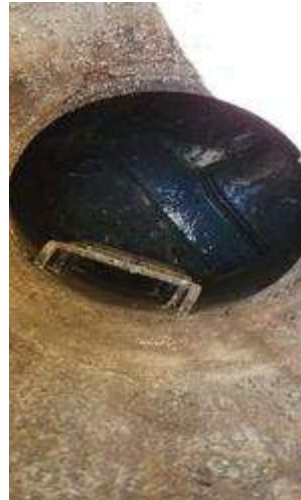
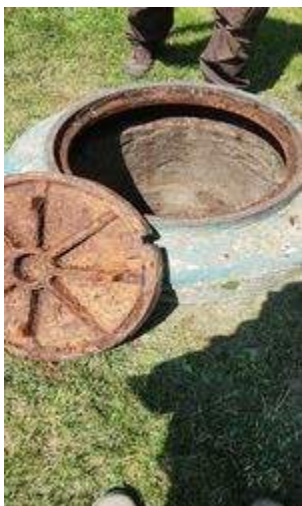
Asset ID
 VG 03

Manhole Condition	
What is the cover condition?	Serviceable
Other notes on the cover?	Rusting
What is the ring and frame condition?	Serviceable
Other notes on the ring and frame?	Rusting
What is the cone and riser condition?	Serviceable
Other notes on the cone and riser?	
What is the barrel condition?	Serviceable
What is the ladder condition?	Serviceable
What is the bench condition?	Serviceable
Other notes on the bench?	
What is the channel condition?	Serviceable
Other notes on the channel?	Debris

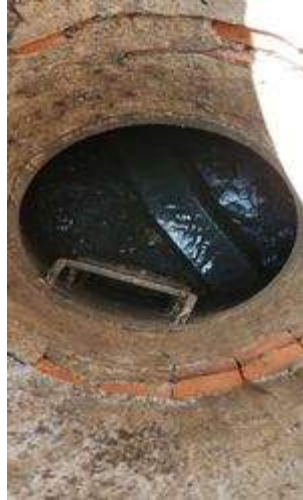
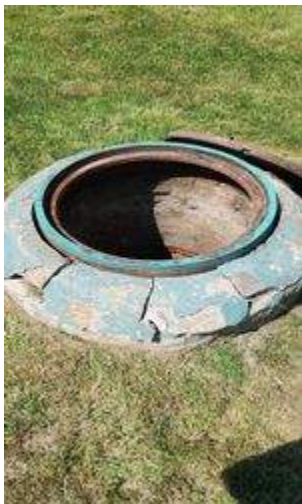
Asset ID
 VG 04

Hydraulics	
Indication of surcharge?	Minor
Issues related to surcharge?	Debris, Silt
Level of infiltration?

Manhole Condition	
What is the cover condition?	Serviceable
Other notes on the cover?	
What is the ring and frame condition?	Serviceable
Other notes on the ring and frame?	
What is the cone and riser condition?	Serviceable
Other notes on the cone and riser?	
What is the barrel condition?	Serviceable
What is the ladder condition?	Serviceable
What is the bench condition?	Serviceable
Other notes on the bench?	Debris from overflow
What is the channel condition?	Serviceable
Other notes on the channel?

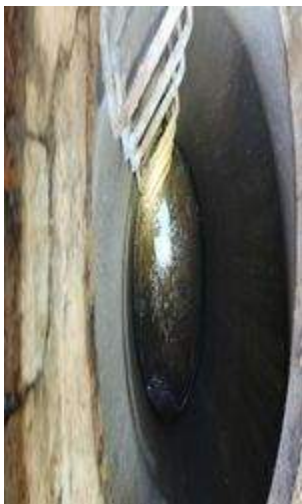
Asset ID
WW 01

General	
Structural Condition	Good
Operational Condition	Good
Debris Amount	Moderate
Cleaning Needed	
Standing Water	Yes
Flow	None
Maintenance Needed

Notes	
Structural Notes	
General Notes	Standing water. Manhole abandoned. No inlets or outlets.

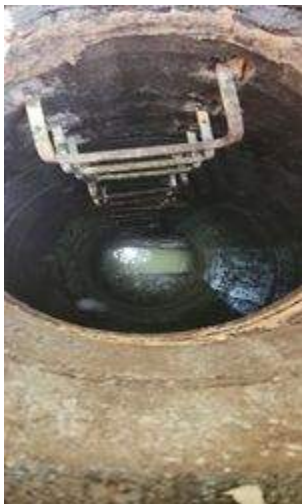
Asset ID
WW 02

General	
Structural Condition	Good
Operational Condition	Good
Debris Amount	None
Cleaning Needed	No
Standing Water	No
Flow	Steady
Maintenance Needed	No

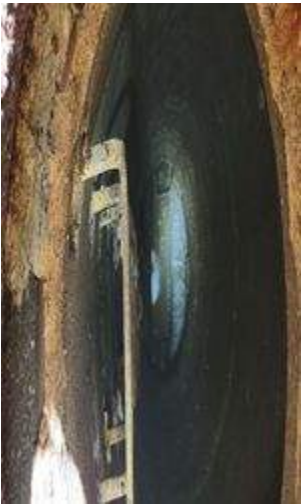
Asset ID
 WW 03

Hydraulics	
Indication of surcharge?	Minor
Issues related to surcharge?	Debris
Level of infiltration?

General	
Structural Condition	Good
Operational Condition	Good
Debris Amount	Slight
Cleaning Needed	No
Standing Water	No
Flow	Steady
Maintenance Needed	No

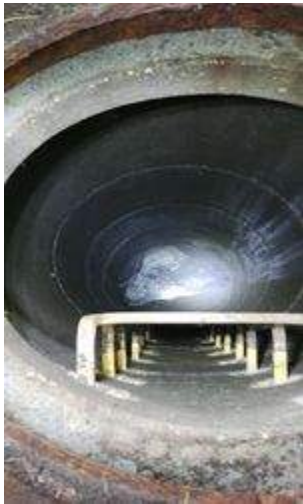
Asset ID
 WW 04

Hydraulics	
Indication of surcharge?	Minor
Issues related to surcharge?	Debris, Silt
Level of infiltration?

General	
Structural Condition	Good
Operational Condition	Good
Debris Amount	Slight
Cleaning Needed	No
Standing Water	No
Flow	Steady
Maintenance Needed	No

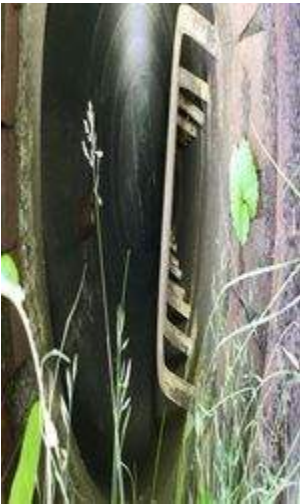
Asset ID
 WW 05

Hydraulics	
Indication of surcharge?	Minor
Issues related to surcharge?	Silt
Level of infiltration?

General	
Structural Condition	Good
Operational Condition	Good
Debris Amount	Slight
Cleaning Needed	No
Standing Water	No
Flow	Steady
Maintenance Needed	No

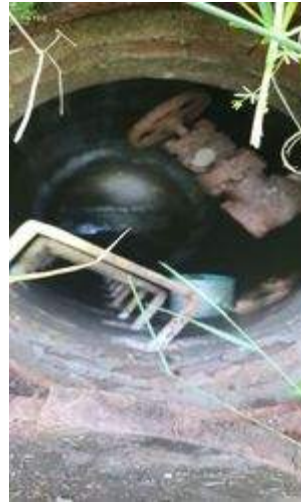
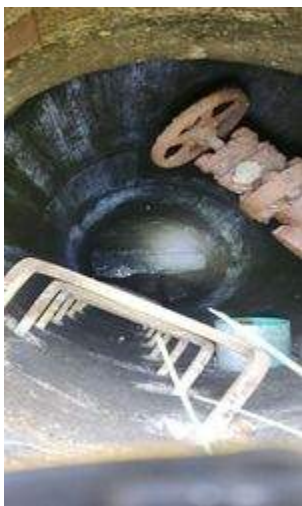
Asset ID
 WW 06

General	
Structural Condition	Good
Operational Condition	Good
Debris Amount	None
Cleaning Needed	No
Standing Water	Yes
Flow	Trickle
Maintenance Needed	No

Notes	
Structural Notes	
General Notes	Slow moving

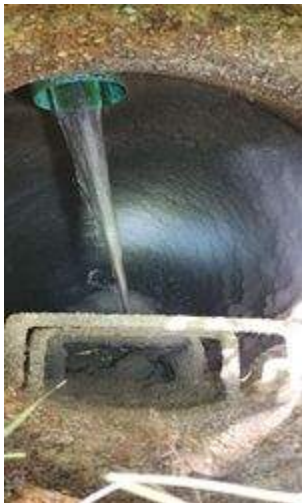
Asset ID
 WW 07

Manhole Condition	
What is the cover condition?	Serviceable
Other notes on the cover?	
What is the ring and frame condition?	
Other notes on the ring and frame?	Corroded
What is the cone and riser condition?	Serviceable
Other notes on the cone and riser?	Debris covering cone
What is the barrel condition?	Serviceable
What is the ladder condition?	Serviceable
What is the bench condition?	Serviceable
Other notes on the bench?	Debris covering bench
What is the channel condition?	Serviceable
Other notes on the channel?

General	
Structural Condition	Good
Operational Condition	Good
Debris Amount	Heavy
Cleaning Needed	Yes
Standing Water	No
Flow	Heavy
Maintenance Needed	No

Notes	
Structural Notes	
General Notes	Needs cleaning. Manhole coated in debris

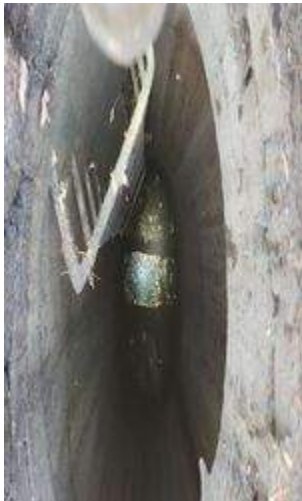
Asset ID
 WW 08

Manhole Condition	
What is the cover condition?	Holes
Other notes on the cover?	Catch basin style cover
What is the ring and frame condition?	Serviceable
Other notes on the ring and frame?	
What is the cone and riser condition?	Serviceable
Other notes on the cone and riser?	
What is the barrel condition?	Serviceable
What is the ladder condition?	Serviceable
What is the bench condition?	Serviceable
Other notes on the bench?	
What is the channel condition?	Serviceable
Other notes on the channel?

General	
Structural Condition	Good
Operational Condition	Good
Debris Amount	Moderate
Cleaning Needed	No
Standing Water	Yes
Flow	Trickle
Maintenance Needed	No

Notes	
Structural Notes	
General Notes	Needs cover replacement

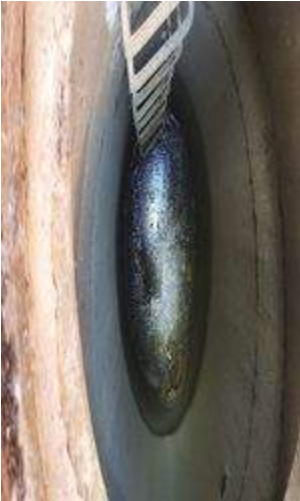
Asset ID
WW 09

General	
Structural Condition	Good
Operational Condition	Good
Debris Amount	Moderate
Cleaning Needed	No
Standing Water	Yes
Flow	None
Maintenance Needed	No

Notes	
Structural Notes	
General Notes	Catch basin style cover
