Richmond Wastewater Treatment Facility 20 Year Evaluation *90% Submittal*

January 29, 2024

Prepared for: Town of Richmond, Vermont

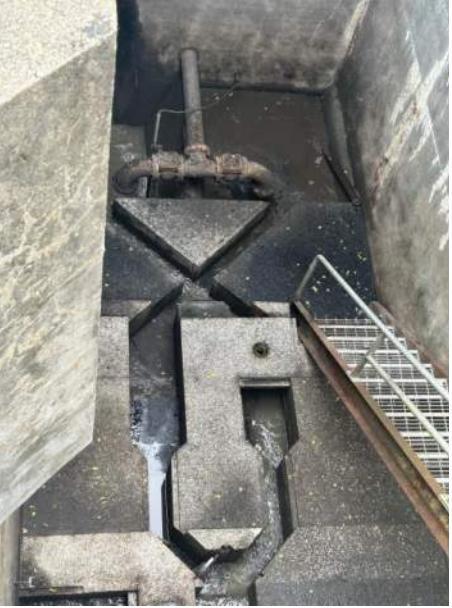
Figure 2-11 Influent Wet Well

Raw wastewater from the collection system enters the Richmond WWTF at the influent wet well, located next to the Operations Building, where it is mixed with RAS, pressate, and filter backwash. The roof drains for the Operations Building also drain to the wet well. The wet well is divided into two cells and the operators indicated that only one side of the wet well is being used due to problems with rags, bricks and stones that make their way through the collection system. A level transmitter in the wet well controls the pumping speed of the influent pumps which are located inside the Operations Building basement. The concrete of the wet well structure was not inspected during the field visit and the condition of the structure is unknown.

- Influent Pump #1 failed and was replaced with a used emergency pump in 2023. The pump is old and only a temporary solution.
- Influent Pump #2 is original to facility. The pump is in poor condition with a leaking seal. This pump is at risk of imminent failure leaving the facility with no pumping redundancy.
- Influent pumps routinely experience problems such as ragging and bricks/rocks causing damage.

- Influent grinder has been removed.
- Hatch not available for pump removal
- Roof drains are connected to the wet well.
- The concrete of wet well structure was not evaluated. It is recommended that a concrete assessment be conducted.
- Additional flow data is required to select influent pump replacements.

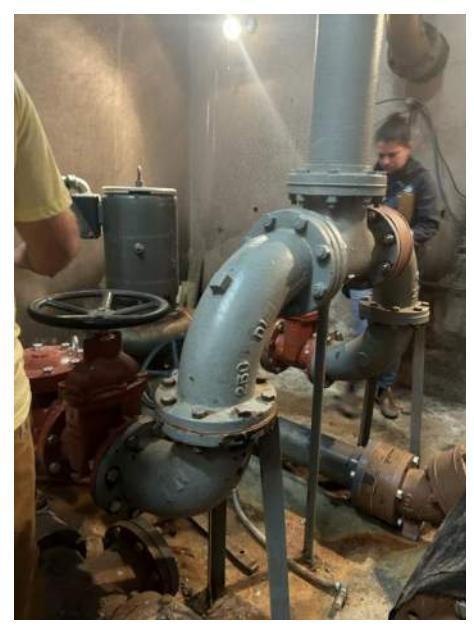
Figure 2-12 Influent Pumping System

The influent pumping system consists of two influent pumps located in the lower level of the Operations Building. Influent pumping transfers wastewater from the wet well to the

Headworks Building where it flows by gravity through the remaining treatment process. An in-line grinder that was part of the original design has been disconnected. There is a magnetic flow meter on the pump discharge header to measure flows. The operators indicated that they do not believe it accurately measures flow. Influent Pump #1 is driven by a 40 HP motor and was installed in 2023 as a temporary replacement for the existing Influent Pump #1 which had failed. Influent Pump #2 is a vertical mounted, flooded suction centrifugal pump driven by a 25 HP motor. Currently, Influent Pump #2 is not in use as it has a leaking seal and sprays the room when operating. The operators indicated that they have replaced both pump discharge check valves recently.

Access to the pumps is problematic with no overhead hatch to hoist pumps through. The operators noted that they have to bring equipment down three flights of stairs if maintenance is required.

The facility experiences significant large solids carried to the wet well through to the influent pumps including large rocks/bricks, large pieces of wood, rag balls greater in diameter than the pumps can pass. These materials often lead to pump clogging, damage to the pump impellers and emergency maintenance of the pumps. The operators indicated that the Town cleaned out the influent collection sewer up to Bridge Street in 2022 to try to mitigate the amount of debris that enters the wet well and pump inlet.

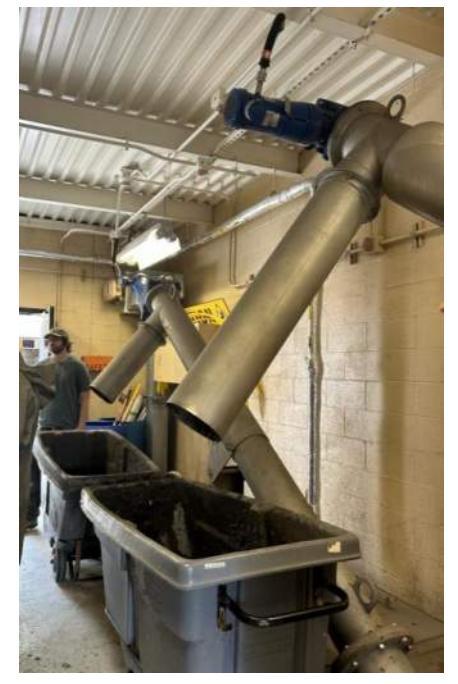
Figure 2-13 Grit Removal

Screening and grit removal consists of a package unit located in the Headworks Building. Screening and grit removal is accomplished using a combination unit that uses a rotary-type mechanical fine screen and an aerated grit removal chamber with a grit dewatering screw to screen inorganics and remove grit from the process stream. Wastewater is pumped to the unit via the influent pumps. Wastewater flows into the unit's screening basket where solids are retained. Screened material is removed from the screening basket and is spray washed to return organics to the process stream. The screened material is then transported up the unit's central screw conveyor, compacted, dewatered, and discharged to storage containers. The wastewater that flows through the screening basket passes directly into a grit removal chamber. Grit settles to the floor of the grit chamber and a grit transport screw moves the settled grit to a lateral sump. A grit dewatering screw transports the settled grit out of the lateral sump and dewaters the grit before it is discharged into storage containers. Air for the aerated grit chamber is fed from a new blower located in the one-room structure located over the aerobic sludge digester tank. Flow from the grit chamber is discharged directly into the first anoxic

The rotary-type fine screen shaft has significant wear and while the screen does catch some rags, the operators indicate that it doesn't work well. The grit auger has significant wear and has been patched over the years. The operators indicated that grit that is captured is not being properly dewatered resulting in a product with a mud-like consistency. The operators have also noted a leak in the stainless steel package unit tank, which they have been patching regularly.

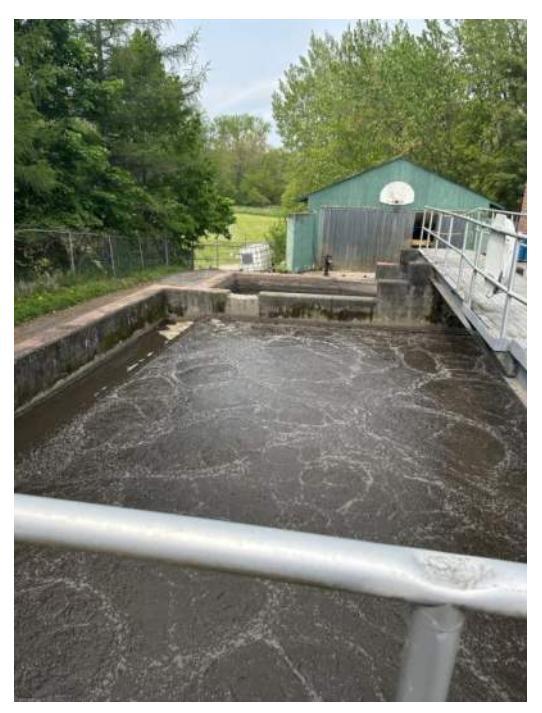
Figure 2-14 Biological Aeration Tank

Flow from the third anoxic selector is designed to split between two parallel aeration tanks, each having a volume of 150,000 gallons. Typical operation consists of one aeration tank in operation at a time. The aeration tanks have a fine bubble diffused air system and are fed air from two (2) 25 HP positive displacement blowers, each with a capacity of 450

scfm, located in the Process Building upper level. A single dissolved oxygen (D.O.) probe is provided but is not connected to SCADA for blower operation. The operators indicated they would like one D.O. probe for each tank. The outdoor intake for the aeration blowers has been disconnected due to noise complaints, and air for the blowers is drawn from the septage holding tank in the Operations Building Garage. This air has significant hydrogen sulfide concentration for the air space above a non-aerated sludge holding tank. Blower control is cycled on/off from SCADA; however, D.O. concentration in the

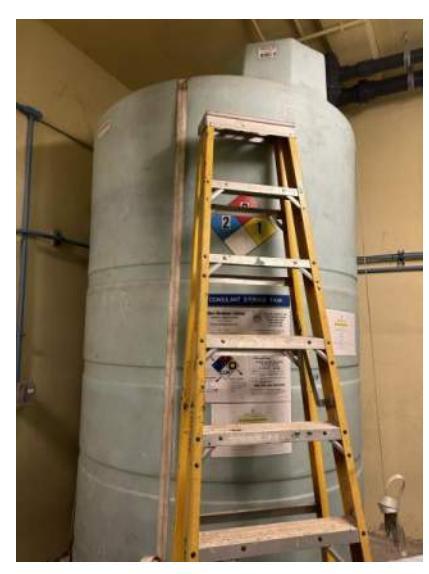
There is one (1) 1,500 gallon sodium aluminate storage tank and two (2) positive displacement diaphragm type feed pumps located in the basement of the Process Building, though only one (1) feed pump is in use and the other is in storage. Secondary containment is provided in the form of a 3-ft high concrete retaining wall around the coagulant storage tank. An emergency eyewash station is located next to the coagulant storage tank; however, there is no emergency shower. The original design allowed for coagulant to be pumped to the aeration tank effluent channel and/or into both clarifier effluent pipes prior to the filter units. Typical operation is consistently dripping sodium aluminate through a 2" line into the aeration tank effluent channel and is based on an operator feed rate that is determined by effluent pH levels.

Figure 2-15 Sodium Aluminate Storage
Description	Existing Design								
Coagulant Storage									
Coagulant	Sodium Aluminate (Alum)								
Storage Tank Capacity	1,500 gallons								
Containment Volume Required	1,875 gallons								
Containment Volume Provided	1,544 gallons								
Coagulant Feed – Process Building									
Feed Pump Type	Positive Displacement, Diaphragm Type								
Number of Pumps	2 (1 duty, 1 in storage)								
Flow Rates	0 – 48 gpd								
Application Points	Aeration Tank Effluent Launder

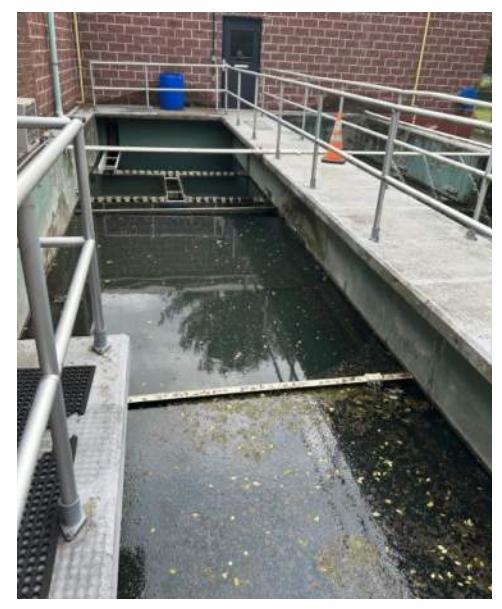
Figure 2-16 Secondary Clarifier

Flow from the aeration tank effluent channel can be split between the two rectangular secondary clarifiers by a splitter box with stop gates. Typically, only one (1) clarifier is in operation at a time. Each rectangular secondary clarifier is 50-ft long and 11-ft wide. An access bridge extends the length of the clarifiers. The drives for the chain and flight scrapers are located on the walkway above each clarifier. Effluent troughs have v-notched weirs to control discharge from the clarifiers. Clarified effluent is discharged through a 12" pipe to filtration.

Flight scrapers scrape sludge along the bottom of the secondary clarifiers toward the influent end of each clarifier into a sump. A waste activated sludge (WAS) pump, located in the basement of the Operations Building, removes sludge from the clarifiers and transports it to the septage holding tanks. Return activated sludge (RAS) is drawn from the same

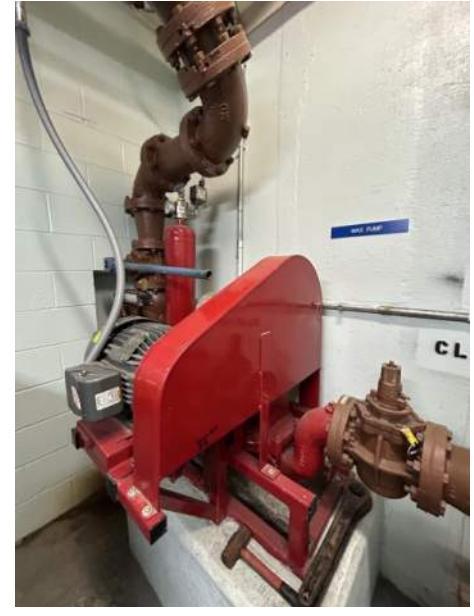
Figure 2-17 WAS Pump

There is one (1) waste activated sludge (WAS) pump located in the Pump Room in the lower level of the Operations Building. The WAS pump is a 7.5 HP Penn Valley Pump double disc, positive displacement pump rated for 150 gpm at 18 ft TDH. The WAS pump moves sludge to the aerated holding basins. The original design also allowed for the WAS to be pumped to the Aerobic Sludge Holding Tank. Operators indicated that many of the valves on the discharge piping are frozen, although they are systematically rebuilding them one at a time. WAS is wasted two (2) times per day for 1-hour intervals and is controlled by a timer. Operators indicate that the pump model is obsolete, and it is hard to get parts.

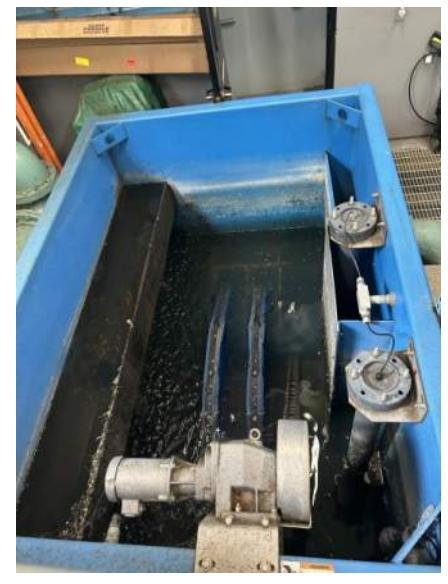
Figure 2-18 Filtration Tank

Operators indicated that the filter units have been going into continuous backwash, causing the operators to have to manually waste sludge from the bottom of the filter tank by opening a drain valve. One suspected reason is polymer carryover from dewatering clogging the cloth media surface. Another is grease and solids carryover from the secondary clarifiers fouling the cloth fabric. All cloth media was replaced within the past few years. The operators noted that the filters are not controlled by the SCADA system, and they have to manually turn on the second filter unit during high flows.

During the site visit, corrosion of the steel tanks was observed.

- Filter units have been going into continuous backwash as cloth media is fouled. Operators need to manually waste solids using drain valves at bottom of tank.
- Polymer carry over from dewatering has negatively impacted cloth media performance.
- Significant corrosion on the steel tank, trough, and rusted filter drains was observed.
- Ventilation in the filter room is sealed/shut off and is not functional.
- Filters not connected to SCADA for automatic operation at high flows, must be started manually.
- Suction of settled solids is not functioning properly
- Filter tank wall elevation is below the 500-year flood elevation.

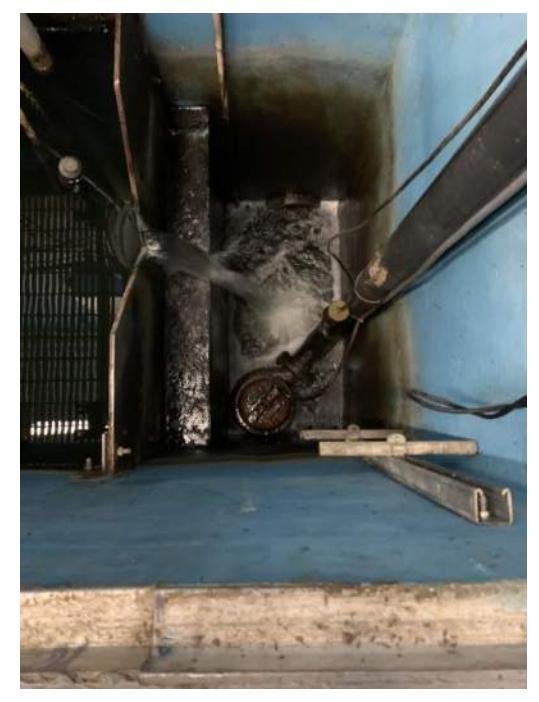
Figure 2-20 Effluent Wet Well & V-Notch

1.4.2, the 100-year and 500-year flood elevations at the Richmond WWTF site are EL. 310.50 ft and EL. 313.77 ft, respectively. The invert of the v-notch weir is EL. 306.14 ft, which is below the updated 100-year flood elevation. A check valve is located on the effluent line to prevent water from hydraulically backing up the outfall during a 100-year or 500-year flood event. During the recent July 2023 flooding event, emergency use of a sump pump to lift flows to an external discharge point was used to prevent flooding of the Filter/UV Room. While the sump pump was able to keep up with flows during the most recent flooding event, it has not been properly sized to handle peak flows and provide redundancy.

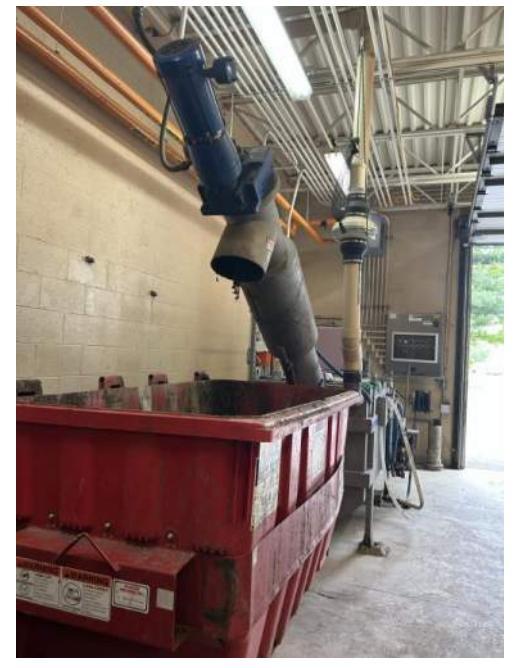
Figure 2-21 Septage Receiving Unit

- The septage receiving unit is reaching the end of its anticipated useful life and was found to be in poor condition, the bearings are gone, and the auger has significant wear.

- The septage receiving room is not compliant with NFPA 820 hazardous classifications.

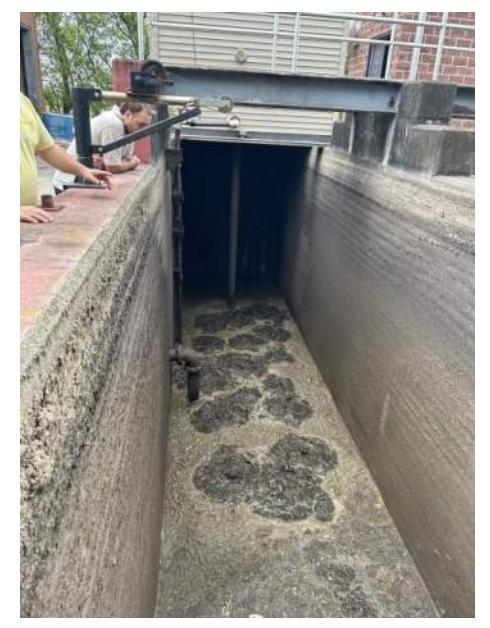
Figure 2-22 Aerobic Sludge Holding Tank

The aerobic sludge holding tank was not drained to evaluate the condition of the concrete tank, nor the existing diffusers. The operators noted that the tank needs to be cleaned as there is an accumulation of rocks, grit, and rags in the tank which are creating plugging issues with the downstream sludge transfer and feed pumps. The non-uniform bubble pattern observed on the surface of the tank contents during the evaluation indicates that some of the diffusers may be clogged and inoperable.

- The concrete tank structure was not able to be evaluated. It is recommended that a concrete assessment be conducted.
- Operators noted that the tank needs to be cleaned as there is an accumulation of rocks, grit, and rags.
- Observance of non-uniform buddle pattern at surface indicates that some diffusers in the aerobic sludge holding tank are not operational and need to be changed.

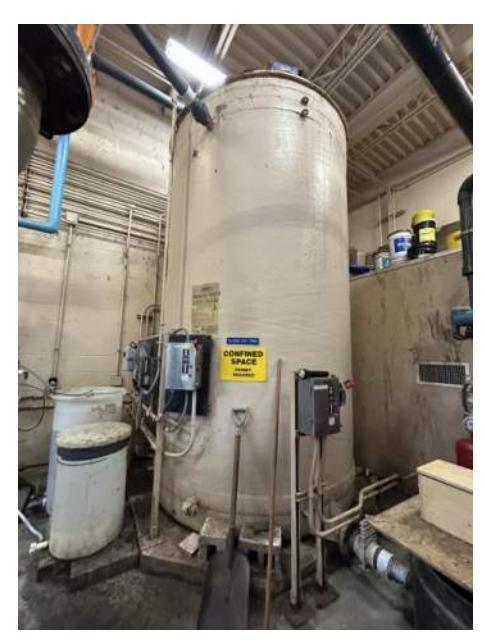
Figure 2-23 Sludge Day Tank

supplies sludge to the dewatering process. The tank has an access hatch at the top and is equipped with a mixer, to keep the contents mixed, and a level detector that is integrated into the controls of the sludge transfer pump and the sludge feed pump. The operators have noted that the sludge day tank needs to be cleaned out as the sludge feed pump routinely gets plugged from rags passing through. The

operators also noted that there is no way to remove the mixer from the day tank as there is no headroom above the tank for the long shaft.

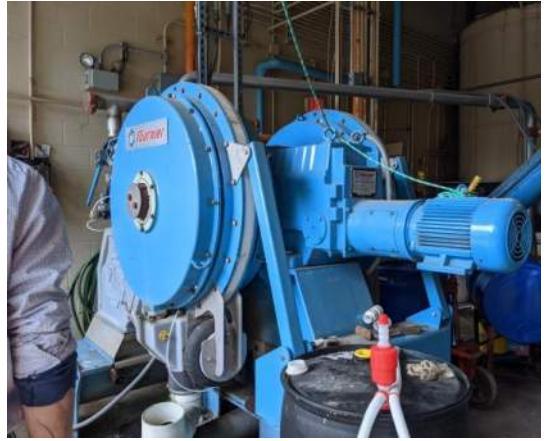
Figure 2-24 Rotary Press

pump. Conditioned sludge then enters a manifold and is divided into a series of circular channels. In the channel, sludge is sandwiched between two (2) low speed rotating perforated screens. The operators noted that maintenance on the rotary press has lapsed, resulting in operational issues. It was noted that regular cleaning is necessary every six months at a minimum. Currently, only one (1) channel in the two (2) channel rotary press is operational. The manufacturer's report indicates that the one inoperable channel has significant damage to it's screen, however all four screens are very warn.

• Significant wear and damage to the screens of the dewatering press screens was observed by the manufacturer's technician during the September 30th site visit. Significant repairs are warranted to keep dewatering operations functional.

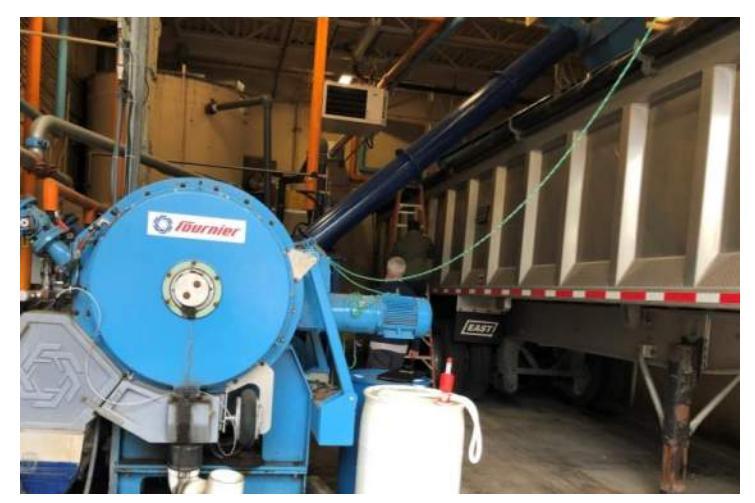
Figure 2-25 Rotary Press Conveyor System

container where it is taken off-site for final disposal. The conveyor consists of three parts: a discharge conveyor, the inclined conveyor, and the distributing conveyor. All three are hollow flight screw type conveyors. The discharge conveyor runs horizontally for 9 feet from the discharge chutes of both channels of the rotary press to the inclined conveyor. The inclined conveyor is 20 feet in length with an approximate slope of 37 degrees. This conveyor brings dewatered cake up to the middle of the distributing conveyor. The distributing conveyor is approximately 32 feet in length and is elevated over the parked roll-off container. The distributing conveyor has openings at either end, and two pneumatically operated slide gates to distribute dried cake evenly within the container. The hollow flight conveyor within the distributing conveyor has a reversing motor to allow cake to be discharged to either end. The operators noted that both the auger and screw were replaced in the Spring of 2022, and that the screw broke again in December of 2022. During the repair, staff noted that the liner needed to be replaced.

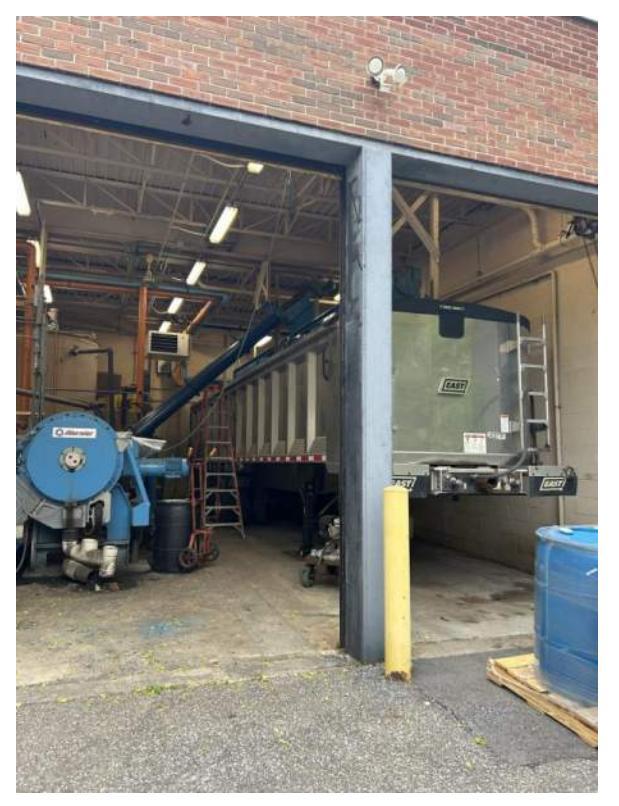
Figure 2-27 Dewatering Building

During the site visit, it was noted that the Dewatering Building does not have proper ventilation. The operators have noted there are significant odors issues and a build-up of ammonia gases, especially in the winter season when garage doors are kept closed. At the time of the site visit, operators noted that the only control for the overhead door is inside the building and across the room from the main entrance. Since then, a switch has been installed on the exterior of the building to allow operators the ability to open the overhead door and vent gases without having to enter the building. A fair amount of corrosion of metal components in the Dewatering Building was also observed during the site visit.

Additionally, the floor of the dewatering building does not have a rear floor drain, causing difficulties managing drainage from the sludge trailer. Operators expressed interest in a water meter on the water line to

- The grinder has been removed from the sludge transfer line.
- No ventilation is provided in the sludge dewatering room resulting in accumulation of corrosive gases and odors within the building.
- No gas detection system in building.
- Day tank needs to be cleaned.
- Mixer in the sludge day tank has a long shaft and there is no way to remove.
- Lack of floor drain at rear of sludge trailer makes it difficult to manage drainage from trailer.
- Polymer system defaults to over-pumping when power is lost.
- Operators noted that the hollow flight augers of the conveyors are deteriorated and need replacement, as well as the liner.
- A check valve on the line between the aerobic sludge holding tank and day tank was added and is cleaned daily.
- The feed pump to the dewatering press plugs frequently.

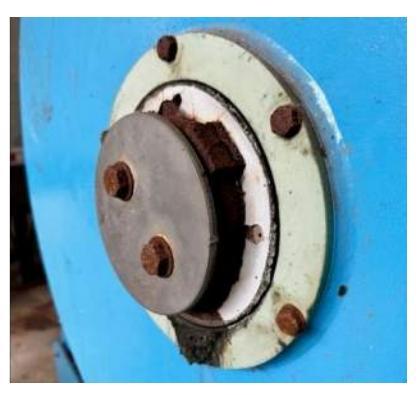
Three-way valve: The existing three-way valve does not work. It has been stuck in the dewatering position and does not turn. This causes problems with a proper startup. Sludge also leaks out of the supply tank, through the sludge pump and, because the valve is stuck in the dewatering position, into the channels.

- New Channels Everything on the channels needs replacement so I would recommend whole new channels. Even if you could spare some parts, we might need to cut the wheels from the shaft.
- 2. New Flocculator Assembly The top of the floccuator need to be dismantled and probably everything needs to be replaced below the gearbox.
- 3. Three-way Valve I would suggest they replace them with two two-way valves.
- 4. Channel Wash Valves If it doesn't already come with the new channels.
- 5. Air supply A new air regulator needs to be installed. As of right now I do not believe they have air going to the three-way valve and they only have it to the bellows.

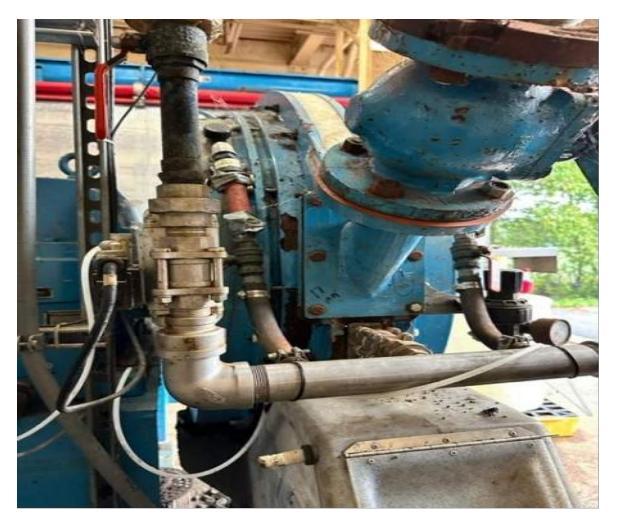
Sludge Pump: The facility has a double disc sludge pump and is in good condition. However, the sludge tank gravity feeds past the pump when it is in the off position.

- Sludge pump The sludge supply tank feeding the pump is gravity feeding through it. The pump may just need new interior parts. Or the sludge valve needs to be closed off when the press is not running.
- Polymer system We determined the polymer was making down a batch of 0.25% concentration, with a polymer to sludge ratio of 8% and a consumption of 26 active lbs/dry ton. An upgrade of the polymer system could produce lower consumption.

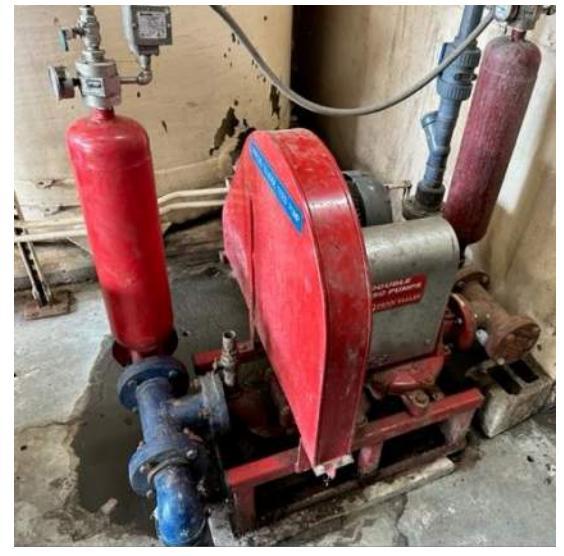
Polymer System: The polymer system does not have an indication of concentration. A batch of diluted polymer is sent to a 50-gallon tank. From there it is pumped to the floccuator at a ratio of the sludge flow.

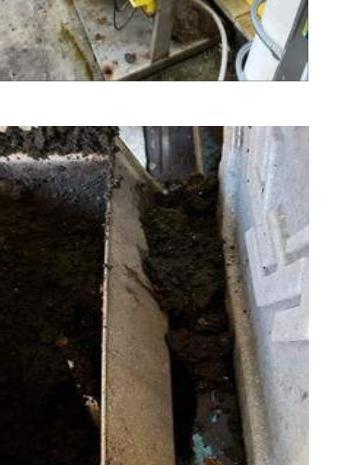
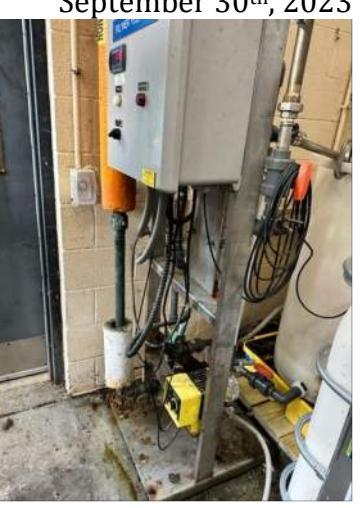
Screens: The facility only runs sludge through one channel and has recently complained about the filtrate quality. They do not run on the other channel due to damaged screens. Opening the restrictor arms on both channels and cleaning the channels out to inspect, I discovered that all four screens were very worn.

the worn screens and down the filtrate. Because they are running a blend of digested and septic sludge the press is still able to produce some cake. I believe if they were just running digested sludge, they would have a hard time getting anything to come out of the channel. The only way to keep sludge producing cake is to treat it gently. If they produce high pressure inside the channel sludge comes out the screens instead of out the front as cake. The key is low outlet pressure 5psi, low inlet pressure 1.2psi, and moderate rotary press speed 30%. This minimizes the sludge in the filtrate being sent to the head of the plant. The press still produces 25-30% cake dryness with a flow of 20-30gpm through the channel. Sludge total solids was 1.45% Polymer consumption was 26 active lbs/dry ton.

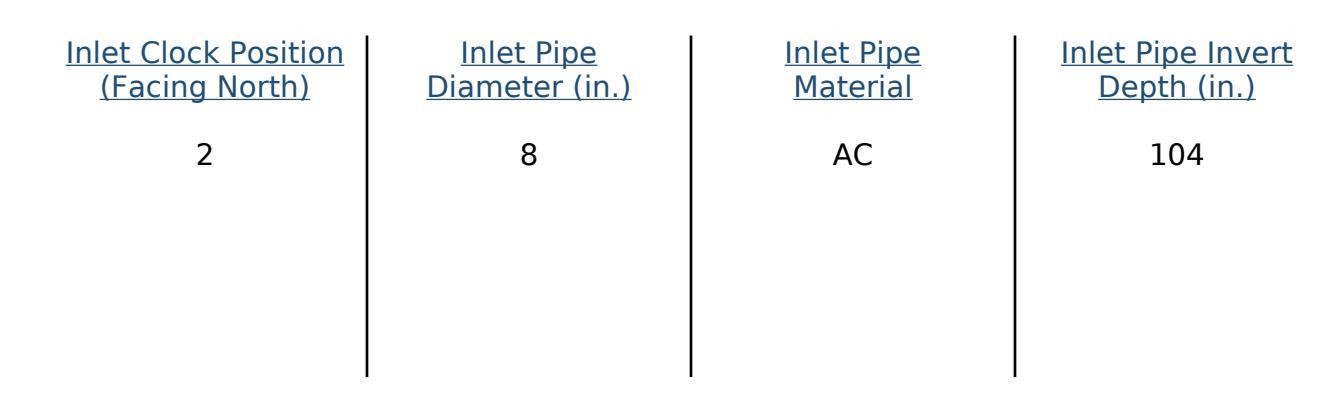
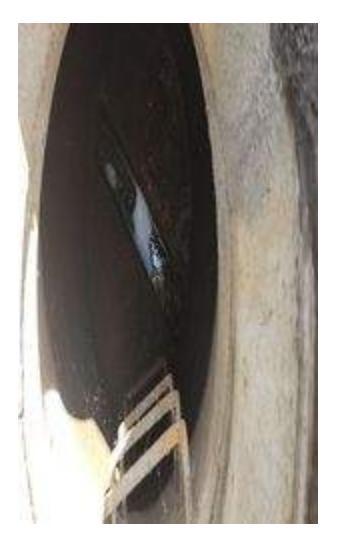
Asset ID BK 01

Other notes on the channel?	Some chan	e sewage blocking nel

Notes					
Structural Notes					
General Notes	Needs cleaning sewage in channel blocking flow at the outlet.

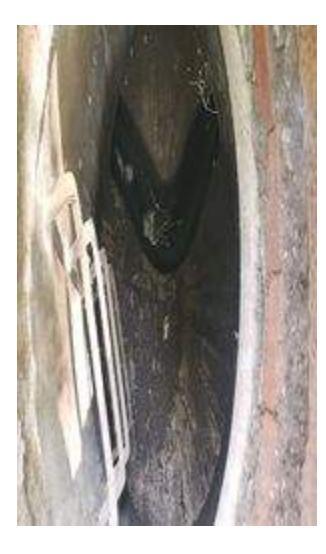
Asset ID BO 07

Outlet Clock Position (Facing North)Outlet Pipe Diameter (in.)			<u>Outlet Pipe</u> <u>Material</u>		<u>Outlet Pipe Invert</u> <u>Depth (in.)</u>	
5 8		AC		70		
Manhole Details			Manhole Condition			
Where is the Grass manhole located?		What is the cover condition? Other notes on the	Servi	cable		
What material is the manhole?	Concret	e		cover? What is the ring and frame condition?	Servi	ceable
What cover size is the	26"			Other notes on the ring and frame?		
What barrel size is the	48"			What is the cone and riser condition?	Servi	ceable
Manhole? Other general			_	Other notes on the cone and riser?		
notes on the manhole				What is the barrel condition?	Servi	ceable
details?	Hydro	ulice		What is the ladder condition?	Servi	ceable
Indication of	None	uncs		What is the bench condition?	Servi	ceable
Issues related to				Other notes on the bench?		
Level of infiltration?				What is the channel condition?	Servi	ceable

General			
Structural Condition	Good		
Operational Condition	Good		
Debris Amount	None		
Cleaning Needed	No		
Standing Water	No		
Flow	Trickle		
Maintenance Needed	No

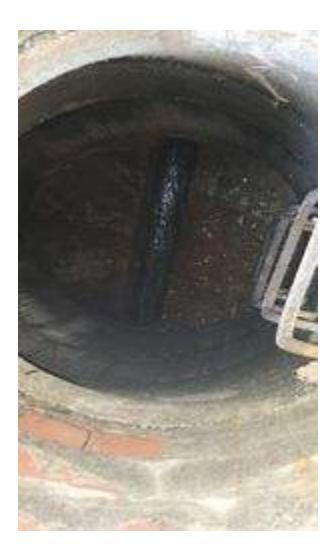
Asset ID BO 08

Outlet Clock Position (Facing North)Outlet Pipe Diameter (in.)		<u>Outlet Pipe</u> <u>Material</u>		<u>Outlet Pipe Invert</u> <u>Depth (in.)</u>		
8 8		AC		99		
	Manhole	Details			Manhc	le Condition
Where is the Woods manhole located?			What is the cover condition? Other notes on the	Servi	cable	
What material is the manhole?	Concret	e		cover? What is the ring and frame condition?	Servi	ceable
What cover size is the	26"			Other notes on the ring and frame?		
What barrel size is the	48"			What is the cone and riser condition?	Servi	ceable
manhole? Other general				Other notes on the cone and riser?		
notes on the manhole				What is the barrel condition?	Servi	ceable
details?	Hydra	ulics		What is the ladder condition?	Servi	ceable
Indication of	None			What is the bench condition?	Servi	ceable
Issues related to				Other notes on the bench?		
Level of infiltration?				What is the channel condition?	Servi	ceable

General			
Structural Condition	Good		
Operational Condition	Good		
Debris Amount	None		
Cleaning Needed	No		
Standing Water	No		
Flow	Trickle		
Maintenance Needed	No

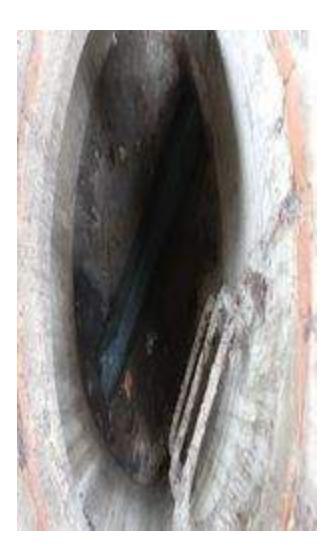
Asset ID BO 09

Outlet Clock Position (Facing North)Outlet Pipe Diameter (in.)		<u>Outlet Pipe</u> <u>Material</u>		<u>Outlet Pipe Invert</u> <u>Depth (in.)</u>			
7			8	AC		81	
Manhole Details			Manhole Condition				
Where is the Woods			What is the cover condition?	cable			
located?				on the cover?			
What material is the manhole?	Concret	e		What is the ring and frame condition?	Servi	ceable	
What cover size is the	26"			Other notes on the ring and frame?			
What barrel size is the	48"			What is the cone and riser condition?	Servi	ceable	
Manhole? Other general				Other notes on the cone and riser?			
notes on the manhole				What is the barrel condition?	Servi	ceable	
details?				What is the ladder	Servi	ceable	
Indication of	None	uncs		What is the bench condition?	Servi	ceable	
surcharge? Issues related to				Other notes on the bench?			
Level of infiltration?				What is the channel condition?	Servi	ceable	
				Other notes on the channel?

General		
Structural Condition	Good	
Operational Condition	Good	
Debris Amount	None	
Cleaning Needed	No	
Standing Water	No	
Flow	Steady	
Maintenance Needed	No

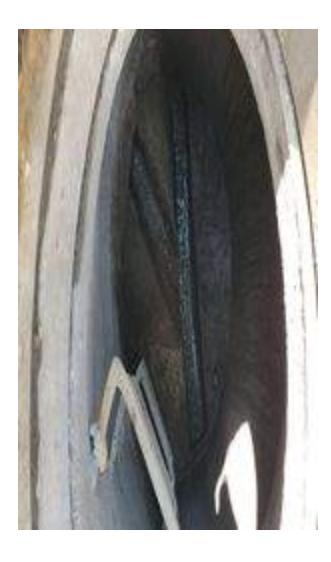
Asset ID BR 01

<u>Outlet Clock</u> (Facing N	<u>Position</u> lorth)	<u>Outlet Pipe</u> Diameter (in.)	<u>Outlet Pip</u> <u>Material</u>	<u>e</u>	<u>Outlet Pipe Invert</u> <u>Depth (in.)</u>	
2		8		AC		110	
Manhole Details				Manhole Condition			
Where is the manhole	Where is the Roadway manhole		What is the cover condition? Other notes	Servi	cable		
located?				on the cover?			
What material is the manhole?	Concret	e		What is the ring and frame condition?	Servi	ceable	
What cover size is the	26"			Other notes on the ring and frame?	Ruste	ed	
What barrel size is the	48"			What is the cone and riser condition?	Servi	ceable	
manhole? Other general				Other notes on the cone and riser?			
notes on the manhole				What is the barrel condition?	Servi	ceable	
details?	Hydra	ulice		What is the ladder	Servi	ceable	
Indication of	None			What is the bench condition?	Servi	ceable	
Issues related to				Other notes on the bench?

General		
Structural Condition	Good	
Operational Condition	Good	
Debris Amount	None	
Cleaning Needed	No	
Standing Water	No	
Flow	Steady	
Maintenance Needed	No

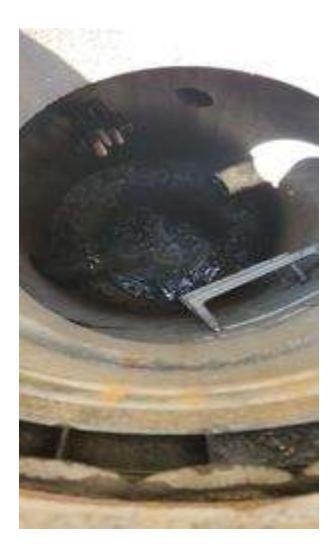
Asset ID BR 02

Outlet Clock Position (Facing North)Outlet Pipe Diameter (in.)			<u>Outlet Pip</u> <u>Material</u>	<u>e</u>	<u>Outlet Pipe Invert</u> <u>Depth (in.)</u>
11					
	Manhole D	etails		Manho	ole Condition
Where is the Roadway manhole		What is the cover condition? Other notes	cable		
What material is the manhole?	Concrete		cover? What is the ring and frame condition?	Servi	ceable
What cover size is the	26"		Other notes on the ring and frame?		
What barrel size is the	48"		What is the cone and riser condition?	Servi	ceable
manhole? Other general			Other notes on the cone and riser?		
notes on the manhole			What is the barrel condition?	Servi	ceable
uetails!	Hydrau	lics	What is the ladder condition?	Servi	ceable
Indication of	None		What is the bench condition?	Servi	ceable
Issues related to			Other notes on the bench?		
Level of infiltration?			What is the channel condition?	Servi	ceable
			Other notes on the channel?

General		
Structural Condition	Good	
Operational Condition	Good	
Debris Amount	Moderate	
Cleaning Needed	Yes	
Standing Water	No	
Flow	Неаvy	
Maintenance Needed	No

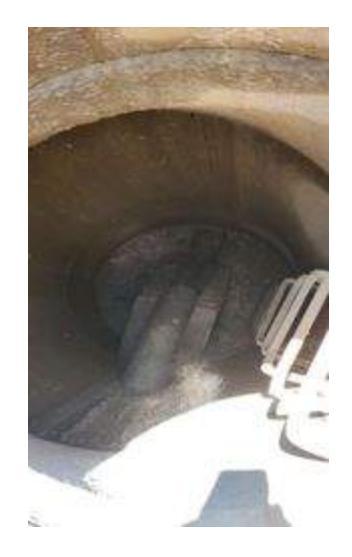
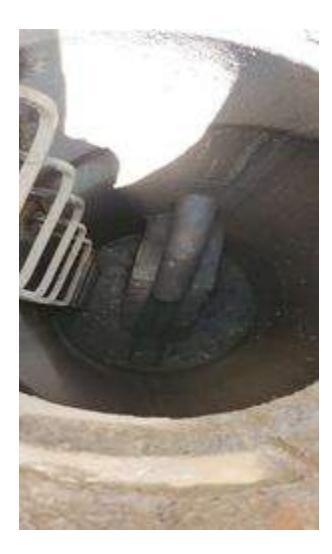
Asset ID BR 03

Outlet Clock Position (Facing North)		<u>Outlet Pipe</u> Diameter (in.)		<u>Outlet Pipe</u> <u>Material</u>		<u>Outlet Pipe Invert</u> <u>Depth (in.)</u>	
7		8		PVC		136	
	Manhole	Details		Manhole Condition			
Where is the manhole	/here is ne Roadway nanhole			What is the cover condition? Other notes	Servi	cable	
located?				on the cover?			
What material is the manhole?	Concret	e		What is the ring and frame condition?	Servi	ceable	
What cover size is the	26"			Other notes on the ring and frame?			
What barrel size is the	48"		-	What is the cone and riser condition?	Serviceable		
Other general	Drop inlet has concrete walls in a built up channel		_	Other notes on the cone and riser?			
notes on the manhole				What is the barrel condition?	Servi	ceable	
details?			What is the ladder condition?	Servi	ceable		
Indication of	None			What is the bench condition?	Servi	ceable	
Issues related to			-	Other notes on the bench?

General		
Structural Condition	Good	
Operational Condition	Good	
Debris Amount	None	
Cleaning Needed	No	
Standing Water	No	
Flow	None	
Maintenance Needed	No

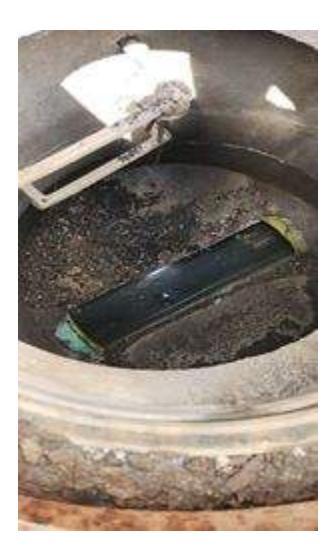
Asset ID BR 04

<u>Outlet Clock</u> (Facing N	<u>Position</u> Iorth)	<u>Outlet Pipe</u> Diameter (in.)	<u>Outlet Pipe</u> <u>Material</u>		<u>Outlet Pipe Invert</u> <u>Depth (in.)</u>	
7		12	PVC		82	
Manhole Details			Manhole Condition			
Where is the manhole located?	Roadwa	У	What is the cover condition? Other notes on the	Servi	icable	
What material is the manhole?	Concret	e	cover? What is the ring and frame condition?	Servi	iceable	
What cover size is the	26"		Other notes on the ring and frame?			
What barrel size is the	48"		What is the cone and riser condition?	Servi	iceable	
manhole? Other general			Other notes on the cone and riser?			
notes on the manhole			What is the barrel condition?	Servi	iceable	
detalls?	Hydra	ulics	What is the ladder condition?	Servi	iceable	
Indication of	None		What is the bench condition?	Servi	iceable	
Issues related to			Other notes on the bench?	Debr	is on bench	
Level of infiltration?			What is the channel condition?	Servi	iceable

General				
Structural Condition	Good			
Operational Condition	Good			
Debris Amount	Slight			
Cleaning Needed	No			
Standing Water	No			
Flow	Steady			
Maintenance Needed	No

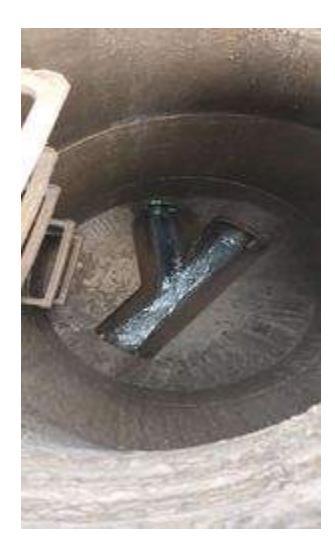
Asset ID BR 05

Outlet Clock Position (Facing North)Outlet Pipe Diameter (in.)		<u>Outlet Pipe</u> <u>Material</u>		<u>Outlet Pipe Invert</u> <u>Depth (in.)</u>		
7		12	AC		93	
	Manhole	Details		Manhole Condition		
Where is the Roadway		у	What is the cover condition?	Servi	cable	
located?			Other notes on the cover?			
What material is the manhole?	Concret	e	What is the ring and frame condition?	Servi	ceable	
What cover size is the	26"		Other notes on the ring and frame?			
What barrel size is the	48"		What is the cone and riser condition?	Servi	ceable	
Other general			Other notes on the cone and riser?			
notes on the manhole			What is the barrel condition?	Servi	ceable	
	Hydra	ulics	What is the ladder condition?	Servi	ceable	
Indication of	None		What is the bench condition?	Servi	ceable	
Issues related to			Other notes on the bench?			
Level of infiltration?			What is the channel condition?	Servi	ceable	
			Other notes on the channel?

General				
Structural Condition	Good			
Operational Condition	Good			
Debris Amount	None			
Cleaning Needed	No			
Standing Water	No			
Flow	Steady			
Maintenance Needed	No

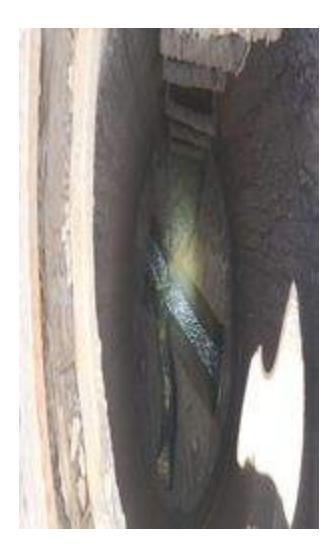
Asset ID BR 06

Outlet Clock Position (Facing North)Outlet Pipe Diameter (in.)		<u>Outlet Pipe</u> <u>Material</u>		<u>Outlet Pipe Invert</u> <u>Depth (in.)</u>		
6		12		AC		105
Manhole Details		Manhole Condition				
Where is the Roadway			What is the cover condition?	Servi	cable	
located?				on the cover?		
What material is the manhole?	Concret	e		What is the ring and frame condition?	Servi	ceable
What cover size is the	26"			Other notes on the ring and frame?		
What barrel size is the	48"		_	What is the cone and riser condition?	Servi	ceable
Other general			_	Other notes on the cone and riser?		
notes on the manhole				What is the barrel condition?	Servi	ceable
	Hydra	ulics]	What is the ladder condition?	Servi	ceable
Indication of	None		-	What is the bench condition?	Servi	ceable
Issues related to			-	Other notes on the bench?		
Level of infiltration?				What is the channel condition?	Servi	ceable
				Other notes on the channel?

General				
Structural Condition	Good			
Operational Condition	Good			
Debris Amount	Moderate			
Cleaning Needed	Yes			
Standing Water	No			
Flow	Steady			
Maintenance Needed	No

Notes				
Structural Notes				
General Notes	Signs of previous infiltration

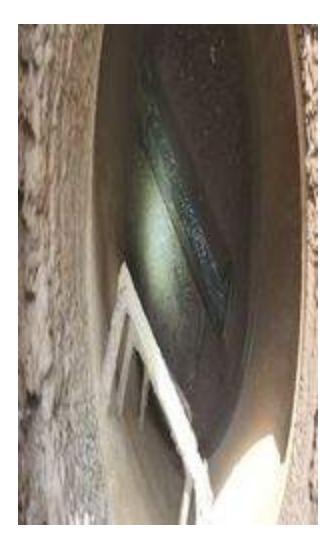
Asset ID BR 07

<u>Outlet Clock</u> (Facing N	Iet Clock PositionOutlet Pipe(Facing North)Diameter (in.)		<u>Outlet Pipe</u> <u>Material</u>		<u>Outlet Pipe Invert</u> <u>Depth (in.)</u>	
8		12	AC		88	
	Manhole	Details	Manhole Condition			
Where is the Roadway		What is the cover condition?	Servi	cable		
located?			on the cover?			
What material is the manhole?	Concret	e	What is the ring and frame condition?	Servi	ceable	
What cover size is the	26"		Other notes on the ring and frame?			
What barrel size is the	48"		What is the cone and riser condition?	Servi	ceable	
Other general			Other notes on the cone and riser?			
notes on the manhole			What is the barrel condition?	Servi	ceable	
detalls?			What is the ladder	Servi	ceable	
	Hydra	ulics	condition? What is the			
Indication of	None		bench condition?	Servi	ceable	
Issues related to			Other notes on the bench?			
Level of infiltration?			What is the channel condition?	Servi	ceable

General			
Structural Condition	Good		
Operational Condition	Good		
Debris Amount	Slight		
Cleaning Needed	No		
Standing Water	No		
Flow	Steady		
Maintenance Needed	No

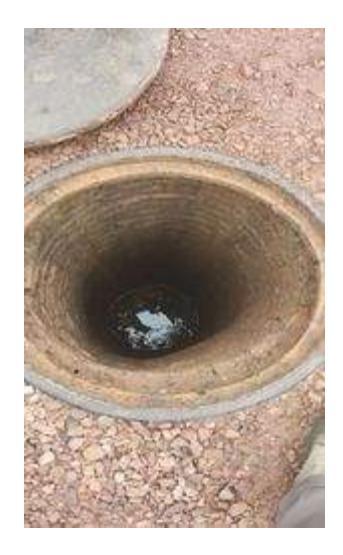
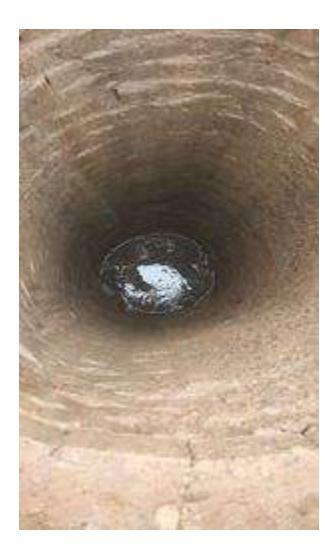
Asset ID BR 08

<u>Outlet Clock</u> (Facing N	utlet Clock PositionOutlet Pipe(Facing North)Diameter (in.)		<u>Outlet Pipe</u> <u>Material</u>		<u>Outlet Pipe Invert</u> <u>Depth (in.)</u>	
9		8	AC		104	
	Manhole	Details		Manhole Condition		
Where is the manhole	Where is the Roadway manhole		What is the cover condition? Other notes	Servi	cable	
located?			on the cover?			
What material is the manhole?	Brick		What is the ring and frame condition?	Servi	ceable	
What cover size is the manhole?	26"		Other notes on the ring and frame?			
What barrel size is the	Other		What is the cone and riser condition?			
Other general	e? Brick straight style		Other notes on the cone and riser?	N/A		
notes on the manhole			What is the barrel condition?	Servi	ceable	
details?			What is the	What is the N/A		
	Hydra	nulics	condition?			
Indication of	Minor		what is the bench condition?			
Issues related to	Silt		Other notes on the bench?	N/A

General			
Structural Condition	Good		
Operational Condition	Good		
Debris Amount	None		
Cleaning Needed	No		
Standing Water	Yes		
Flow	Steady		
Maintenance Needed	No

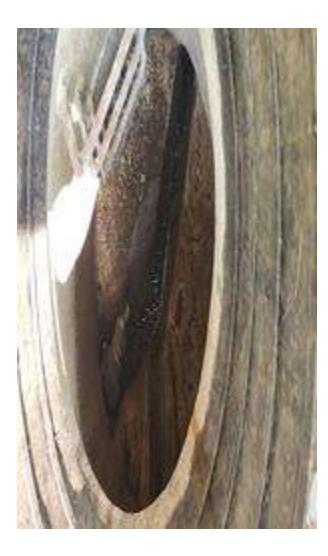
Asset ID BU 01

<u>Outlet Clock</u> (Facing N	<u>Position</u> lorth)	<u>Outl</u> Diame	<u>et Pipe</u> eter (in.)	<u>Outlet Pipe</u> <u>Material</u>		Outlet Pipe Invert Depth (in.)
3			8	AC		84
	Manhole	Details		Manhole Condition		
Where is the manhole	Roadwa	у		What is the cover condition? Other notes	Servi	cable
located?				on the cover?		
What material is the manhole?	Concret	e		What is the ring and frame condition?	Servi	ceable
What cover size is the	26"			Other notes on the ring and frame?		
What barrel size is the	48"			What is the cone and riser condition?	Servi	ceable
Other general				Other notes on the cone and riser?		
notes on the manhole				What is the barrel condition?	Servi	ceable
details?				What is the ladder	Servi	ceable
	Hydra	ulics		condition?		
Indication of	None			bench condition?	Servi	ceable
Issues related to				Other notes on the bench?		
Level of infiltration?				What is the channel condition?	Servi	ceable, Obstructed

General			
Structural Condition	Good		
Operational Condition	Good		
Debris Amount	None		
Cleaning Needed	No		
Standing Water	No		
Flow	None		
Maintenance Needed	No

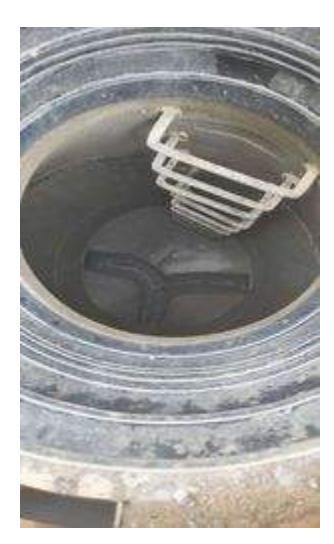
Asset ID BU 02

Outlet Clock Position (Facing North)Outlet Pipe Diameter (in.)		<u>Outlet Pipe</u> <u>Material</u>		<u>Outlet Pipe Invert</u> <u>Depth (in.)</u>			
6			8	AC		147	
	Manhole	Details			Manhole Condition		
Where is the Roadway		What is the cover condition?	Servi	cable			
located?				on the cover?			
What material is the manhole?	Concret	e		What is the ring and frame condition?	Servi	ceable	
What cover size is the	26"			Other notes on the ring and frame?			
What barrel size is the	48"			What is the cone and riser condition?	Servi	ceable	
Other general				Other notes on the cone and riser?			
notes on the manhole				What is the barrel condition?	Servi	ceable	
detalls?	Hydro	ulice		What is the ladder condition?	Servi	ceable	
Indication of	None			What is the bench condition?	Servi	ceable	
Issues related to				Other notes on the bench?			
Level of infiltration?				What is the channel condition?	Servi	ceable	
				Other notes on the channel?

General		
Structural Condition	Good	
Operational Condition	Good	
Debris Amount	None	
Cleaning Needed	No	
Standing Water	No	
Flow	None	
Maintenance Needed	No

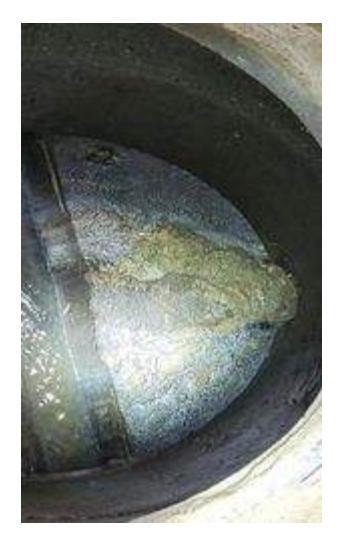
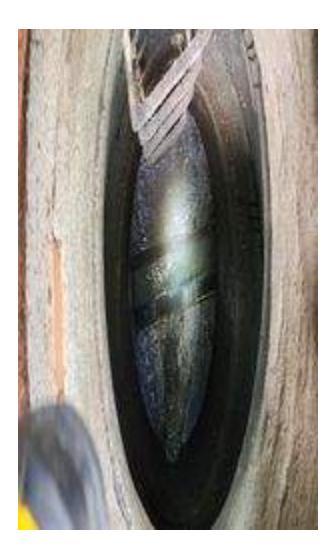
Asset ID CH 01

<u>Outlet Clock</u> (Facing N	<u>Position</u> lorth)	<u>Outlet Pipe</u> Diameter (in.)	<u>Outlet Pip</u> <u>Material</u>	<u>e</u>	<u>Outlet Pipe Invert</u> <u>Depth (in.)</u>
6		12	AC		113
	Manhole	Details		Manho	ole Condition
Where is the Grass, Row/Easement		What is the cover condition?			
manhole located?	Other notes on the cover?				
What material is the manhole?	Concret	e	What is the ring and frame condition?	Servi	ceable
What cover size is the	26"		Other notes on the ring and frame?		
What barrel size is the	48"		What is the cone and riser condition?	Servi	ceable
Manhole? Other general			Other notes on the cone and riser?		
notes on the manhole			What is the barrel condition?	Servi	ceable
detalls?			What is the ladder	Servi	ceable
	Hydra	ulics	condition? What is the		
Indication of	Minor		bench condition?	Servi	ceable
Issues related to			Other notes on the bench?	Debr inlet	is buildup on bench from at 3 oclock

General		
Structural Condition	Good	
Operational Condition	Good	
Debris Amount	Moderate	
Cleaning Needed	Yes	
Standing Water	No	
Flow	Trickle	
Maintenance Needed	No

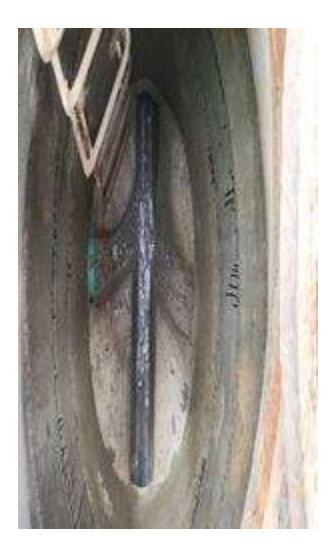
Asset ID CH 03

Outlet Clock Position (Facing North)Outlet Pipe Diameter (in.)		<u>Outlet Pipe</u> <u>Material</u>		<u>Outlet Pipe Invert</u> <u>Depth (in.)</u>			
11		8		PVC		100	
	Manhole	Details		Manhole Condition			
Where is the Woods		What is the cover condition?	Servi	cable			
located?			on the cover?				
What material is the manhole?	Concret	e		What is the ring and frame condition?	Servi	ceable	
What cover size is the	26"			Other notes on the ring and frame?			
What barrel size is the	48"			What is the cone and riser condition?	Servi	ceable	
Manhole? Other general				Other notes on the cone and riser?			
notes on the manhole				What is the barrel condition?	Servi	ceable	
	Hydra	ulics]	What is the ladder condition?	ceable		
Indication of	Minor			What is the bench condition?	Servi	ceable	
Issues related to	Debris,	Silt		Other notes on the bench?			
Level of infiltration?				What is the channel condition?	Servi	ceable

General					
Structural Condition	Good				
Operational Condition	Good				
Debris Amount	Slight				
Cleaning Needed	No				
Standing Water	No				
Flow	None				
Maintenance Needed	No

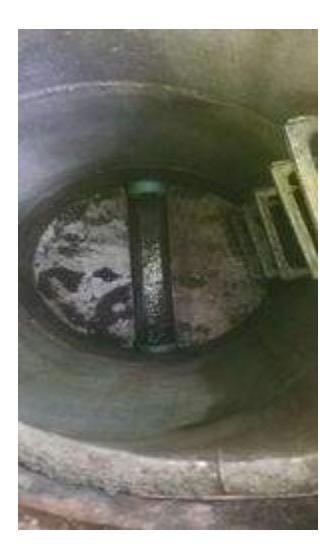
Asset ID CH 04

<u>Outlet Clock</u> (Facing N	<u>Position</u> Iorth)	<u>Outlet Pipe</u> Diameter (in.)	<u>Outlet Pip</u> <u>Material</u>	<u>e</u>	<u>Outlet Pipe Invert</u> <u>Depth (in.)</u>
9		6		PVC		51
	Manhole	Details			Manhc	le Condition
Where is the Roadway, Grass		What is the cover condition?	Servi	cable		
located?				on the cover?		
What material is the manhole?	Concret	e		What is the ring and frame condition?	Servi	ceable
What cover size is the	26"			Other notes on the ring and frame?		
What barrel size is the	48"			What is the cone and riser condition?	Servi	ceable
manhole? Other general				Other notes on the cone and riser?		
notes on the manhole				What is the barrel condition?	Servi	ceable
details?	Hvdra	ulics		What is the ladder condition?	Servi	ceable
Indication of	None			What is the bench condition?	Servi	ceable
Issues related to				Other notes on the bench?	Debr	is on bench
Level of infiltration?				What is the channel condition?	Servi	ceable

Other notes on the channel?	Stand	ding water and debris

General					
Structural Condition	Good				
Operational Condition	Good				
Debris Amount	Slight				
Cleaning Needed	No				
Standing Water	Yes				
Flow	None				
Maintenance Needed	No

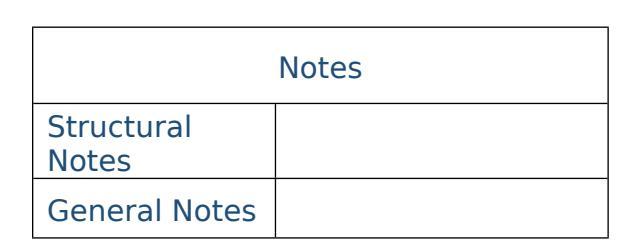
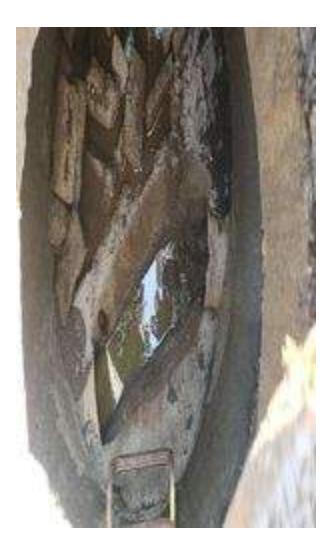
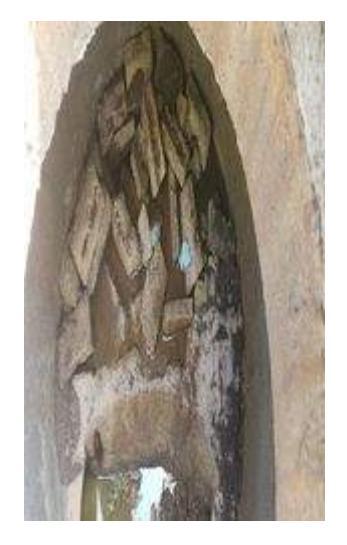
Asset ID CH 05

<u>Outlet Clock</u> (Facing N	Outlet Clock PositionOutlet Pipe(Facing North)Diameter (in.)			<u>Outlet Pipe</u> <u>Material</u>		<u>Outlet Pipe Invert</u> <u>Depth (in.)</u>			
5			8		AC		57		
	Manhole	Deta	iils		Manhole Condition				
Where is the manhole located?	Grass, Does Grade Slope Away			What is the cover condition? Other notes on the	Servi	icable			
What material is the manhole?	Concret	e		-	cover? What is the ring and frame condition?	Servi	iceable		
What cover size is the	26"				Other notes on the ring and frame?	Some	e rust		
What barrel size is the	48"				What is the cone and riser condition?	Servi	iceable		
manhole? Other general					Other notes on the cone and riser?				
notes on the manhole					What is the barrel condition?	Servi	iceable		
details?	Hydra	ulics]	What is the ladder condition?	Servi	iceable		
Indication of	None				What is the bench condition?	Servi	iceable		
Issues related to					Other notes on the bench?	Heav	y debris

General					
Structural Condition	Good				
Operational Condition	Good				
Debris Amount	Heavy				
Cleaning Needed	Yes				
Standing Water	Yes				
Flow	None				
Maintenance Needed	No
