Richmond Wastewater Treatment Facility 20 Year Evaluation *90% Submittal*

January 29, 2024

Prepared for: Town of Richmond, Vermont

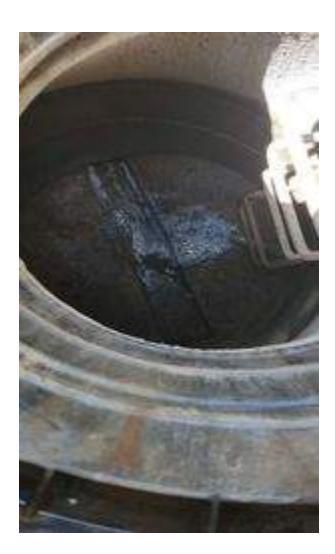
Asset ID CO 01

<u>Outlet Clock</u> (Facing N	Outlet Clock PositionOutlet Pipe(Facing North)Diameter (in.)		<u>Outlet Pipe</u> <u>Material</u>		<u>Outlet Pipe Invert</u> <u>Depth (in.)</u>		
10		8		AC		95	
	Manhole	Details			Manho	ble Condition	
Where is the manhole located?	Roadway			What is the cover condition? Other notes on the	Servi	cable	
What material is the manhole?	Concret	e		What is the ring and frame condition?	Servi	ceable	
What cover size is the	26"			Other notes on the ring and frame?			
What barrel size is the	48"	3"		What is the cone and riser condition?	Servi	ceable	
manhole? Other general				Other notes on the cone and riser?			
notes on the manhole				What is the barrel condition?	Servi	ceable	
details?	Hydra	ulics		What is the ladder condition?	Servi	ceable	
Indication of	Minor			What is the bench condition?	Servi	ceable	
Issues related to	Debris,	Silt		Other notes on the bench?			
Level of infiltration?				What is the channel condition?	Servi	ceable

Other notes on the channel?	Debr	is

General				
Structural Condition	Good			
Operational Condition	Good			
Debris Amount	Slight			
Cleaning Needed	No			
Standing Water	No			
Flow	None			
Maintenance Needed	No

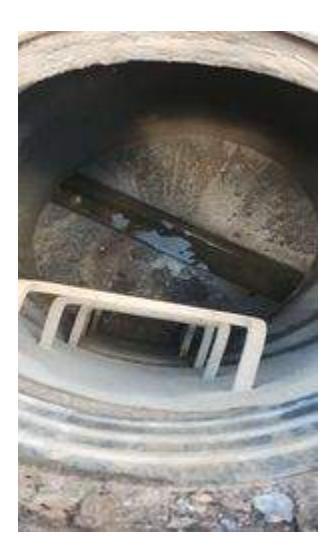
Asset ID CO 02

<u>Outlet Clock</u> (Facing N	<u>Position</u> lorth)	<u>Outlet Pipe</u> Diameter (in.)		<u>Outlet Pip</u> <u>Material</u>	<u>e</u>	<u>Outlet Pipe Invert</u> <u>Depth (in.)</u>	
8		8		AC		89	
	Manhole	Details			Manho	le Condition	
Where is the Roadway		What is the cover condition?	Servi	cable, Damaged			
manhole located?				Other notes on the cover?	Rusting		
What material is the manhole?	Concret	e		What is the ring and frame condition?	Servi	ceable	
What cover size is the	26"			Other notes on the ring and frame?	Rusti	ng	
What barrel size is the	48"			What is the cone and riser condition?	Servi	ceable	
manhole? Other general			_	Other notes on the cone and riser?			
notes on the manhole				What is the barrel condition?	Servi	ceable	
	Hydra	ulics		What is the ladder condition?	Servi	ceable	
Indication of	None		_	What is the bench condition?	Servi	ceable	
Issues related to				Other notes on the bench?

Level of infiltration?				What is the channel condition?	Servi	ceable	
				Other notes on the channel?	Slow	moving

General				
Structural Condition	Good			
Operational Condition	Good			
Debris Amount	Slight			
Cleaning Needed	No			
Standing Water	Yes			
Flow	Trickle			
Maintenance Needed	No

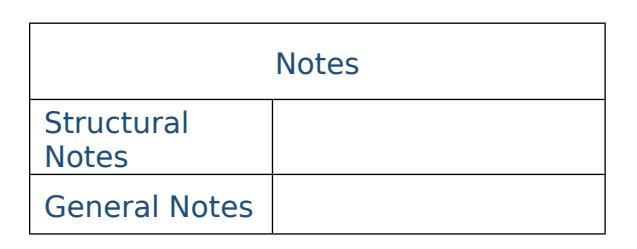
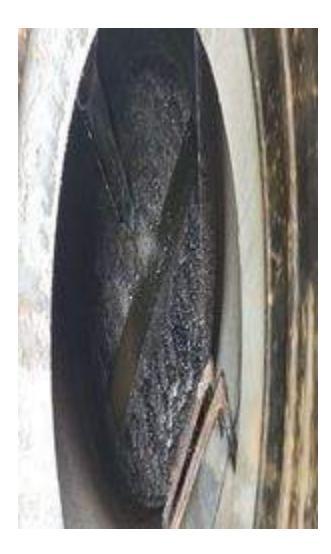
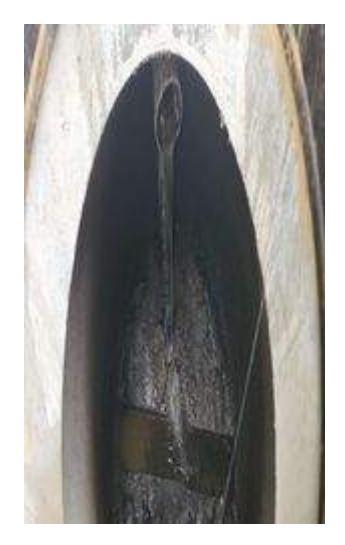
Asset ID DP 04

Outlet Clock Position (Facing North)Outlet Pipe Diameter (in.)		<u>Outlet Pipe</u> <u>Material</u>		<u>Outlet Pipe Invert</u> <u>Depth (in.)</u>		
4		8		AC		115
	Manhole	Details			Manhc	le Condition
Where is the Grass				What is the cover condition?		cable
located?				Other notes on the cover?		
What material is the manhole?	Concret	e		What is the ring and frame condition?	Servi	ceable
What cover size is the	26"			Other notes on the ring and frame?	Some	e rust
What barrel size is the	60"			What is the cone and riser condition?	Servi	ceable
Other general				Other notes on the cone and riser?		
notes on the manhole				What is the barrel condition?	Servi	ceable
details?	Lludra	ulice		What is the ladder	Servi	ceable
Indication of	None			What is the bench condition?	Servi	ceable
Issues related to				Other notes on the bench?		
Level of infiltration?				What is the channel condition?	Servi	ceable
				Other notes on the channel?

General			
Structural Condition	Good		
Operational Condition	Good		
Debris Amount	Slight		
Cleaning Needed	No		
Standing Water	No		
Flow	Steady		
Maintenance Needed	No

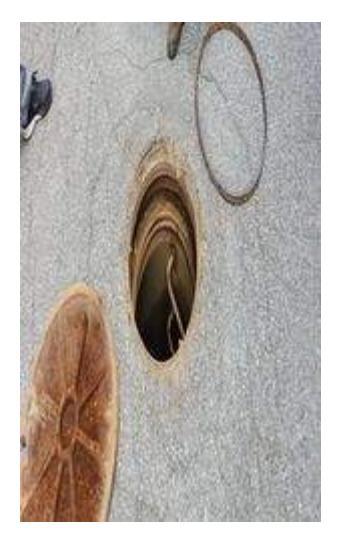
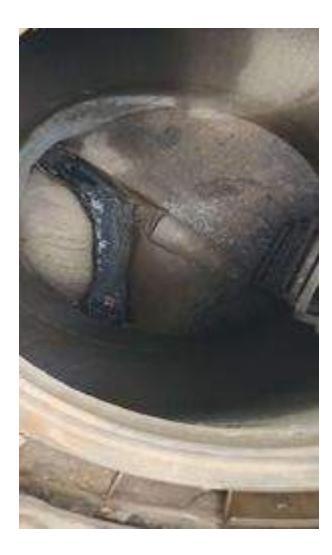
Asset ID ES 01

Level of infiltration?	evel of nfiltration?			What is the channel condition?	Servi	ceable	
				Other notes on the channel?	Smal chan	l amount of debris in nel

General				
Structural Condition	Fair			
Operational Condition	Good			
Debris Amount	Slight			
Cleaning Needed	No			
Standing Water	No			
Flow	Trickle			
Maintenance Needed	Yes

Notes
Structural Notes	Loose frame and ring
General Notes

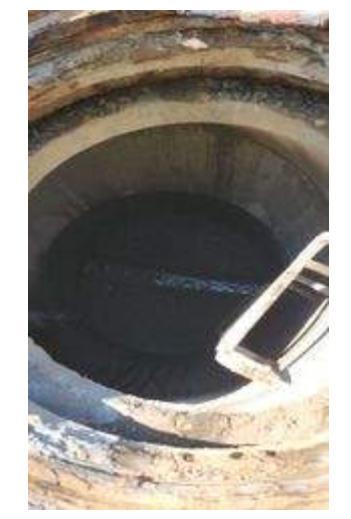
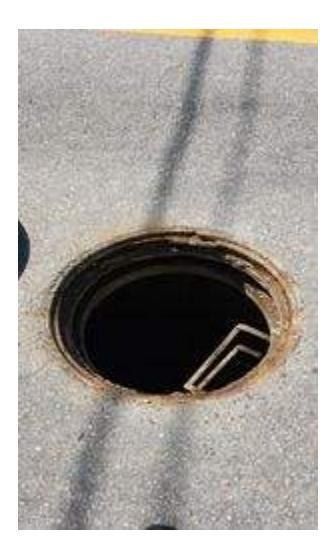
Asset ID HU 02

Level of infiltration?					What is the channel condition?	Serv	iceable		
					Other notes on the channel?	Bit o	f debris looks like rags

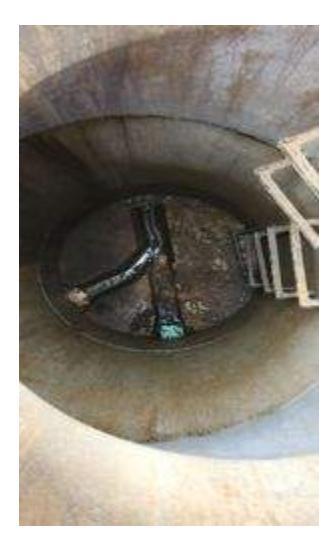
Asset ID JO 01

Level of infiltration?	of ation?		What is the channel condition?	Servi	ceable, Obstructed		
			Other notes on the channel?

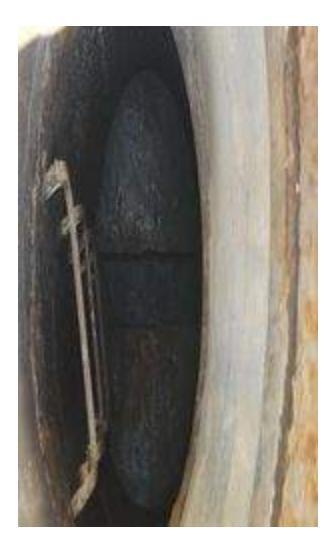
Asset ID JR 05

Outlet Clock Position (Facing North)Outlet Pipe Diameter (in.)			<u>Outlet Pipe</u> <u>Material</u>		<u>Outlet Pipe Invert</u> <u>Depth (in.)</u>		
6			8		AC		92
Manhole Details				Manhole Condition			
Where is the Roadway					What is the cover condition?	Servi	cable
manhole located?					Other notes on the cover?		
What material is the manhole?	Concret	oncrete			What is the ring and frame condition?	Servi	ceable
What cover size is the manhole?	26"				Other notes on the ring and frame?		
What barrel size is the	48"				What is the cone and riser condition?	ceable	
Other general					Other notes on the cone and riser?		
notes on the manhole	notes on the manhole details?			What is the barrel condition?	Servi	ceable	
detalls?				What is the ladder condition?	Servi	ceable	
Indication of	None				What is the bench condition?	Servi	ceable
Issues related to					Other notes on the bench?		
Level of infiltration?					What is the channel condition?	Servi	ceable

General				
Structural Condition	Good			
Operational Condition	Good			
Debris Amount	None			
Cleaning Needed	No			
Standing Water	No			
Flow	None			
Maintenance Needed	No

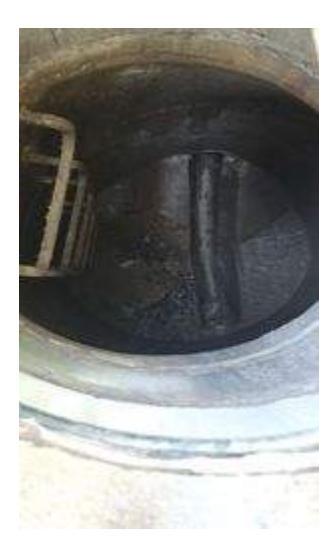
Asset ID JR 06

<u>Outlet Clock</u> (Facing N	<u>Position</u> Iorth)	D	<u>Outlet Pipe</u> iameter (in.)		<u>Outlet Pip</u> <u>Material</u>	<u>e</u>	<u>Outlet Pipe Invert</u> <u>Depth (in.)</u>
6			8		AC		106
	Manhole	Deta	ils			Manho	ole Condition
Where is the Roadway				What is the cover condition?	Servi	cable	
manhole located?		Other notes on the cover?					
What material is the manhole?	Concret	e			What is the ring and frame condition?	Servi	ceable
What cover size is the manhole?	26"				Other notes on the ring and frame?		
What barrel size is the	48"			-	What is the cone and riser condition?	Servi	ceable
Other general	Other general			Other notes on the cone and riser?			
notes on the manhole	es on nhole				What is the barrel condition?	ceable	
details?	Hydro	ulice]	What is the ladder	Servi	ceable
Indication of	None			-	What is the bench condition?	Servi	ceable
Issues related to					Other notes on the bench?		
Level of infiltration?					What is the channel condition?	Servi	ceable

General				
Structural Condition	Good			
Operational Condition	Good			
Debris Amount	None			
Cleaning Needed	No			
Standing Water	No			
Flow	None			
Maintenance Needed	No

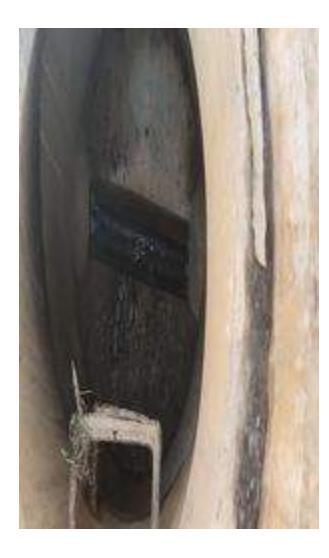
Asset ID JR 09

<u>Outlet Clock</u> (Facing N	<u>Position</u> Iorth)	<u>Outlet Pipe</u> Diameter (in.)		<u>Outlet Pip</u> <u>Material</u>	<u>e</u>	<u>Outlet Pipe Invert</u> <u>Depth (in.)</u>	
6		8		PVC		89	
Manhole Details				Manhole Condition			
Where is the Grass manhole located?		What is the cover condition?	cable				
		Other notes on the cover?					
What material is the manhole?	Concret	e		What is the ring and frame condition?	Servi	ceable	
What cover size is the manhole?	26"			Other notes on the ring and frame?			
What barrel size is the	48"			What is the cone and riser condition?	Servi	ceable	
Other general				Other notes on the cone and riser?			
notes on the manhole				What is the barrel condition?	Servi	ceable	
details?	Hydra	ulics		What is the ladder condition?	Servi	ceable	
Indication of	None			What is the bench condition?	Servi	ceable	
Issues related to				Other notes on the bench?	Some	e debris on bench

General					
Structural Condition	Good				
Operational Condition	Good				
Debris Amount	Slight				
Cleaning Needed	No				
Standing Water	No				
Flow	Trickle				
Maintenance Needed	No

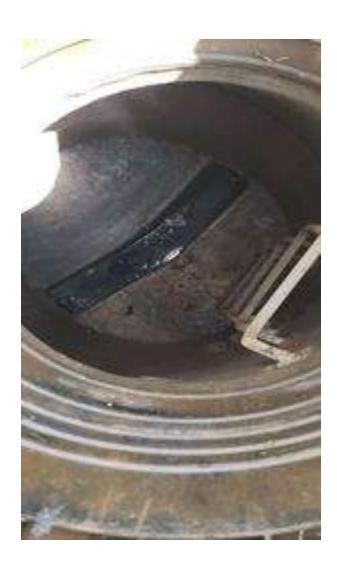
Asset ID ML 01

Outlet Clock Position (Facing North)Outlet Pipe Diameter (in.)		<u>Outlet Pipe</u> <u>Material</u>		<u>Outlet Pipe Invert</u> <u>Depth (in.)</u>			
7		8	AC		93		
	Manhole D	etails	Manhole Condition				
Where is the manhole located?	Roadway		What is the cover condition? Other notes on the	Servi	icable		
What material is the manhole?	Concrete		cover? What is the ring and frame condition?	Servi	iceable		
What cover size is the	26"		Other notes on the ring and frame?				
What barrel size is the	48"		What is the cone and riser condition?	Servi	iceable		
manhole? Other general			Other notes on the cone and riser?				
notes on the manhole			What is the barrel condition?	Servi	iceable		
details?	Hydraul	ics	What is the ladder condition?	Servi	iceable		
Indication of	None		What is the bench condition?	Servi	iceable		
Issues related to			Other notes on the bench?				
Level of infiltration?			What is the channel condition?	Servi	iceable, Obstructed

Other notes on the channel?	Sewa	age in channel

General				
Structural Condition	Good			
Operational Condition	Good			
Debris Amount	None			
Cleaning Needed	Yes			
Standing Water	Yes			
Flow	None			
Maintenance Needed	No

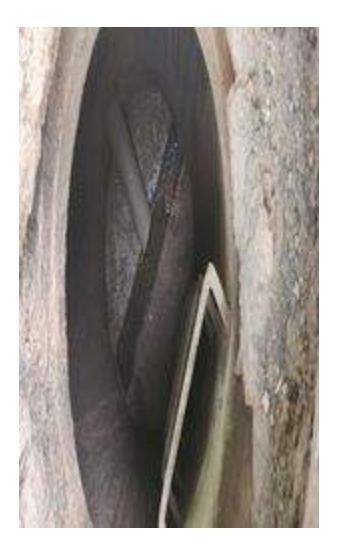
Asset ID NM 04

Outlet Clock Position (Facing North)Outlet Pipe Diameter (in.)			<u>Outlet Pipe</u> <u>Material</u>		<u>Outlet Pipe Invert</u> <u>Depth (in.)</u>		
4		8		AC		119	
	Manhole	Details		Manhole Condition			
Where is the Roadway		What is the cover condition? Other notes	Servicable				
located?				on the cover?			
What material is the manhole?	Concret	e		What is the ring and frame condition?	Servi	iceable	
What cover size is the	26"			Other notes on the ring and frame?	Ruste	ed	
manhole? What barrel size is the	48"		-	What is the cone and riser condition?	Servi	iceable	
manhole? Other general			-	Other notes on the cone and riser?	Missi	ng bricks	
notes on the manhole				What is the barrel condition?	Servi	iceable	
details?	Hydra	ulics		What is the ladder condition?	Servi	iceable	
Indication of	Minor		-	What is the bench condition?	Servi	iceable	
Issues related to	Debris,	Infiltration		Other notes on the bench?

Level of infiltration?	Some			What is the channel condition?		iceable	
				Other notes on the channel?

General				
Structural Condition	Good			
Operational Condition	Good			
Debris Amount	Moderate			
Cleaning Needed	No			
Standing Water	No			
Flow	Steady			
Maintenance Needed	Yes

Notes				
Structural Notes	Missing bricks in riser and bricks/debris in the channel			
General Notes

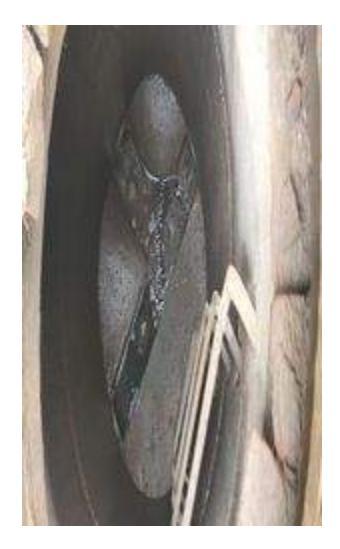
Asset ID NM 05

<u>Outlet Clock</u> (Facing N	<u>Position</u> lorth)	<u>Outlet Pipe</u> Diameter (in.)	<u>Outlet Pip</u> <u>Material</u>	<u>e</u>	<u>Outlet Pipe Invert</u> <u>Depth (in.)</u>
5		8	AC		99
Manhole Details		Manhole Condition			
Where is the manhole located?	Roadwa	У	What is the cover condition? Other notes	Servi	icable
What material is the manhole?	Concret	e	cover? What is the ring and frame condition?	Servi	iceable
What cover size is the	26"		Other notes on the ring and frame?		
What barrel size is the	48"		What is the cone and riser condition?	Servi	iceable, Misaligned
manhole? Other general			Other notes on the cone and riser?	Missi	ng some bricks
notes on the manhole			What is the barrel condition?	Servi	iceable
	Hvdra	ulics	What is the ladder condition?	Servi	iceable
Indication of	None		What is the bench condition?	Servi	iceable
Issues related to			Other notes on the bench?		
Level of infiltration?			What is the channel condition?	Servi	iceable, Obstructed

General			
Structural Condition	Good		
Operational Condition	Good		
Debris Amount	Moderate		
Cleaning Needed	Yes		
Standing Water	No		
Flow	Steady		
Maintenance Needed	Yes

Notes				
Structural Notes	Need to replace bricks in riser			
General Notes	Need to clean and remove debris in channel

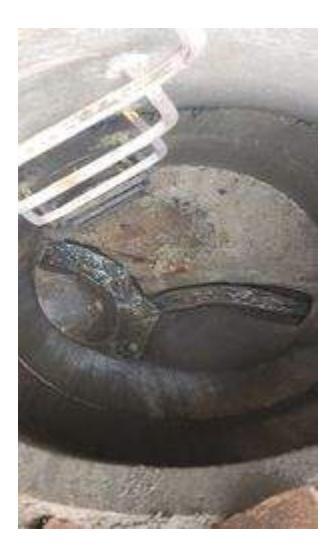
Asset ID NM 06

<u>Outlet Clock</u> (Facing N	<u>Position</u> Iorth)	<u>Outlet</u> Diamete	<u>Pipe</u> er (in.)	<u>Outlet Pip</u> <u>Material</u>	<u>e</u>	<u>Outlet Pipe Invert</u> <u>Depth (in.)</u>	
6		8		AC		95	
Manhole Details				Manho	le Condition		
Where is the Sidewalk			What is the cover condition?	Servicable			
manhole located?				Other notes on the cover?			
What material is the manhole?	Concrete	Concrete		What is the ring and frame condition?	Servi	ceable	
What cover size is the	26"			Other notes on the ring and frame?			
What barrel size is the	48"			What is the cone and riser condition?	Servi	ceable	
Other general				Other notes on the cone and riser?	Missi	ng bricks in riser	
notes on the manhole				What is the barrel condition?	Servi	ceable	
	Hydra	ulics		What is the ladder condition?	Servi	ceable	
Indication of	None			What is the bench condition?	Servi	ceable, Cracked/Broken	
Issues related to				Other notes on the bench?	Some does	e missing pieces but n't affect operation

Level of infiltration?				What is the channel condition?	Servi	ceable, Obstructed	
				Other notes on the channel?	Brick chan	s from the riser in the nel

Notes
Structural Notes	Some missing bricks in riser but okay for now
General Notes

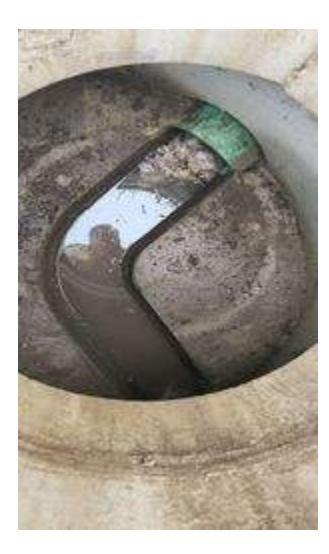
Asset ID NM 09

<u>Outlet Clock</u> (Facing N	Position orth)	<u>Outlet Pipe</u> Diameter (in.)		<u>Outlet Pip</u> <u>Material</u>	<u>e</u>	<u>Outlet Pipe Invert</u> Depth (in.)
6		8		PVC		47
Manhole Details			Manhole Condition			
Where is the Grass manhole			What is the cover condition? Other notes	Servi	cable	
What material is the manhole?	Concret	e	-	What is the ring and frame condition?	Servi	ceable
What cover size is the	26"			Other notes on the ring and frame?		
What barrel size is the	48"			What is the cone and riser condition?	Servi	ceable
manhole? Other general			-	Other notes on the cone and riser?		
notes on the manhole				What is the barrel condition?	Servi	ceable
details?	Hydra	ulics]	What is the ladder condition?	Servi	ceable
Indication of	None			What is the bench condition?	Servi	ceable
Issues related to				Other notes on the bench?		
Level of infiltration?			-	What is the channel condition?	Servi	ceable, Obstructed

Other notes on the channel?	Chan	nel full of sewage

General		
Structural Condition	Good	
Operational Condition	Poor	
Debris Amount	None	
Cleaning Needed	No	
Standing Water	Yes	
Flow	None	
Maintenance Needed	No

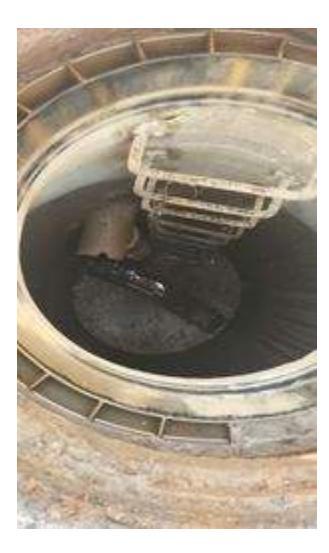
General					
Structural Condition	Good				
Operational Condition	Good				
Debris Amount	None				
Cleaning Needed	No				
Standing Water	No				
Flow	Trickle				
Maintenance Needed	Yes

Notes
Structural Notes	Frame needs replacing
General Notes

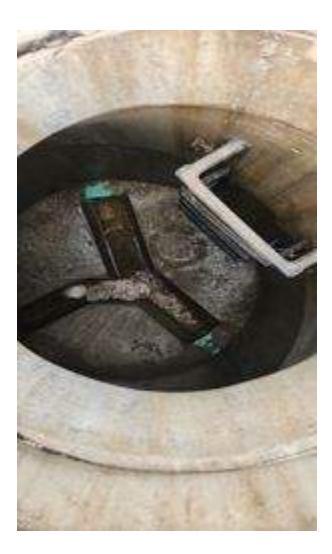
Asset ID RR 02

<u>Outlet Clock</u> (Facing N	<u>Position</u> lorth)	<u>Outlet Pipe</u> Diameter (in.)		<u>Outlet Pip</u> <u>Material</u>	<u>e</u>	<u>Outlet Pipe Invert</u> <u>Depth (in.)</u>
6		12		PVC		94
Manhole Details		Manhole Condition				
Where is the manhole located?	Grass			What is the cover condition? Other notes on the	Servi	cable
What material is the manhole?	Concret	e		cover? What is the ring and frame condition?	Servi	ceable
What cover size is the	26"			Other notes on the ring and frame?		
What barrel size is the	48"			What is the cone and riser condition?	Servi	ceable
manhole? Other general				Other notes on the cone and riser?		
notes on the manhole				What is the barrel condition?	Servi	ceable
details?	Hvdra	ulics		What is the ladder condition?	Servi	ceable
Indication of	None			What is the bench condition?	Servi	ceable
surcharge? Issues related to				Other notes on the bench?		
Level of infiltration?				What is the channel condition?	Obst	ructed

Other notes on the channel?	Debr to be	is in the channel. Needs cleaned.

General				
Structural Condition	Good			
Operational Condition	Fair			
Debris Amount	Moderate			
Cleaning Needed	Yes			
Standing Water	Yes			
Flow	Trickle			
Maintenance Needed	No

Notes					
Structural Notes					
General Notes	Needs cleaning. Water backing up.

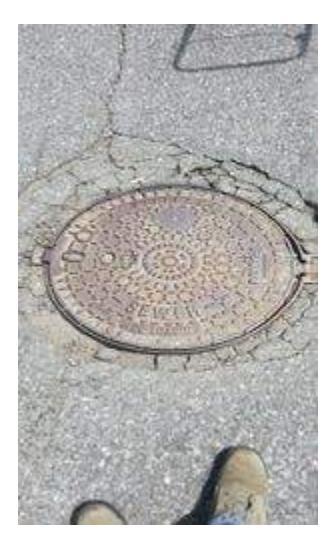
Asset ID RR 04

Notes				
Structural Notes				
General Notes	Unable to open

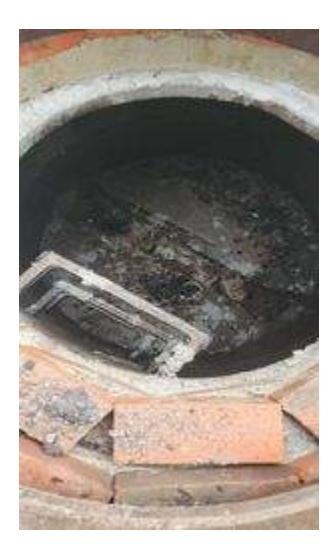
Asset ID SM 04

<u>Outlet Clock</u> (Facing N	<u>Position</u> lorth)	<u>Outlet Pipe</u> Diameter (in.)		<u>Outlet Pipe</u> <u>Material</u>		<u>Outlet Pipe Invert</u> <u>Depth (in.)</u>
10		8		AC		79
	Manhole	Details			Manho	ole Condition
Where is the manhole located?	Roadwa	у		What is the cover condition? Other notes on the	Servi	icable
What material is the manhole?	Concret	e	_	cover? What is the ring and frame condition?	Servi	iceable
What cover size is the	26"			Other notes on the ring and frame?		
What barrel size is the	48"			What is the cone and riser condition?	Servi	iceable, Misaligned
manhole? Other general				Other notes on the cone and riser?		
notes on the manhole				What is the barrel condition?	Servi	iceable
	Hvdra	ulics		What is the ladder condition?	Servi	iceable
Indication of	None			What is the bench condition?	Servi	iceable
Issues related to				Other notes on the bench?	Some	e debris
Level of infiltration?				What is the channel condition?	Servi	iceable

Other notes on the channel?	Sewa	age in the channel

General		
Structural Condition	Good	
Operational Condition	Good	
Debris Amount	Moderate	
Cleaning Needed	No	
Standing Water	No	
Flow	Trickle	
Maintenance Needed	No

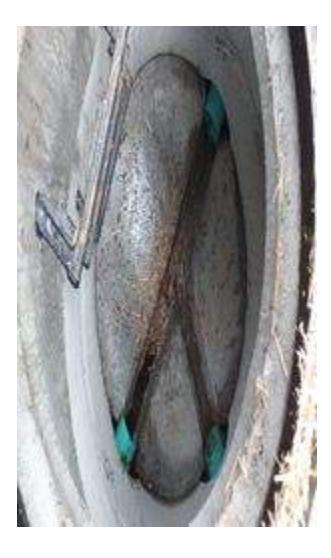
Asset ID SM 07

Notes						
Structural Notes						
General Notes	Brand new manhole. Installed in 2023.

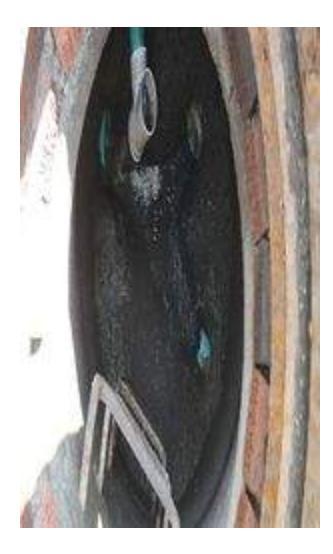
Asset ID TD 05

Level of infiltration?				What is the channel condition?	Servi	ceable, Obstructed		
				Other notes on the channel?	Some	e rags in channel

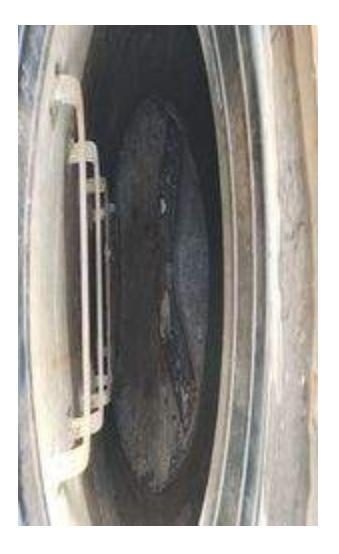
Asset ID TD 07

Level of infiltration?			What is the channel condition?	Obst	ructed	
			Other notes on the channel?	A lot	of debris in channel.

General		
Structural Condition	Fair	
Operational Condition	Good	
Debris Amount	Heavy	
Cleaning Needed	Yes	
Standing Water	No	
Flow	None	
Maintenance Needed	Yes

Notes
Structural Notes	Ring and frame needs replacing
General Notes	Lots of debris in channel.

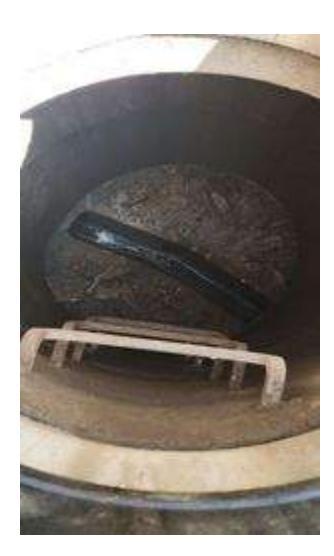
Asset ID TD 08

Other notes on the channel?	Some	e rags in the channel.

General					
Structural Condition	Good				
Operational Condition	Good				
Debris Amount	Slight				
Cleaning Needed	No				
Standing Water	No				
Flow	Trickle				
Maintenance Needed	No

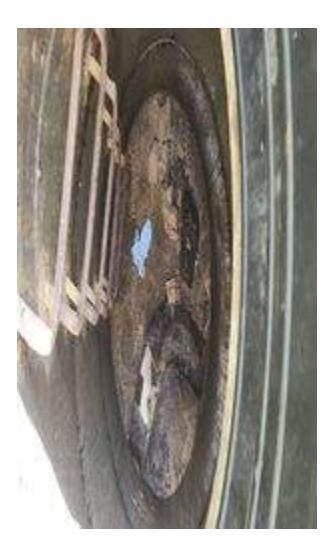
Asset ID TH 01

Other notes on the channel?	Debr	is blocking channel

General					
Structural Condition	Good				
Operational Condition	Good				
Debris Amount	Moderate				
Cleaning Needed	Yes				
Standing Water	Yes				
Flow	Trickle				
Maintenance Needed	No

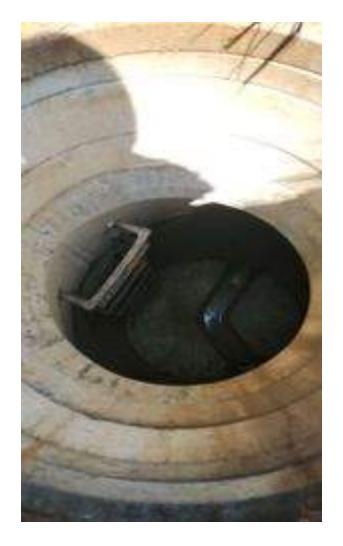
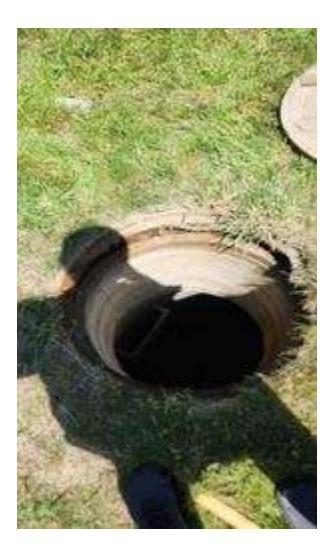
Asset ID TH 05

Outlet Clock Position (Facing North)Outlet Pipe Diameter (in.)		<u>Outlet Pipe</u> <u>Material</u>		<u>Outlet Pipe Invert</u> <u>Depth (in.)</u>		
1		8		PVC		135
	Manhole	Details			Manhc	le Condition
Where is the manhole located?	Grass			What is the cover condition? Other notes on the	Servi	cable
What material is the manhole?	Concret	e		Cover? What is the ring and frame condition?	Servi	ceable
What cover size is the	26"			Other notes on the ring and frame?		
What barrel size is the	48"			What is the cone and riser condition?	Servi	ceable
manhole? Other general				Other notes on the cone and riser?		
notes on the manhole				What is the barrel condition?	Servi	ceable
details?	Hydra	ulics		What is the ladder condition?	Servi	ceable
Indication of	None			What is the bench condition?	Servi	ceable
Issues related to				Other notes on the bench?		
Level of infiltration?				What is the channel condition?	Servi	ceable

General				
Structural Condition	Good			
Operational Condition	Good			
Debris Amount	Slight			
Cleaning Needed	No			
Standing Water	No			
Flow	None			
Maintenance Needed	No

Notes					
Structural Notes					
General Notes	Some dirt from opening manhole

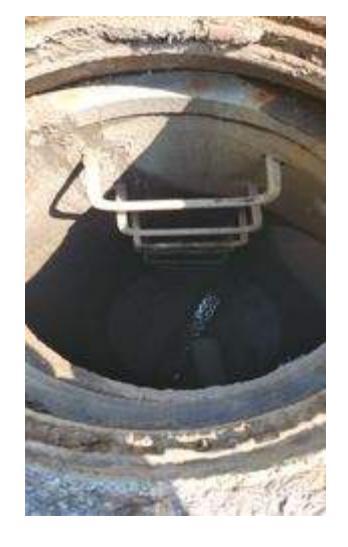
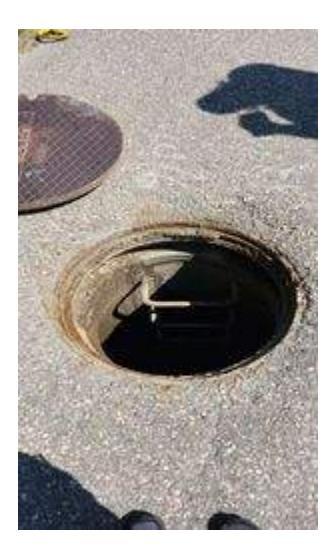
Asset ID TH 06

Outlet Clock Position (Facing North)Outlet Pipe Diameter (in.)			<u>Outlet Pipe</u> <u>Material</u>		<u>Outlet Pipe Invert</u> Depth (in.)		
3			8		AC		131
	Manhole	De	etails			Manho	ole Condition
Where is the	Roadwa	У			What is the cover condition?ServicableOther notes		
located?					on the cover?		
What material is the manhole?	Concret	e			What is the ring and frame condition?	Serv	iceable
What cover size is the	26"				Other notes on the ring and frame?		
What barrel size is the	48"	8"			What is the cone and riser condition?	Serv	iceable
manhole? Other general					Other notes on the cone and riser?		
notes on the manhole					What is the barrel condition?	Serv	iceable
details?	Hydra	uli	cs]	What is the ladder condition?	Serv	iceable
Indication of	Minor				What is the bench condition?	Serv	iceable
Issues related to	Debris			_	Other notes on the bench?		
Level of infiltration?					What is the channel condition?	Obst	ructed

Other notes on the channel?	Rags	in channel

General				
Structural Condition	Good			
Operational Condition	Good			
Debris Amount	Slight			
Cleaning Needed	Yes			
Standing Water	No			
Flow	Steady			
Maintenance Needed	No

Notes					
Structural Notes					
General Notes	Rags on ladder rung and in channel

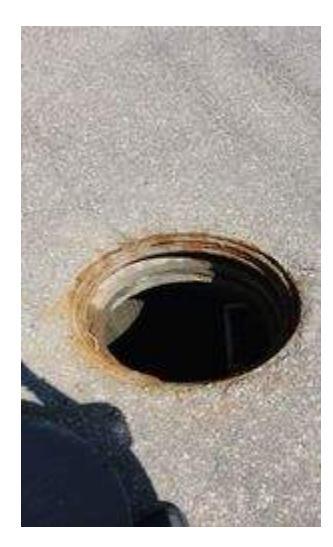
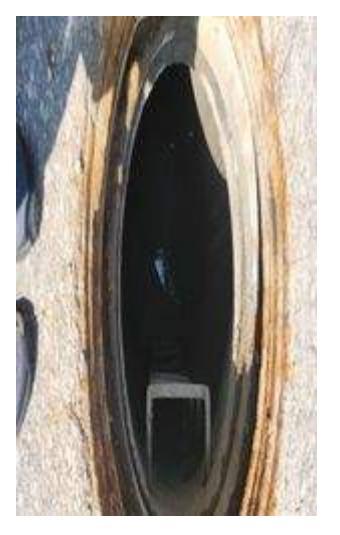
Asset ID TH 07

Outlet Clock Position (Facing North)Outlet Pip Diameter (i		<u>Outlet Pipe</u> Diameter (in.)	<u>Outlet Pip</u> <u>Material</u>	<u>)e</u>	<u>Outlet Pipe Invert</u> <u>Depth (in.)</u>		
2		8	AC		160		
Manhole Details				Manhole Condition			
Where is the manhole located?	Roadwa	у	What is the cover condition?ServicableOther notes on the				
What material is the manhole?	Concret	e	cover? What is the ring and frame condition?	Servi	iceable		
What cover size is the	26"		Other notes on the ring and frame?				
What barrel size is the	48"		What is the cone and riser condition?	Servi	iceable		
Other general			Other notes on the cone and riser?				
notes on the manhole			What is the barrel condition?	Servi	iceable		
details?			What is the ladder	Servi	iceable		
Indication of	None	ulics	What is the bench condition?	Servi	iceable		
Issues related to			Other notes on the bench?				
Level of infiltration?			What is the channel condition?	Servi	iceable

General		
Structural Condition	Good	
Operational Condition	Good	
Debris Amount	None	
Cleaning Needed	No	
Standing Water	No	
Flow	Steady	
Maintenance Needed	No

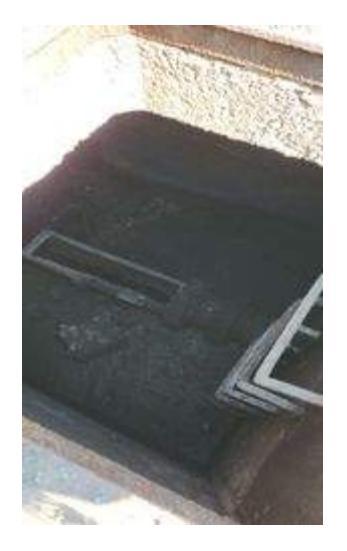
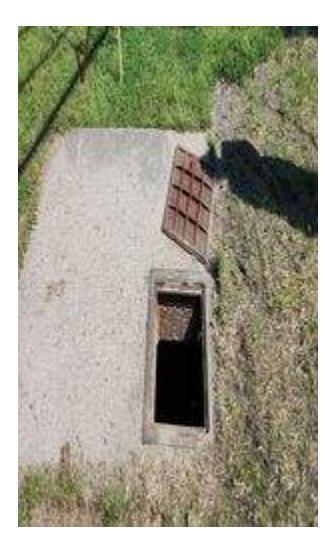
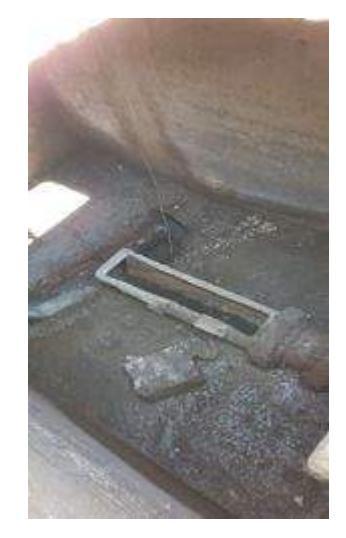
Asset ID VG 01

<u>Outlet Clock</u> (Facing N	<u>Position</u> lorth)	<u>Outlet Pipe</u> Diameter (in.)	<u>Outlet Pip</u> <u>Material</u>	<u>e</u>	<u>Outlet Pipe Invert</u> <u>Depth (in.)</u>	
11		8	AC		113	
	Manhole	Details		Manhole Condition		
Where is the Grass		What is the cover condition?	Servi	cable		
located?			on the cover?			
What material is the manhole?	Concret	e	What is the ring and frame condition?	Servi	ceable	
What cover size is the manhole?	26"		Other notes on the ring and frame?			
What barrel size is the	Other		What is the cone and riser condition?	Servi	ceable	
Other general	manhole?Other general notes on theOpening is offset to inlet 1 and outlet		Other notes on the cone and riser?	Not a	pplicable precast vault	
notes on the manhole			What is the barrel condition?	Servi	ceable	
details?			What is the ladder	Servi	ceable	
Indication	Hydra	ulics	condition? What is the	Soni	caphla	
of	None		bench condition?	Servi

General		
Structural Condition	Good	
Operational Condition	Good	
Debris Amount	Slight	
Cleaning Needed	Yes	
Standing Water	No	
Flow	Steady	
Maintenance Needed	No

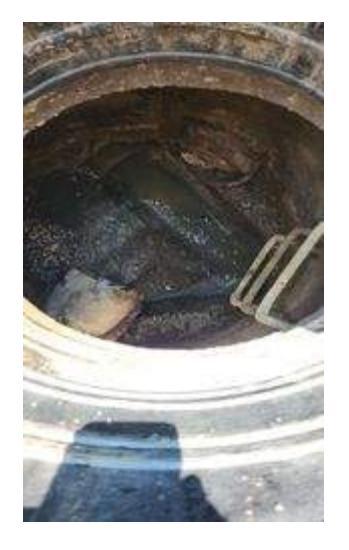
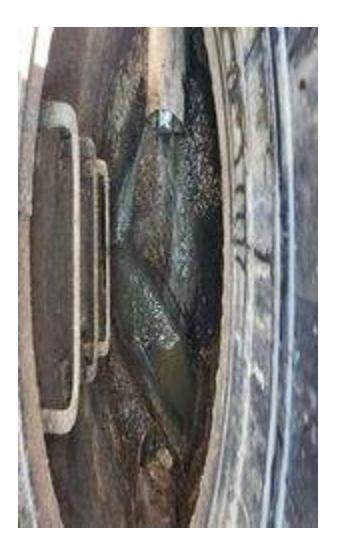
Asset ID VG 02

<u>Outlet Clock</u> (Facing N	<u>Position</u> lorth)	<u>Outlet Pipe</u> <u>Diameter (in.)</u>	<u>Outlet Pip</u> <u>Material</u>	<u>e</u>	<u>Outlet Pipe Invert</u> <u>Depth (in.)</u>	
12		8	AC		94	
	Manhole	Details		Manhole Condition		
Where is the Roadway		What is the cover condition?	Servi	cable, Damaged		
manhole located?			Other notes on the cover?	Ruste	ed	
What material is the manhole?	Concret	e	What is the ring and frame condition?	Servi	ceable	
What cover size is the manholo?	26"		Other notes on the ring and frame?			
What barrel size is the	48"		What is the cone and riser condition?	Servi	ceable, Misaligned	
Other general	manhole? Other general notes on blocked overflow to river the manhole		Other notes on the cone and riser?			
notes on the manhole			What is the barrel condition?	Servi	ceable	
details?	Hydra	ulics	What is the ladder condition?	Servi	ceable	
Indication of	None		What is the bench condition?	Servi	ceable

Issues related to			Other notes on the bench?	Could	d use some work	
Level of infiltration?			What is the channel condition?	Servi	ceable	
			Other notes on the channel?

General		
Structural Condition	Good	
Operational Condition	Good	
Debris Amount	None	
Cleaning Needed	No	
Standing Water	No	
Flow	Steady	
Maintenance Needed	Yes

Notes			
Structural Notes Frame and cover misaligned			
General Notes	Bricked off overflow to the river

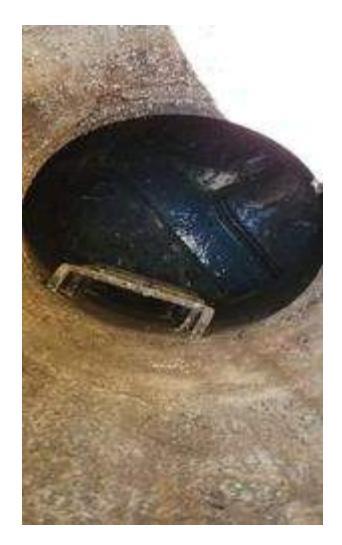
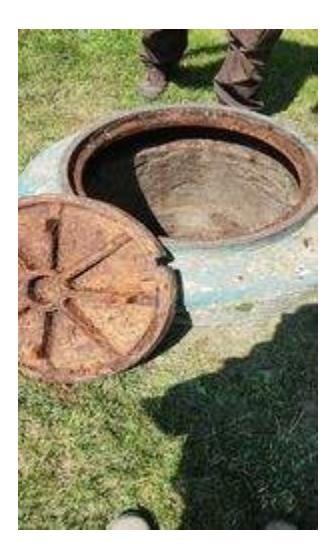
Asset ID VG 03

<u>Outlet Clock</u> (Facing N	Position orth)	<u>Ou</u> Diar	<u>itlet Pipe</u> neter (in.)	<u>Outlet Pi</u> <u>Materia</u>	<u>pe</u> I	<u>Outlet Pipe Invert</u> <u>Depth (in.)</u>		
10			8	AC		109		
	Manhole	Details			Manhole Condition			
Where is the Grass		What is the cover condition?	Servi	cable				
manhole located?				Other notes on the cover?	Rusti	ng		
What material is the manhole?	Concret	e		What is the ring and frame condition?	Servi	ceable		
What cover size is the	26"			Other notes on the ring and frame?	Rusti	ng		
What barrel size is the	60"			What is the cone and riser condition?	Servi	ceable		
Other general	Deized			Other notes on the cone and riser?				
the manhole details?	Raiseu	Jover		What is the barrel condition?	Servi	ceable		
	Hydra	ulics		What is the ladder condition?	Servi	ceable		
Indication of	None			What is the bench condition?	Servi	ceable		
Issues related to				Other notes on the bench?

Level of infiltration?				What is the channel condition?	Servi	ceable		
				Other notes on the channel?	Debr	is

General		
Structural Condition	Good	
Operational Condition	Good	
Debris Amount	Slight	
Cleaning Needed	No	
Standing Water	No	
Flow	Trickle	
Maintenance Needed	No

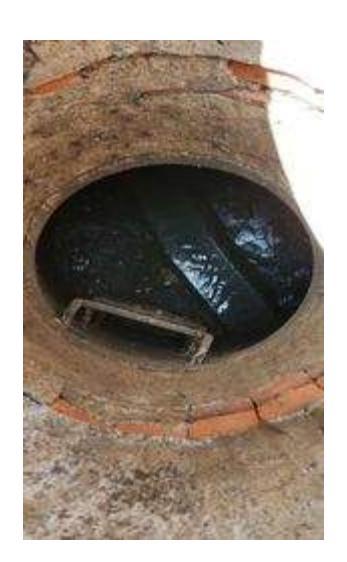
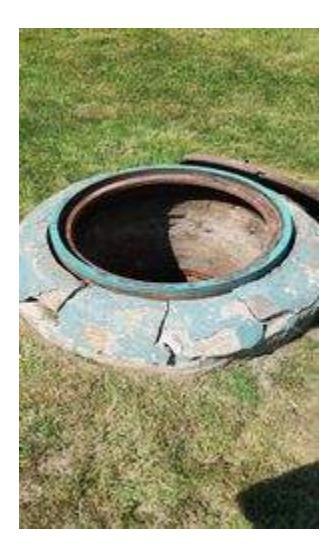
Asset ID VG 04

Outlet Clock Position (Facing North)Outlet Pipe Diameter (in.)			<u>Outlet Pipe</u> <u>Material</u>		<u>Outlet Pipe Invert</u> <u>Depth (in.)</u>	
10		8		AC		104
	Manhole	Details			Manho	ole Condition
Where is the manhole located?	Grass		-	What is the cover condition? Other notes	Servi	cable
What material is the manhole?	Concret	e	-	what is the ring and frame condition?	Servi	ceable
What cover size is the	26"			Other notes on the ring and frame?		
What barrel size is the	48"		-	What is the cone and riser condition?	Servi	ceable
manhole? Other general			-	Other notes on the cone and riser?		
notes on the manhole				What is the barrel condition?	Servi	ceable
details?	Hydra	ulics]	What is the ladder condition?	Servi	ceable
Indication of	Minor		-	What is the bench condition?	Servi	ceable
Issues related to	Debris,	Silt	-	Other notes on the bench?	Debr	is from overflow
Level of infiltration?				What is the channel condition?	Servi	ceable

General		
Structural Condition	Good	
Operational Condition	Good	
Debris Amount	Slight	
Cleaning Needed	No	
Standing Water	No	
Flow	Trickle	
Maintenance Needed	No

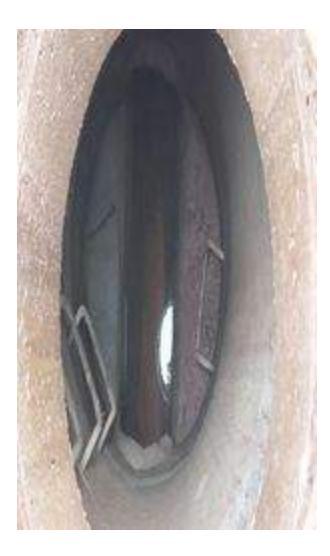
Asset ID VG 05

<u>Outlet Clock</u> (Facing N	<u>Position</u> lorth)	<u>Outlet Pipe</u> Diameter (in.)		<u>Outlet Pip</u> <u>Material</u>	<u>e</u>	<u>Outlet Pipe Invert</u> <u>Depth (in.)</u>
5		20		AC		83
	Manhole	Details			Manho	ble Condition
Where is the manhole	Other			What is the cover condition? Other notes	Servi	cable
located?				on the cover?		
What material is the manhole?	Concret	e		What is the ring and frame condition?	Servi	ceable
What cover size is the	26"			Other notes on the ring and frame?		
What barrel size is the	48"			What is the cone and riser condition?	Servi	ceable
Other general				Other notes on the cone and riser?		
notes on the manhole				What is the barrel condition?	Servi	ceable
	Hydra	ulics		What is the ladder condition?	Servi	ceable
Indication of	None		_	What is the bench condition?	Servi	ceable
Issues related to				Other notes on the bench?		
Level of infiltration?				What is the channel condition?	Servi	ceable

General		
Structural Condition	Good	
Operational Condition	Good	
Debris Amount	Slight	
Cleaning Needed	No	
Standing Water	No	
Flow	Steady	
Maintenance Needed	No

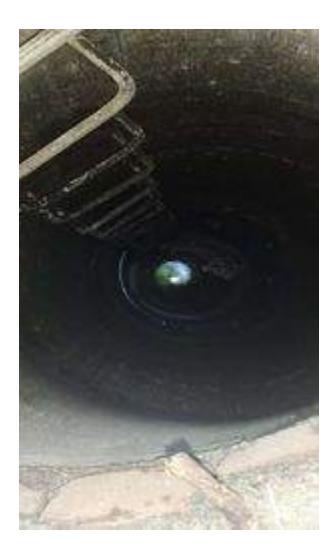
Asset ID VG 06

Manhole Condition		
What is the cover condition?	Servicable	
Other notes on the cover?		
What is the ring and frame condition?	Serviceable	
Other notes on the ring and frame?		
What is the cone and riser condition?	Serviceable, Misaligned	
Other notes on the cone and riser?	Frame and cover are slighly off but it would be difficult to reset due to presence of trees.	
What is the barrel condition?	Serviceable	
What is the ladder condition?	Serviceable	
What is the bench condition?	Serviceable	
Other notes on the bench?	N/A	
What is the channel condition?	Serviceable	
Other notes on the channel?

General		
Structural Condition	Good	
Operational Condition	Good	
Debris Amount	None	
Cleaning Needed	No	
Standing Water	No	
Flow	Steady	
Maintenance Needed	No

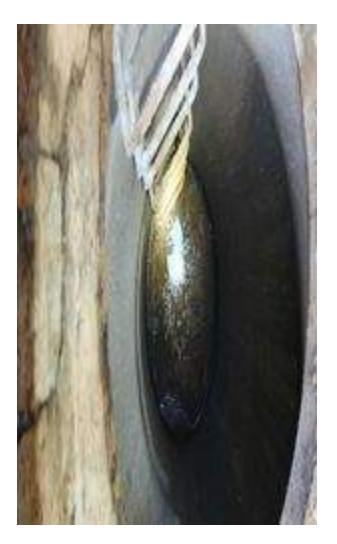
Asset ID WW 01

General			
Structural Condition	Good		
Operational Condition	Good		
Debris Amount	Moderate		
Cleaning Needed			
Standing Water	Yes		
Flow	None		
Maintenance Needed

Notes				
Structural Notes				
General Notes	Standing water. Manhole abandoned. No inlets or outlets.

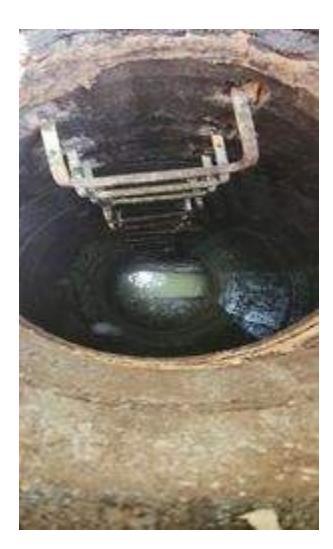
Asset ID WW 02

<u>Outlet Clock</u> (Facing N	<u>Position</u> Iorth)	<u>Outlet Pipe</u> Diameter (in.)	<u>Outlet Pip</u> <u>Material</u>	<u>e</u>	<u>Outlet Pipe Invert</u> <u>Depth (in.)</u>
9		12	AC		227
Manhole Details		Manhole Condition			
Where is the Roadway, Grass manhole located?		What is the cover condition?	Servi	icable	
		Other notes on the cover?			
What material is the manhole?	Concret	e	What is the ring and frame condition?	Servi	iceable
What cover size is the manhole?	26"		Other notes on the ring and frame?		
What barrel size is the	48"		What is the cone and riser condition?	Serviceable	
Other general			Other notes on the cone and riser?		
notes on the manhole			What is the barrel condition?	Servi	iceable
detalls?	Lludra	ulice	What is the ladder	Servi	iceable
Indication of	None		What is the bench condition?	Servi	iceable
Issues related to			Other notes on the bench?		
Level of infiltration?			What is the channel condition?	Servi	iceable

Other notes on the channel?		
General					
--------------------------	--------	--	--		
Structural Condition	Good				
Operational Condition	Good				
Debris Amount	None				
Cleaning Needed	No				
Standing Water	No				
Flow	Steady				
Maintenance Needed	No

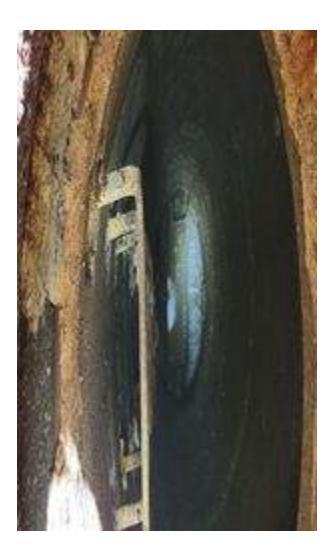
Asset ID WW 03

Outlet Clock Position (Facing North)Outlet Pipe Diameter (in.)		<u>Outlet Pipe</u> <u>Material</u>		<u>Outlet Pipe Invert</u> <u>Depth (in.)</u>		
9		12	AC		202	
	Manhole	Details		Manhole Condition		
Where is the Grass, In Sump/Depression		What is the cover condition?	Servi	cable		
manhole located?			Other notes on the cover?			
What material is the manhole?	Concret	e	What is the ring and frame condition?	Servi	ceable	
What cover size is the	26"		Other notes on the ring and frame?			
What barrel size is the	48"		What is the cone and riser condition?	Servi	ceable	
Other general			Other notes on the cone and riser?			
notes on the manhole			What is the barrel condition?	Servi	ceable	
details?			What is the ladder	Servi	ceable	
	Hydra	oulics	condition? What is the			
Indication of surcharge?	Minor		bench condition?	Servi	ceable	
Issues related to	Debris		Other notes on the bench?			
Level of infiltration?			What is the channel condition?	Servi	ceable

General			
Structural Condition	Good		
Operational Condition	Good		
Debris Amount	Slight		
Cleaning Needed	No		
Standing Water	No		
Flow	Steady		
Maintenance Needed	No

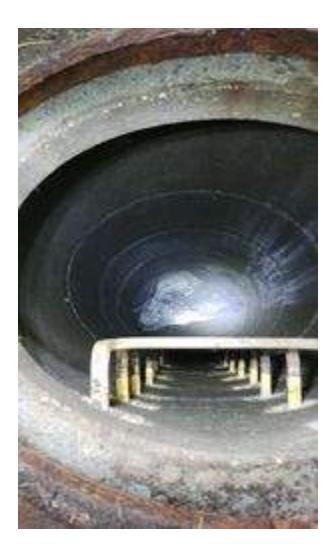
Asset ID WW 04

<u>Outlet Clock</u> (Facing N	<u>Position</u> lorth)	<u>Outlet Pipe</u> Diameter (in.)	<u>Outlet Pip</u> <u>Material</u>	<u>)e</u>	<u>Outlet Pipe Invert</u> <u>Depth (in.)</u>	
6		12	AC		202	
	Manhole	Details		Manhole Condition		
Where is the	Where is Grass, In Sump/Depression, Does		What is the cover condition?	Servi	cable	
located?	Grade 5	юре Амау	on the cover?			
What material is the manhole?	Concret	e	What is the ring and frame condition?	Servi	ceable	
What cover size is the	26"		Other notes on the ring and frame?			
What barrel size is the	48"		What is the cone and riser condition?	Servi	ceable	
manhole? Other general			Other notes on the cone and riser?			
notes on the manhole			What is the barrel condition?	Servi	ceable	
	Hydra	ulics	What is the ladder condition?	Servi	ceable	
Indication of	Minor		What is the bench condition?	Servi	ceable	
Issues related to	Debris,	Silt	Other notes on the bench?

General			
Structural Condition	Good		
Operational Condition	Good		
Debris Amount	Slight		
Cleaning Needed	No		
Standing Water	No		
Flow	Steady		
Maintenance Needed	No

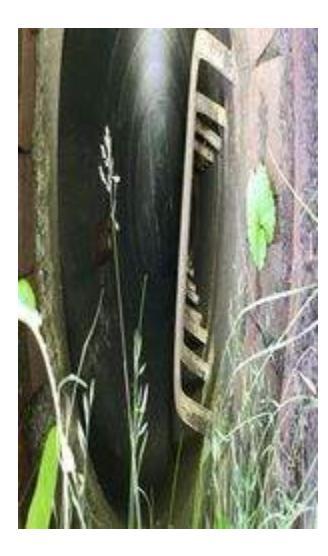
Asset ID WW 05

Outlet Clock Position (Facing North)Outlet Pipe Diameter (in.)			<u>Outlet Pipe</u> <u>Material</u>		<u>Outlet Pipe Invert</u> <u>Depth (in.)</u>		
3		12		AC		205	
	Manhole	Details		Manhole Condition			
Where is the maphala Grass, Does Grade Slope			What is the cover condition?	Servi	cable		
located?				on the cover?			
What material is the manhole?	Concret	e		What is the ring and frame condition?	Servi	ceable	
What cover size is the	26"			Other notes on the ring and frame?			
What barrel size is the	48"		-	What is the cone and riser condition?	Servi	ceable	
manhole? Other general			-	Other notes on the cone and riser?			
notes on the manhole				What is the barrel condition?	Servi	ceable	
details?]	What is the ladder	Servi	ceable	
	Hydra	ulics		condition?			
Indication of surcharge?	Minor			bench condition?	Servi	ceable	
Issues related to	Silt			Other notes on the bench?			
Level of infiltration?				What is the channel condition?	Servi	ceable

General			
Structural Condition	Good		
Operational Condition	Good		
Debris Amount	Slight		
Cleaning Needed	No		
Standing Water	No		
Flow	Steady		
Maintenance Needed	No

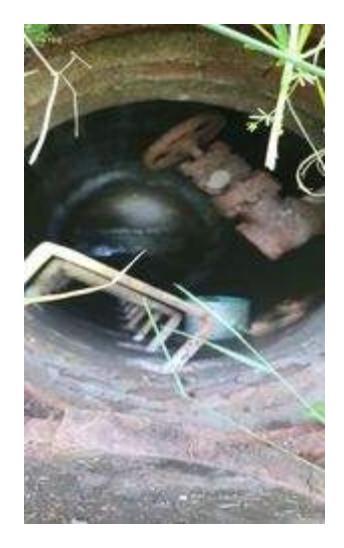
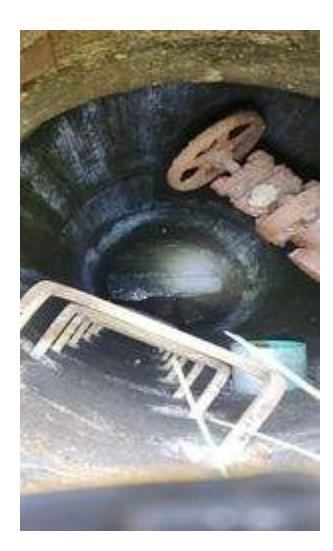
Asset ID WW 06

<u>Outlet Clock</u> (Facing N	<u>Position</u> lorth)	<u>Outl</u> Diam	<u>et Pipe</u> eter (in.)	<u>Outlet Pipe</u> <u>Material</u>		<u>Outlet Pipe Invert</u> <u>Depth (in.)</u>
3			12	AC		204
	Manhole	Details		Manhole Condition		
Where is the	Where is he Grass, Does Grade Slope		What is the cover condition?	Servi	cable	
manhole located?	, may			Other notes on the cover?		
What material is the manhole?	Concret	e		What is the ring and frame condition?	Servi	ceable
What cover size is the	26"			Other notes on the ring and frame?		
What barrel size is the	48"			What is the cone and riser condition?	Servi	ceable
Manhole? Other general				Other notes on the cone and riser?		
notes on the manhole				What is the barrel condition?	Servi	ceable
detalls?				What is the ladder	Servi	ceable
	Hydra	ulics		condition?		
Indication of surcharge?	None			bench condition?	Servi	ceable
Issues related to				Other notes on the bench?

General			
Structural Condition	Good		
Operational Condition	Good		
Debris Amount	None		
Cleaning Needed	No		
Standing Water	Yes		
Flow	Trickle		
Maintenance Needed	No

Notes				
Structural Notes				
General Notes	Slow moving

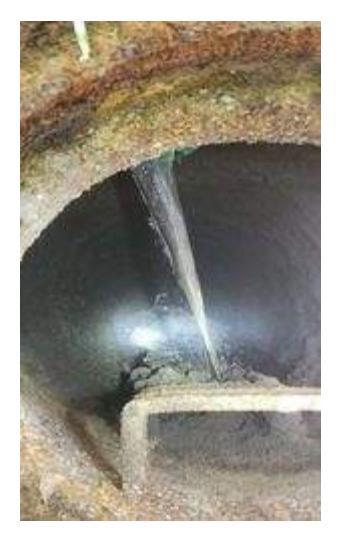
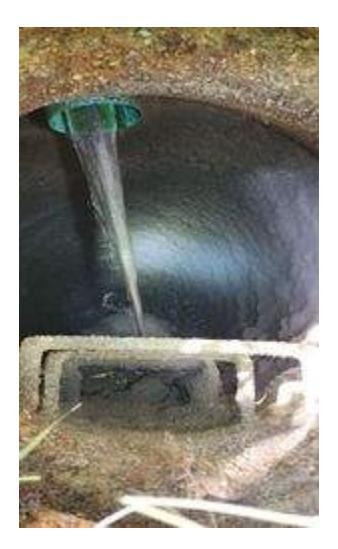
Asset ID WW 07

<u>Outlet Clock</u> (Facing N	<u>Position</u> Iorth)	<u>Outlet Pipe</u> Diameter (in.)		<u>Outlet Pipe</u> <u>Material</u>		<u>Outlet Pipe Invert</u> <u>Depth (in.)</u>
3		12		AC		189
	Manhole	Details		Manhole Condition		
Where is the	Where is the Away		What is the cover condition?	Servi	icable	
located?	_			on the cover?		
What material is the manhole?	Concret	e		What is the ring and frame condition?		
What cover size is the	26"			Other notes on the ring and frame?	Corro	oded
What barrel size is the	48"			What is the cone and riser condition?	Servi	iceable
manhole? Other general				Other notes on the cone and riser?	Debr	is covering cone
notes on the manhole				What is the barrel condition?	Servi	iceable
detalls?				What is the ladder	Servi	iceable
	Hydra	iulics		condition? What is the		
Indication of	None			bench condition?	Servi	iceable
Issues related to				Other notes on the bench?	Debr	is covering bench

General			
Structural Condition	Good		
Operational Condition	Good		
Debris Amount	Heavy		
Cleaning Needed	Yes		
Standing Water	No		
Flow	Неаvy		
Maintenance Needed	No

Notes
Structural Notes	
General Notes	Needs cleaning. Manhole coated in debris

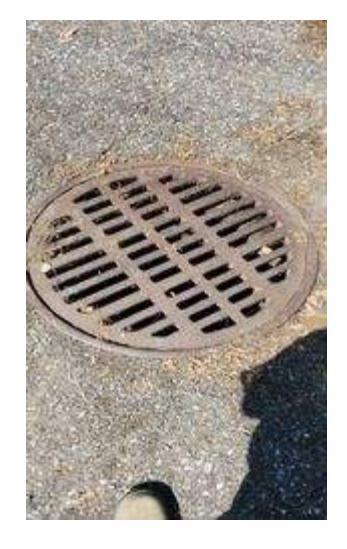
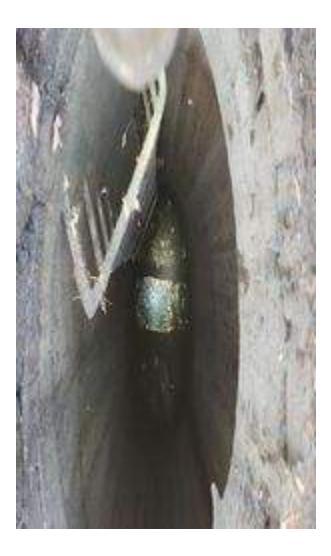
Asset ID WW 08

<u>Outlet Clock</u> (Facing N	<u>Position</u> lorth)	<u>Outlet Pipe</u> Diameter (in.)	<u>Outlet Pip</u> <u>Material</u>	<u>e</u>	<u>Outlet Pipe Invert</u> <u>Depth (in.)</u>	
12		12	AC		182	
	Manhole	Details		Manhole Condition		
Where is the	Where is the Roadway		What is the cover condition?	Holes	5	
manhole located?			Other notes on the cover?	Catch basin style cover		
What material is the manhole?	Concret	e	What is the ring and frame condition?	Servi	ceable	
What cover size is the manhole?	26"		Other notes on the ring and frame?			
What barrel size is the	48"		cone and riser condition?	Serviceable		
Other general	Open se	ewer manhole	Other notes on the cone and riser?			
notes on the manhole	connect	ed with storm	What is the barrel condition?	Servi	ceable	
detalls?	Hydro	ulice	What is the ladder	Servi	ceable	
Indication of	None		What is the bench condition?	Servi	ceable	
Issues related to			Other notes on the bench?

General					
Structural Condition	Good				
Operational Condition	Good				
Debris Amount	Moderate				
Cleaning Needed	No				
Standing Water	Yes				
Flow	Trickle				
Maintenance Needed	No

Notes
Structural Notes	
General Notes	Needs cover replacement

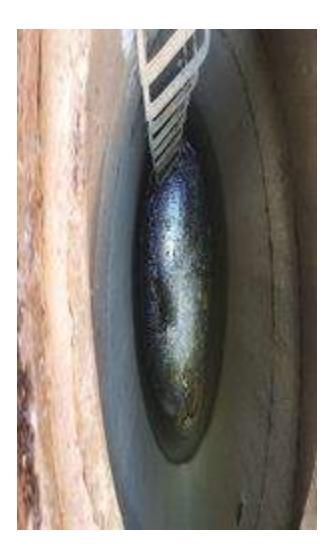
Asset ID WW 09

Outlet Clock Position (Facing North)Outlet Pipe Diameter (in.)				<u>Outlet Pipe</u> <u>Material</u>	<u>e</u>	<u>Outlet Pipe Invert</u> <u>Depth (in.)</u>			
3		12		AC		128			
	Manhole	Details		Manhole Condition					
Where is the	Roadwa	Roadway		What is the cover condition?	Servicable, Holes				
manhole located?				Other notes on the cover?	Catch basin style cover				
What material is the manhole?	Concret	e		What is the ring and frame condition?	Servi	ceable			
What cover size is the manhole?	'hat over size 26" the			Other notes on the ring and frame?					
What barrel size is the	What barrel size 48" is the			what is the cone and riser condition?	Servi	ceable			
Other general				Other notes on the cone and riser?					
the manhole	No met	5		What is the barrel condition?	Serviceable				
	Hydra	nulics		What is the ladder condition?	Servi	ceable			
Indication of	Indication of surcharge? Issues related to			What is the bench condition?

General					
Structural Condition	Good				
Operational Condition	Good				
Debris Amount	Moderate				
Cleaning Needed	No				
Standing Water	Yes				
Flow	None				
Maintenance Needed	No

Notes							
Structural Notes							
General Notes	Catch basin style cover

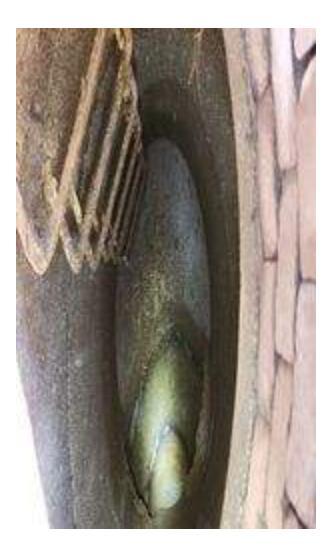
Asset ID WW 10

Outlet Clock Position (Facing North)Outlet Pipe Diameter (in.)		<u>Outlet Pipe</u> <u>Material</u>		<u>Outlet Pipe Invert</u> <u>Depth (in.)</u>				
6		12	AC		114			
	Manhole	Details		Manhole Condition				
Where is the Grass			What is the cover condition?	Servicable				
manhole located?			Other notes on the cover?					
What material is the manhole?	Concret	e	What is the ring and frame condition?	Servi	ceable			
What cover size is the manholo?	26"		Other notes on the ring and frame?					
What barrel size is the	<u>?</u> 2e 48"		What is the cone and riser condition?	What is the cone and Serviceable riser condition?				
Other general			Other notes on the cone and riser?					
notes on the manhole			What is the barrel condition?	Servi	ceable			
details?	Hydra	ulics	What is the ladder Serviceable		ceable			
Indication of	Indication of None		What is the bench condition?	Servi	ceable			
Issues related to			Other notes on the bench?

General					
Structural Condition	Good				
Operational Condition	Good				
Debris Amount	None				
Cleaning Needed	No				
Standing Water	No				
Flow	Steady				
Maintenance Needed	No
