PACIF Risk Management Report

Member: Richmond Town

Visit Date: 05/02/2023

Location Detail: Volunteer Park

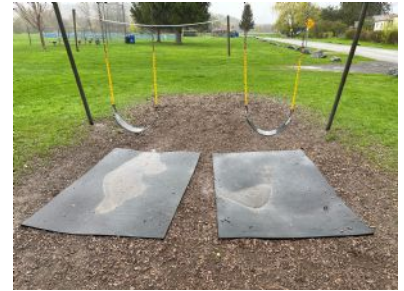
Issue ID: 8492

Issue: Playground surfacing materials had thinned out in several locations. Loose-fill surfacing materials require special maintenance.

Recommendation: Mark ideal surfacing depths on equipment posts. Monitor surface material depths and distribution and rake displaced material back into its proper place so that a constant depth is maintained throughout the playground. New material will need to be added periodically to maintain the appropriate surfacing depth.

You will need 9 inches of wood chips based on the height of the highest play structure.

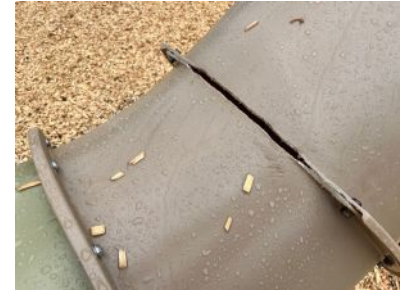
Issue ID: 8494

Location Detail: Volunteer Park - Tube Slide

Issue: There was significant damage to recreational equipment or play equipment.

Recommendation: Complete repairs to the item in question. If this is not possible, remove the damaged equipment from the playground/park.

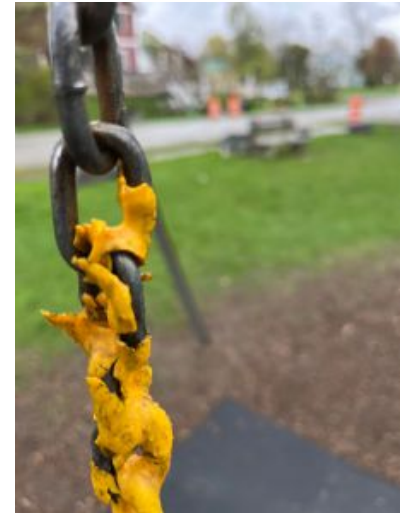
Issue ID: 8496 **Priority:** **Suggested Correction Date:** **Status:** Open

Location: Playground & Related **Location Detail:** Volunteer Park - Plastic coating on the swings.

Issue: Sections of wooden play equipment exhibited sharp corners, were rough or had splinters present.

Recommendation: Sharp points, corners, or edges on any part of the playground or playground equipment may cut or puncture a child's skin. Plastic play elements must be regularly maintained to eliminate the potential for cuts.

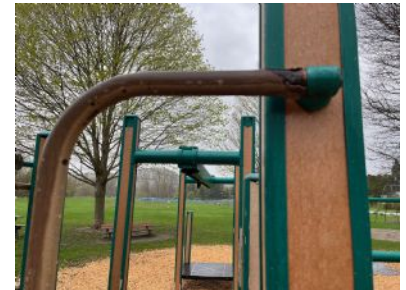
Issue ID: 8497 **Priority:** MEDIUM **Suggested Correction Date:** 07/01/2023 **Status:** Open

Location: Playground & Related **Location Detail:** Volunteer Park - main play structure

Issue: There was significant damage to recreational equipment or play equipment.

Recommendation: This damage was not significant and can easily be repaired until funds are available for new play structures. Although, not significant, there were many areas where plastic was peeling off the metal of the play structures. See example photo.

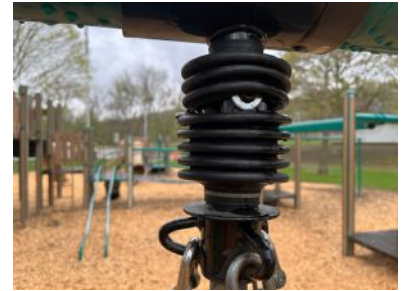
Issue ID: 8498 **Priority:** LOW **Suggested Correction Date:** 07/31/2023 **Status:** Open

Location: Playground & Related **Location Detail:** Volunteer Park - Tire swing swivel rubber boot

Issue: There was significant damage to recreational equipment or play equipment.

Recommendation: Rubber, swivel boot cover for tire swing is damaged and in need of replacement

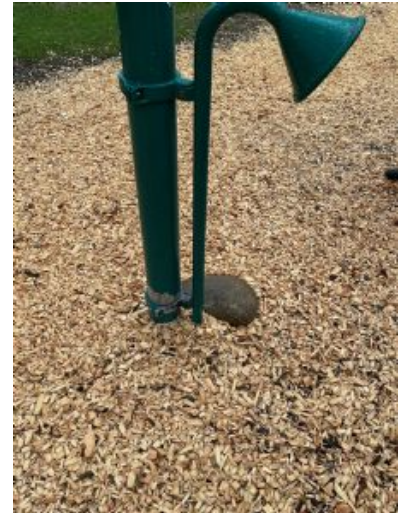
Issue ID: 8499 **Priority:** MEDIUM **Suggested Correction Date:** 07/01/2023 **Status:** Open

Issue: A portion of a walkway was uneven, contained gaps, or posed other trip/fall hazards to users..

Recommendation: All walkways and paths should be kept in good condition to prevent slips, trips and falls.

Remove or cover rock with wood chips. See photo.
