FY 2025 Municipal Highway Grant Application

RICHMOND TOWN HIGHWAY STRUCTURES FY 25 GRANT REQUEST PROJECT DESCRIPTION AND SCOPE OF WORK

Location: Stage Road TH 14 (culvert #1410)

RE: Hydraulic Study – Stage Road (TH14)
GPS Coordinates: 44.39374 N / -72.93248W
Waterbody: Unnamed tributary to the Winooski River

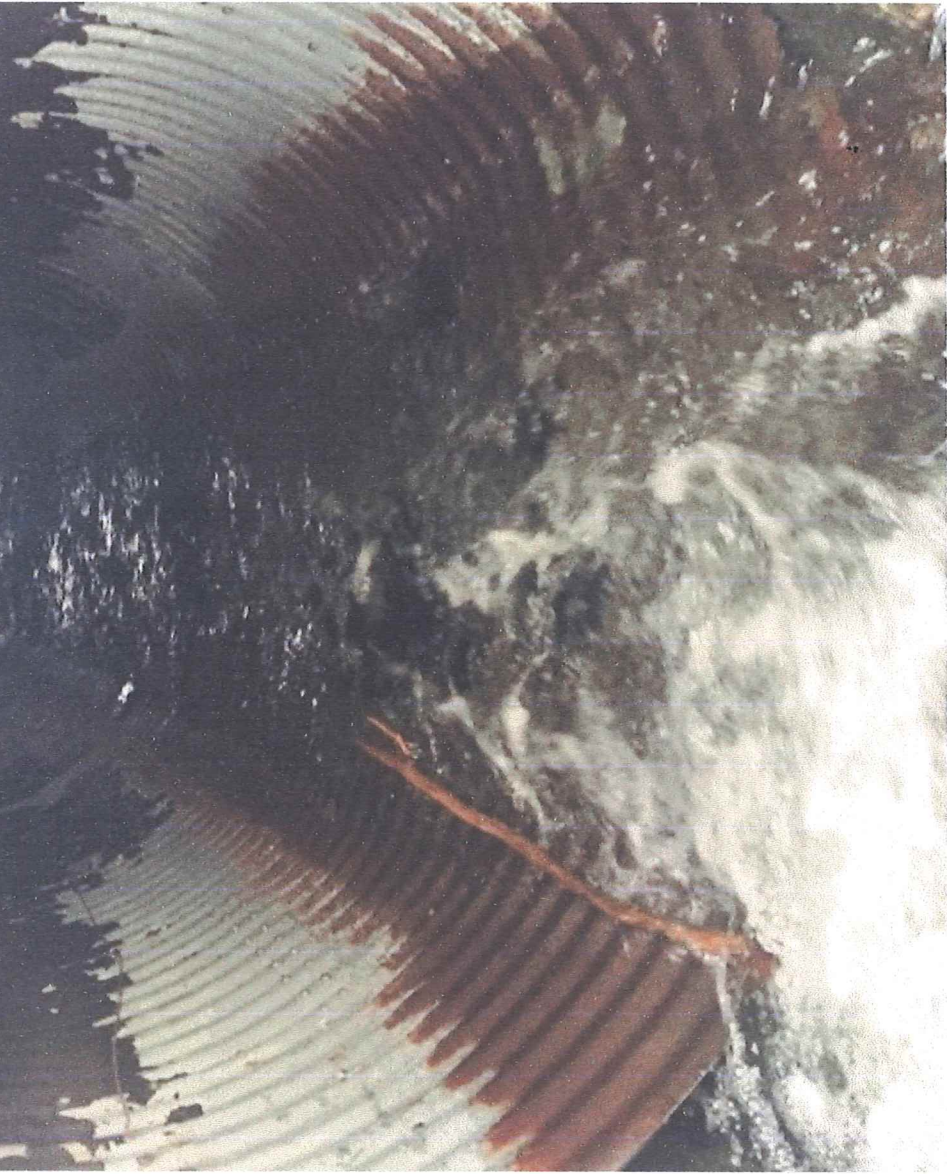
1410 FROM INLET

Culvert is deteriorated and too short for the crossing. The hydraulic study concludes the culvert is undersized. Guardrails are tipping out from the road due to lack of adequate shoulder. The center of the culvert is bowed and showing signs of collapse. Culvert overtopped from the July 16, 2023 storm and washed out 2650 feet of Stage Road.

Replace 60"x40' cmp road crossing culvert to a 142" x 91" x 60" corrugated metal arch pipe with poured in place concrete headwalls. Install new guardrails.
